FULFORD WATER SERVICE COMMISSION SPECIAL MEETING

Fulford Water System Asset Management Plan

McElhanney Consulting Services Ltd.

FULFORD WATER SYSTEM ASSET CONDITION ASSESSMENT TABLE

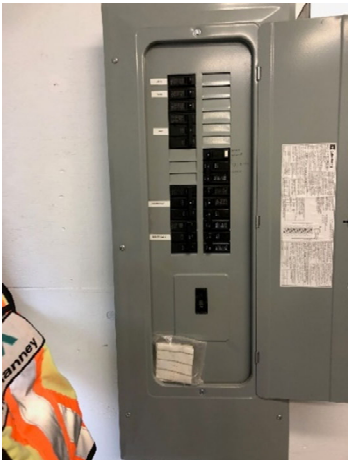
Description:
		Site Main Incoming Electrical Service
		Observation:
		Panel Directory needs to be finalized
		CRD Personnel Observation:

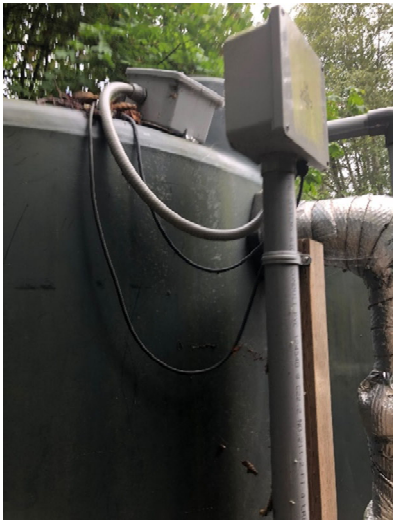
Description:
	Storage Tanks
	<p>Observation:</p> <p>Onsite storage tanks have exposed cabling for level transducers and floats, all subject to vandalism.</p>
<p>CRD Personnel Observation:</p> <p>No issues noted</p>

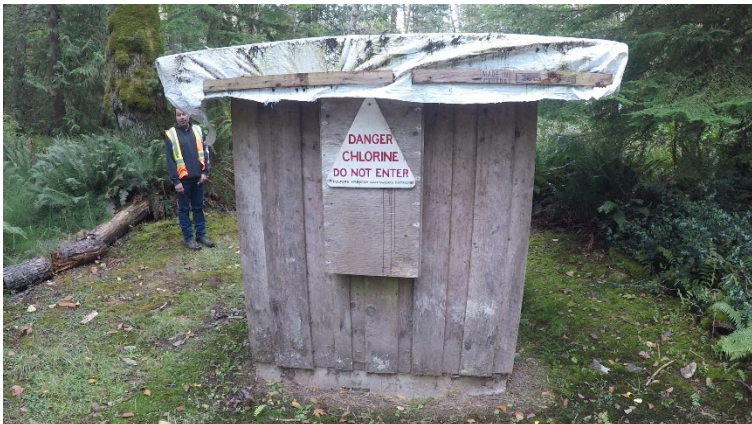
Description:
	Raw Water Flow Meter Shed
	Observation: View of the shed housing a raw water meter and strainer assembly. The asset was previously used for chlorination of raw water supply. Currently, it is used for flow metering and leak detection in the raw water supply line.

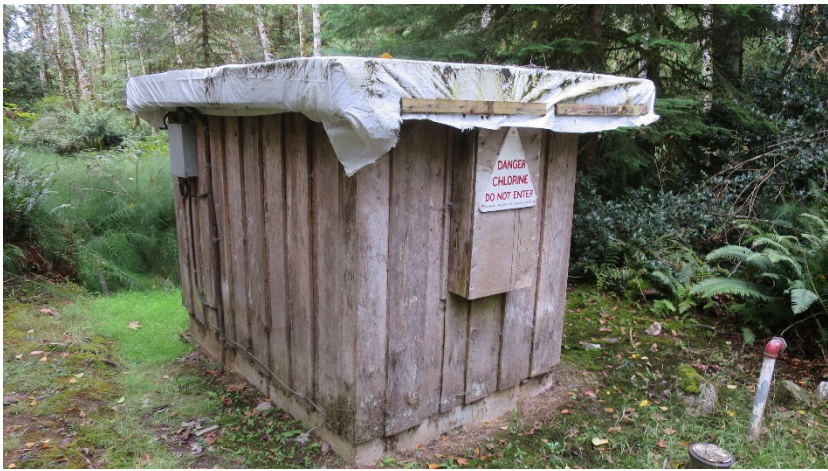
Description:
	Strainer Building.
	Observation:

Roof is leaking and exterior finishes have exceeded life expectancy.
	CRD Personnel Observation:
	No issues noted

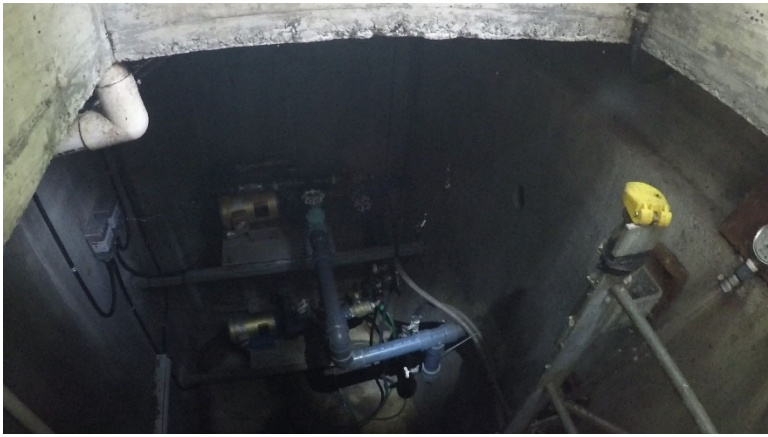
Description:
	Sunnyside Pump Station
	<p>Observation:</p> <p>Top view of a booster duplex pump station feeding the water treatment plant. Access to the pump station is restricted due to confined space entry.</p>

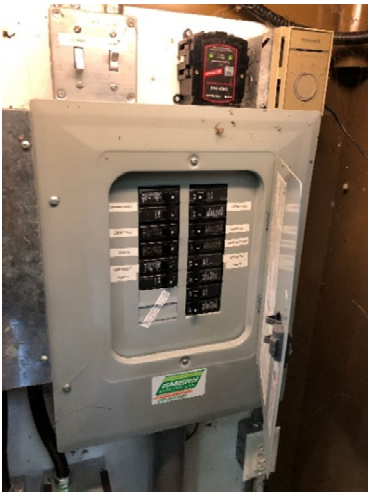
Description:
	Site Main Incoming Electrical Service
	Observation: Annual house keeping, vacuum enclosure needs to be preformed along with kiosk maintenance plans.

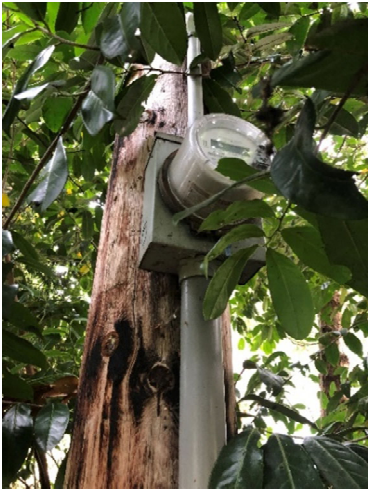
Description:
	Pole mounted BC Hydro meter
	Observation: Tree trimming needs to be performed
	CRD Personnel Observation:
	No issues noted

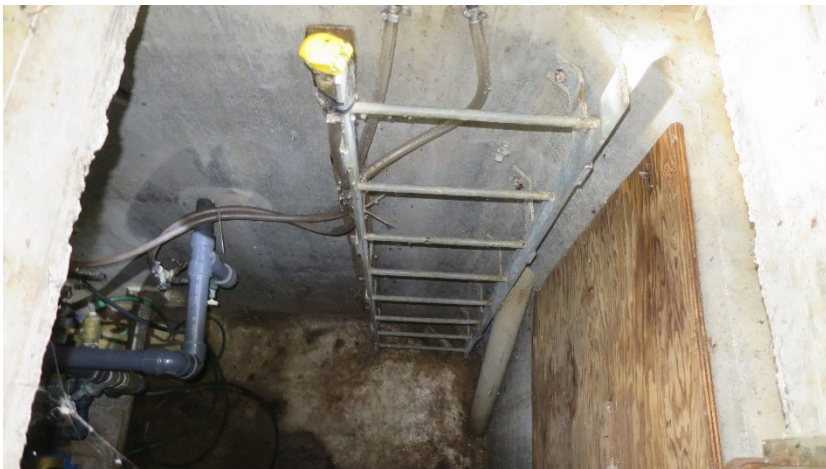
Description:
	Ladder to the tank.
	Observation: Access ladder has safety post as per requirements. Access is considered confined space and requires lifting apparatus for personnel.
	CRD Personnel Observation:
	No issues noted

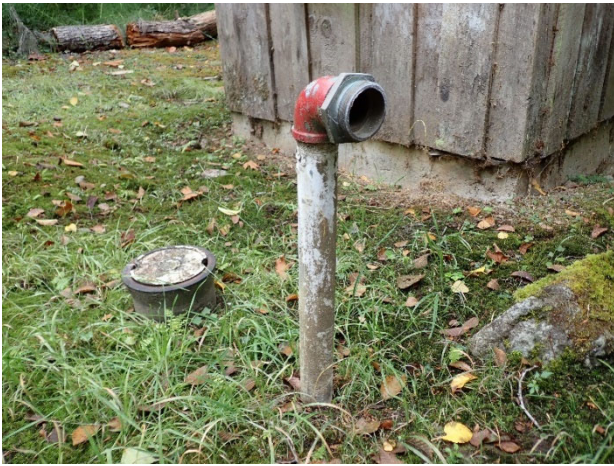
Description:
	Standpipe
	Observation:
	In general, all standpipes should have cap on outlet.

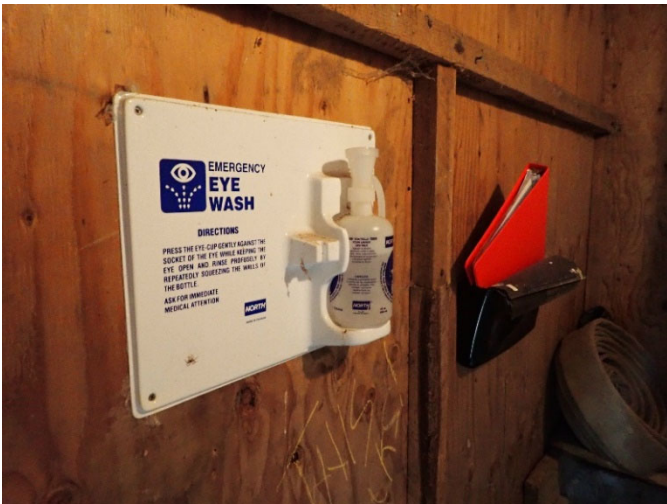
Description:
	Eye Wash Station
	Observation:
	No issues noted. Raw water meter building is suggested to be decommissioned, as the building is deemed not safe.

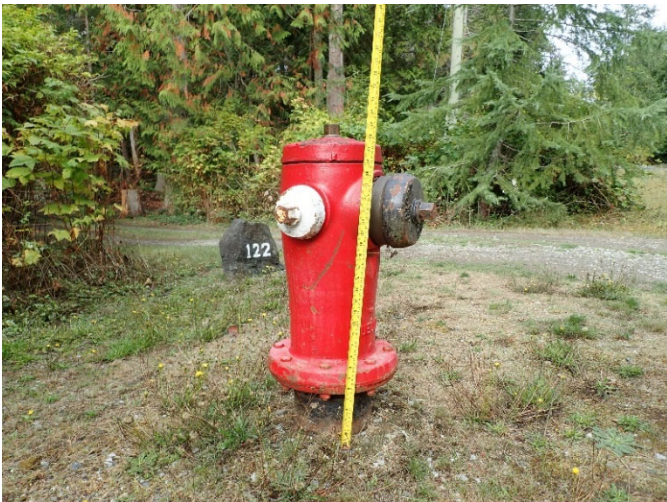
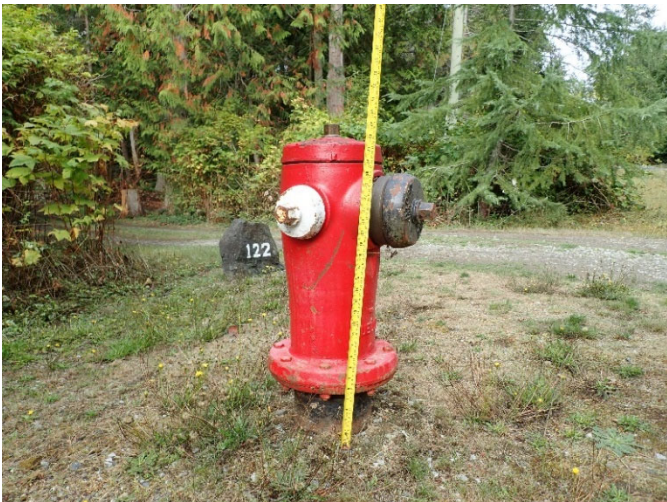
Description:
	Fire hydrant at 122 Sunnyside Drive
	Observation:
	Fire hydrants are in good condition but requires operational maintenance.

CRD Personnel Observation:
	Fire hydrants have not been maintained.
