SOUTHERN GULF ISLANDS HARBOURS COMMISSION
Notice of Meeting on **Thursday, November 23, 2023 at 9:30 a.m.**
Saanich Peninsula Wastewater Treatment Plant Meeting Room,
9055 Mainwaring Road, North Saanich, BC

Southern Gulf Islands Harbours DOCK INSPECTION REPORT

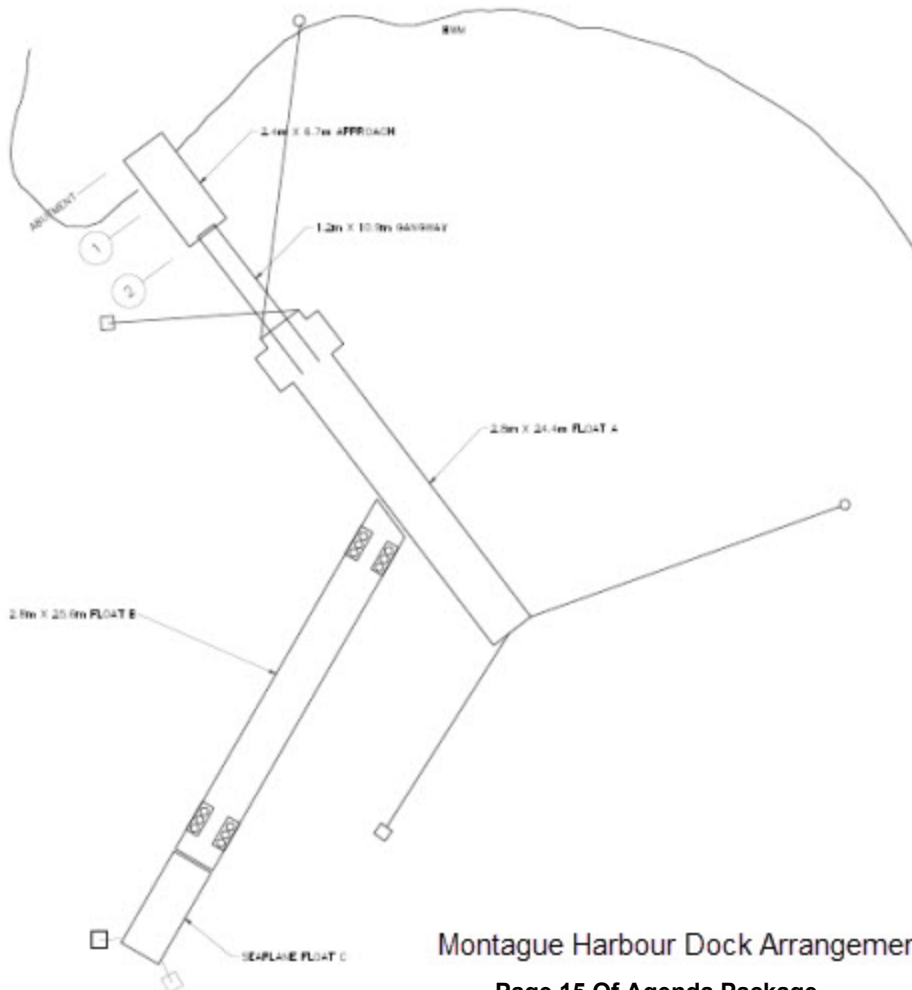
Montague Harbour Dock Arrangement

GANGWAY FLOATS	The aluminum gangway is in good condition, the transitions plates are freshly painted with non-skid and the wheels and guide rails are also in good condition.
	Float A is in fair condition for it's age. The decking and bull rails are in good condition and the bull rail bolts are tight and the flotation is good. Pressure washing is required in the area around and under the gangway, include the bull rails. The steel pile next to the gangway is in good condition but I couldn't check the anode but it still has weight to it.
	Float B decking, bull rails and flotation are in good condition. The bull rail bolts are tight. There are 4 pile wells with 3 piles/well and all are in good condition with minimal wear showing.
	Float C and D are in good condition, decking, bull rails and flotation have no issues. All bull rail bolts are tight. Yellow paint is required on the Loading Zone and the Sea Plane Landing bull rails. Pressure washing the seaplane landing float is required. There are 2 missing tires on the seaplane landing that require replacement. There is 1 steel pile with an anode that are in good condition.

COMMENTS/INSTRUCTIONS	> Pressure washing as described (A & D float).
	> Yellow paint is required as described (C & D float).
	> 2 tires are required for the Sea Plane Landing float.

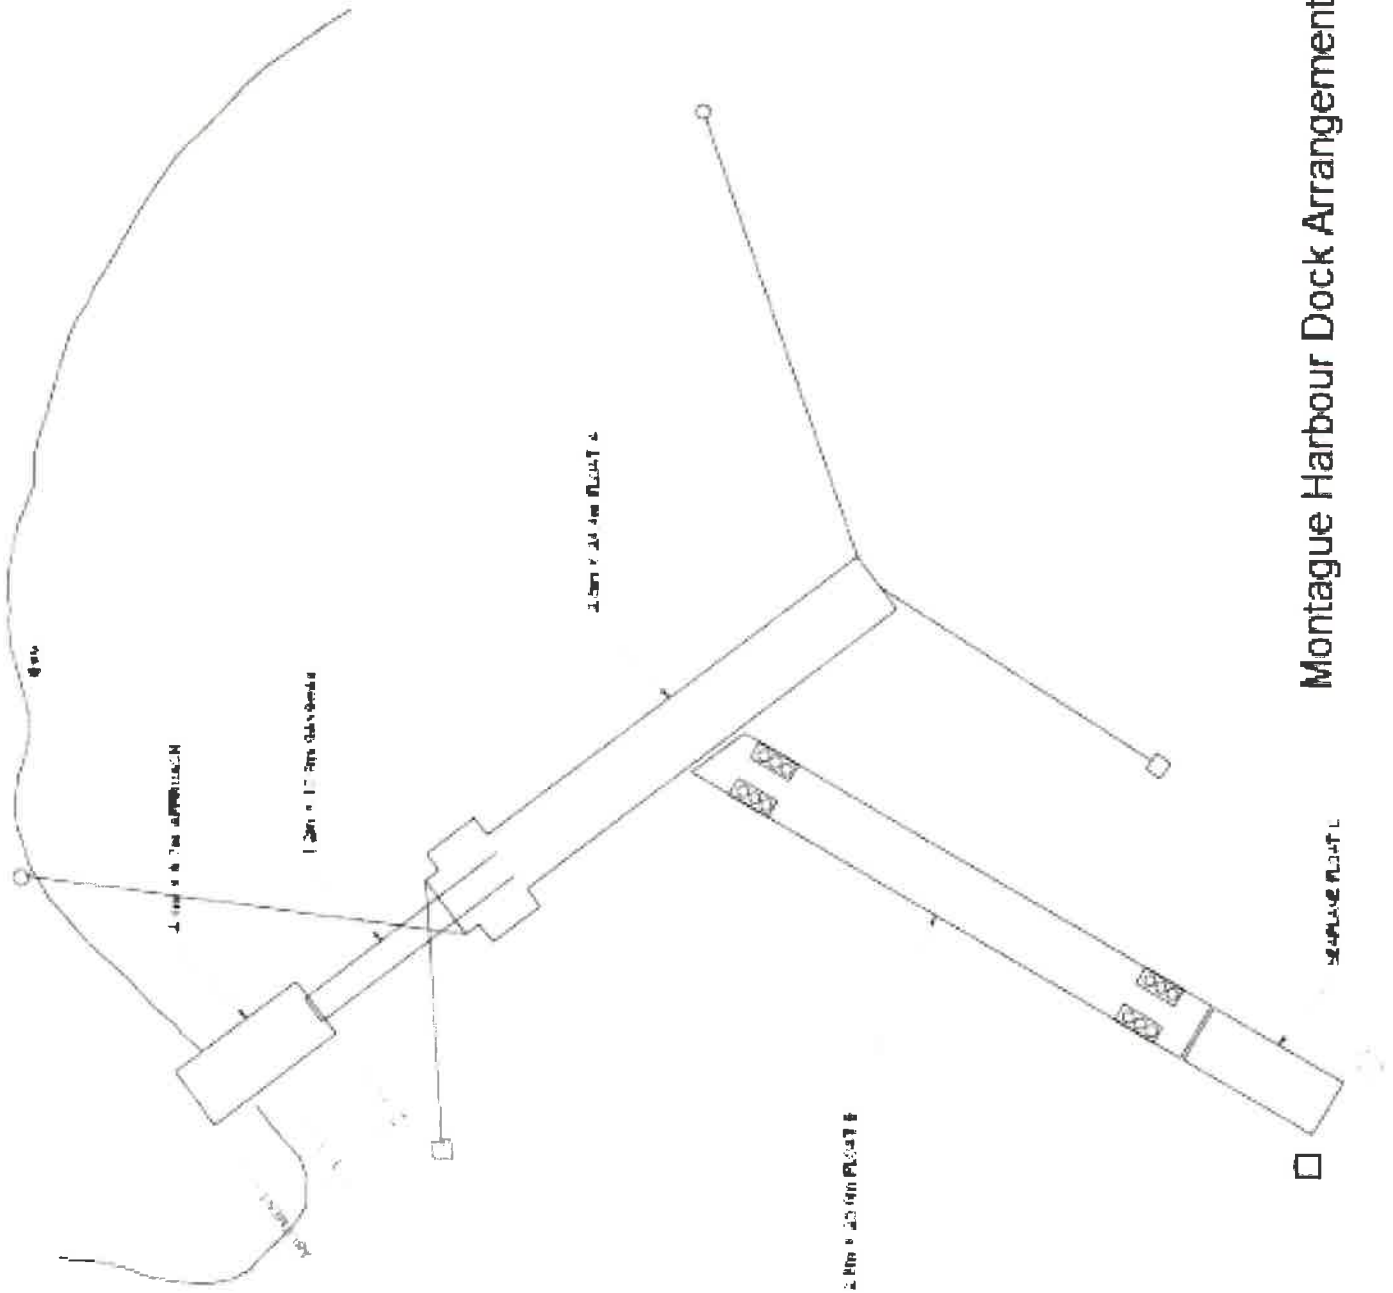
Montague Harbour Dock Arrangement

GANGWAY FLOATS	The top and bottom gangway transition plates have been painted with yellow son-skid paint and the gangway has no issues.
	Float A and the WCMRC float are all in good condition. The steel pile is in good condition, anode is good. Float B is in good condition and all pilings and pile wells are showing minimal wear. The new UHMW rub boards are working as they should! Float C is in good condition, decking is in good condition, bull rail bolts are tight and there is fresh yellow paint for the loading zone bull rails and the float plane landing. The steel pile and anode are in good condition. Float C is in fair condition. A steel pile anode replacement schedule is recommended.

COMMENTS/INSTRUCTIONS	> A schedule replacing the anodes on the steel pilings is recommended.

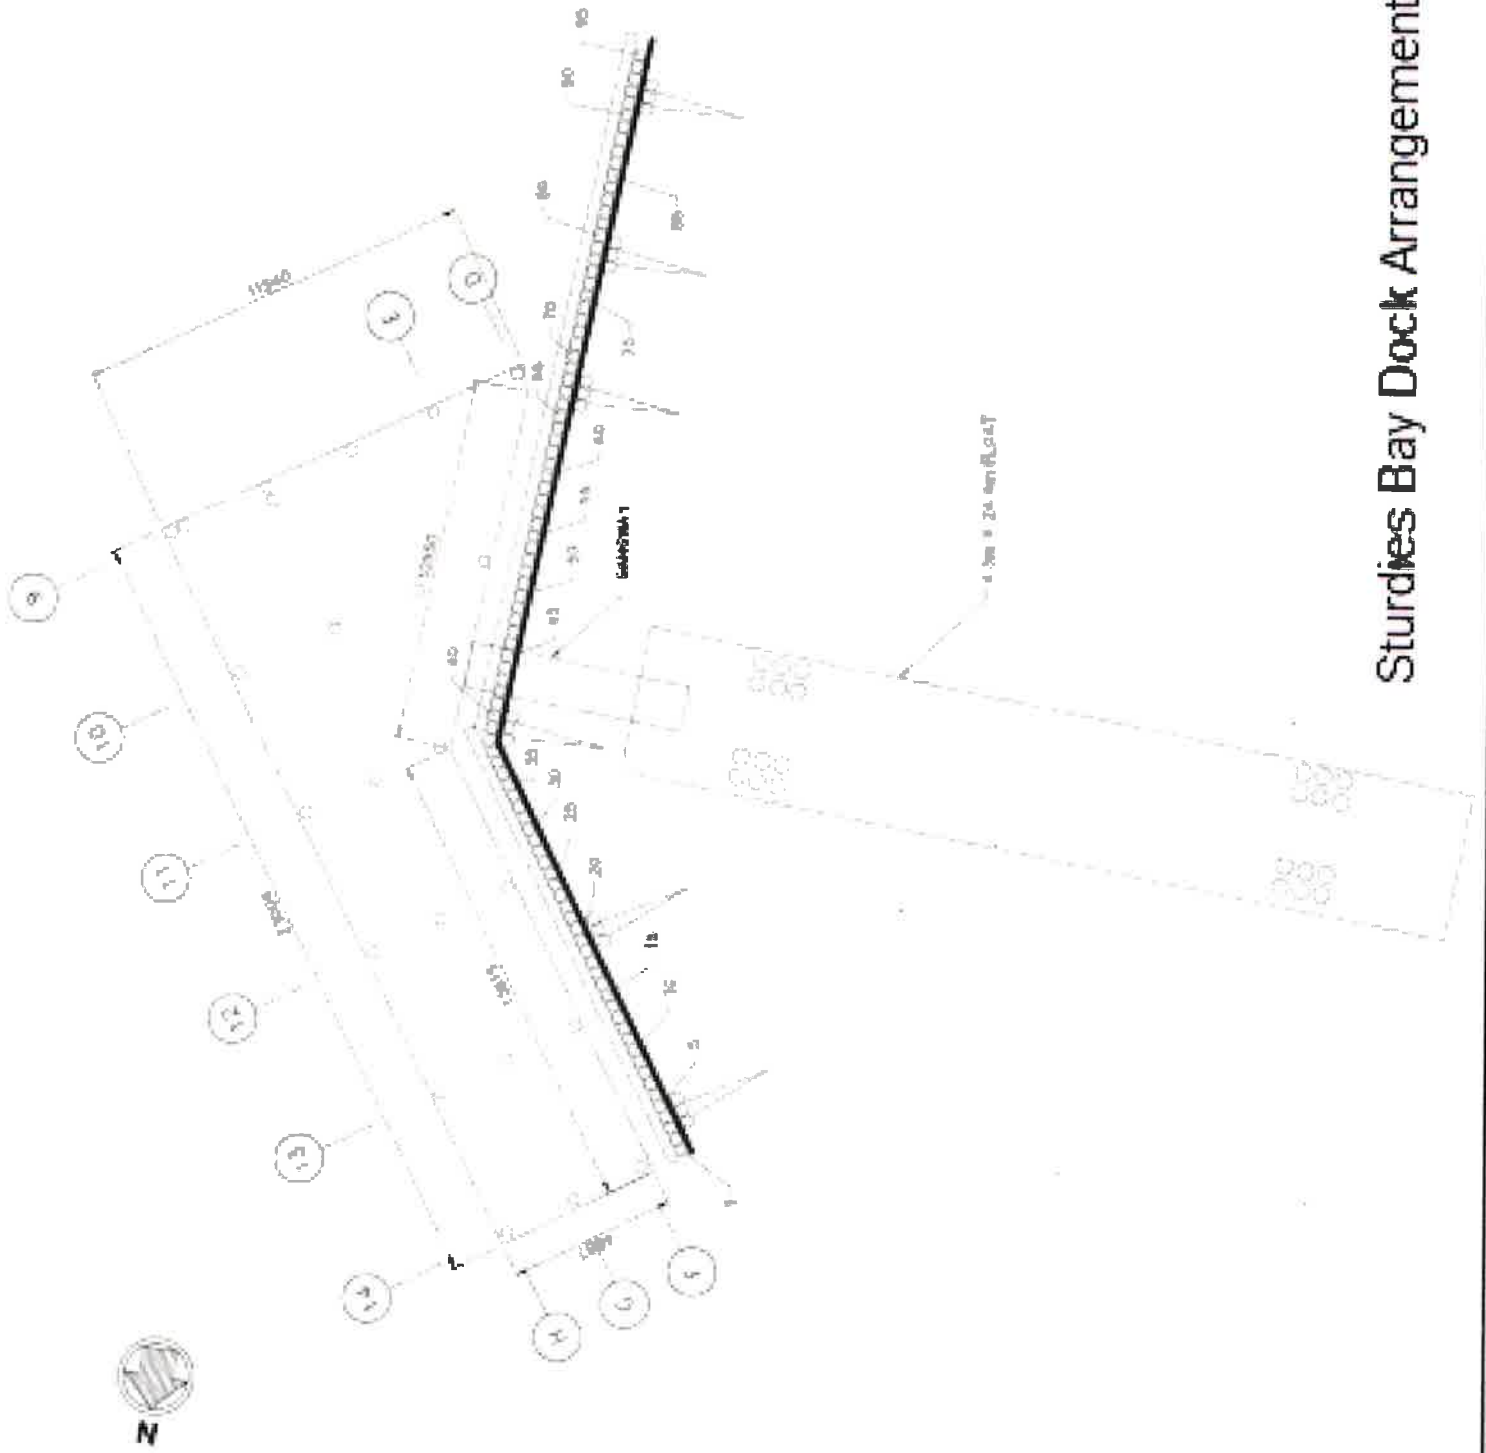
Sturdies Bay Dock Arrangement

COMMENTS/INSTRUCTIONS	<p>> Pressure washing as described.</p>
	<p>> Repair the electrical panel door.</p> <p>> The notice board requires painting.</p>

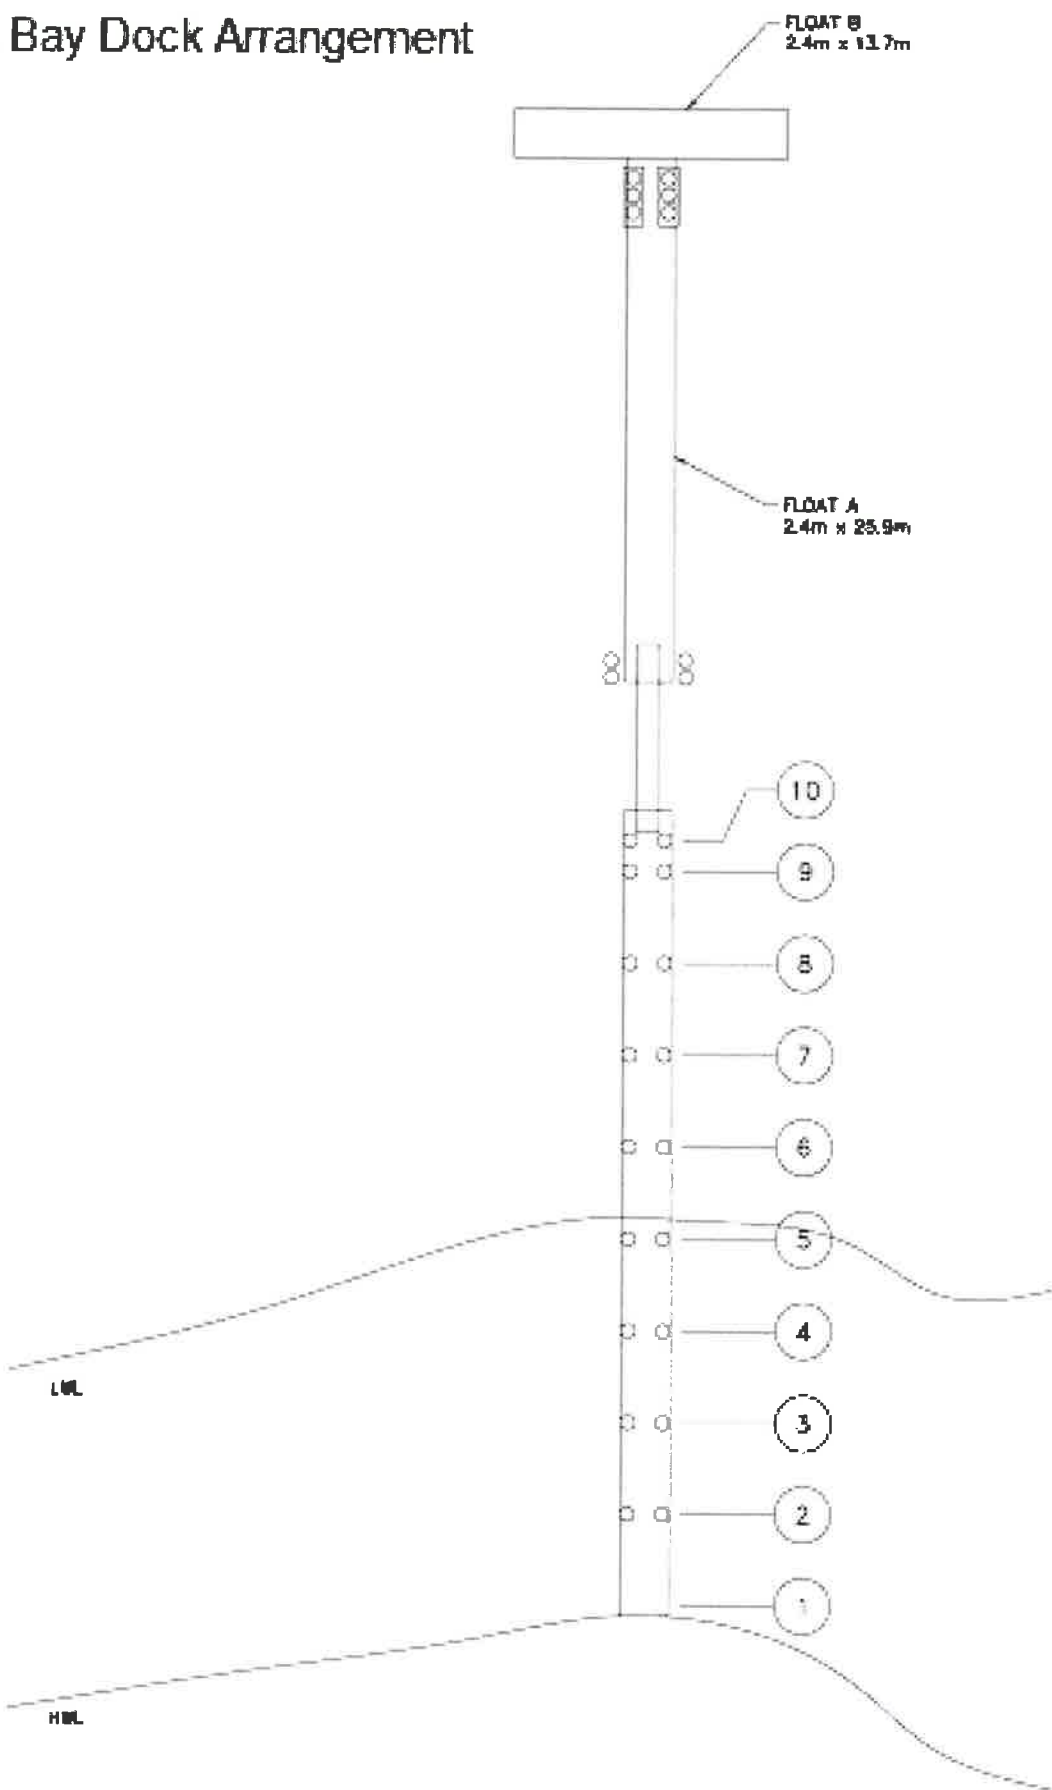
Horton Bay Dock Arrangement

COMMENTS/INSTRUCTIONS	<p>> The decking on the lower half of the approach requires replacement especially in the area of the notice board and the light standard.</p>
	<p>> The railings require painting and some rotten sections require replacement.</p> <p>> A new life ring is required.</p>

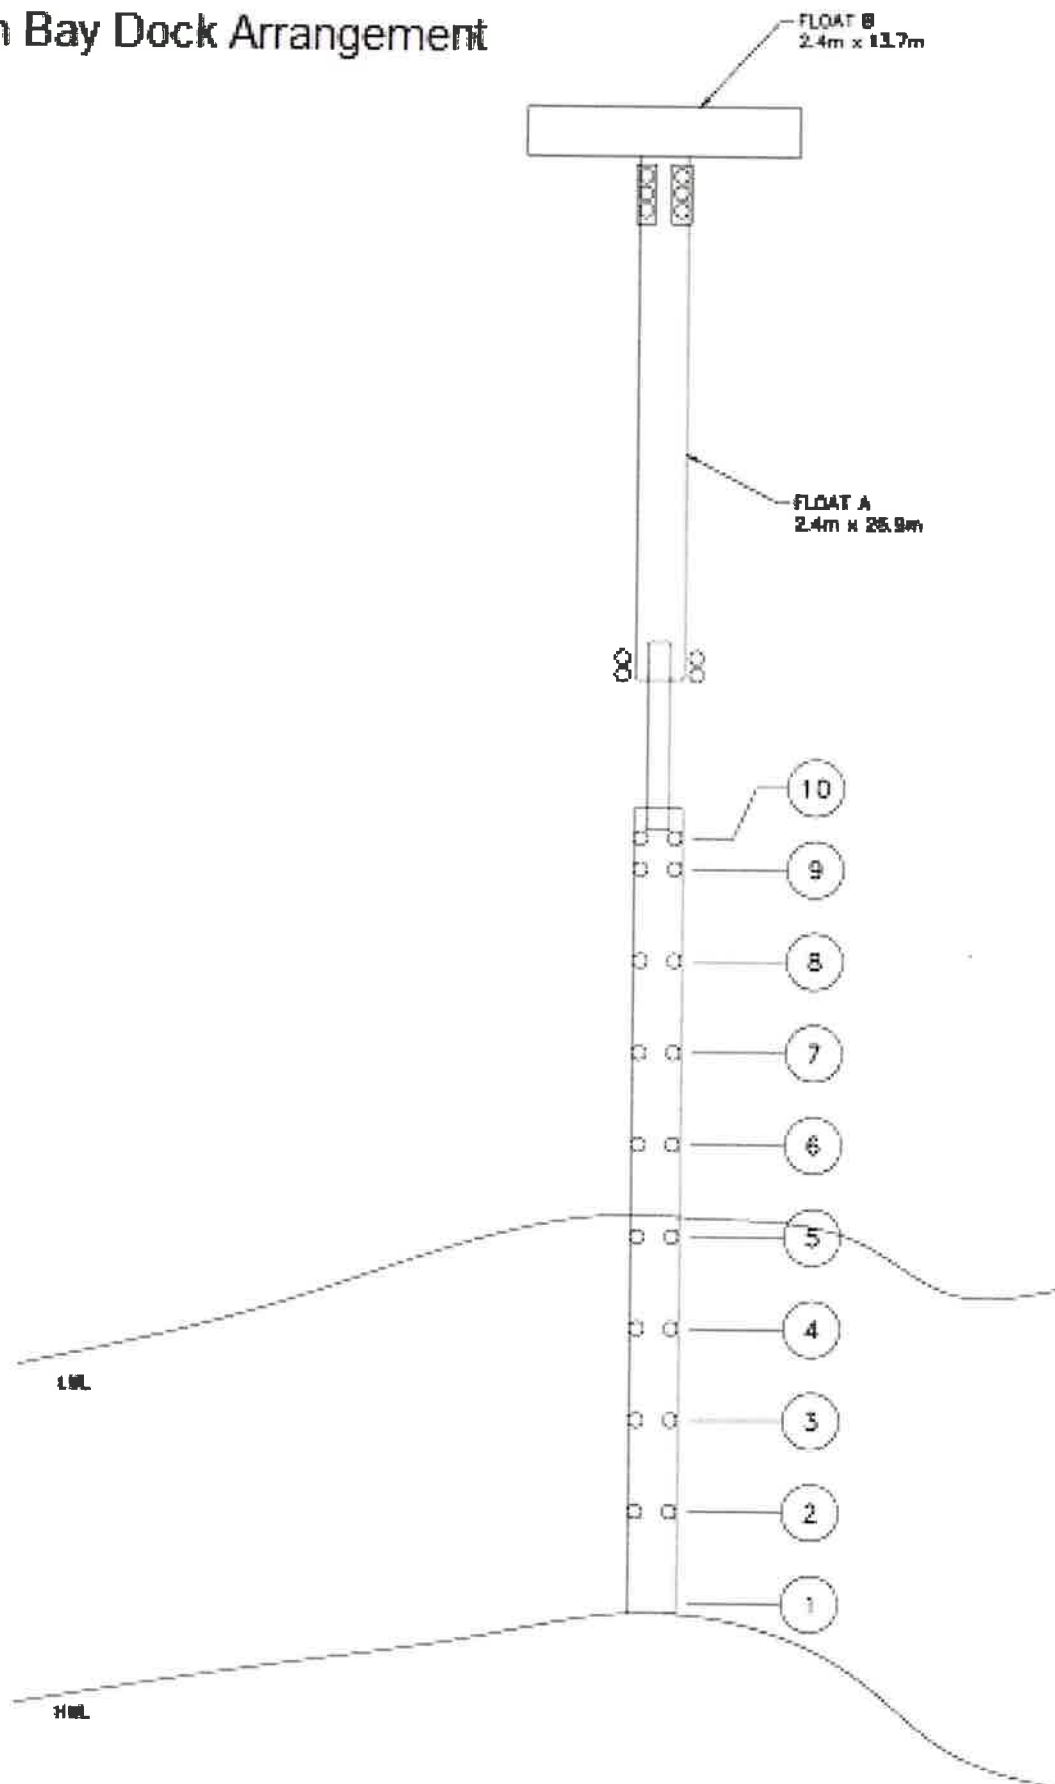
Horton Bay Dock Arrangement

COMMENTS/INSTRUCTIONS	<p>> The decking on the gangway is in serious need of replacement.</p>
	<p>> The decking on the approach along with a few sections of the railing require replacement.</p> <p>> The notice board and lamp standard require secure refastening.</p> <p>> The roller bearings (pillow blocks) and the guide rails require replacement.</p> <p>> The life ring is missing and replacement is recommended</p>

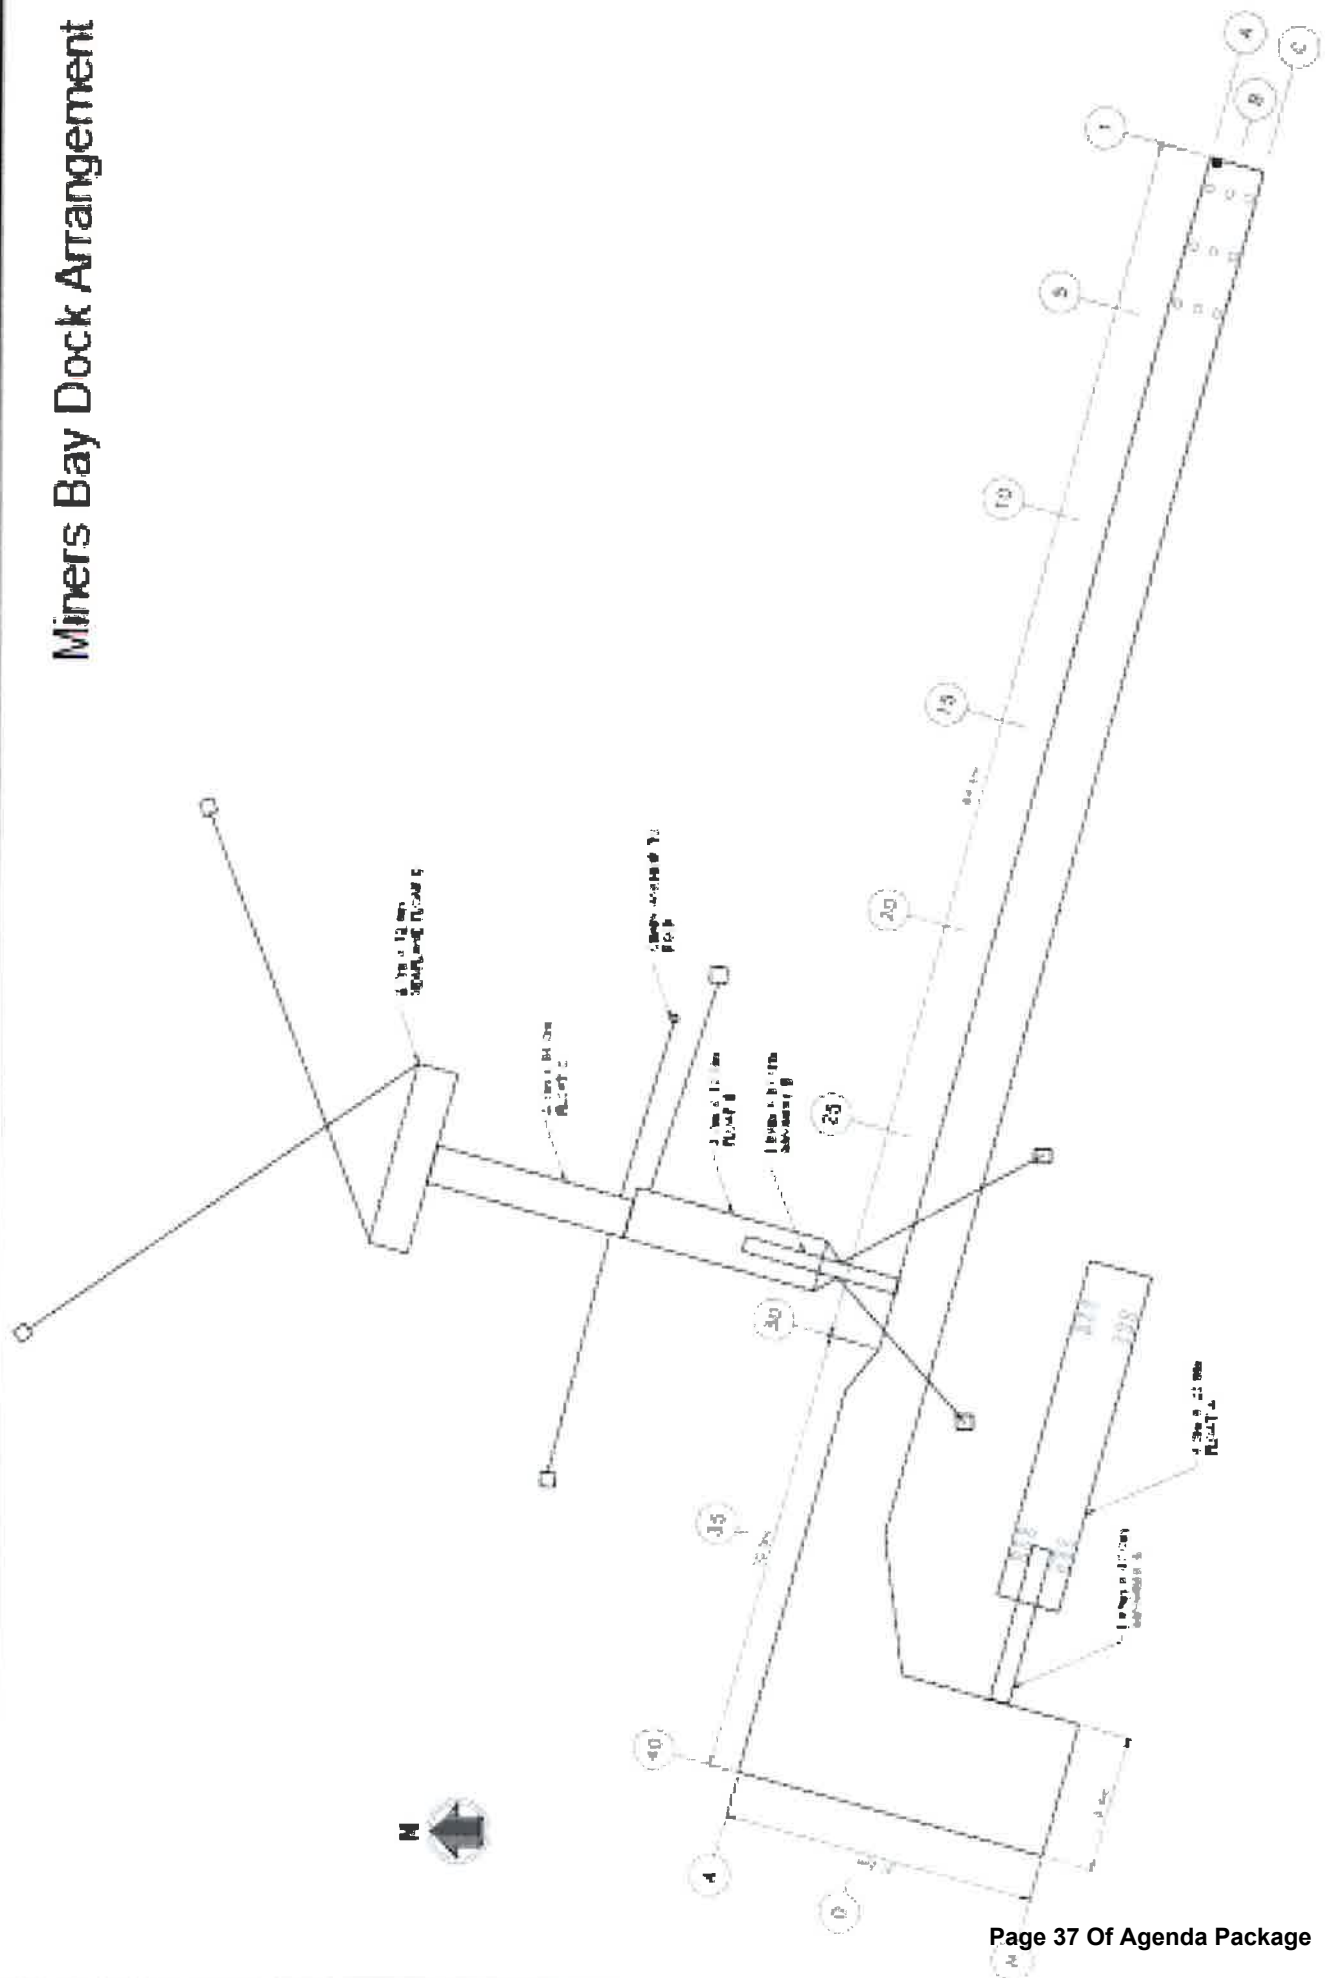
Miners Bay Dock Arrangement

COMMENTS/INSTRUCTIONS	
	<ul style="list-style-type: none"> > Replace rotten notice board. > Inspect all the light standards mounting bolts and condition of decking they are mounted to. > Upgrade gangway A decking. > Replace skid shoe on gangway A bottom transition plate. > Replace worn UHMW backing boards and adjust / refasten UHMW in the pile wells next to float A gangway. > Inspect the position of float B in relation to the end travel of the gangway. Can the float be adjusted back? > Painting is recommended as described. > Inspect bull rail bolts on float B.

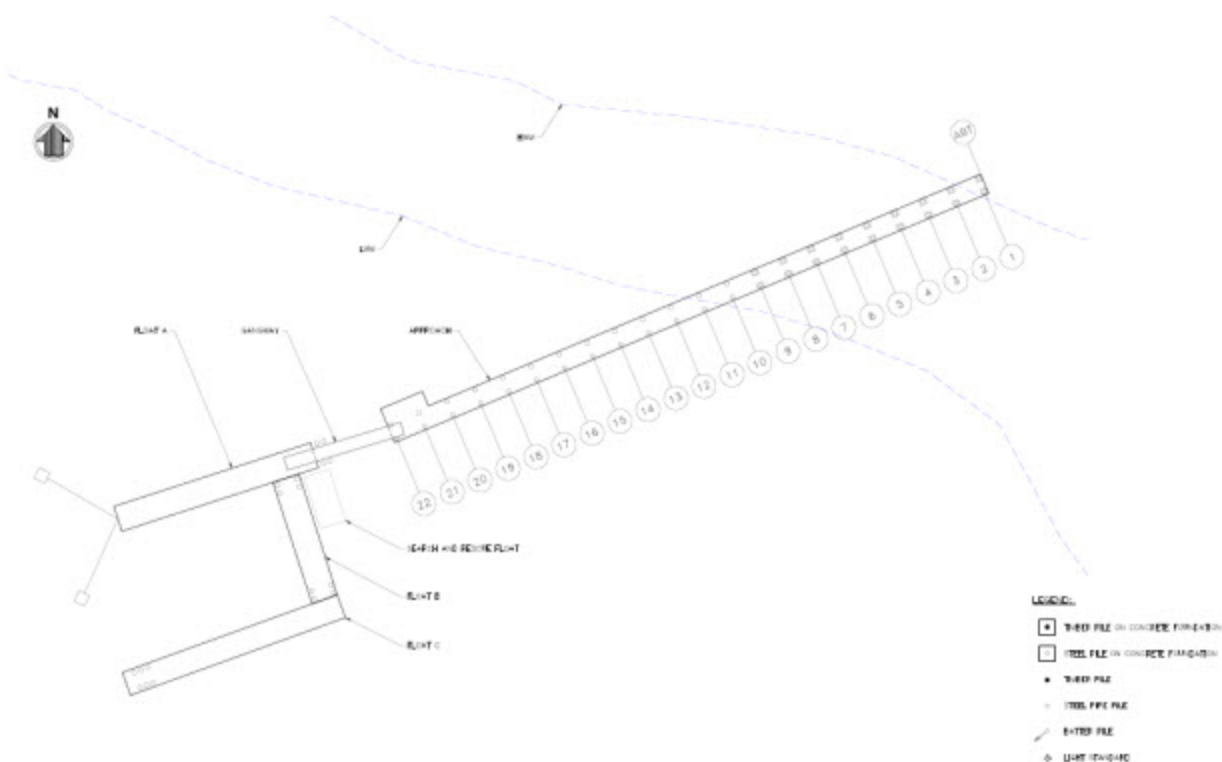
Port Browning Dock Arrangement

COMMENTS/INSTRUCTIONS	<p>> The seriously rotten notice board requires replacement.</p> <p>> The railings on the approach require painting.</p> <p>> The dinghy landing zone requires yellow paint on the bull rails.</p> <p>> A new case is required for the fire extinguisher.</p> <p>> Pressure washing is required as described.</p>
------------------------------	--

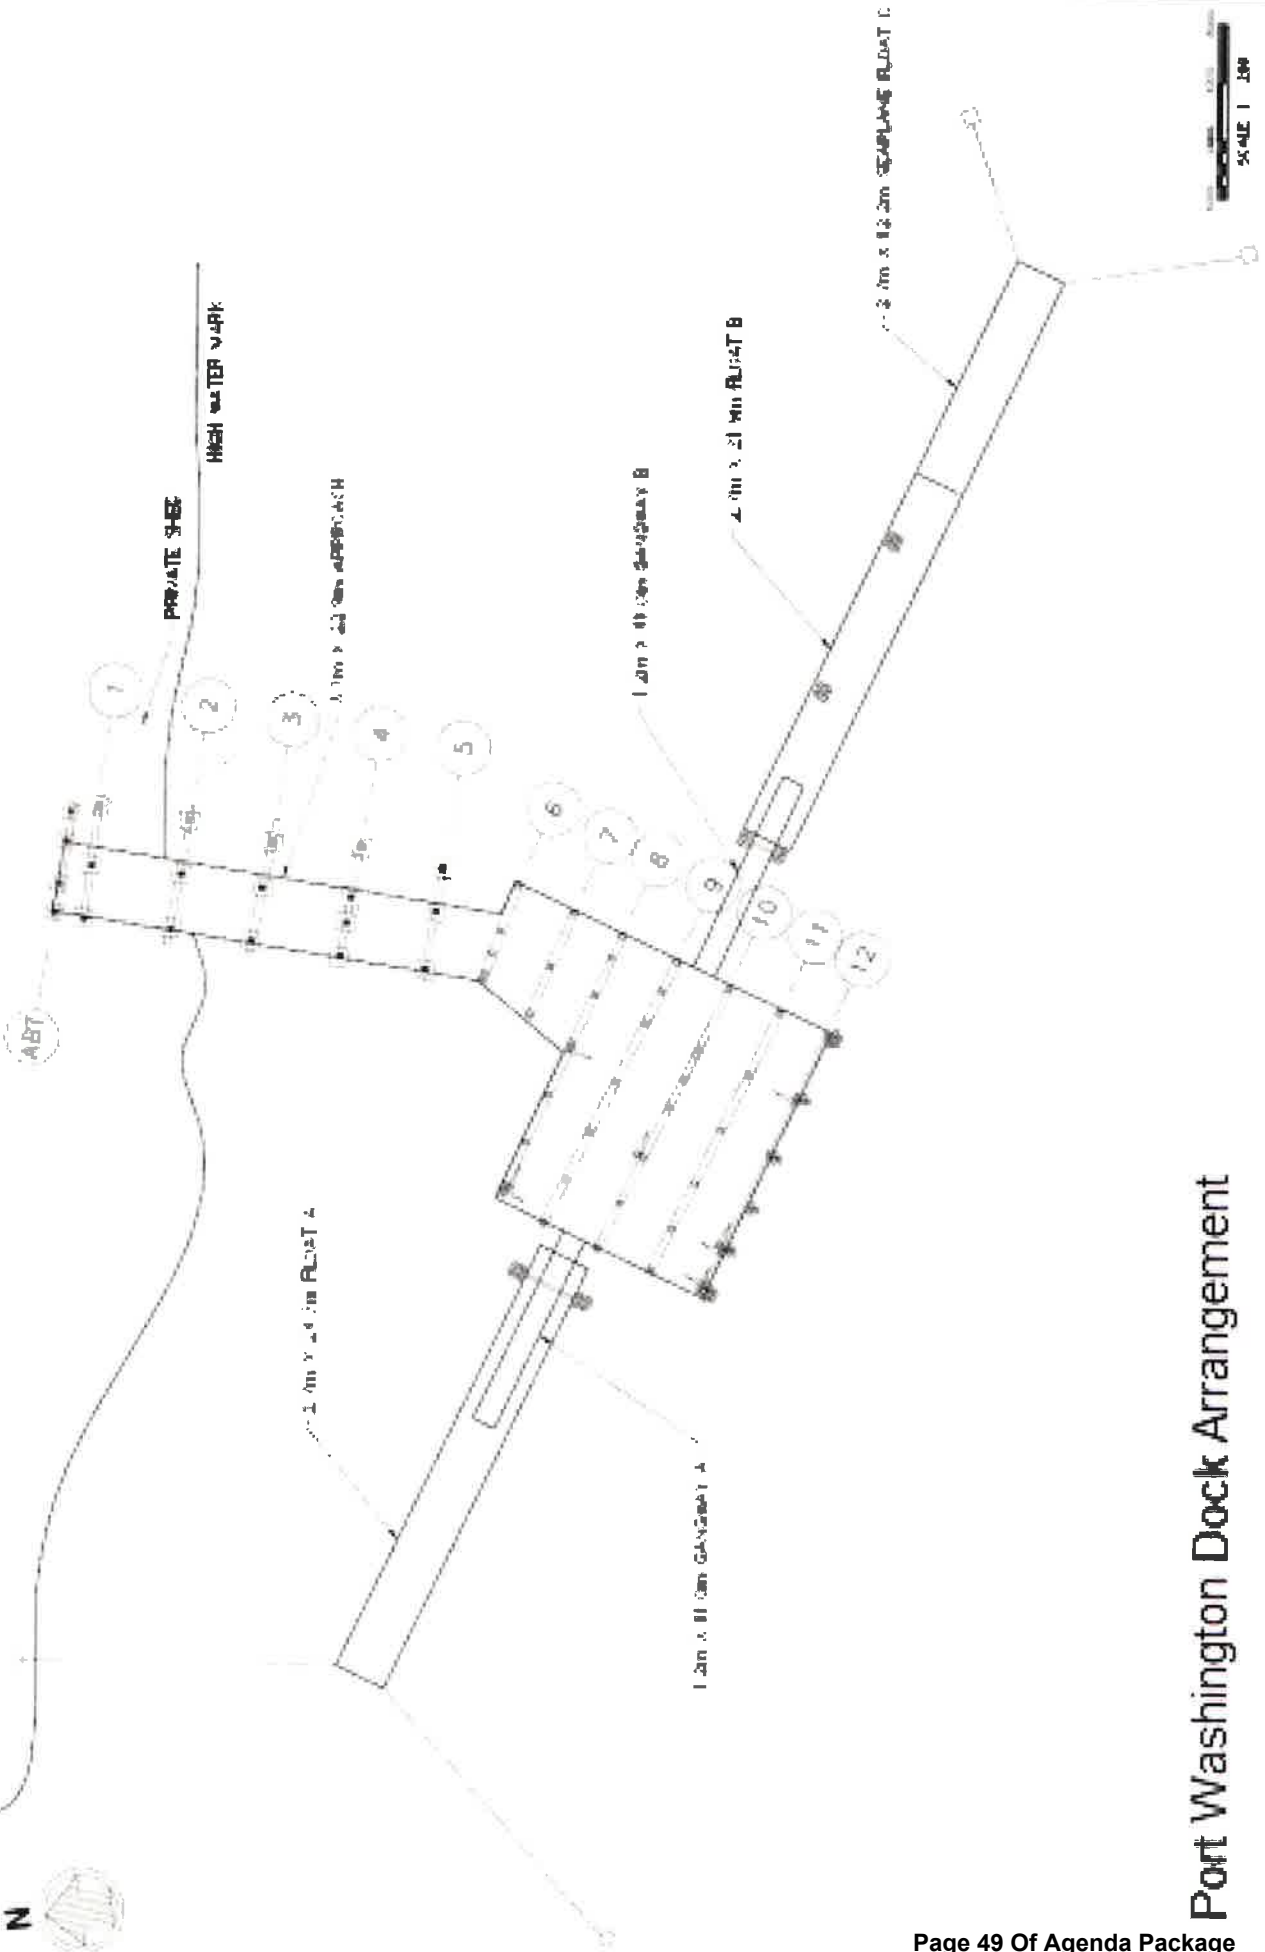
Port Washington Dock Arrangement

COMMENTS/INSTRUCTIONS	<p>> Replace rotten Notice Board</p> <p>> Reposition roller shaft in the bearings on gangway A.</p> <p>> Replacement of sections of bull rail on float B and the framing around the 2 pile wells is recommended.</p>
------------------------------	---

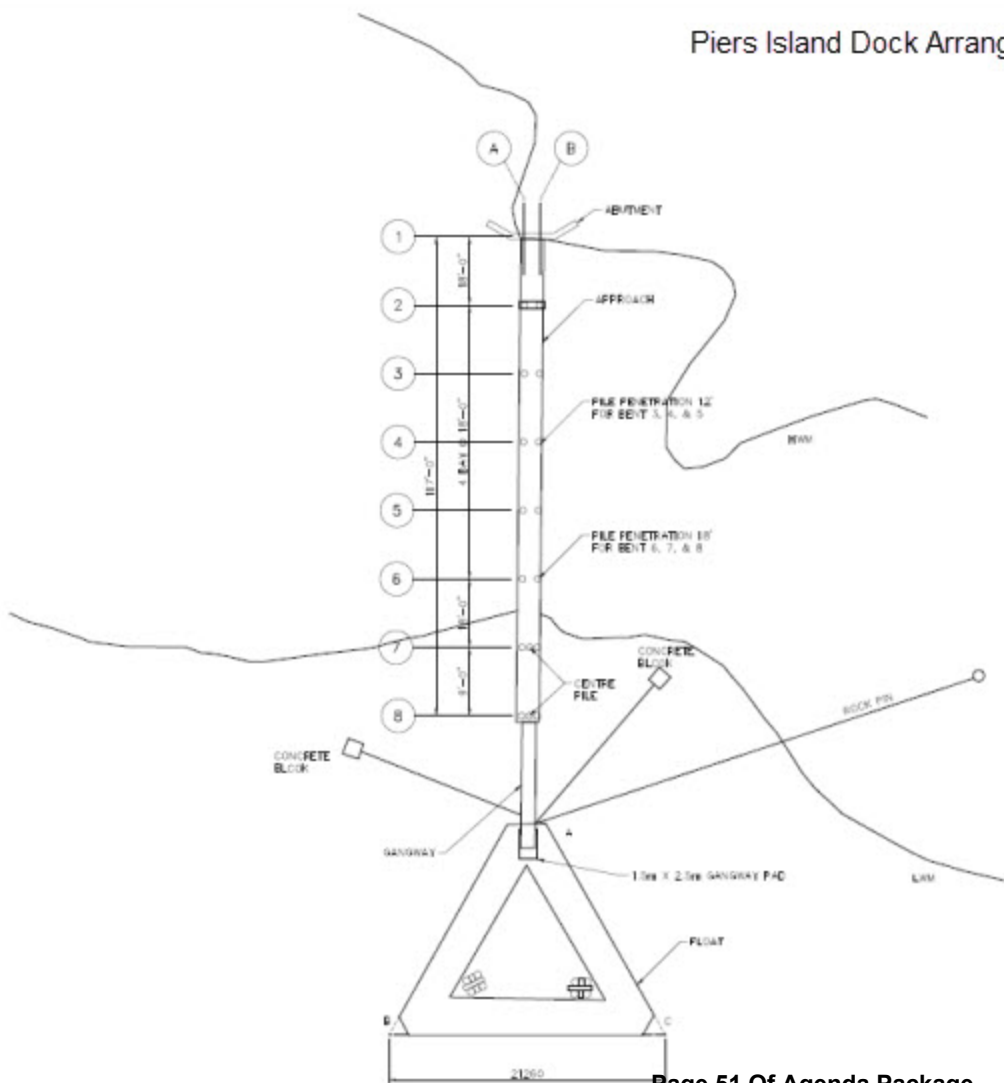
Piers Island Dock Arrangement

COMMENTS/INSTRUCTIONS	<p>> The biggest concern is the deterioration of the expanded aluminum grating used as for the non-skid surface on the gangway and the float. While most of it is in fair condition there are areas that have more wear and as this breaks, it can lift up and present a tripping hazard. The area at the bottom end of the gangway is in the worst condition and also the decking that requires replacement.</p>
	<p>> Replace missing UHMW piling rub board in the SE corner well.</p> <p>> Extending the yellow paint for the loading zone by 6 feet is recommended.</p>

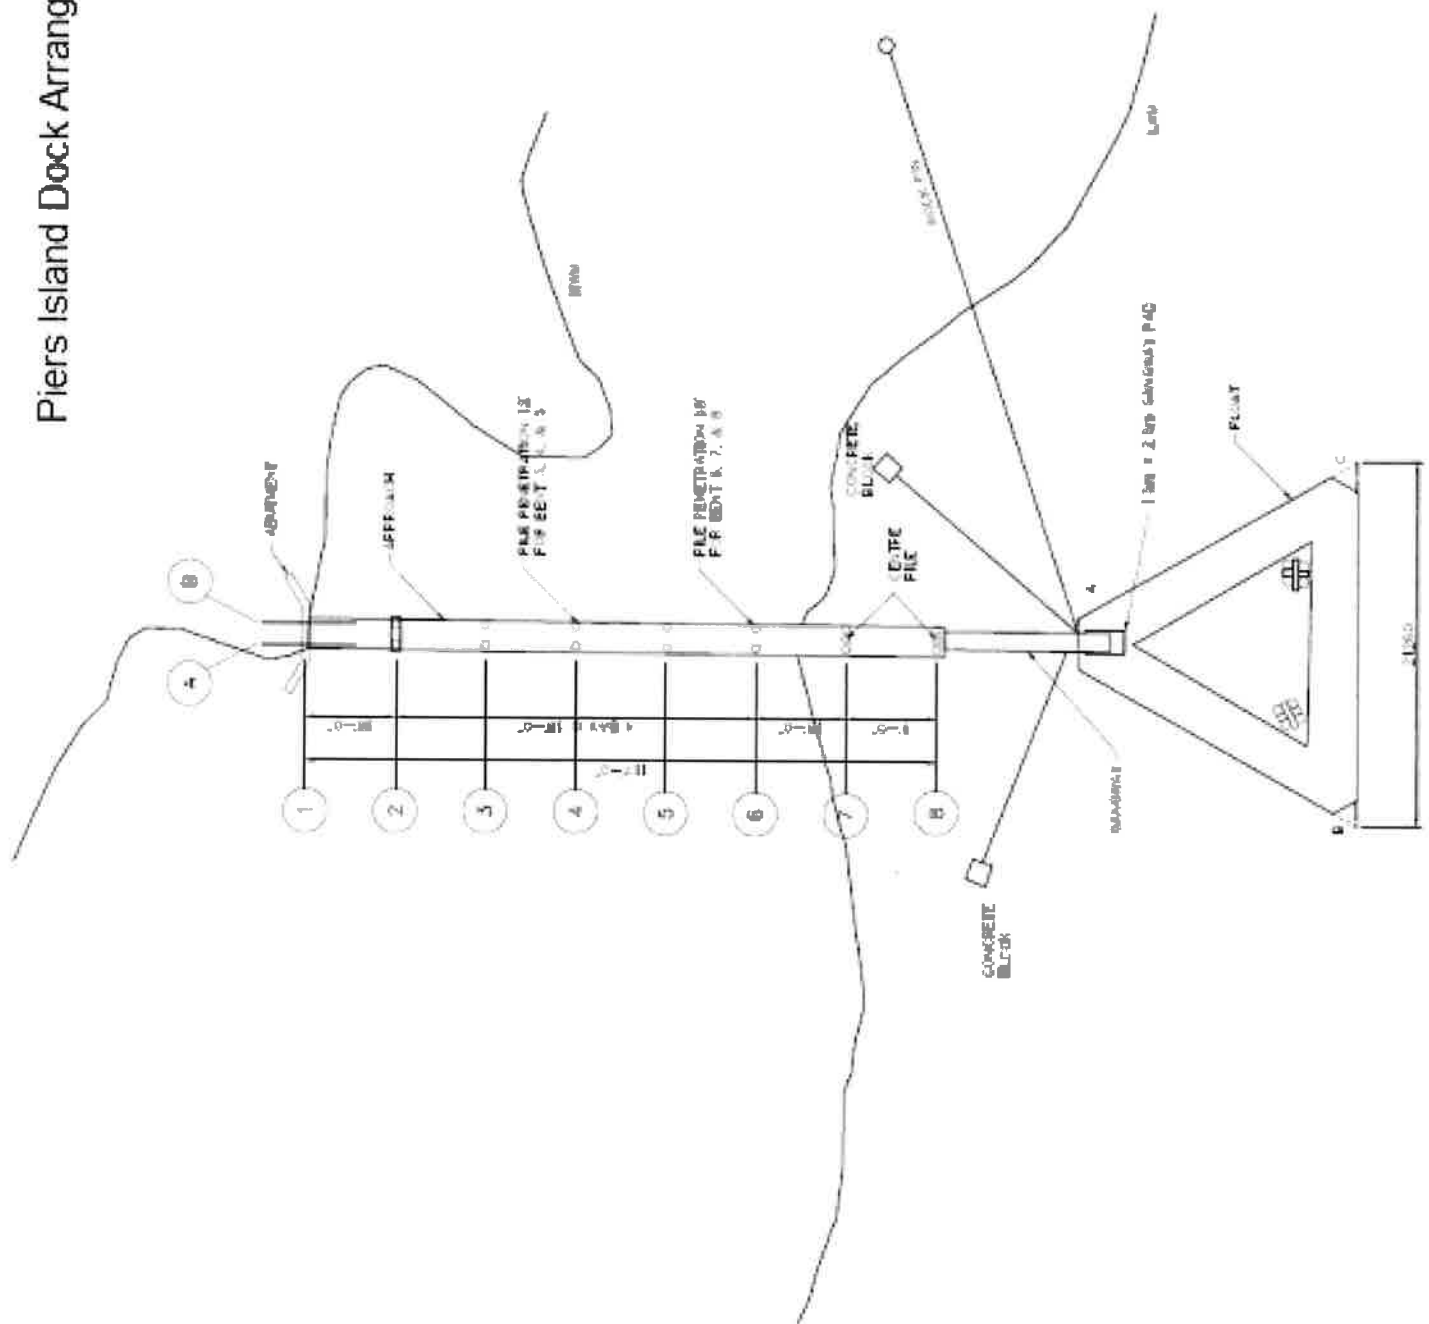
Piers Island Dock Arrangement

COMMENTS/INSTRUCTIONS	<ul style="list-style-type: none"> > The non-skid on the gangway requires upgrading as recommended. > The non-skid and the deck boards at the bottom of the Gangway require replacement. > A piece of UHMW rub board is required to replace the missing piece in the SE corner open pile well. > A new Wharfinger is required.
------------------------------	--

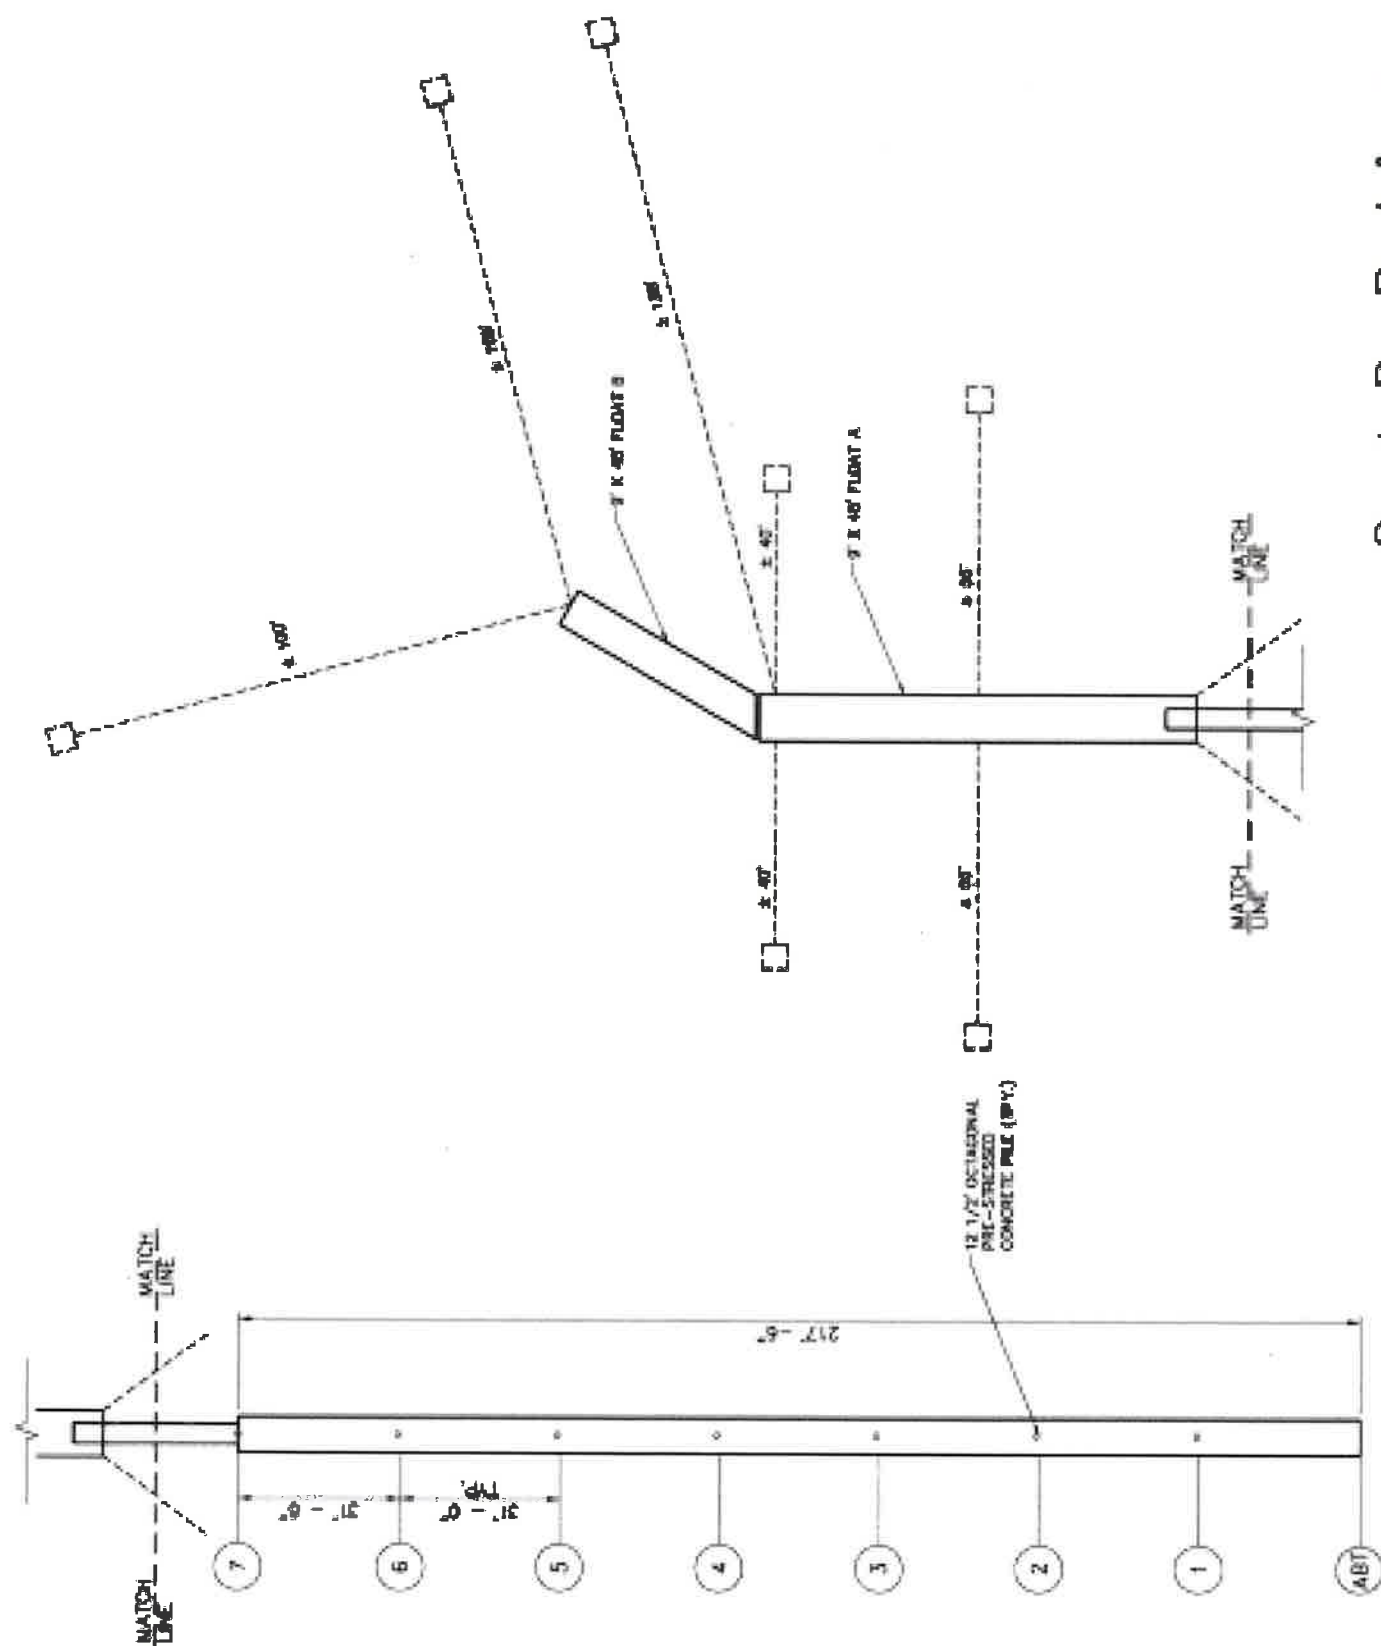
Swartz Bay Dock Arrangement

COMMENTS/INSTRUCTIONS	<ul style="list-style-type: none"> > The decking on the gangway requires upgrading as recommended. > Repair to the gangway bottom transition plate is required. > Inspect the flotation and chain connection at the end of float B.
------------------------------	---
