**SURFSIDE PARK ESTATES WATER SERVICE COMMITTEE**  
Notice of Meeting on **Tuesday, February 13, 2024 at 2 p.m.**  
Goldstream Conference Room, 479 Island Highway, Victoria, BC

**SUBJECT**     **Surfside Park Estates Water System Tank Replacement Options Analysis**

**TO:** Natalie Tokgoz, P.Eng.  
**FROM:** Katarina Konicek, P.Eng.  
**DATE:** August 21, 2023  
**SUBJECT:** **Mayne Island – SURFSIDE PARK ESTATE WATER SYSTEM: System Review and Options Analysis for Tank Replacement & Relocation**

### Surfside Park Estate Water System Tank Replacement Options Analysis

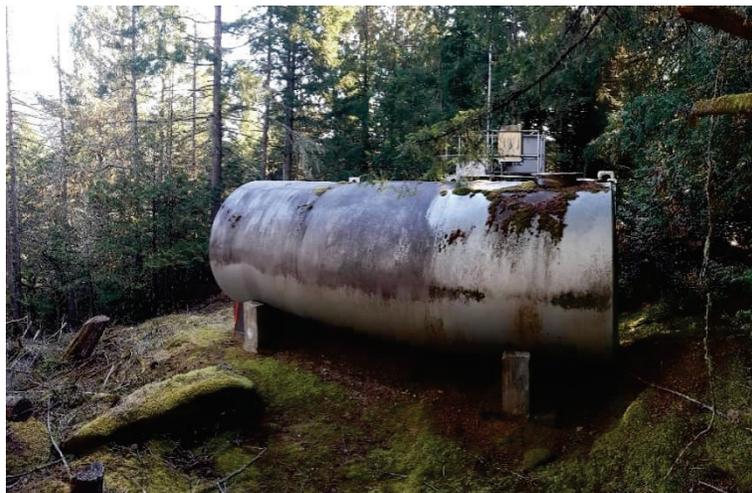
Figure 2-1 Surfside Water Storage Tanks

The existing cylindrical horizontal welded steel tanks have been identified as having significant corrosion and poor access for operation, and consideration of options for their replacement is required.

The Surfside water service area does not include land of suitable elevation for gravity storage tanks, so these are located outside of the service area, across the valley to the south in a steeply sloped and heavily wooded area. The tanks were constructed in the 1970s and are constructed as horizontal steel cylinders, each supported on two concrete saddles. One of the tanks is shown in Figure 2-1 with the second tank out of view behind it.

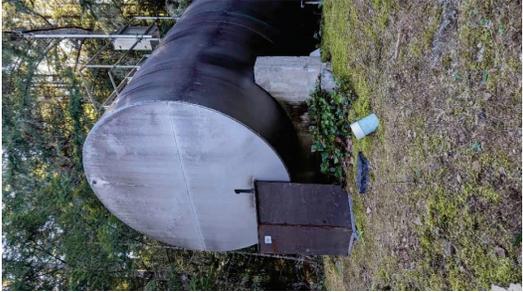
Figure A-5 Existing Reservoir

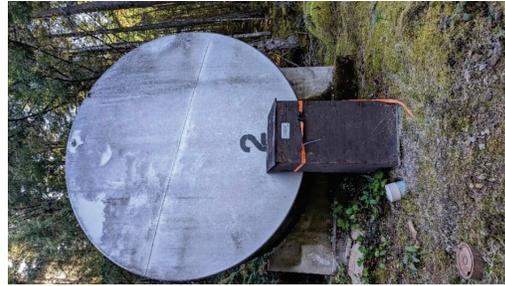
Figure A-9 Existing Reservoir #2

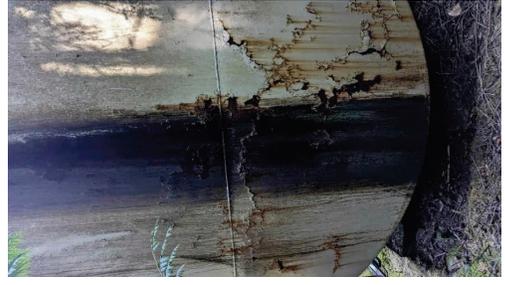
Figure A-31 Reservoir #2 Corrosion

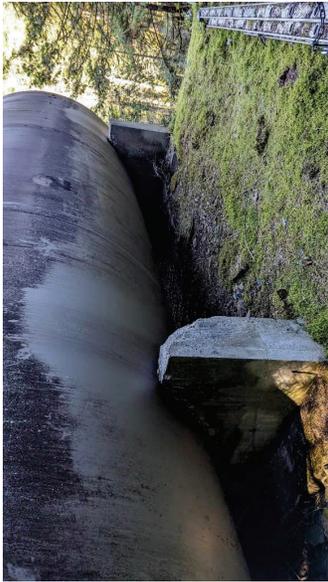
Figure A-13 Existing Reservoir Concrete Saddles

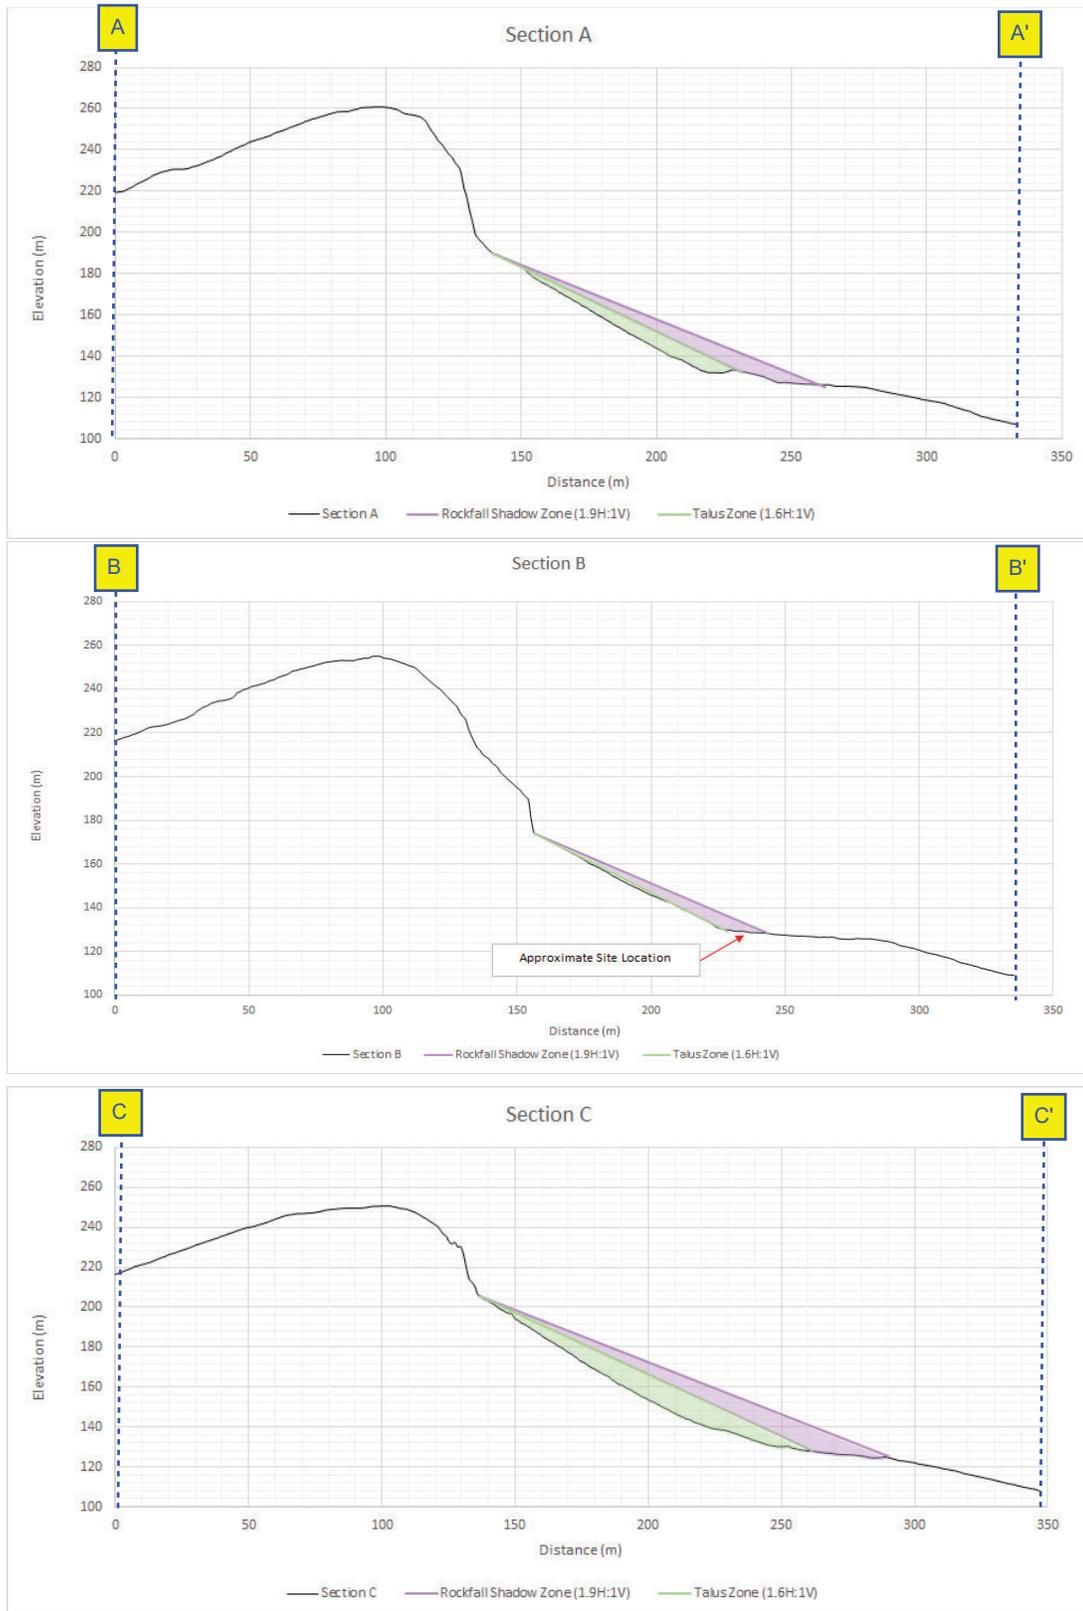
Figure 3 - Talus and Rock Fall Shadow Zones
