**SOUTHERN GULF ISLANDS HARBOURS COMMISSION**  
Notice of Meeting on **Thursday, February 27, 2025 at 9:30 a.m.**  
Saanich Peninsula Wastewater Treatment Plant Meeting Room,  
9055 Mainwaring Road, North Saanich, BC

# Southern Gulf Islands Harbours DOCK INSPECTION REPORT

DATE: 16-Dec-2024  
INSPECTOR: Peter Binner

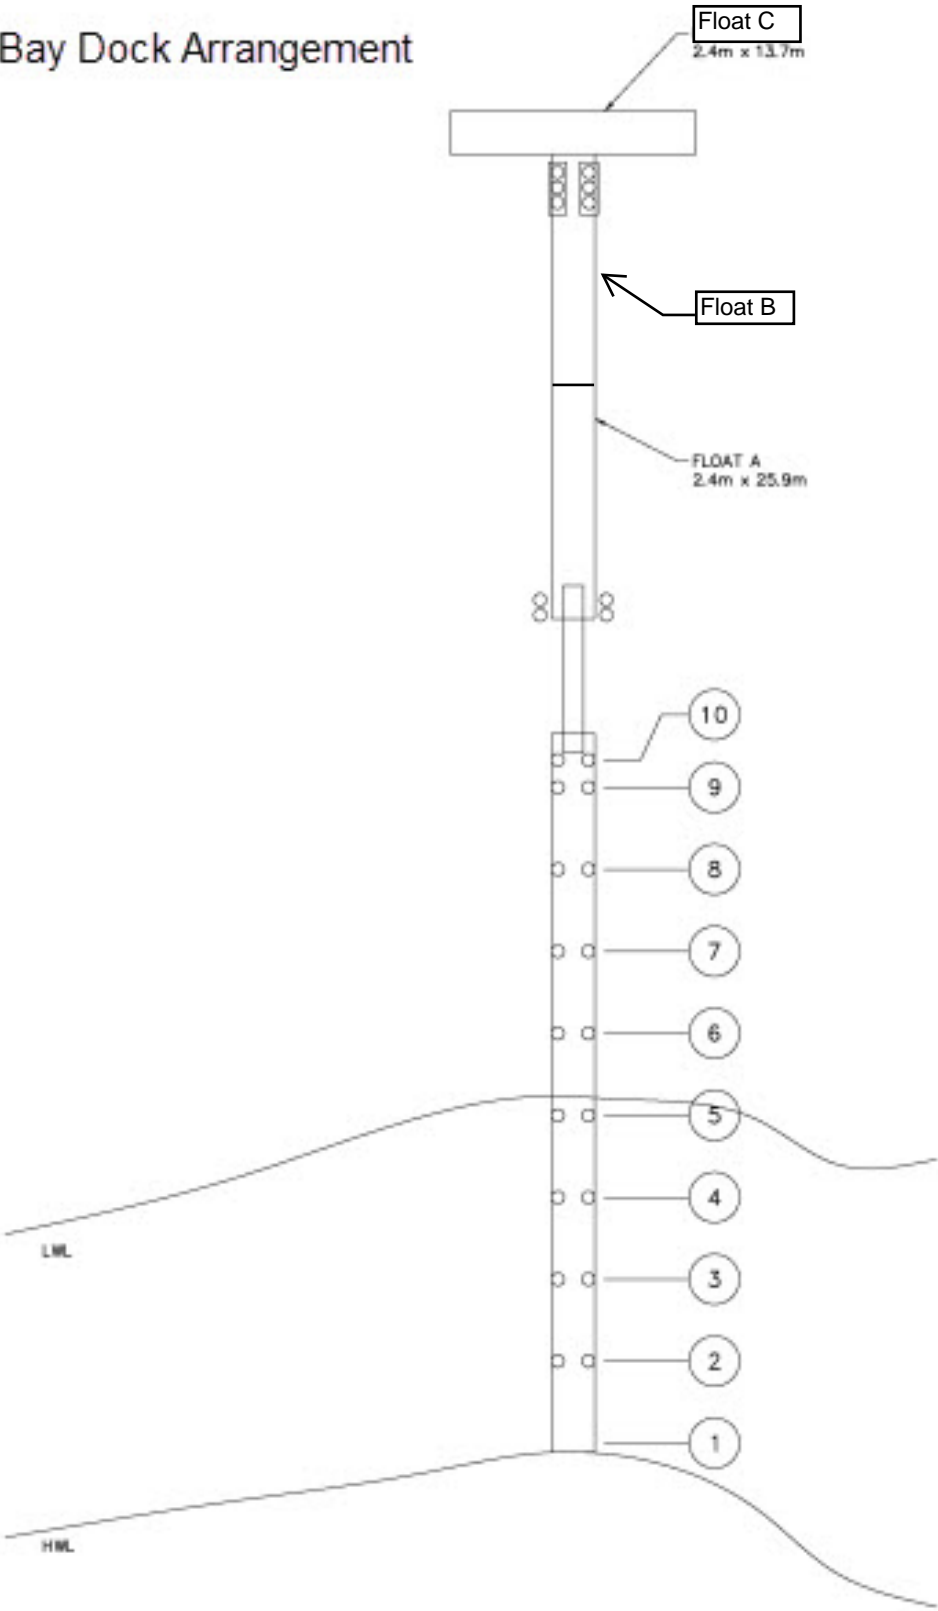
Horton Bay Dock Arrangement

| | <p>The new unpainted wood railings, bull rails and decking are all in very good condition. There is a problem at the entrance of the approach where the run-off from the dirt path is washing onto the wood decking. An 8' length of MiniMesh is recommended as a mud grate for this area of the approach. Pressure washing of this area is required unless the new mud grade is installed first.</p> <p>The notice board is a piece of plywood attached to the railing and is in the covered area of the approach and is adequate until a new notice board is supplied.</p> <p>Salt and sand was supplied.</p> |

| <b>GANGWAY FLOATS</b> | <p>The old steel gangway has been refurbished and MiniMesh has been installed for the decking along with a new aluminum/MiniMesh bottom apron. There is an old steel roller, guide rails and pillow blocks that are all in good condition and no work is required.</p> <p>There is a new main float constructed of wood with bull rails, decking and rub boards, all in very good condition. The dinghy float is an older relocated wood constructed float that is in fair condition and is attached to the end of the main float under the gangway. The dinghy float requires pressure washing.</p> <p>There is also a new WCMRC float attached to the end of the main float that is in very good condition.</p> |

| <b>COMMENTS/INSTRUCTIONS</b> | <p>&gt; A mud grate is required at the entrance of the approach.</p> <p>&gt; A new notice board is required.</p> <p>&gt; Pressure washing is required as described.</p> |

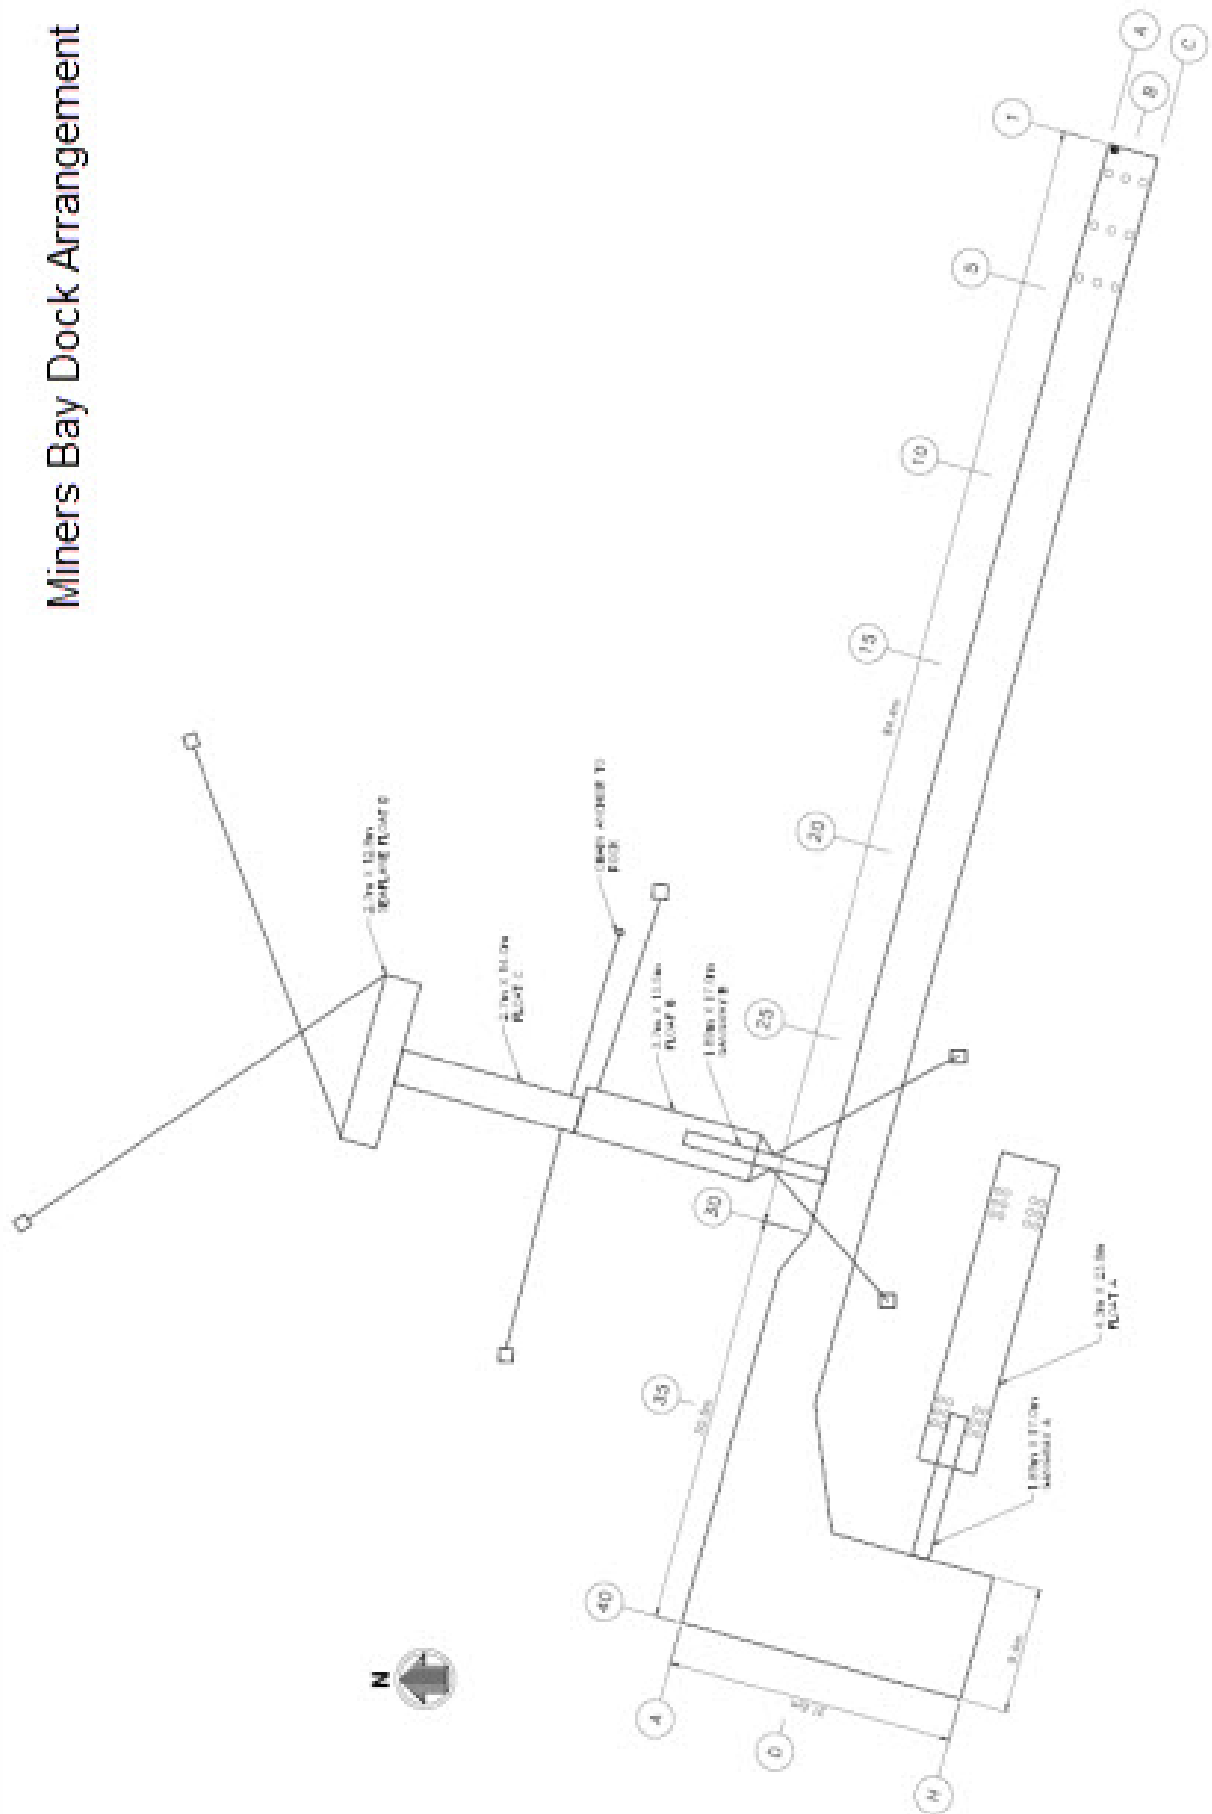
# Miners Bay Dock Arrangement

| | <p>This is a long older wooden structure with painted bull rails, railings and decking that is fair condition. There is a long run of rubber traction mat to the entrance of Float B and this is in good condition. There are a few areas of developing rot in the deck boards and monitoring for replacement is recommended. Painting the railings and bull rails is recommended.</p> <p>The notice board is in poor condition and replacement is required.</p> |

| | <p>The large wharfhead has had roughly 80% of the wood decking replaced along with a new unpainted railing surrounding the whole wharfhead. There are still a few deck boards with minor rot that require monitoring for replacement.</p> <p>Continued from GANGWAY &amp; FLOATS:</p> <p>Float "B" is constructed of wood and has a concrete tile decking that is in stable condition considering this location. There are a few cracked tiles and the bull rail bolts are all tight. The sea plane landing area is a seagull resort and requires extensive pressure washing! The float has a slight bend to it and the flotation is lower at the gangway end. All safety ladders on both floats require inspection and cleaning. One ladder on float B is broken and requires replacement.</p> |

| <b>GANGWAY FLOATS</b> | <p>Gangway "A" is an old painted steel structure with wood decking that has partial expanded metal grating for non-skid and old wooden "ladder rungs" that are in poor condition. The decking requires replacement (MiniMesh) as the old wood is deteriorating and close to becoming unsafe. The aluminum top and bottom transition plates are in good condition but the bottom roller bed boards are old and worn and require replacement along with a new skid plate for the apron. The steel roller, guide rails and pillow blocks are in fair condition and the bearings require service.</p> <p>Float "A" is an older wood float with bull rails, rub boards and decking in worn but fair condition. There is a section of bull rail that has broken off and the bull rail along this side is also in poor condition and replacement is recommended. The rub boards are also in a similar condition and replacement is recommended. There are 4 closed pile wells with 6 piles / well. The 2 wells next to the gangway have more wear with the UHMW rub boards and the piles also have more wear with the 3 piles in the inside of both wells. The 2 pile wells at the end of the float are in better condition as are the piles that show minimal wear and there is 1 pile with a boar hole showing at a low tide. The flotation is good and pressure washing is required: pile wells, bull rails and decking.</p> <p>Gangway "B" is an unpainted heavy steel structure with an open steel grating for the decking that is in good condition. Steel roller, steel guide rails and pillow blocks that are in good condition. Cont'd in "WHARFHEAD"</p> |

| <b>COMMENTS/INSTRUCTIONS</b> | <p>&gt; Gangway "A" requires new decking.</p> <p>&gt; The notice board requires replacement.</p> <p>&gt; Float "A" requires new roller bed boards, bottom apron skid plate and bull rails as described.</p> <p>&gt; Float "A" pile wells next to the gangway require repair to the wood and UHMW rub boards.</p> <p>&gt; Service pillow block bearings on gangway A.</p> <p>&gt; All safety ladders require inspection and cleaning, replace broken ladder.</p> <p>&gt; Painting the railings and bull rails on the approach is recommended.</p> <p>&gt; Monitor the wear with the pilings for float A and the developing rot with the deck boards on the approach and wharfhead.</p> <p>&gt; Pressure washing is required as described. &gt;&gt;&gt;&gt;&gt;A must do!!!&lt;&lt;&lt;&lt;&lt;</p> |

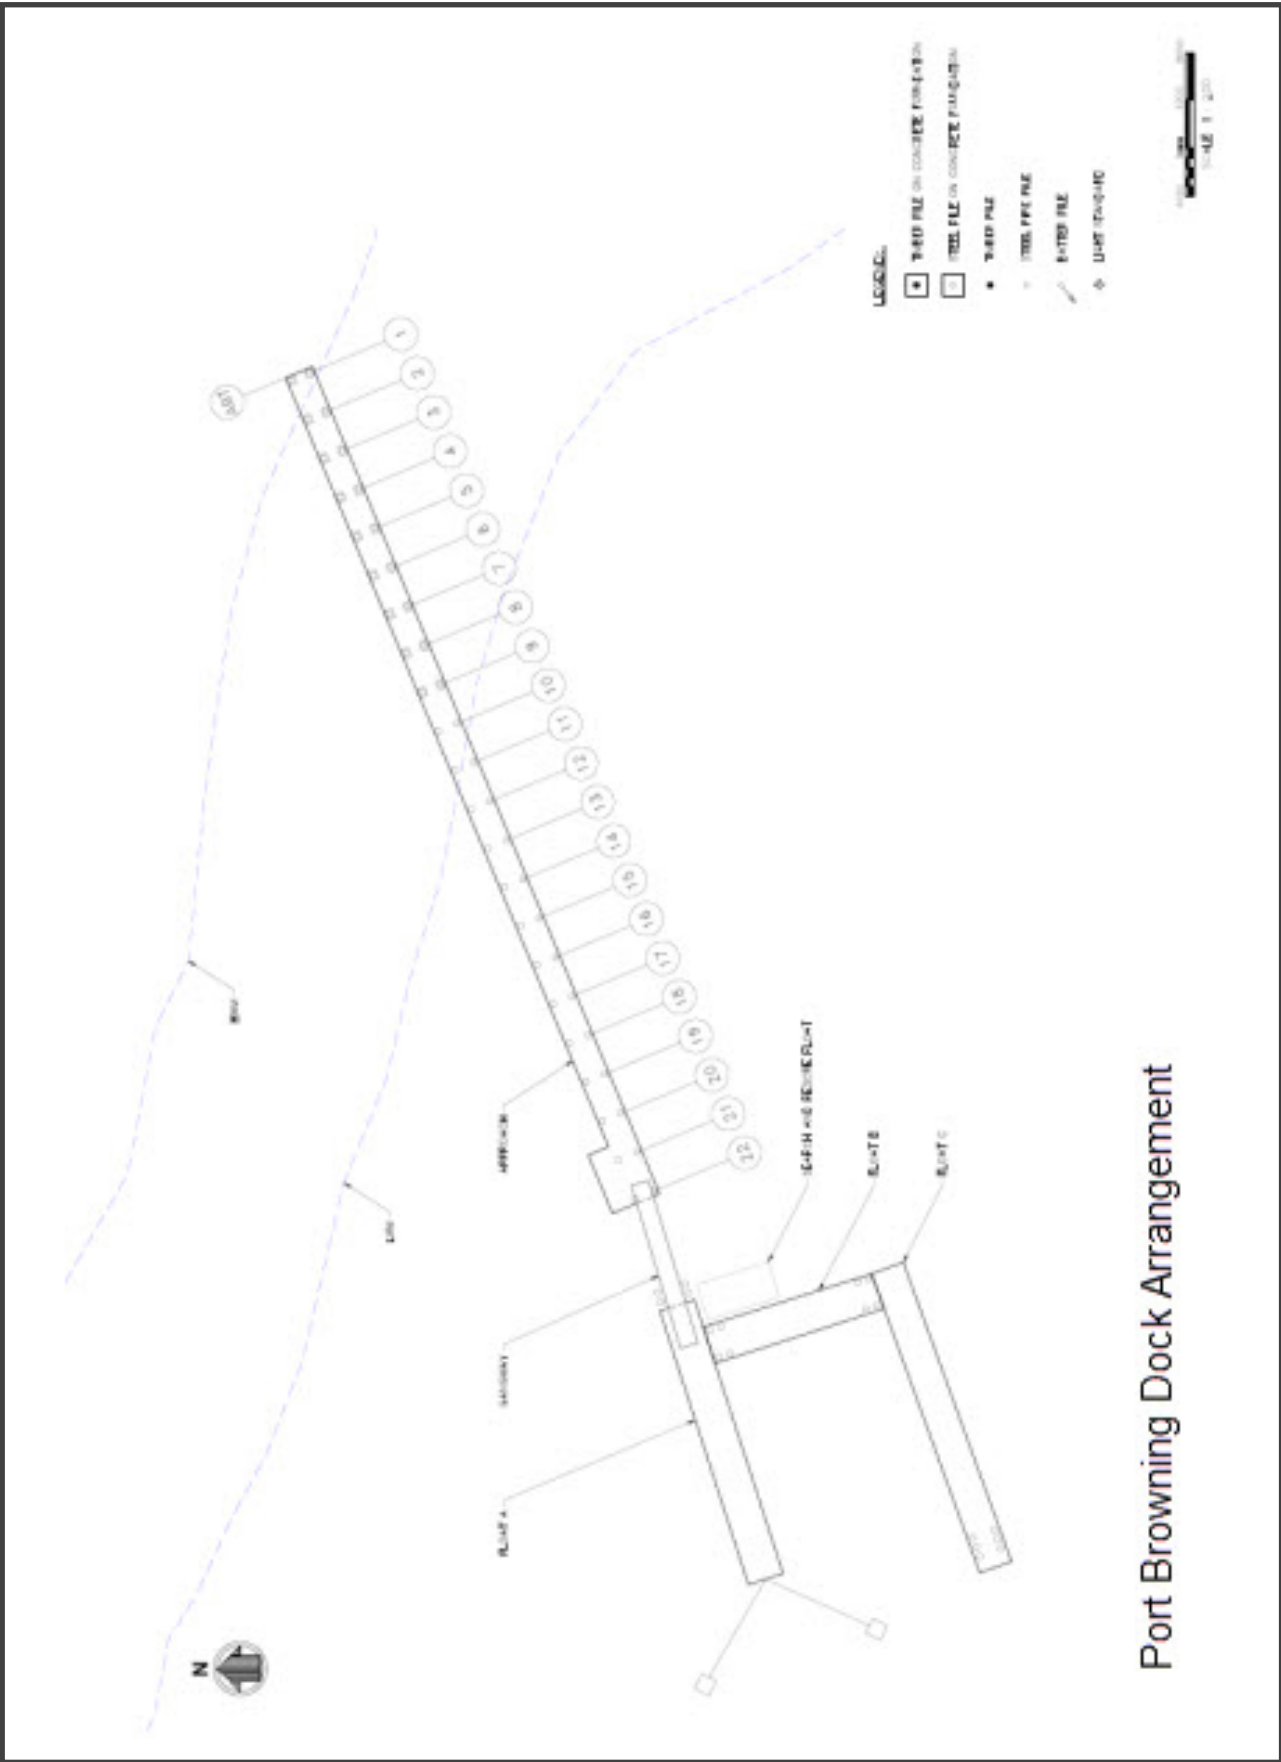
Port Browning Dock Arrangement

| | <p>The flaking and faded painted railings and bull rails are in fair condition, painting is recommended. The new mud grate is working well and the decking is generally in good condition but there are roughly 30 or so boards with developing rot that will require replacing in the near future. The notice board requires replacement. There is a spill kit and salt and sand was supplied at this location.</p> |

| | <p>FLOAT "C" CONTINUED:<br/>All bull rail bolts are tight. There are 2 safety ladders that require inspection and cleaning. The flotation is good and there is a slight dip at the end that connects to float B. There are 2 closed pile wells at the end of the float with 3 piles/well that are showing minimal wear and the wells and the UHMW are all in very good condition. The float was recently pressure washed.</p> |

| <b>GANGWAY FLOATS</b> | <p>The painted steel gangway is in good condition and has wood decking with half expanded aluminum grating and half wooden ladder rungs in fair to good condition. There is a steel top transition plate in good condition and a bottom aluminum apron with expanded metal grating that is also in good condition. The steel roller and guide rails are rusty but in good condition. The pillow blocks are in good condition, no servicing is required. The decking was recently pressure washed.</p> <p>Float "A" is a wood framed float with bull rails, rub boards and decking in good condition and all bull rail bolts are tight. The float was recently pressure washed. There are 2 open pile wells at the end under the gangway with 2 piles/well. The wells and older UHMW rub boards are in fair condition and the pilings are showing minimal wear as viewed. The flotation is good and there is a slight dip at the end of the float. One of the 2 safety ladders requires inspection and cleaning. Float "B" is wood framed with bull rails, rub boards and decking in good condition. All bull rail bolts are tight and yellow paint is required on the bull rails for the dinghy landing zone. There are 4 closed pile wells with 2 piles/well at the connection of float A and 3 piles/well at the connection to float C. The pile wells and UHMW are all in good condition and all pilings except one (boar hole @ low tide) are showing minimal wear. The flotation is generally good but is lower at the connection of float C. The float was recently pressure washed. Float "C" is wood framed with bull rails, rub boards and decking in good condition. Cont'd in "WHARFHEAD"</p> |

| <b>COMMENTS/INSTRUCTIONS</b> | <p>&gt; Replace the notice board.</p> <p>&gt; Yellow paint is required on the bull rails in the dinghy landing zone.</p> <p>&gt; Clean and inspect the safety ladders as described.</p> <p>&gt; Monitor the deck boards on the approach for replacement.</p> |

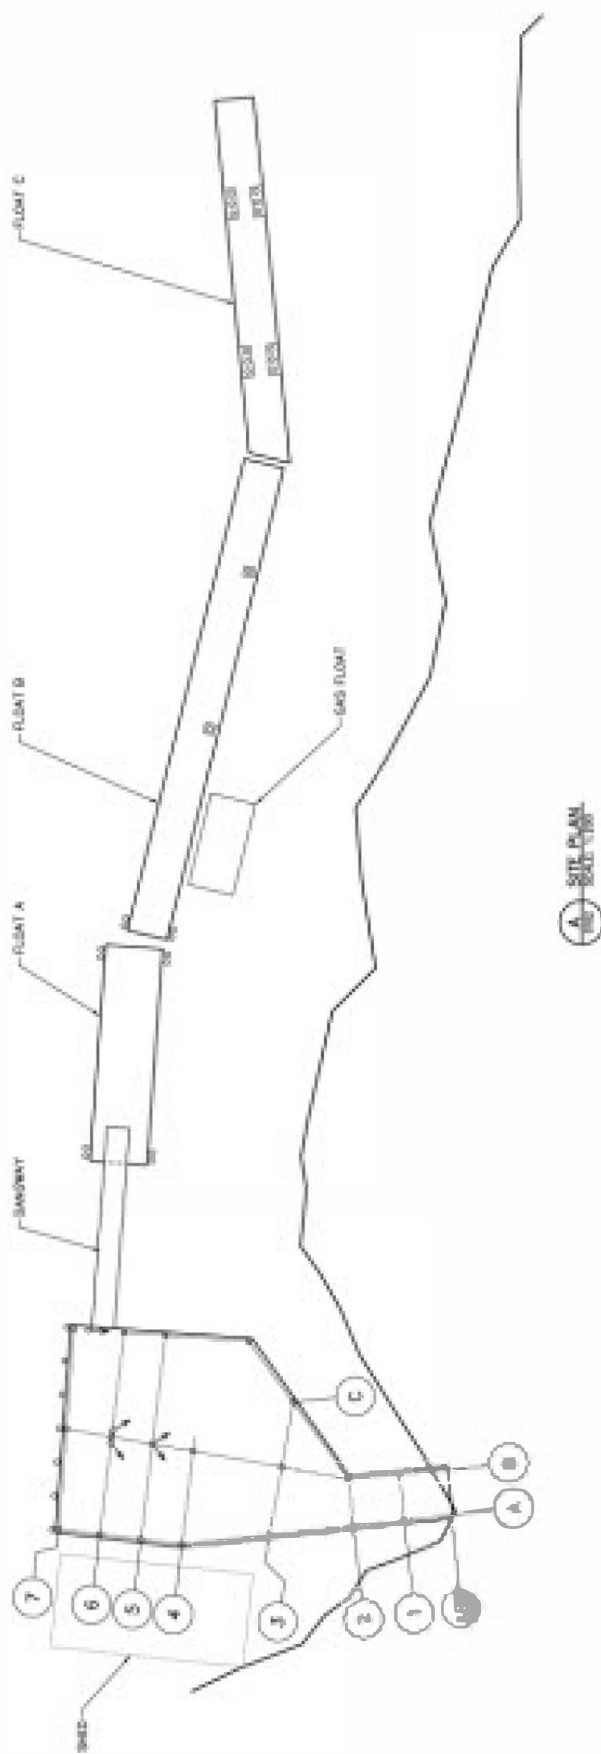
## Lyall Harbour Dock Arrangement

| | Float "B" continued:<br>One of the 2 safety ladders requires inspection and cleaning. The float has been recently pressure washed.<br>Float "C" is a fairly new wood framed float with bull rails, rub boards and decking in good condition. The bull rails bolts are tight and there is a new aluminum transition between float B. The flotation is generally good with a slight hump to the float. The 3 safety ladders have some but minimal growth, cleaning and inspection is recommended.<br>The sea plane landing is located at the end of the float and requires yellow paint on the bull rails and replacement of 1 tire is required. |

| | This is a concrete wharfhead with large wood bull rails and unpainted steel railings on both sides of the wharfhead. There are no issues to report for this area.<br>The notice board is located here and it is in fair condition. There is a large Spill Kit container located here too. Salt and sand was supplied. |

| <b>GANGWAY FLOATS</b> | The aluminum gangway with MiniMesh decking is in very good condition as are the roller wheels and aluminum guide rails. There is an old rusty steel transition plate at the top that requires painting and an aluminum bottom apron with expanded metal grating for the non-skid surface that is in very good condition. There are hard rubber roller wheels and aluminum guide rails that are also in good condition.<br>Float "A" is an older wood framed float that is made of 2 sections. The smaller section supports the gangway and the WCMRC float is attached to this section and the longer section provides the short and long term moorage to the connection of float B. The bull rails, rub boards and decking are worn but in fair condition in this first section and in good condition in the longer section. All bull rail bolts are tight. There has been a recent addition of billets to improve the flotation. There are 2 open pile wells with 2 piles/well at the gangway end that are in good condition with minimal wear as viewed. There are 2 other open pile wells with 3 piles/well (the end of the first section) that are in good condition. There are 2 other steel piles in closed wells on the float.<br>Float "B" is an older wood framed float with bull rails, rub boards and decking in fair condition. The flotation is lower at the end that connects to float A and there is a new aluminum transition plate between these 2 floats. All bull rail bolts are tight. There are 4 closed pile wells with 3 piles/well that show minimal wear as viewed. The pile wells have old UHMW in fair condition and the wells are in good condition otherwise. Cont'd in "APPROACH" | |

| <b>COMMENTS/INSTRUCTIONS</b> | > The bull rails require yellow paint for the Emergency/Loading and seaplane landing zones.<br>> Replace 1 tire at the end of the float in the seaplane landing zone.<br>> Inspect and clean the safety ladders as described. |

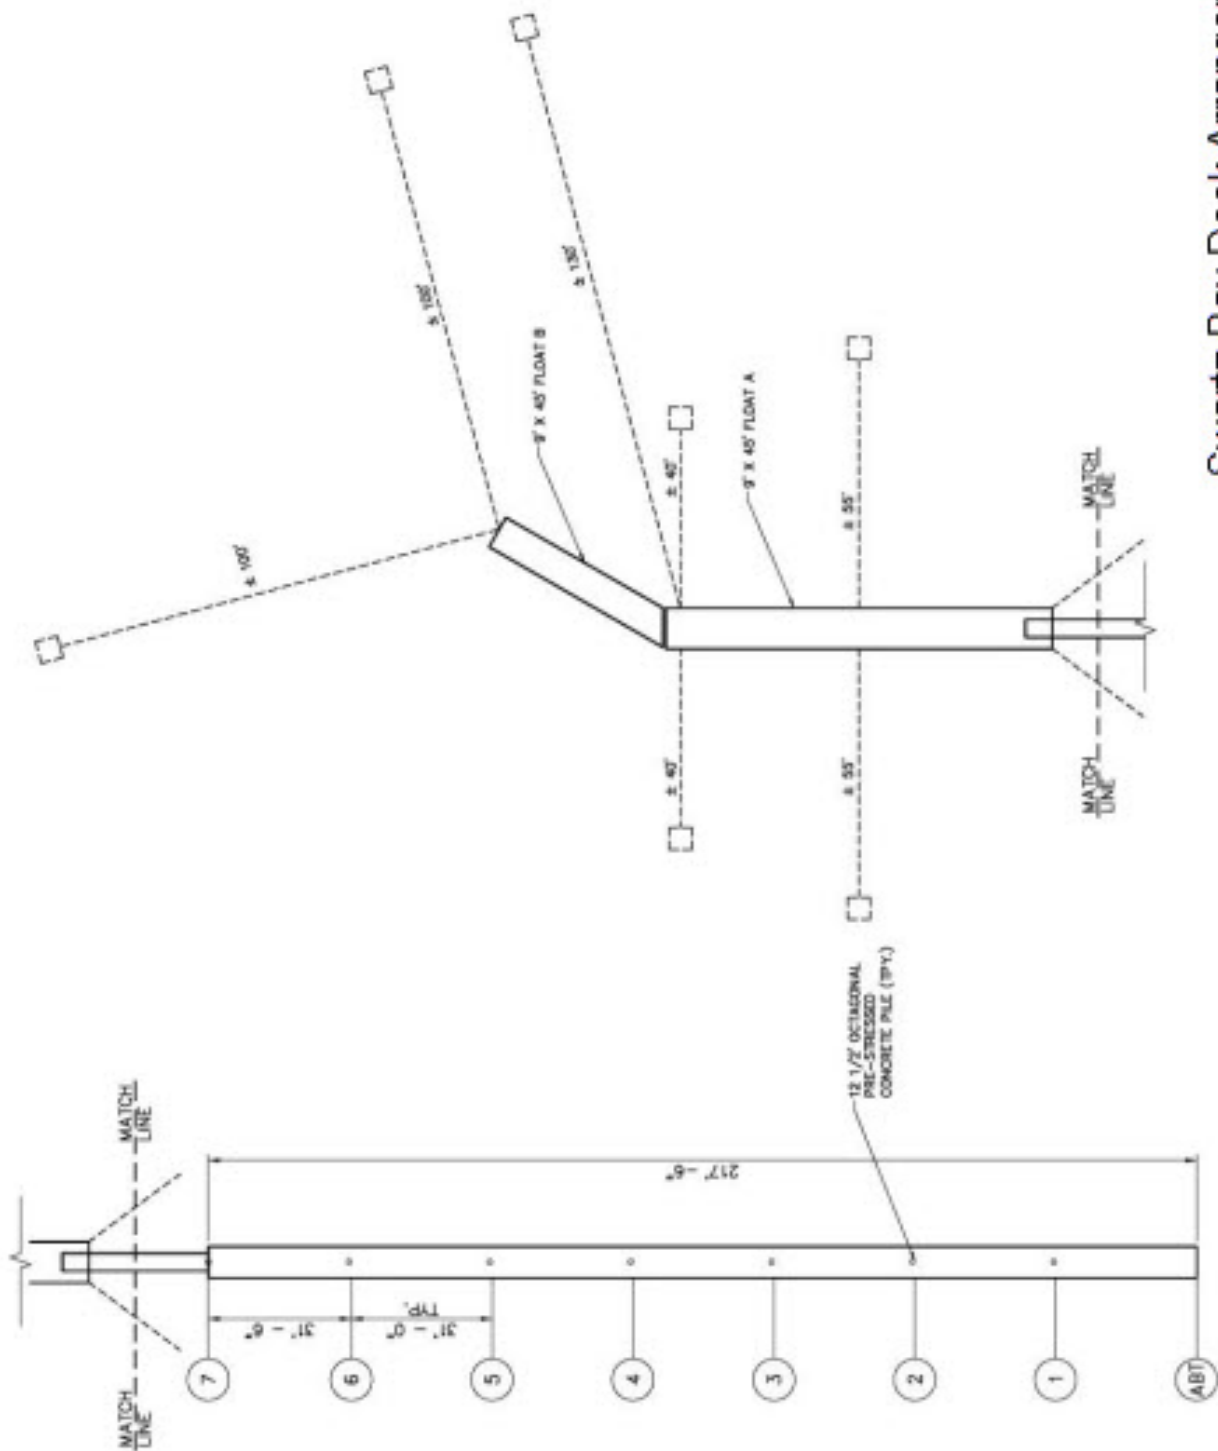
Swartz Bay Dock Arrangement

| | <p>This is a concrete structure with painted metal railings that is in good condition. The aluminum notice board is in good condition and salt and sand was supplied. There are 4 light standards with all lights working.</p> |

| <b>GANGWAY FLOATS</b> | <p>This is an older painted steel gangway in good condition with new MiniMesh decking. The expanded aluminum bottom apron is in poor condition with an area of broken grating and also an area of the frame has been torn due to the apron snagging on the steel guide rail due to the high tides. The roller bed boards for the apron may require extending but it is more likely the anchor chains require adjusting, to pull the floats back towards shore so there is more room for the apron to move before it makes contact with the guide rail (photo available).<br/>Float "A" is a new wooden float and all bull rails, rub boards and decking are in good condition and the bull rail bolts are tight and the flotation is good. Pressure washing is required and the safety ladder requires inspection and cleaning. There is an aluminum transition plate between float A &amp; B that is in good condition.</p> <p>Float "B" is a wooden float and the bull rails, rub boards and decking are in good condition and all bull rail bolts are tight. The flotation is good with the end of the float slightly lower in the water. The safety ladder is bent and requires inspection and cleaning. Pressure washing is also required.</p> |

| <b>COMMENTS/INSTRUCTIONS</b> | <p>&gt; The aluminum bottom gangway apron is in poor condition, replacement is recommended.</p> <p>&gt; The anchor chains may need adjustment to prevent the bottom gangway apron from snagging on the steel guide rail at high tide, inspection is required.</p> <p>&gt; Pressure washing the floats is required.</p> <p>&gt; Inspect and clean safety ladders.</p> |
