## Notice of Meeting and Meeting Agenda Regional Parks Committee

**6.1.**      [26-0200](#)      Feasibility of Reconstructing the Marine Access Ramp at Island View Beach Regional Park

## Island View Beach Regional Park: Marine Access Ramp

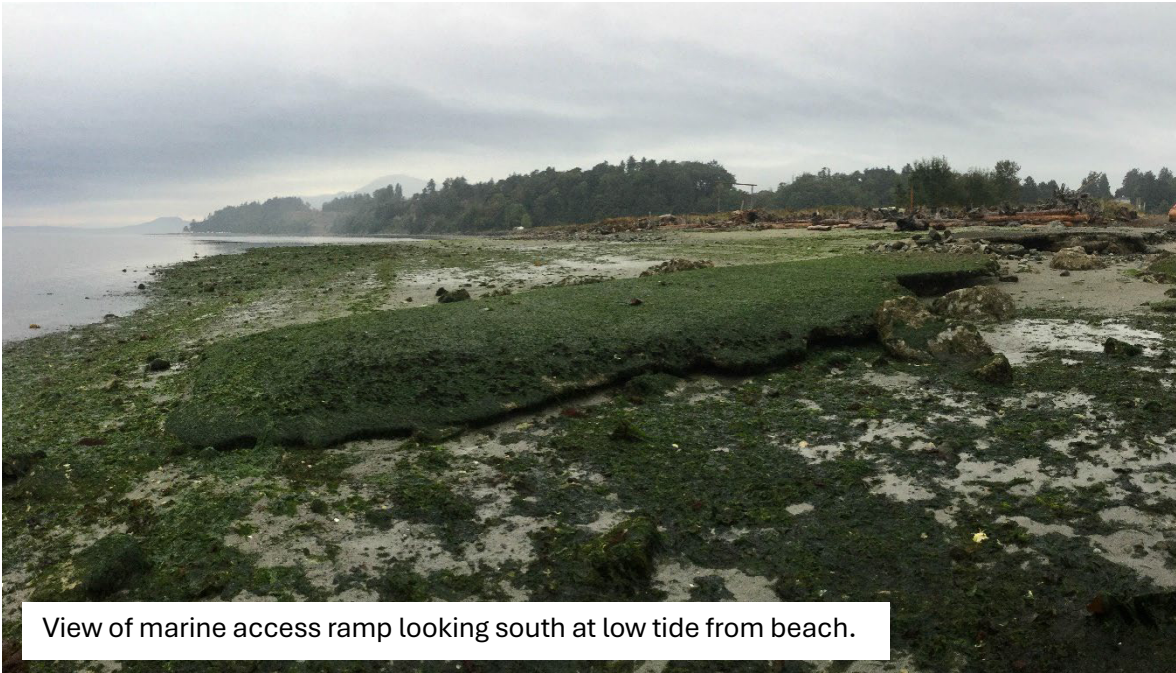
The marine access ramp is in a state of disrepair and is unusable. It has not been maintained for many years and consists of failing concrete and debris accumulation. At very low tides, the ramp does not extend far enough into the water, further limiting its usability as a boat launch. Overall, the ramp is unsuitable for safe and reliable marine access without major intervention.

View of marine access ramp looking south at low tide from beach.

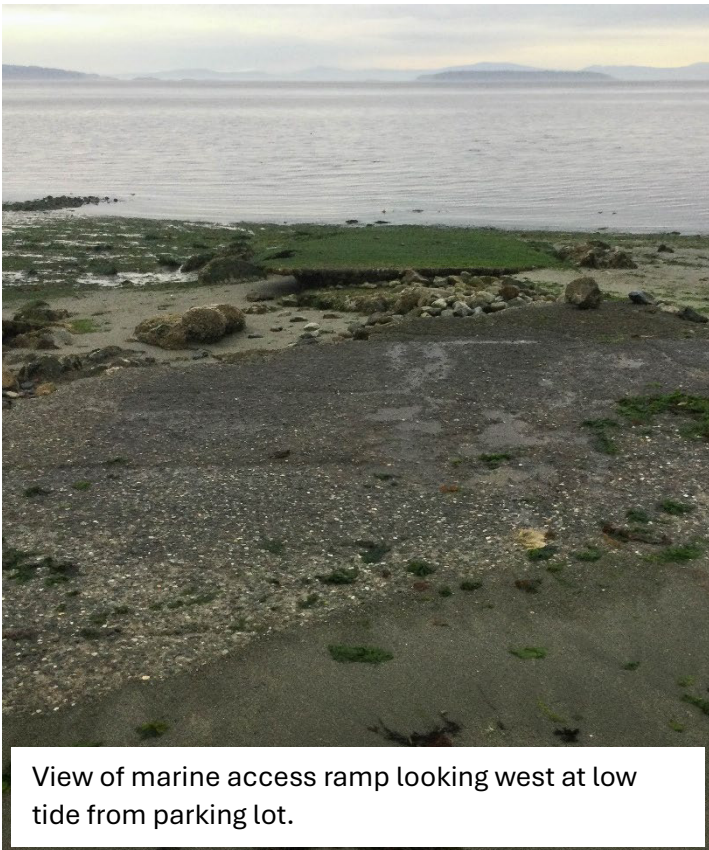
View of marine access ramp looking west at low tide from parking lot.

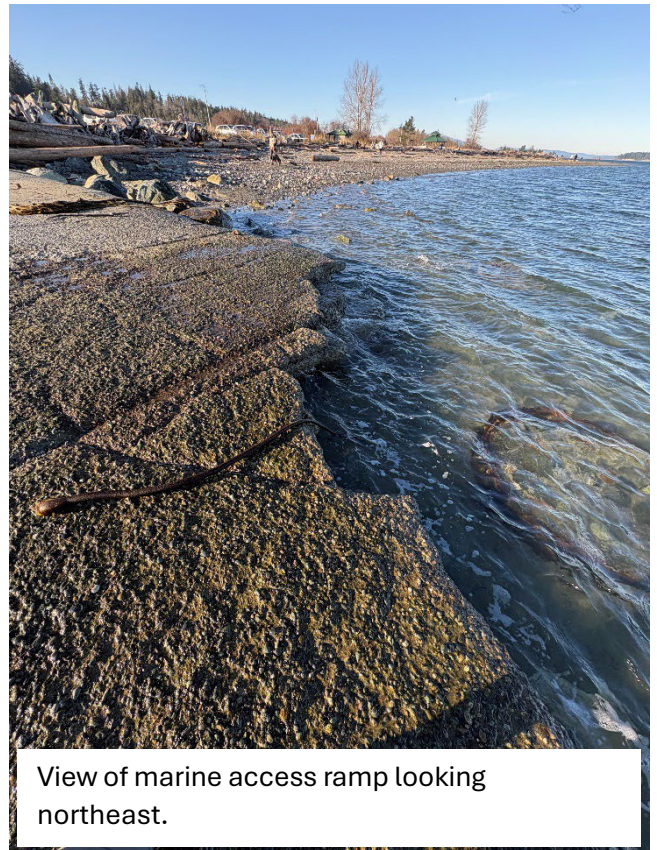
View of marine access ramp looking northeast.

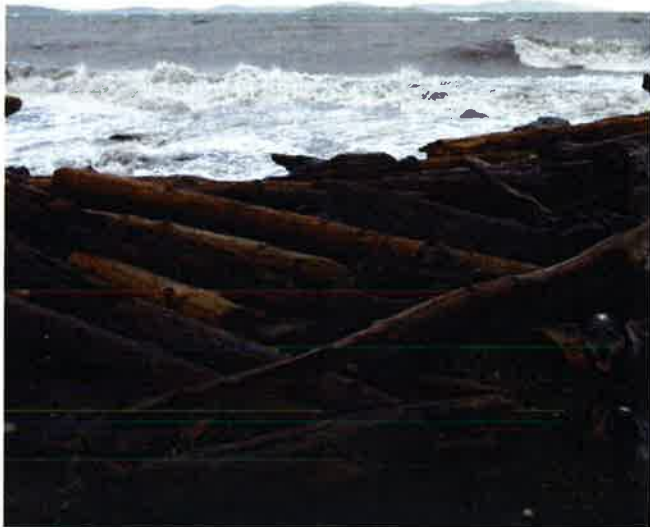
*Photograph 1: Image taken facing east along the boat ramp on December 3, 2015*

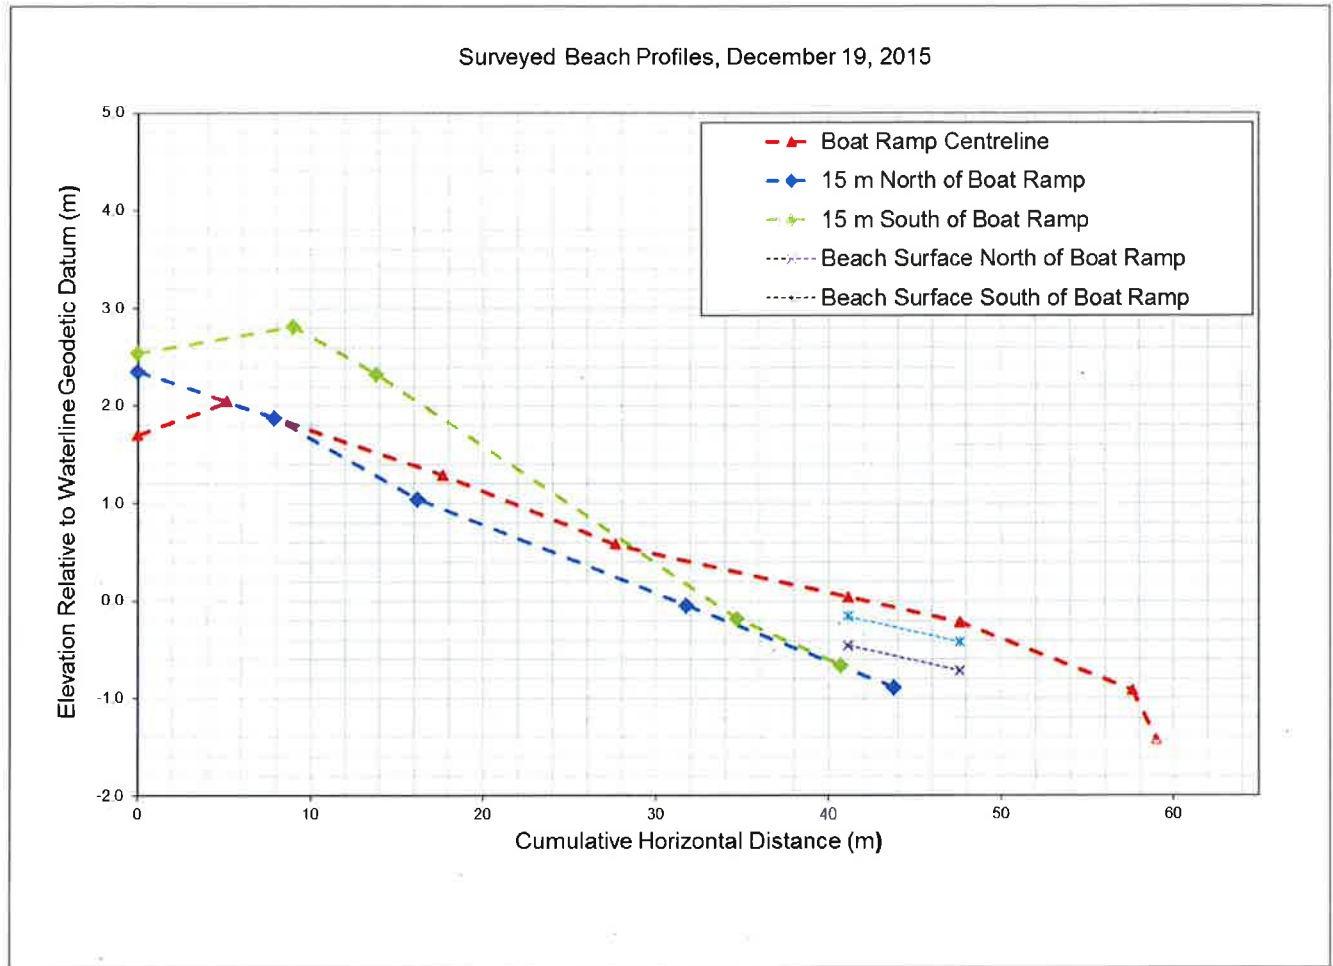
Figure 3: Surveyed beach profiles taken on December 19, 2015

The cross shore profiles indicate that the beach to the south of the boat ramp (green line, Figure 3) is higher than the beach to the north of the boat ramp (blue line, Figure 3) across the surveyed section of the shoreline. The difference in elevation varies between approximately 0.1 m and 1.1 m with an average of 0.6 m. The change in elevation is consistent with the trapping of beach sediment on the updrift side of an obstacle and erosion on the downdrift side of an obstacle. Along this shoreline updrift is to the south and downdrift is to the north. The boat ramp is lower than the beach to the south through the upper foreshore for a distance of approximately 28 m (red line, Figure 3) and higher through the intertidal zone. This appears to be related to the accumulation of woody debris south of the boat ramp. The boat ramp is higher than the beach to the north except landward of the boat ramp crest and the area of woody debris accumulation. This appears to be related to erosion of the downdrift shore. At approximately mean sea level, the boat ramp lies proud of the beach surface, approximately 0.3 m higher than the beach to the south (light blue line, Figure 3) and approximately 0.5 m to the north (light purple line, Figure 3). This implies that the boat ramp acts as an obstacle to longshore transport.

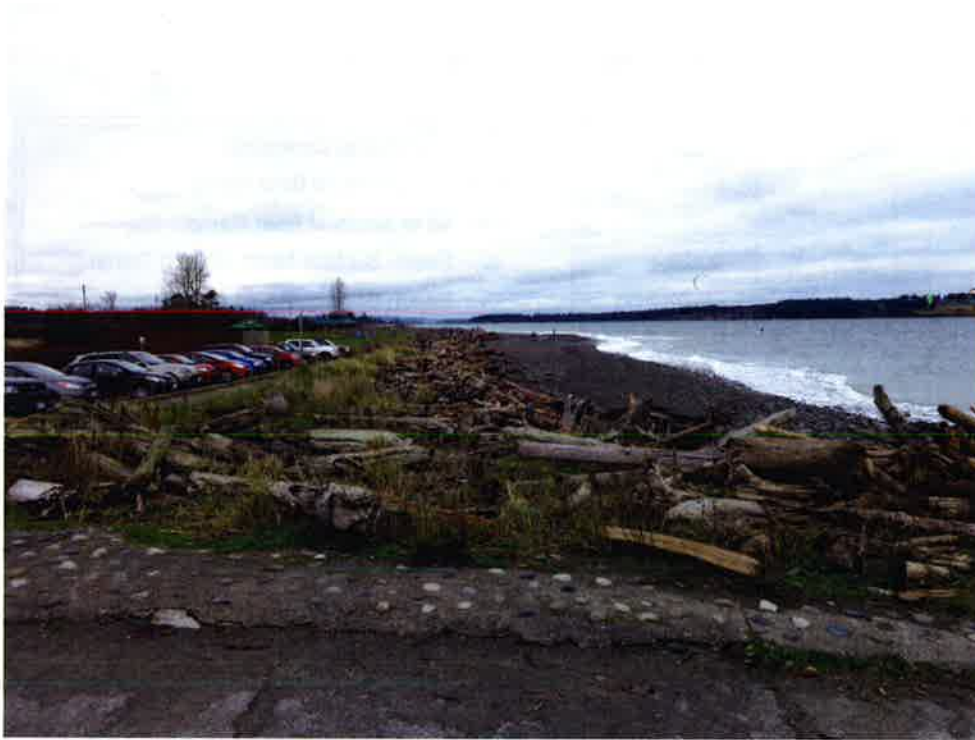
The boat ramp was examined from the parking lot down to the waterline. The boat ramp consists of a concrete structure with a crest approximately located in line with the zone of accumulated woody debris on the shoreline to the north and south (Photograph 2). The crest of the boat ramp was observed to be blocked with woody debris (Photograph 3) on December 19. Woody debris was also observed at the crest on December 3 (Photograph 4), but we understand that the woody debris observed on December 3 was fully removed from the ramp prior to December 19. This implies that the woody debris observed on December 19 had accumulated on the ramp in under two weeks.

*Photograph 2: Image taken facing north from the crest of the boat ramp on December 19, 2015*

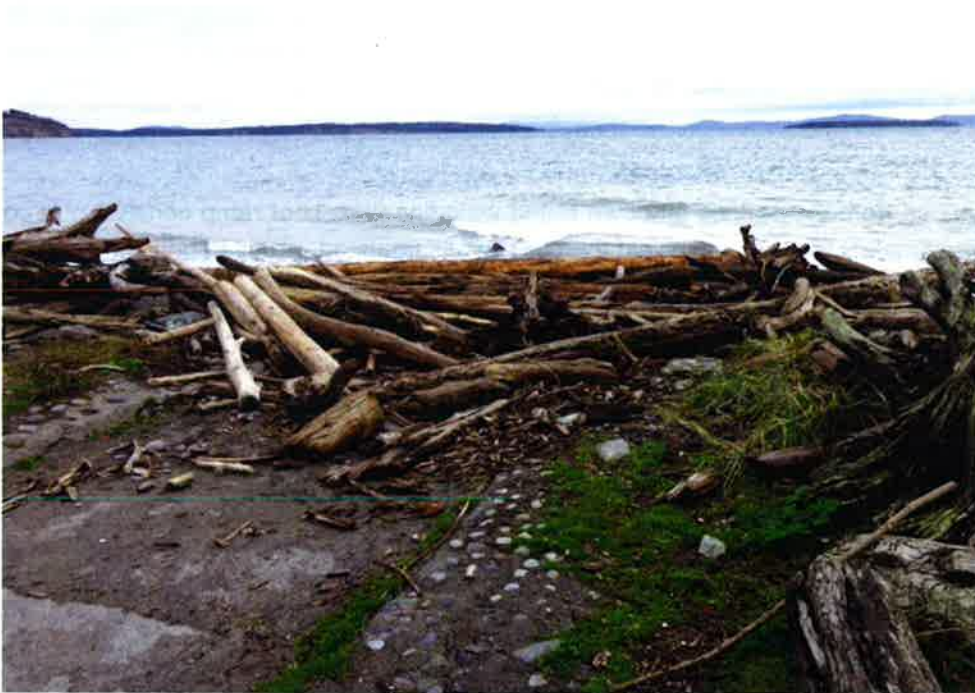
*Photograph 3: Image taken facing east on December 19, 2015*

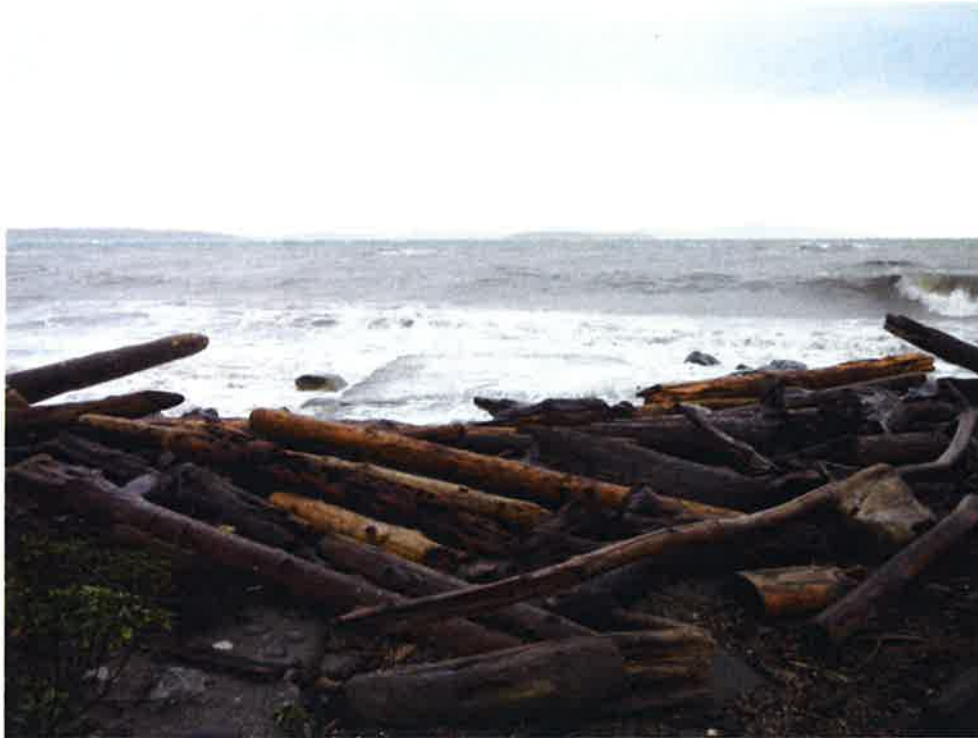
*Photograph 4: Image taken facing east on December 3, 2015.*

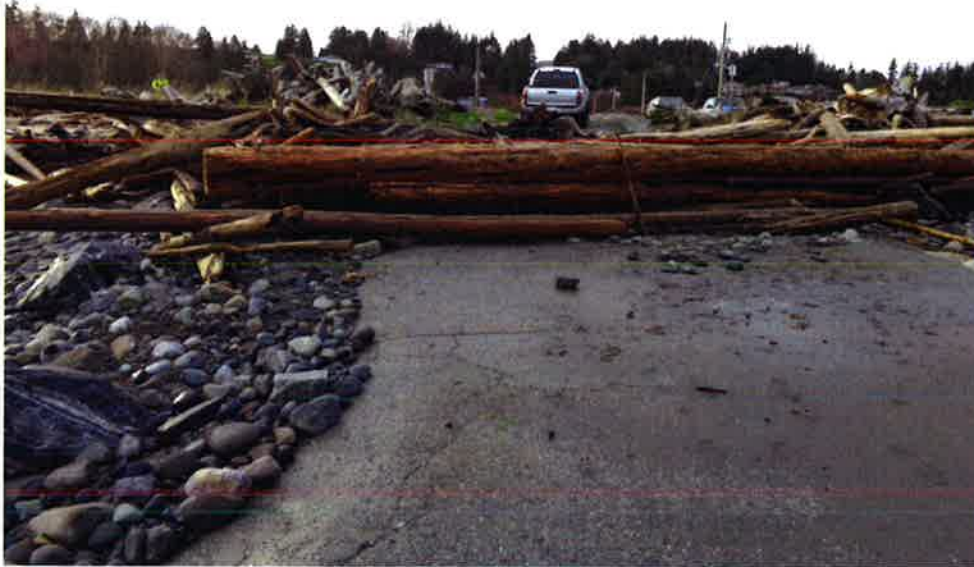
The boat ramp beyond the woody debris slopes seaward at a typical gradient of 4% to 5% (Photograph 5). The boat ramp is approximately 5 m wide and extends seawards from the area of woody debris accumulation for at least 30 m (e.g., Photograph 3). The seaward end of the boat ramp was not observed during the site visit; however, subsequent review of available satellite imagery (GoogleEarth™, image date June 7, 2015) indicates that the boat ramp extends approximately 59 m offshore of the parking lot and the survey extended approximately 58 m offshore of the parking lot. Probing with a rod beyond the furthest point surveyed indicated a drop-off of approximately 0.5 m at the end of the boat ramp to the surrounding seabed. This drop off has been included in Figure 3 as a hollow red triangle. These survey data place the seaward end of the boat ramp at an elevation of approximately -0.9 m Geodetic Datum (1.3 m Chart Datum) and the foot of the boat ramp structure 0.5 m lower at approximately -1.4 m Geodetic Datum (0.8 m Chart Datum).

*Photograph 5: Approximately the centre of the boat ramp (cross-shore) taken facing west on December 19, 2015.*

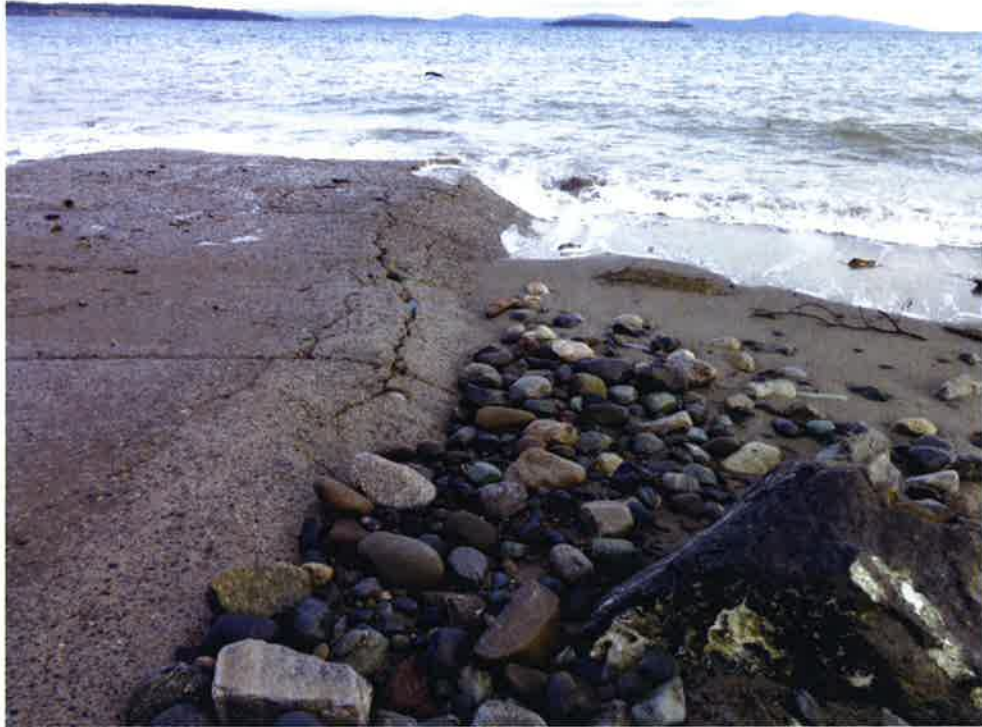
The boat ramp has a relatively intact sloped concrete edge facing south (Photograph 6). The north edge of the boat ramp has been eroded and indicates that the ramp consists of a concrete cap over a core of cobble-to-gravel-sized fill (Photograph 7). Sections of rebar were observed in the eroded surface of the boat ramp at a distance of approximately 45 m from the parking lot (Photograph 8). The hollow in the surface of the boat ramp was approximately 2 to 2.5 m wide, 1.5 to 2 m long, and 0.3 to 0.5 m deep. The hollow occupied approximately half the width of the crest of the boat ramp and appeared to limit the use of the ramp.

*Photograph 6: The southern side of the boat ramp taken facing east on December 19, 2015*

Evidence of cracking and spalling of the concrete was observed seawards of the woody debris (e.g., Photographs 6 and 7). The elevation drop that occurs immediately on either side of the ramp is shown in Figure 3 and in Photographs 9 and 10. No sediment was observed on the boat ramp surface during the site visit. The elevation drop on the south side is less pronounced than the elevation drop on the north side. This difference in beach elevation is indicative of northwards directed sediment transport. The beach surface to the south consists of a higher proportion of sand sized material relative to the beach surface to the north where more cobble-sized material was observed (e.g., Photographs 9 and 10). Typical cobble size was estimated in the field to be 150 mm minus (6" minus).

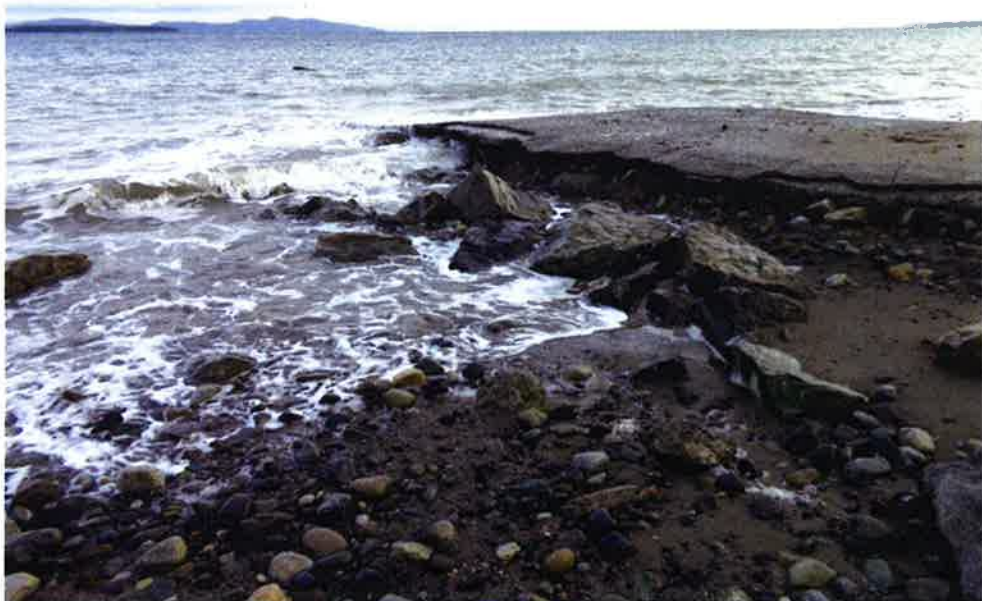
*Photograph 7: The northern side of the boat ramp taken facing southeast on December 19, 2015*

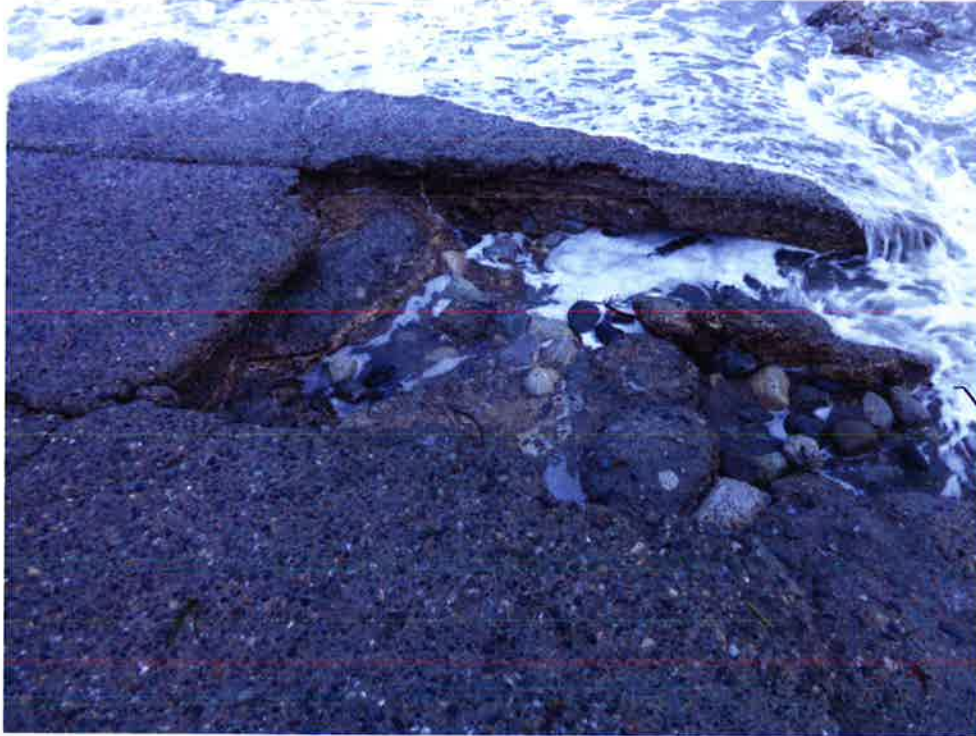
*Photograph 8: Eroded surface of the boat ramp taken facing east on December 19, 2015*

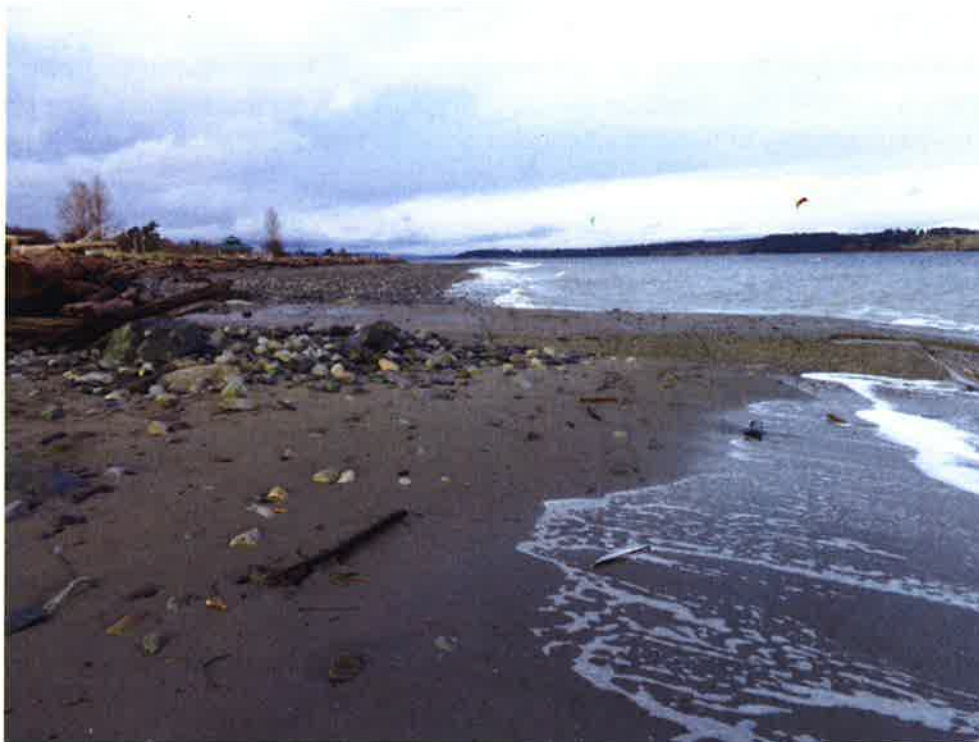
*Photograph 9: Beach to the south of the boat ramp taken facing north on December 19, 2015*

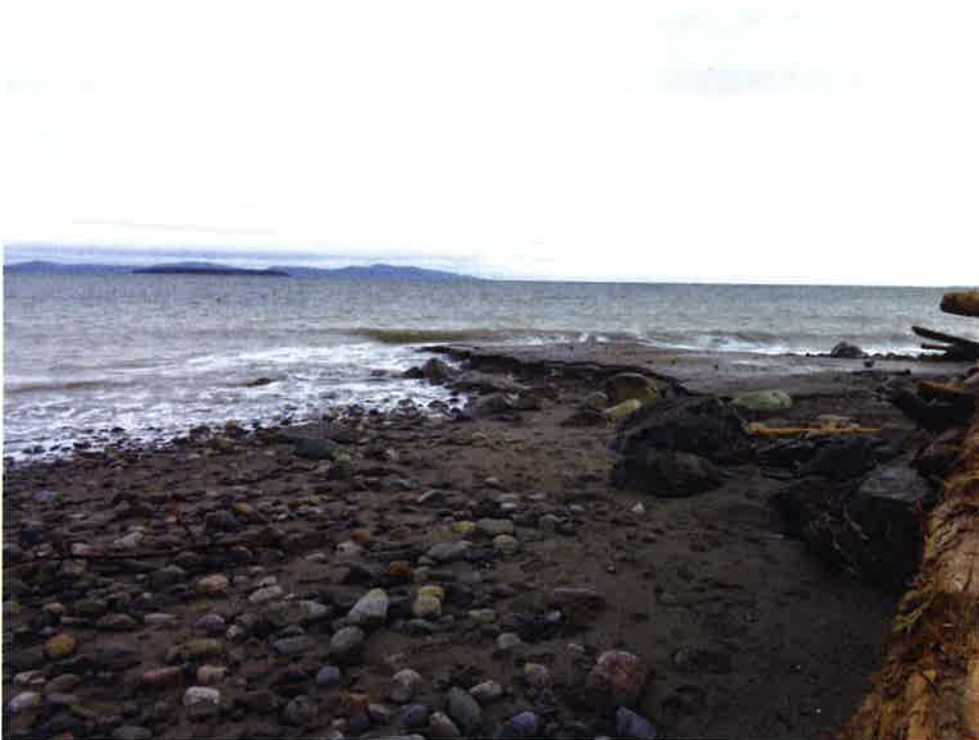
*Photograph 10: Beach to the north of the boat ramp taken facing southeast on December 19, 2015*

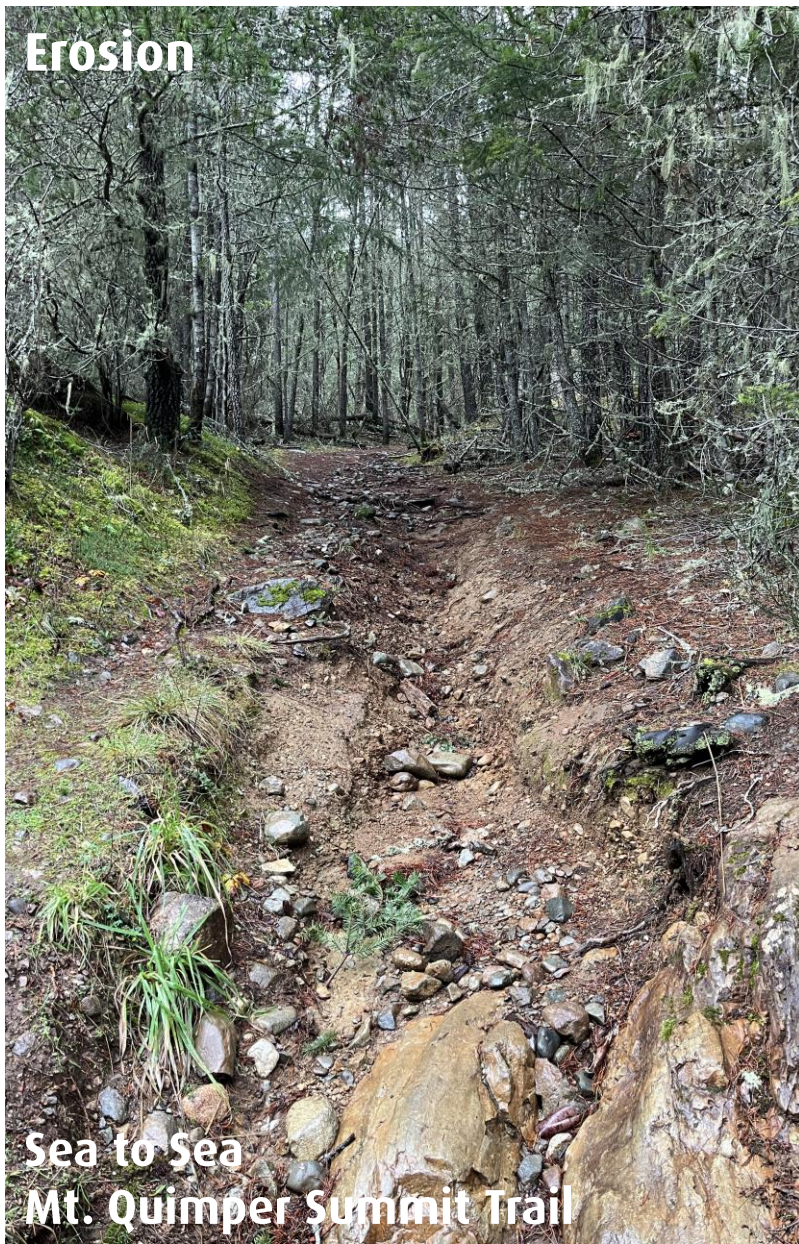
Sea to Sea  
Mt. Quimper Summit Trail

Erosion

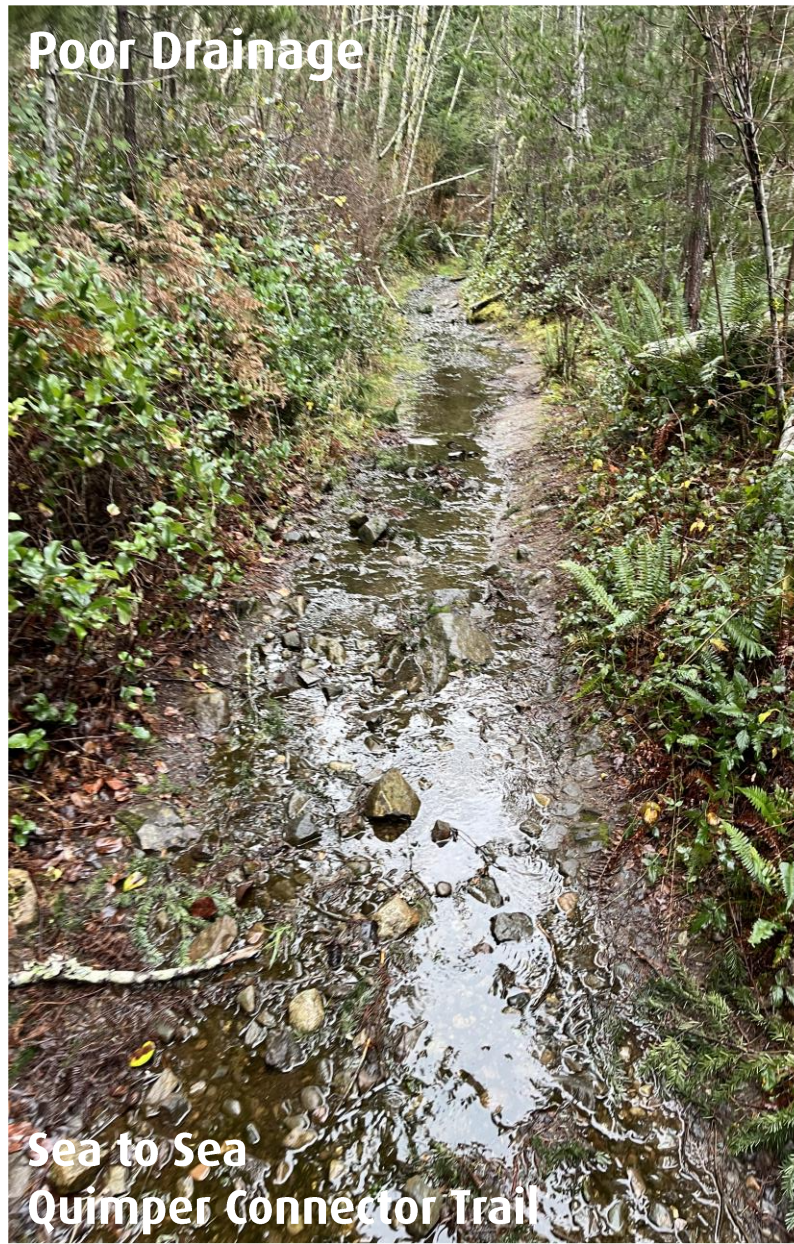
Sea to Sea  
Quimper Connector Trail

Poor Drainage
