**SOUTHERN GULF ISLANDS HARBOURS COMMISSION**  
Notice of Meeting on **Friday, October 9, 2026 at 9:30 am**  
Saanich Peninsula Wastewater Treatment Plant Meeting Room,  
9055 Mainwaring Road, North Saanich, BC

The Southern Gulf Islands Harbours service area is comprised of thirteen dock facilities among six islands. Through the service's five-year capital plan, the Capital Regional District (CRD) executes capital projects to maintain the level of service, improve service and conduct major repairs. The following is a summary of the projects that are active and recently completed.

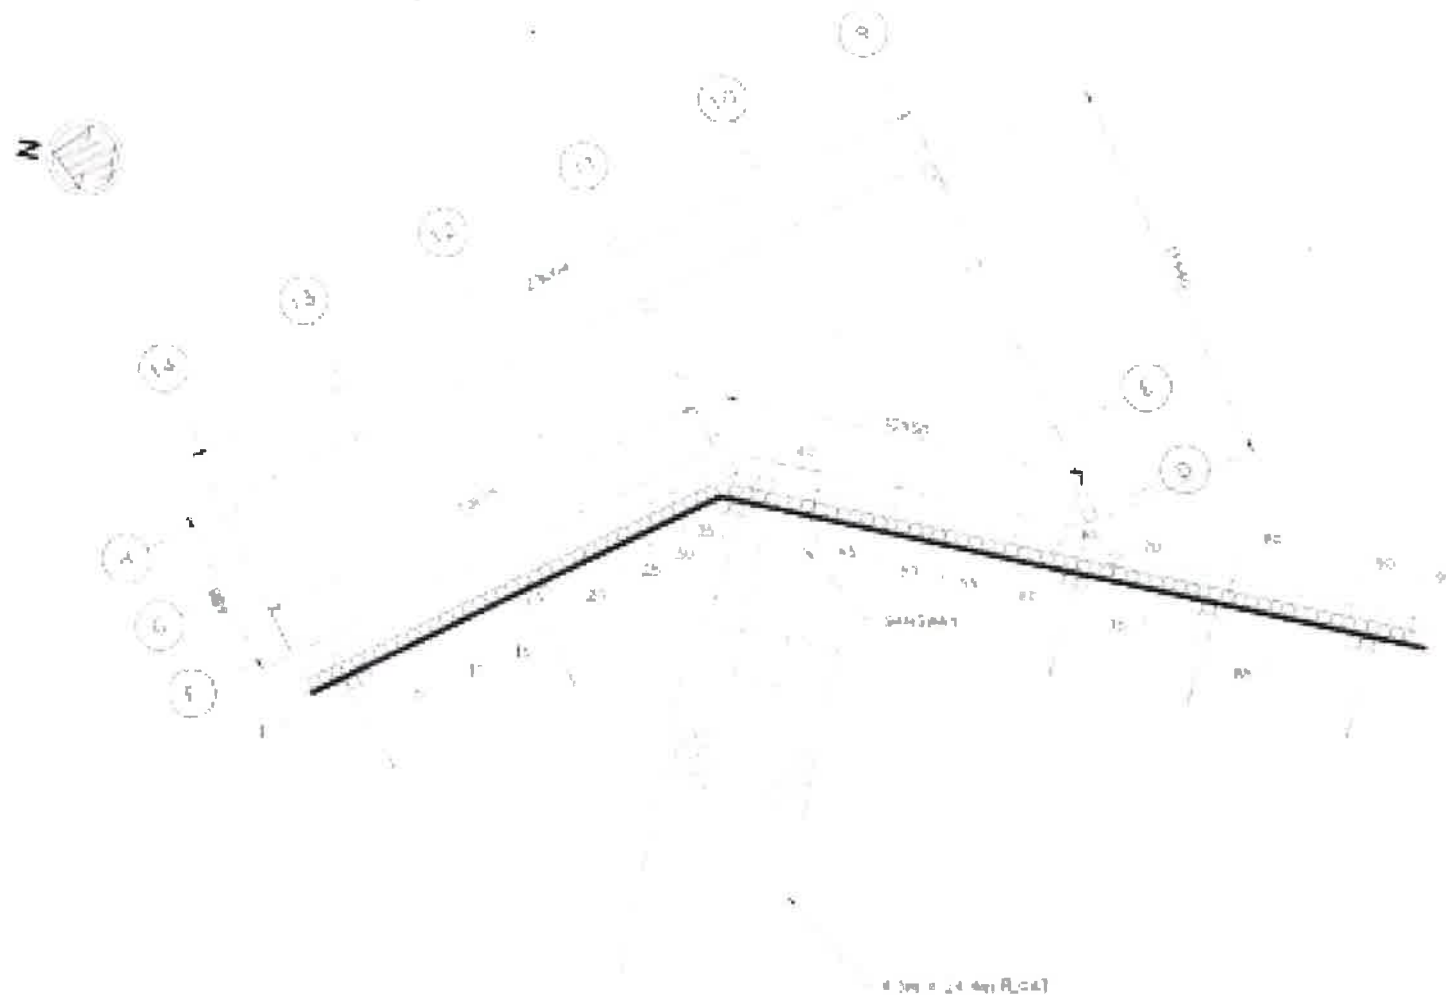
Sturdies Bay Dock Arrangement

| | <p>The large painted steel bollard restricts any vehicle traffic to this wood decked structure with unpainted railings and bull rails that are in good condition for its age. There are some small areas of decking with minor developing rot. The painted wood notice board is in fair condition and fresh paint or replacement with an aluminum notice board is recommended.</p> <p>The fire extinguisher case is broken and replacement is not urgent but recommended.</p> |

| <b>GANGWAY FLOATS</b> | <p>The heavy old painted steel gangway has NEW mini mesh decking. There is a steel transition plate with fresh non-skid paint at the top and an expanded metal grating apron at the bottom that are in good condition. There is very poor access to the steel roller and the pillow blocks. They require an inspection as one may be broken. A guide rail may also be broken and will require replacement. The roller bed boards are also in poor condition and replacement is recommended.</p> <p>The single wood float with decking, rub boards and bull rails with mostly tight bolts but near the gangway they are very loose and require tightening. The float has good flotation. It is heavily built and in fair condition for its age. There is a fair amount of flexing happening in the middle of this float but it is holding up well at the moment. There are 2 safety ladders at each end of the float that are in good condition. There is new yellow paint on the bull rails in the emergency/loading zone. There are 4 large pile wells with 6 wood piles / well. The piles generally have minimum wear except for a few piles in each corner that have roughly 20% wear. The closed wells are in good condition along with the UHMW rub boards.</p> |

| <b>COMMENTS/INSTRUCTIONS</b> | <p>&gt; Inspect the pillow blocks on the gangway along with the guide rail, these may be broken.</p> <p>&gt; Tighten the loose bull rail bolts on the shore side of the float near the gangway.</p> |

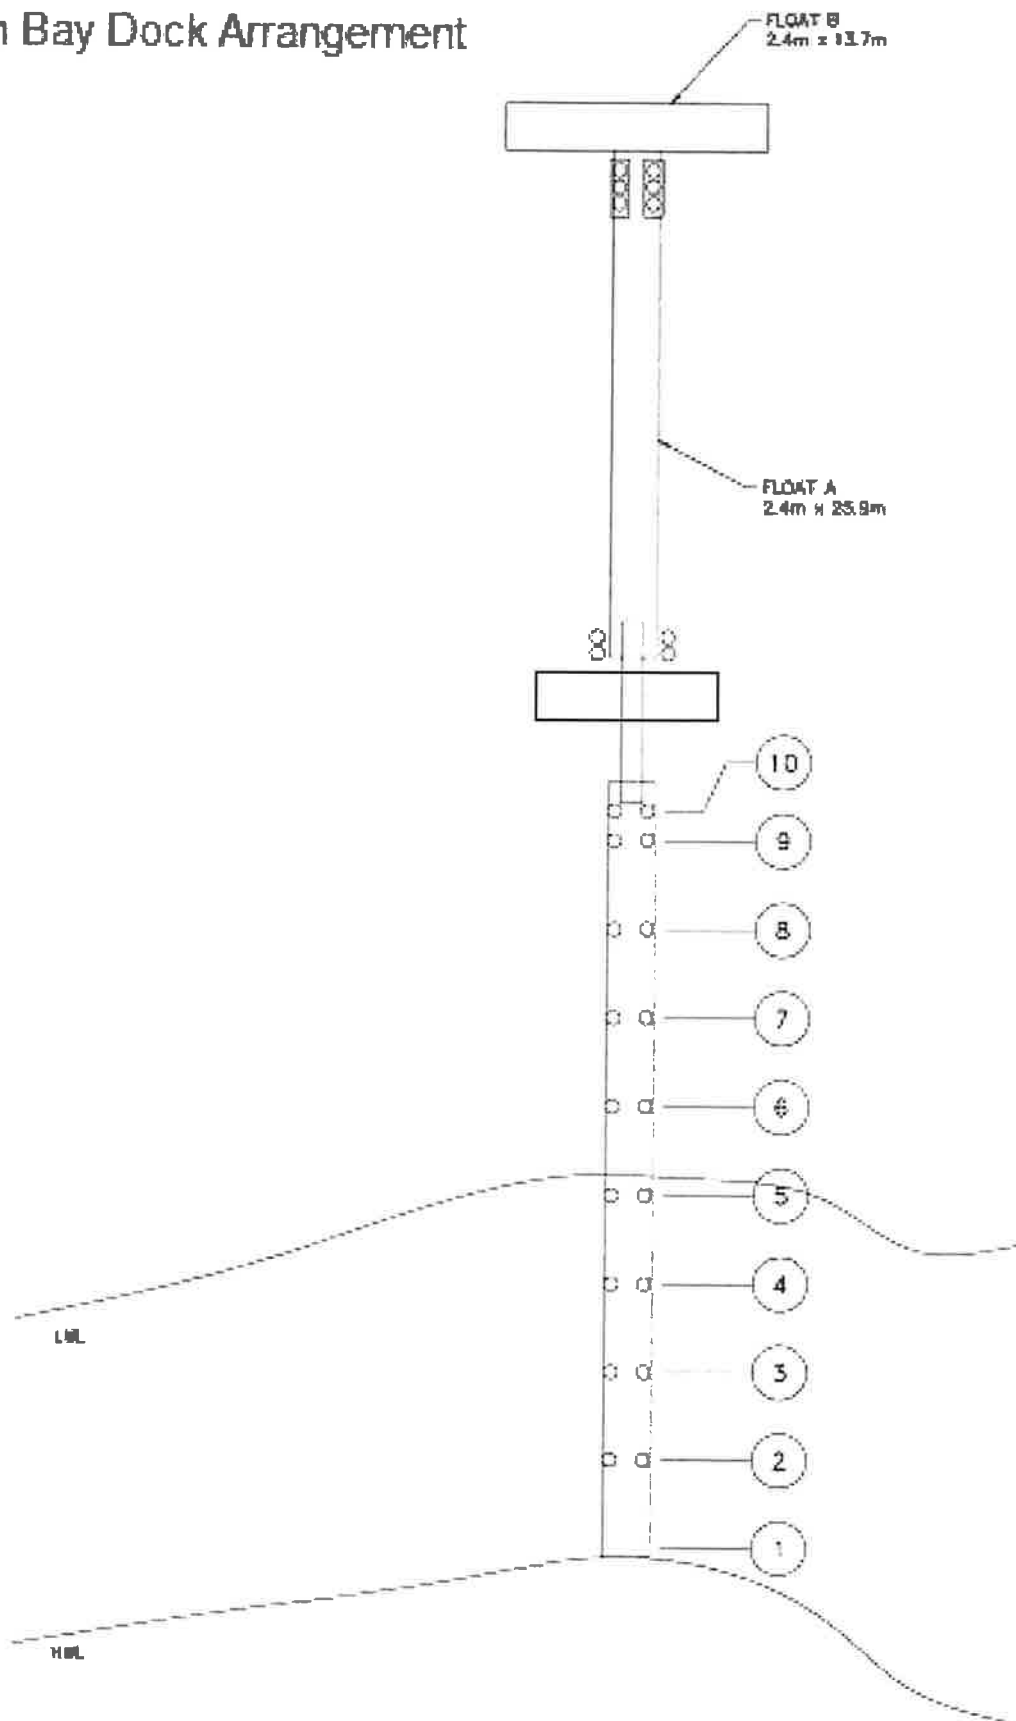
# Horton Bay Dock Arrangement

| | <p>There is a mini mesh mud grate at the entrance of the approach. The wood railings at the entrance are painted. The railings and bull rails in the newer section, after the covered area, are unpainted and in good condition. The wood decking at the entrance is new and covered with expanded metal grating. The new decking and bull rails that continue from the covered area to the gangway, are in good condition. There is a piece of plywood attached to the railing in the covered area that works well for the notice board.</p> |

| <b>GANGWAY FLOATS</b> | <p>The old painted steel gangway is in good condition and has new mini mesh decking. There is an aluminum top transition plate with non-skid and an aluminum bottom apron with mini mesh decking in very good condition. One of the UHMW runners for the bottom apron has come loose and requires refastening. The older steel roller and steel guide rails are rusty but in fair condition along with the pillow blocks that are in good condition.</p> |
| | <p>The new wood float has mini mesh decking, wood rub boards and bull rails all with tight bolts. The float is in very good condition with good flotation except at the pile well end that is low in the water. There are 2 safety ladders in good condition. The WCMRC float is attached to the end of this float and is in good condition. On either side of the gangway, there are 2 new outside steel pipe pile wells that contain the 2 older wood piles/well that are in fair condition. There is a new single closed pile well at the end of the float with 6 older wood piles in good condition. The UHMW rub boards are in new condition.</p> |
| | <p>There is an older wood float, recently pressure washed, being used as a dinghy float attached to the new main float. The flotation is good and the wood decking, rub boards and bull rails are in fair condition. There is a hard rubber mat as a transition between the floats and the connecting hardware is in good condition.</p> |

| <b>COMMENTS/INSTRUCTIONS</b> | <p>&gt; The electrical service is old and requires inspection.</p> |

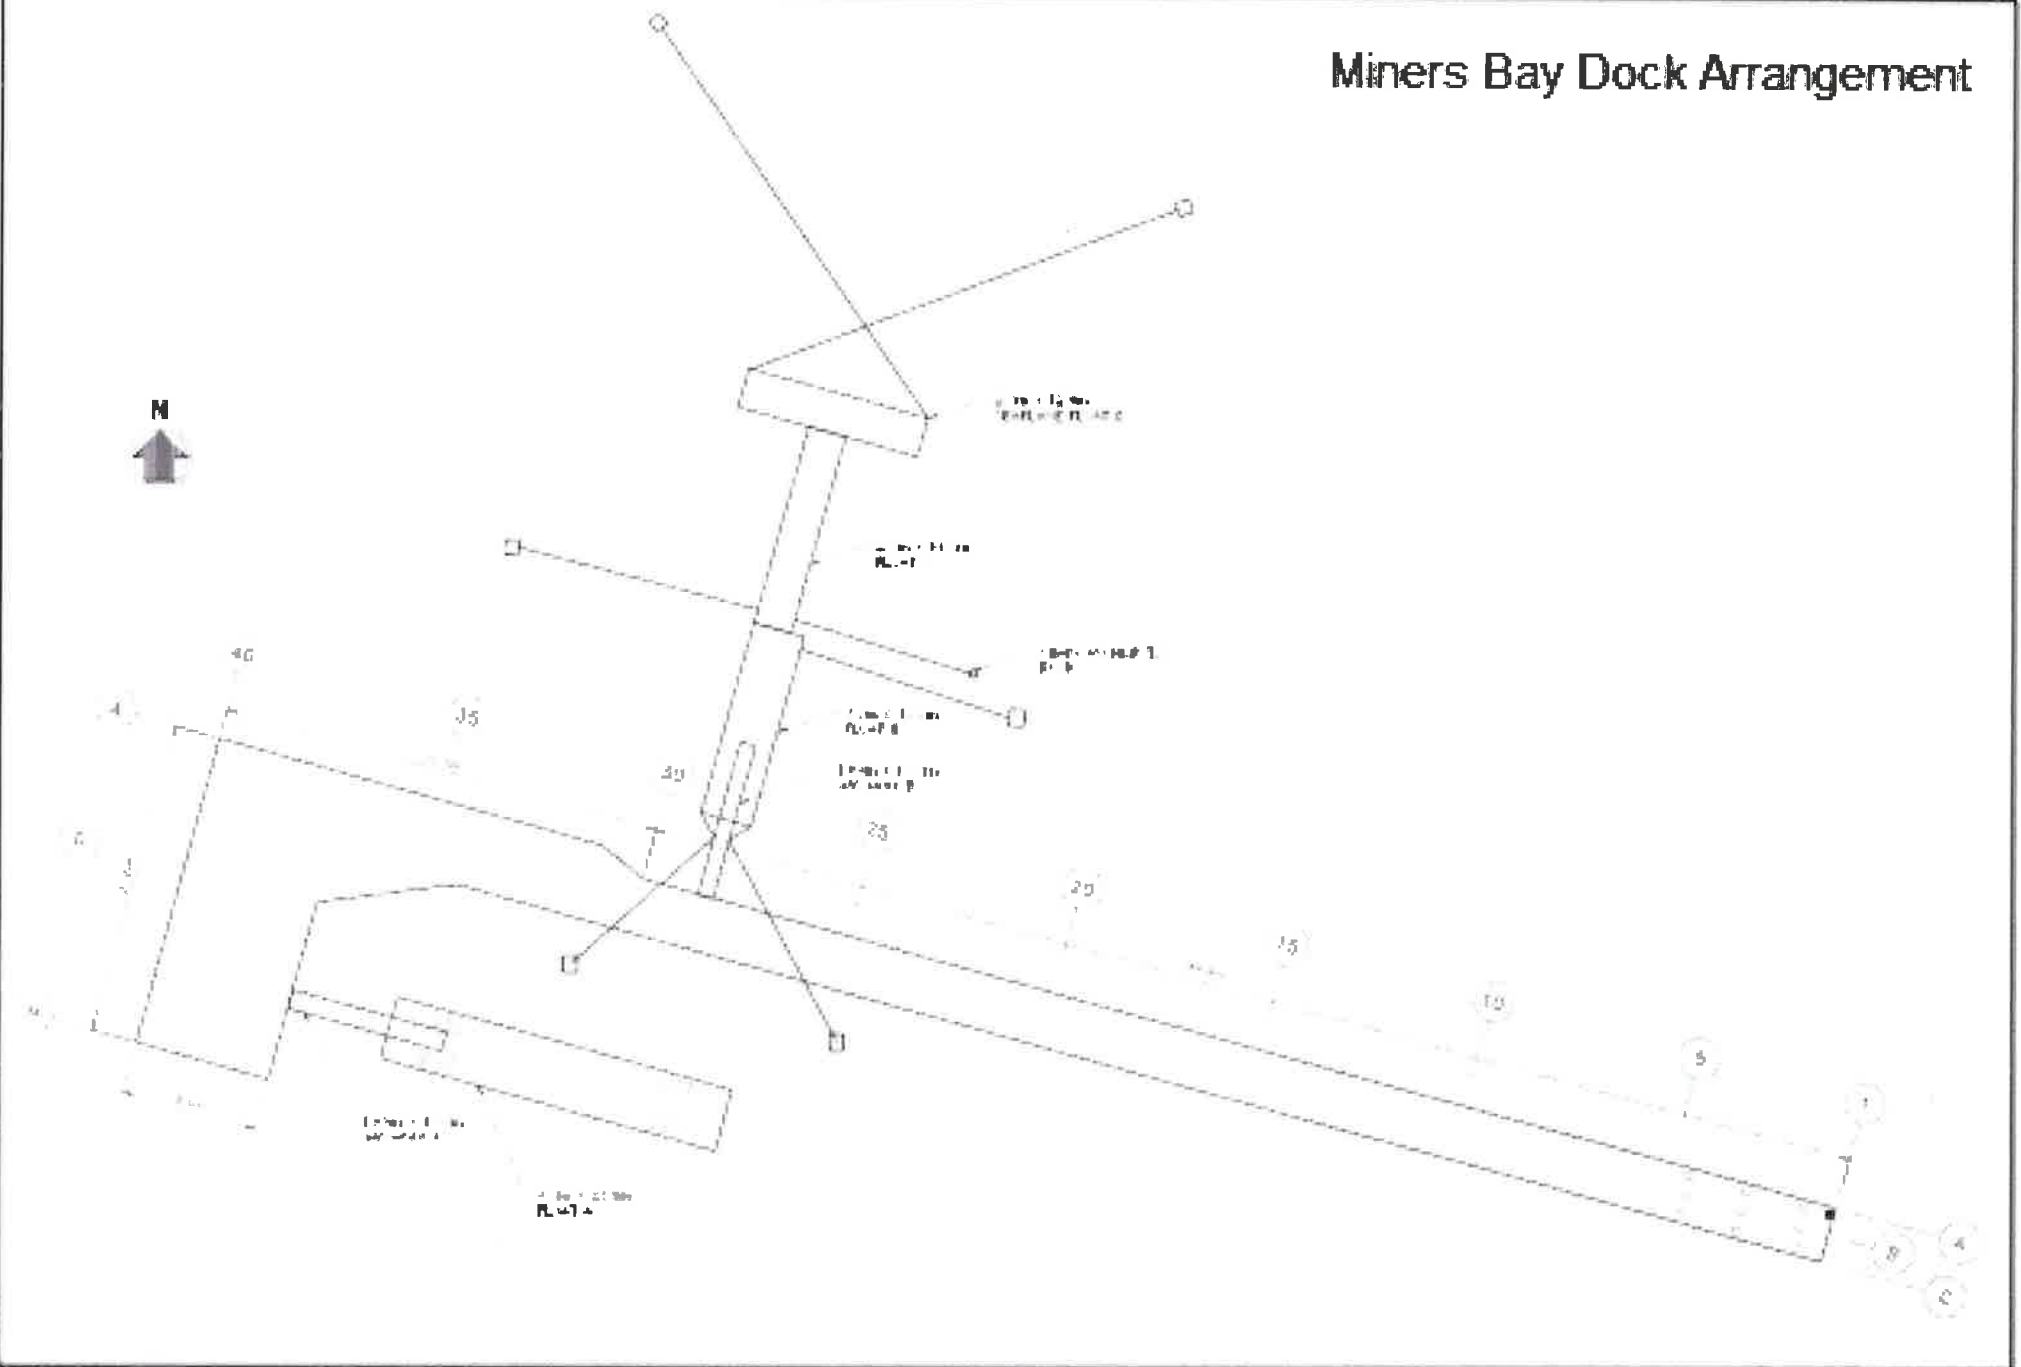
# Miners Bay Dock Arrangement

| | <p>This is an old long wood structure with painted (faded) railings and bull rails that are in fair condition. The wood decking is in fair condition with several boards that have developing rot and require monitoring for replacement and 4 severely rotten boards that require replacement. Nico has temporarily covered them with plywood. There is a conveyor belt mat that runs from the top to the entrance of Float B. Pressure washing the railings and bull rails is recommended. There is a new aluminum notice board that looks great! There is a new unpainted wood shelter next to the notice board.</p> |

| | <p>This is a large area with large wood bull rails and new unpainted wood railings surrounding the wharfhead. Most of the wood decking has been replaced but there are still a number of boards that require monitoring for developing rot and future replacement. This area is in generally good condition and has been pressure washed. The Spill Kit container has been opened and is continually being filled with trash. This is an on going issue at this facility for years.</p> |

| <b>GANGWAY FLOATS</b> | <p>Gangway A is an older painted (faded) steel structure with areas of rust. There is new mini mesh decking. The old painted kick boards have some areas of rot at each end. The top and bottom transition plates are steel with non-slip and in good condition but the bottom plate requires a new UHMW skid shoe or runners. Painting is recommended. The steel roller, guide rails and pillow blocks are in good condition and service may be required at this time (difficult access).</p> <p>Float A is an older wood float with decking, rub boards and worn bull rails with some loose bolts on the south side and loose deck boards caused by the dry weather. Replacing the bull rails on the south side is recommended. The flotation is in fair condition. There are 4 closed pile wells with 6 wood/steel (2) piles/well that are in good to fair condition with 2 very worn piles in the wells next to the gangway, observed at low tide. The pile wells and the UHMW rub boards are in mostly good to fair condition.</p> <p>Gangway B is an older heavily built unpainted steel structure with an open steel grating in good condition. There is a floating steel top transition plate with non skid. The bottom apron is constructed the same as the gangway decking and is in good to fair condition. There is a steel roller on guide rails and pillow blocks that are in good condition.</p> <p>Float B is a newer float constructed of wood with concrete square tiles for the decking. There are 3 tiles with cracks showing but are stable as viewed. The wood bull rails are in good condition, the bull rail bolts are no longer tight and are very loose on both sides of the float, tightening is required. The float is anchored and the flotation is good. Painting has been done for the loading/emergency landing zone and seaplane landing zone. Long &amp; short term moorage along with the loading/emergency signs are deteriorating and new signs were provided to the wharfinger to install as required. There is a safety ladder that requires repair.</p> |

| <b>COMMENTS/INSTRUCTIONS</b> | <p>&gt; Replace the 4 rotten deck boards on the approach near the entrance to Float B.</p> <p>&gt; Replace UHMW skid shoe or install runners on gangway (Float A) bottom apron.</p> <p>&gt; Replace bull rails on Float A (worn/broken/missing and loose rail bolts).</p> <p>&gt; Safety ladders require cleaning on Float A, repair ladder on float B (short term side).</p> <p>&gt; Monitor the developing rot on the approach, wharfhead and wear of the wood piles of float A.</p> <p>&gt; Decking on Float A is loose and refastening is recommended.</p> |

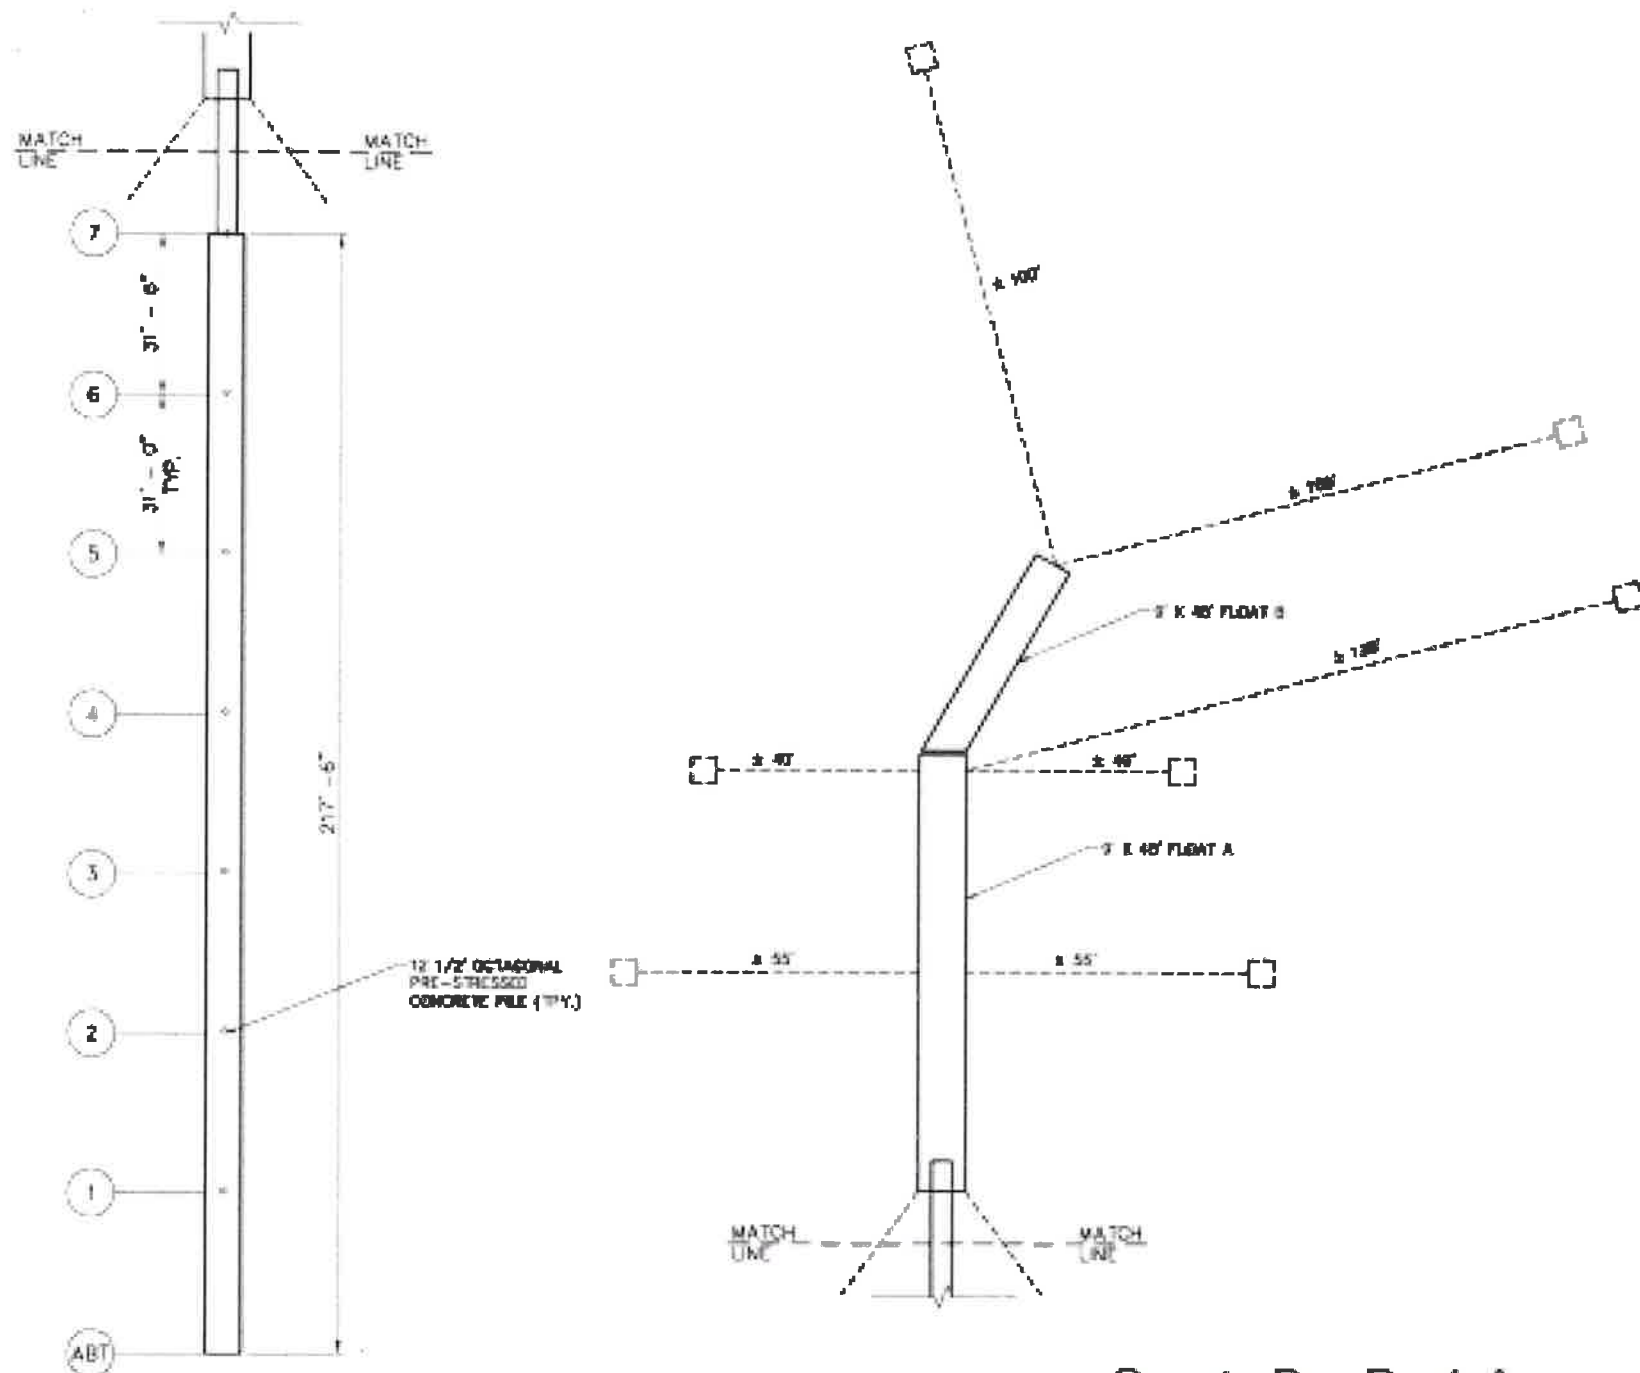
Swartz Bay Dock Arrangement

| <b>COMMENTS/INSTRUCTIONS</b> | <ul style="list-style-type: none"> <li>&gt; Repair or replace the damaged gangway apron &amp; extending the wooden runners (3 feet) is recommended.</li> <li>&gt; Replace the top gangway hinge pin.</li> <li>&gt; Replace the broken fire extinguisher case. (on order)</li> </ul> |

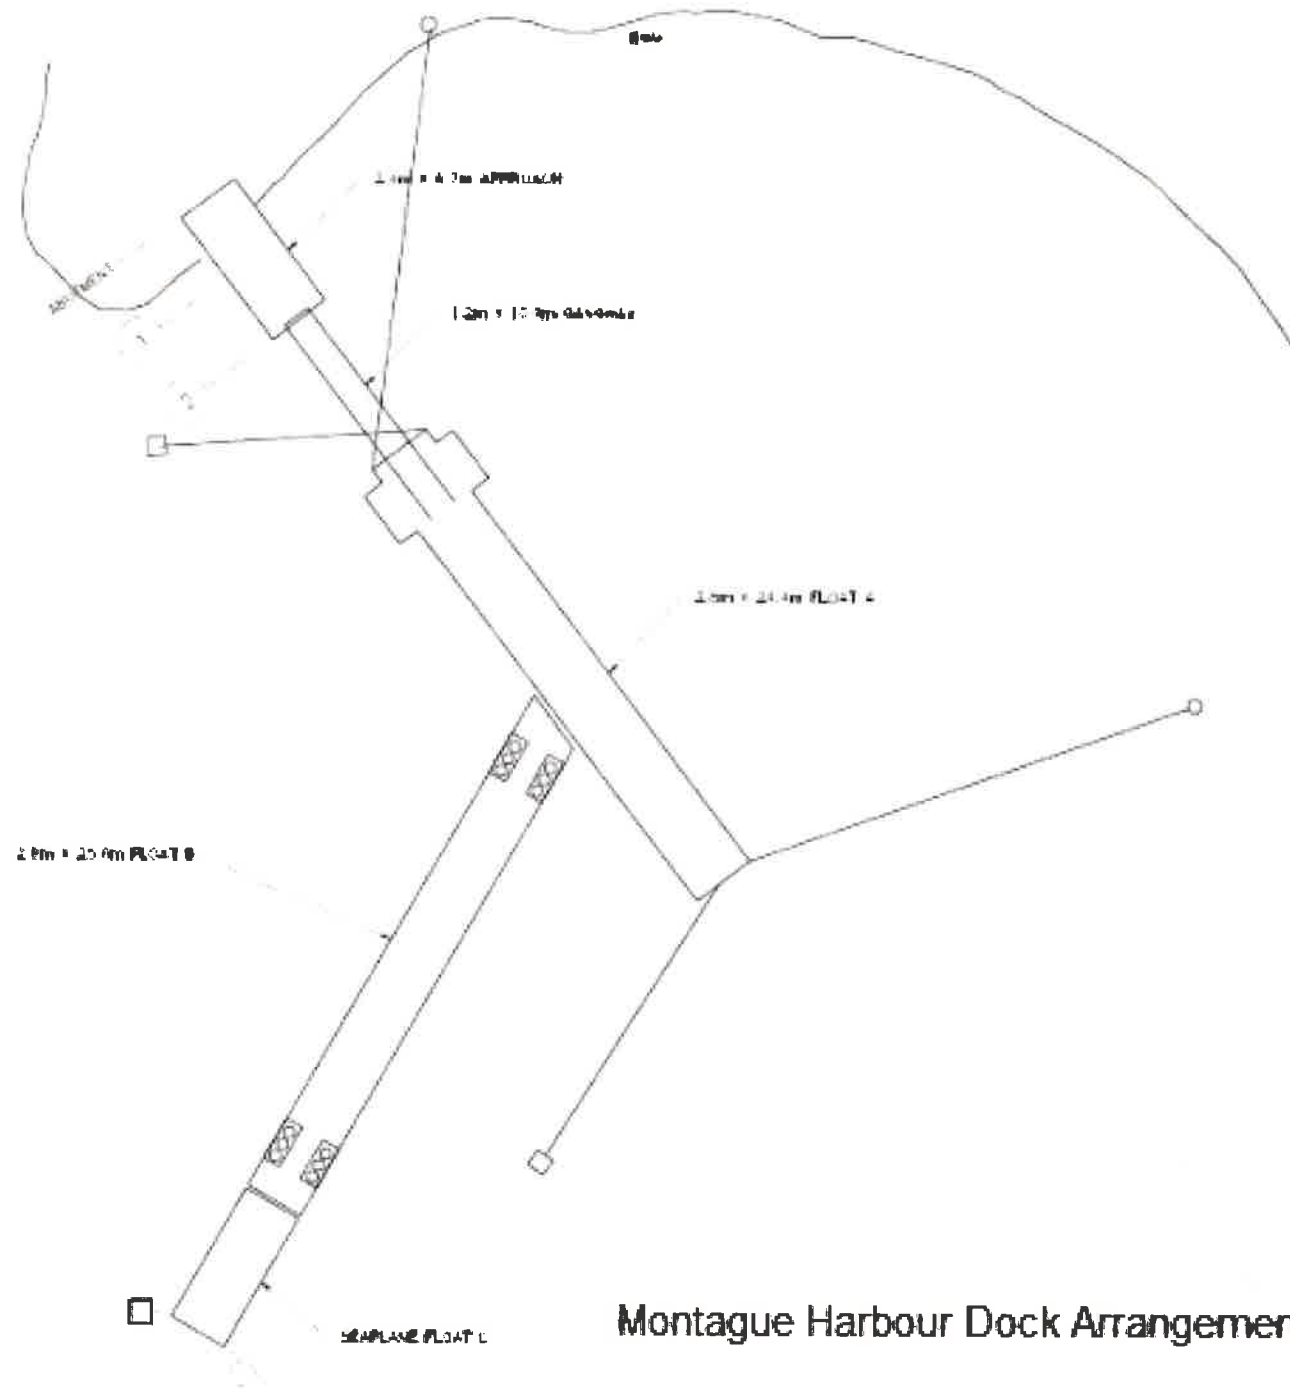
Montague Harbour Dock Arrangement

| | > Monitor the wear on the connecting hardware for floats A & B. |
