**SOUTHERN GULF ISLANDS HARBOURS COMMISSION**  
Notice of Meeting on **Friday, October 9, 2026 at 9:30 am**  
Saanich Peninsula Wastewater Treatment Plant Meeting Room,  
9055 Mainwaring Road, North Saanich, BC

# Southern Gulf Islands Harbours DOCK INSPECTION REPORT

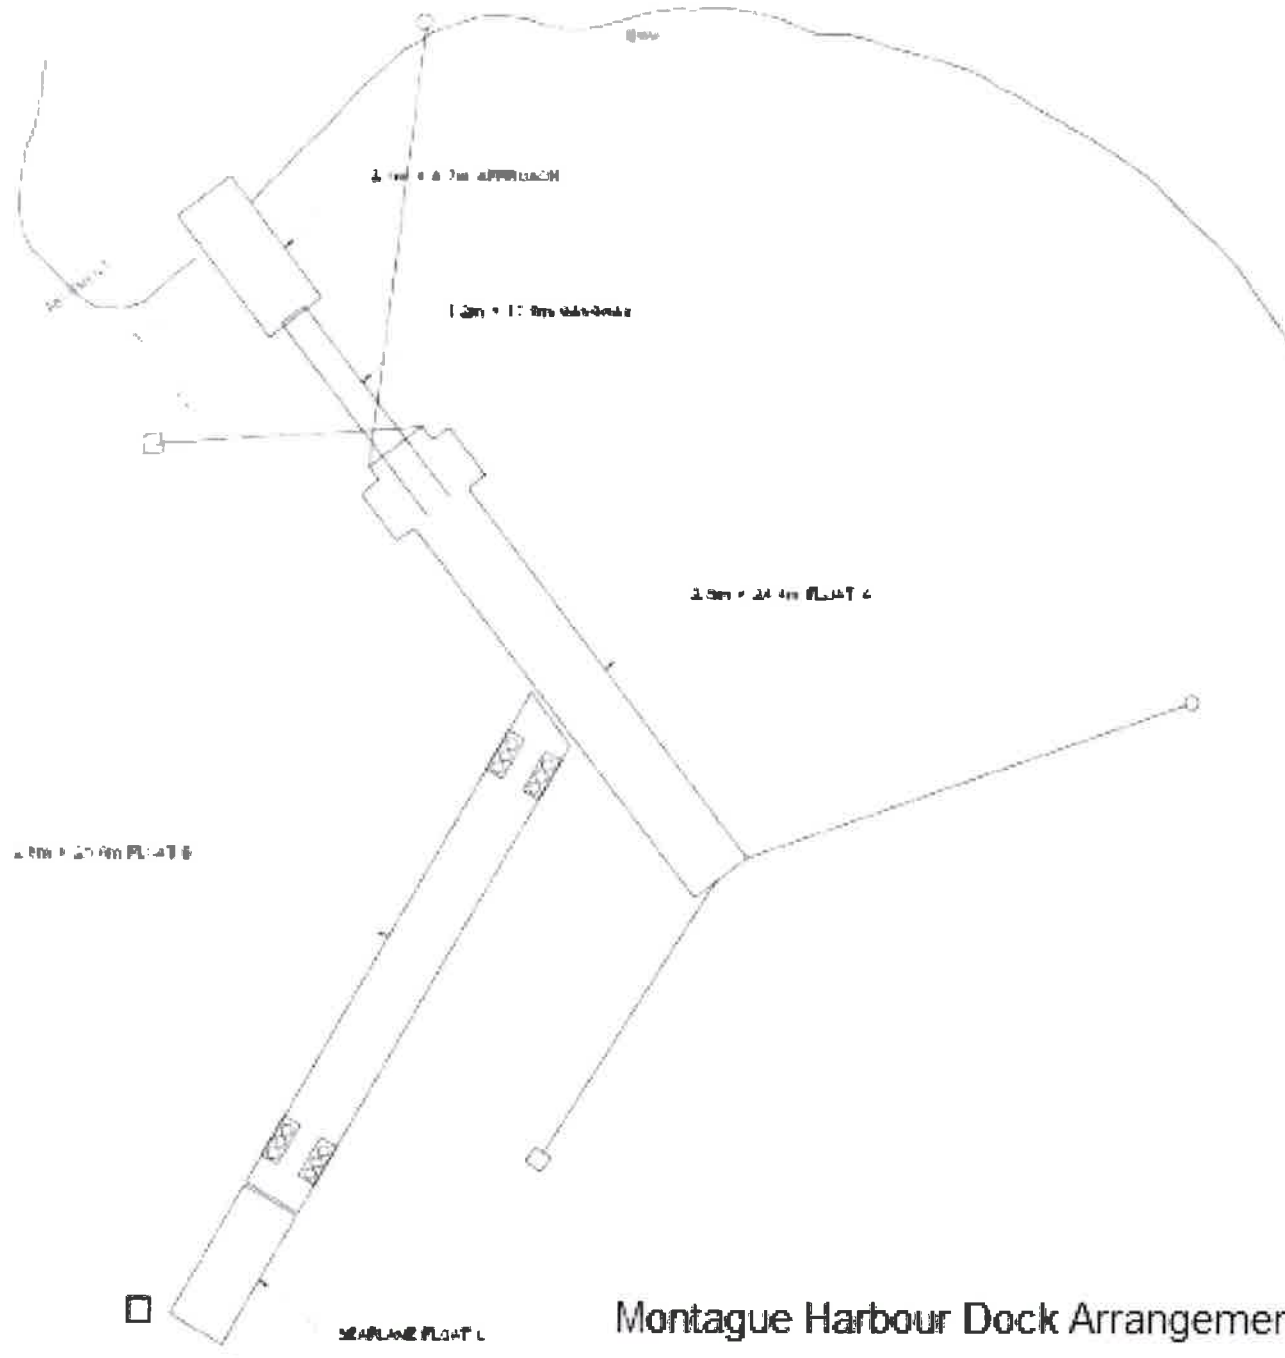
Montague Harbour Dock Arrangement

| <b>GANGWAY FLOATS</b> | <p>The aluminum gangway with Mini Mesh decking is in good condition. There is a floating top aluminum transition plate with painted non-skid and a bottom aluminum apron with Mini Mesh for decking that are in good condition. The hard rubber wheels run on steel guide rails and these are also in good condition.</p> <p>Float A is an older wood float with decking, rub boards and bull rails with tight bolts that are in worn but good condition. There is a single steel piling (good anode) in a closed well next to the gangway that is also in good condition. The 2 safety ladders here and one on the sea plane float are in good condition. The flotation is low at the end of the float and monitoring is recommended.</p> <p>Float B is an older wood float with decking, rub boards and bull rails with tight bolts, that are worn but in good condition. There is a large steel transition plate between floats A &amp; B that has been recently painted with new non-slip. The connection hardware is old and rusty with 50% wear on one shackle, inspection is recommended. There are 4 closed pile wells with 3 piles/well. There is minimal wear on all of these pilings and the wells are in good condition with new UHMW rub boards.</p> <p>Float C is an older wood float with decking, rub boards and bull rails with a few loose bolts, the bull rails are worn but in fair condition. There is a single steel pile in a closed well in good condition and has a good anode.</p> <p>Float D looks to be the oldest float. This has wood decking, rub boards and bull rails with tight bolts and is in worn but still in fair condition. The deck boards are drying out and the boards are getting loose, re-nailing is recommended. There is fresh yellow paint on the loading zone and sea plane landing. New signs were installed for the sea plane landing and the loading zone bull rails.</p> <p>The WCMRC is connected to Float A and is in good condition.</p> |

| <b>COMMENTS/INSTRUCTIONS</b> | <p>&gt; Loose deck boards require re-nailing.</p> <p>&gt; Float A life ring requires a new grab line.</p> <p>&gt; Monitor the flotation at the end of float A.</p> <p>&gt; Monitor the wear on the connecting hardware for floats A &amp; B.</p> |

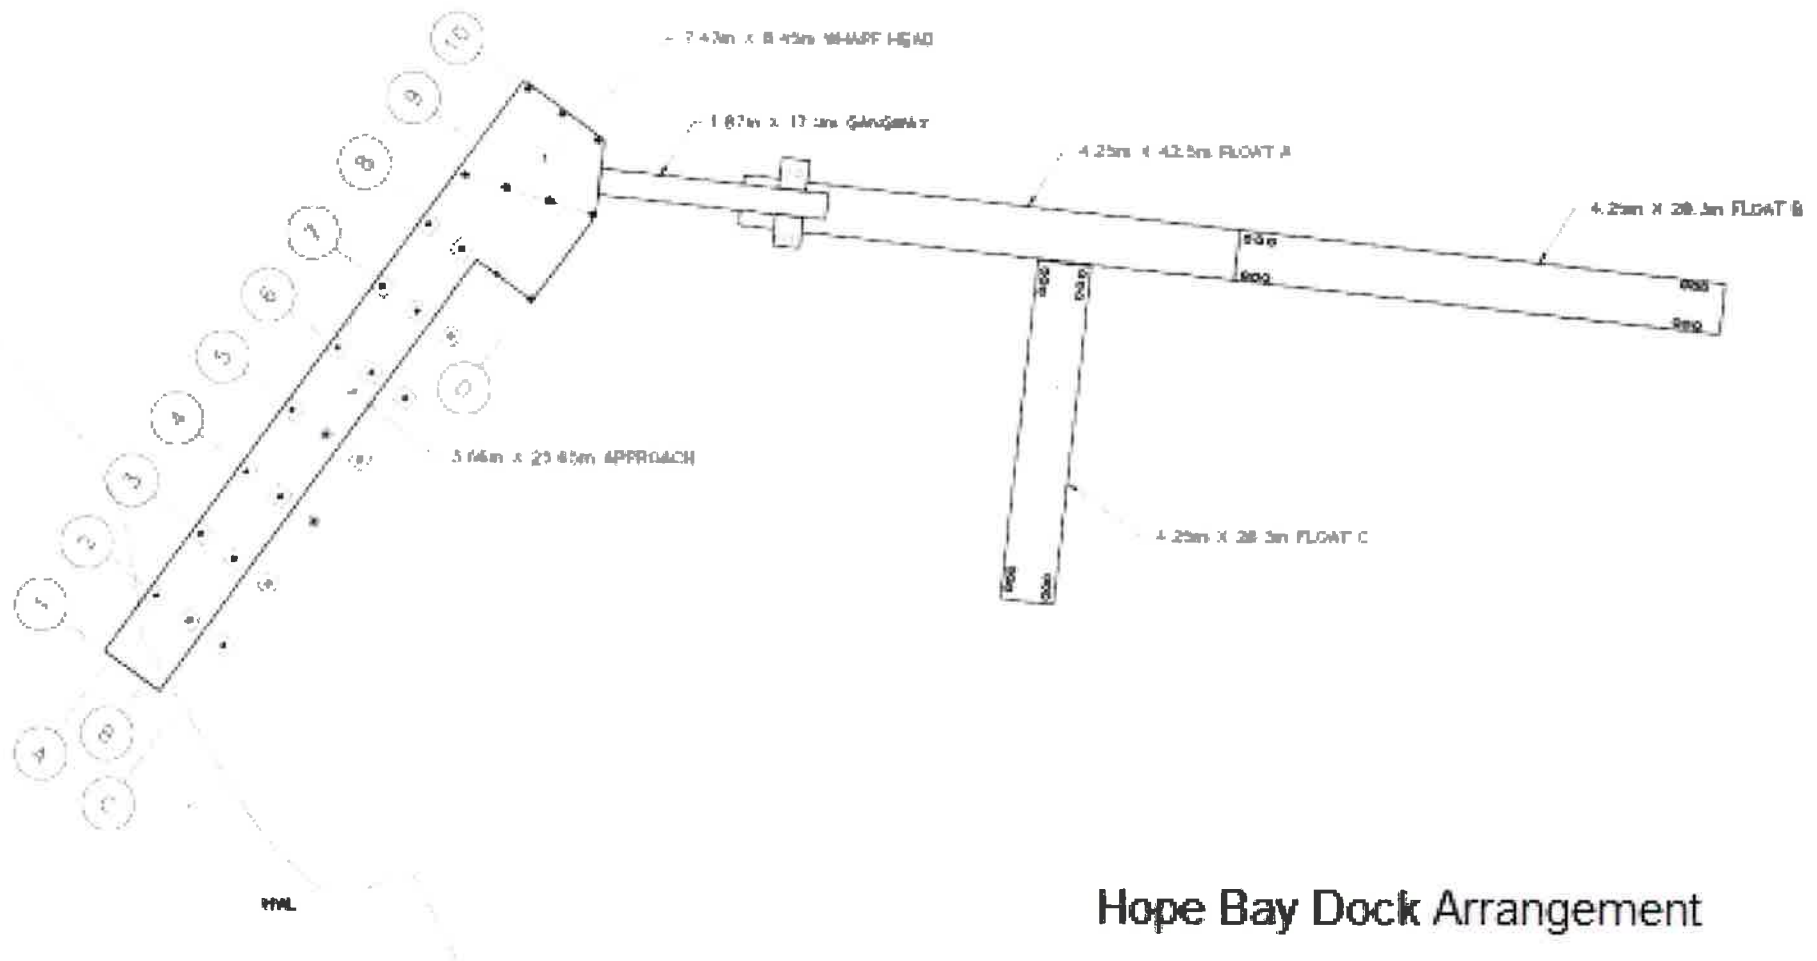
Hope Bay Dock Arrangement

| <b>GANGWAY FLOATS</b> | <p>The old painted steel gangway is in fair condition with the usual amount of rust at the bottom end and on the cross-bracing, painting is recommended. The wood decking, half expanded metal for non-skid and half wood rungs, is in good condition. There is a top aluminum transition plate with non-skid and a bottom aluminum apron with expanded metal grating that is in good condition. The steel roller is new along with the pillow blocks but the steel guide rails are coming to the end of their service life and will require replacement in the near future.</p> |

| | > Replacing the older wood decking on the gangway with Mini Mesh decking is recommended. |
| | > Refastening the metal fencing on the approach is required along the bottom edge or replace with new fencing. |

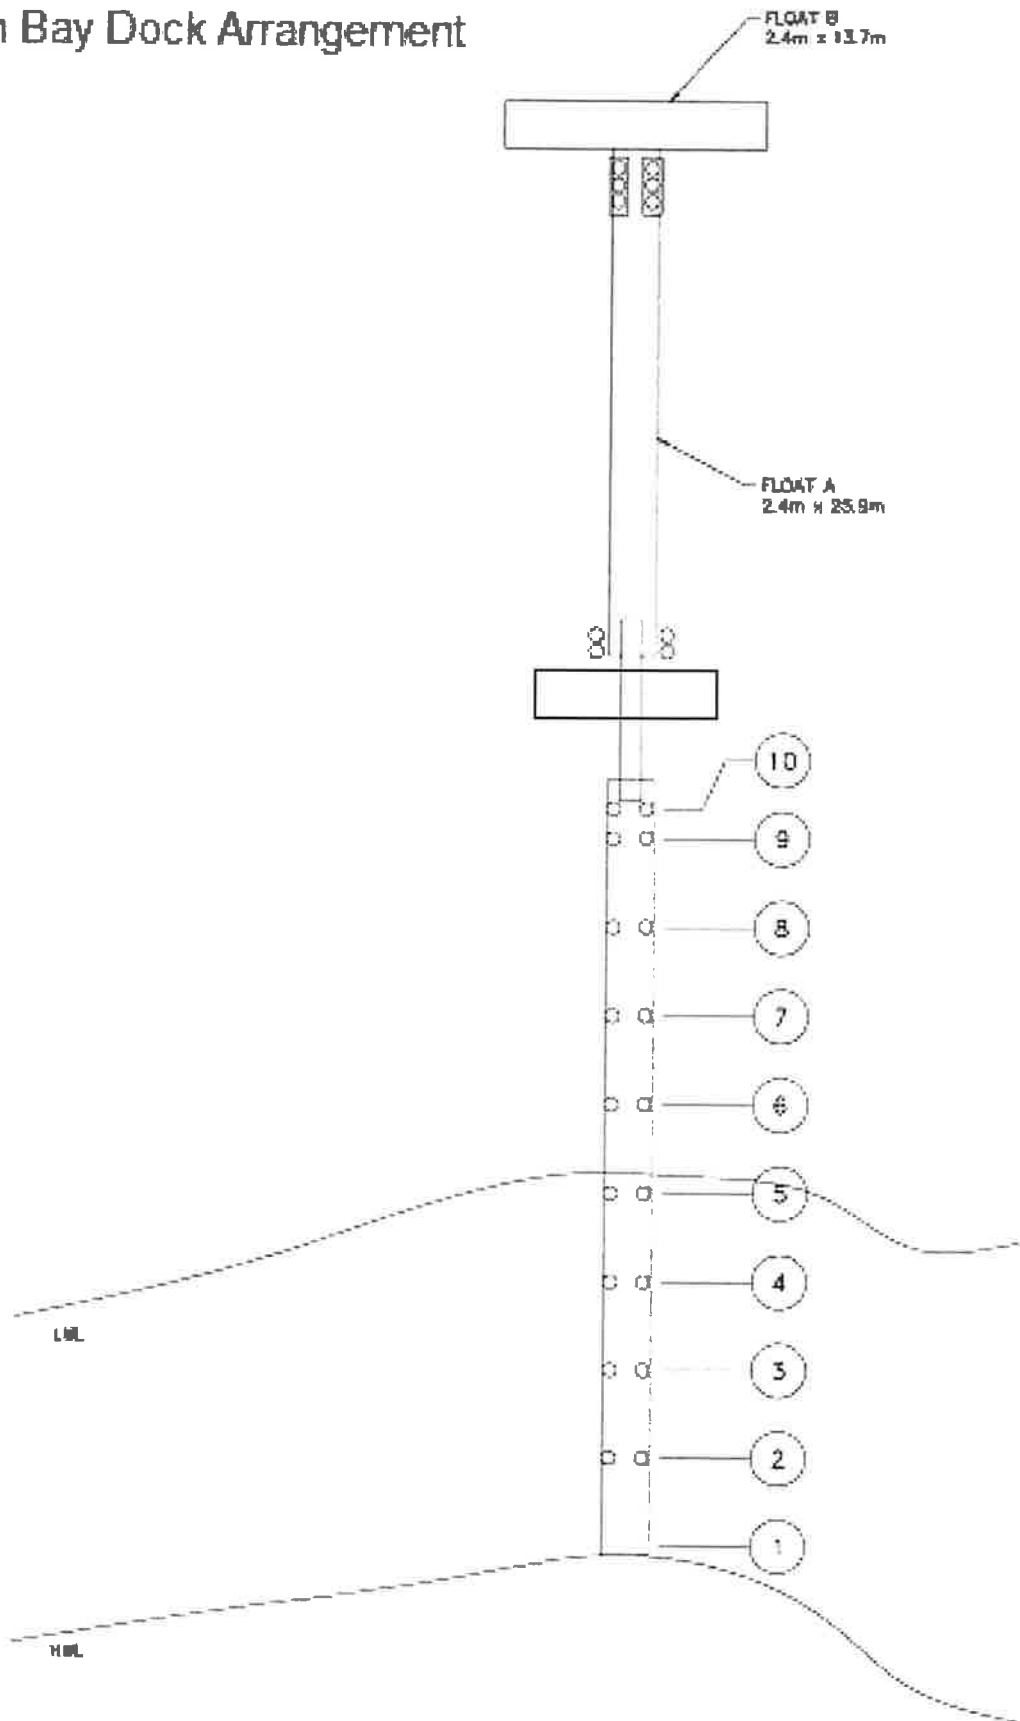
# Horton Bay Dock Arrangement

| | <p>The new wood float has mini mesh decking, wood rub boards and bull rails all with tight bolts. The float is in very good condition with good flotation except at the pile well end that is low in the water. There are 2 safety ladders in good condition. The WCMRC float is attached to the end of this float and is in good condition. On either side of the gangway, there are 2 new outside steel pipe pile wells that contain the 2 older wood piles/well that are in fair condition. There is a new single closed pile well at the end of the float with 6 older wood piles in good condition. The UHMW rub boards are in new condition.</p> |

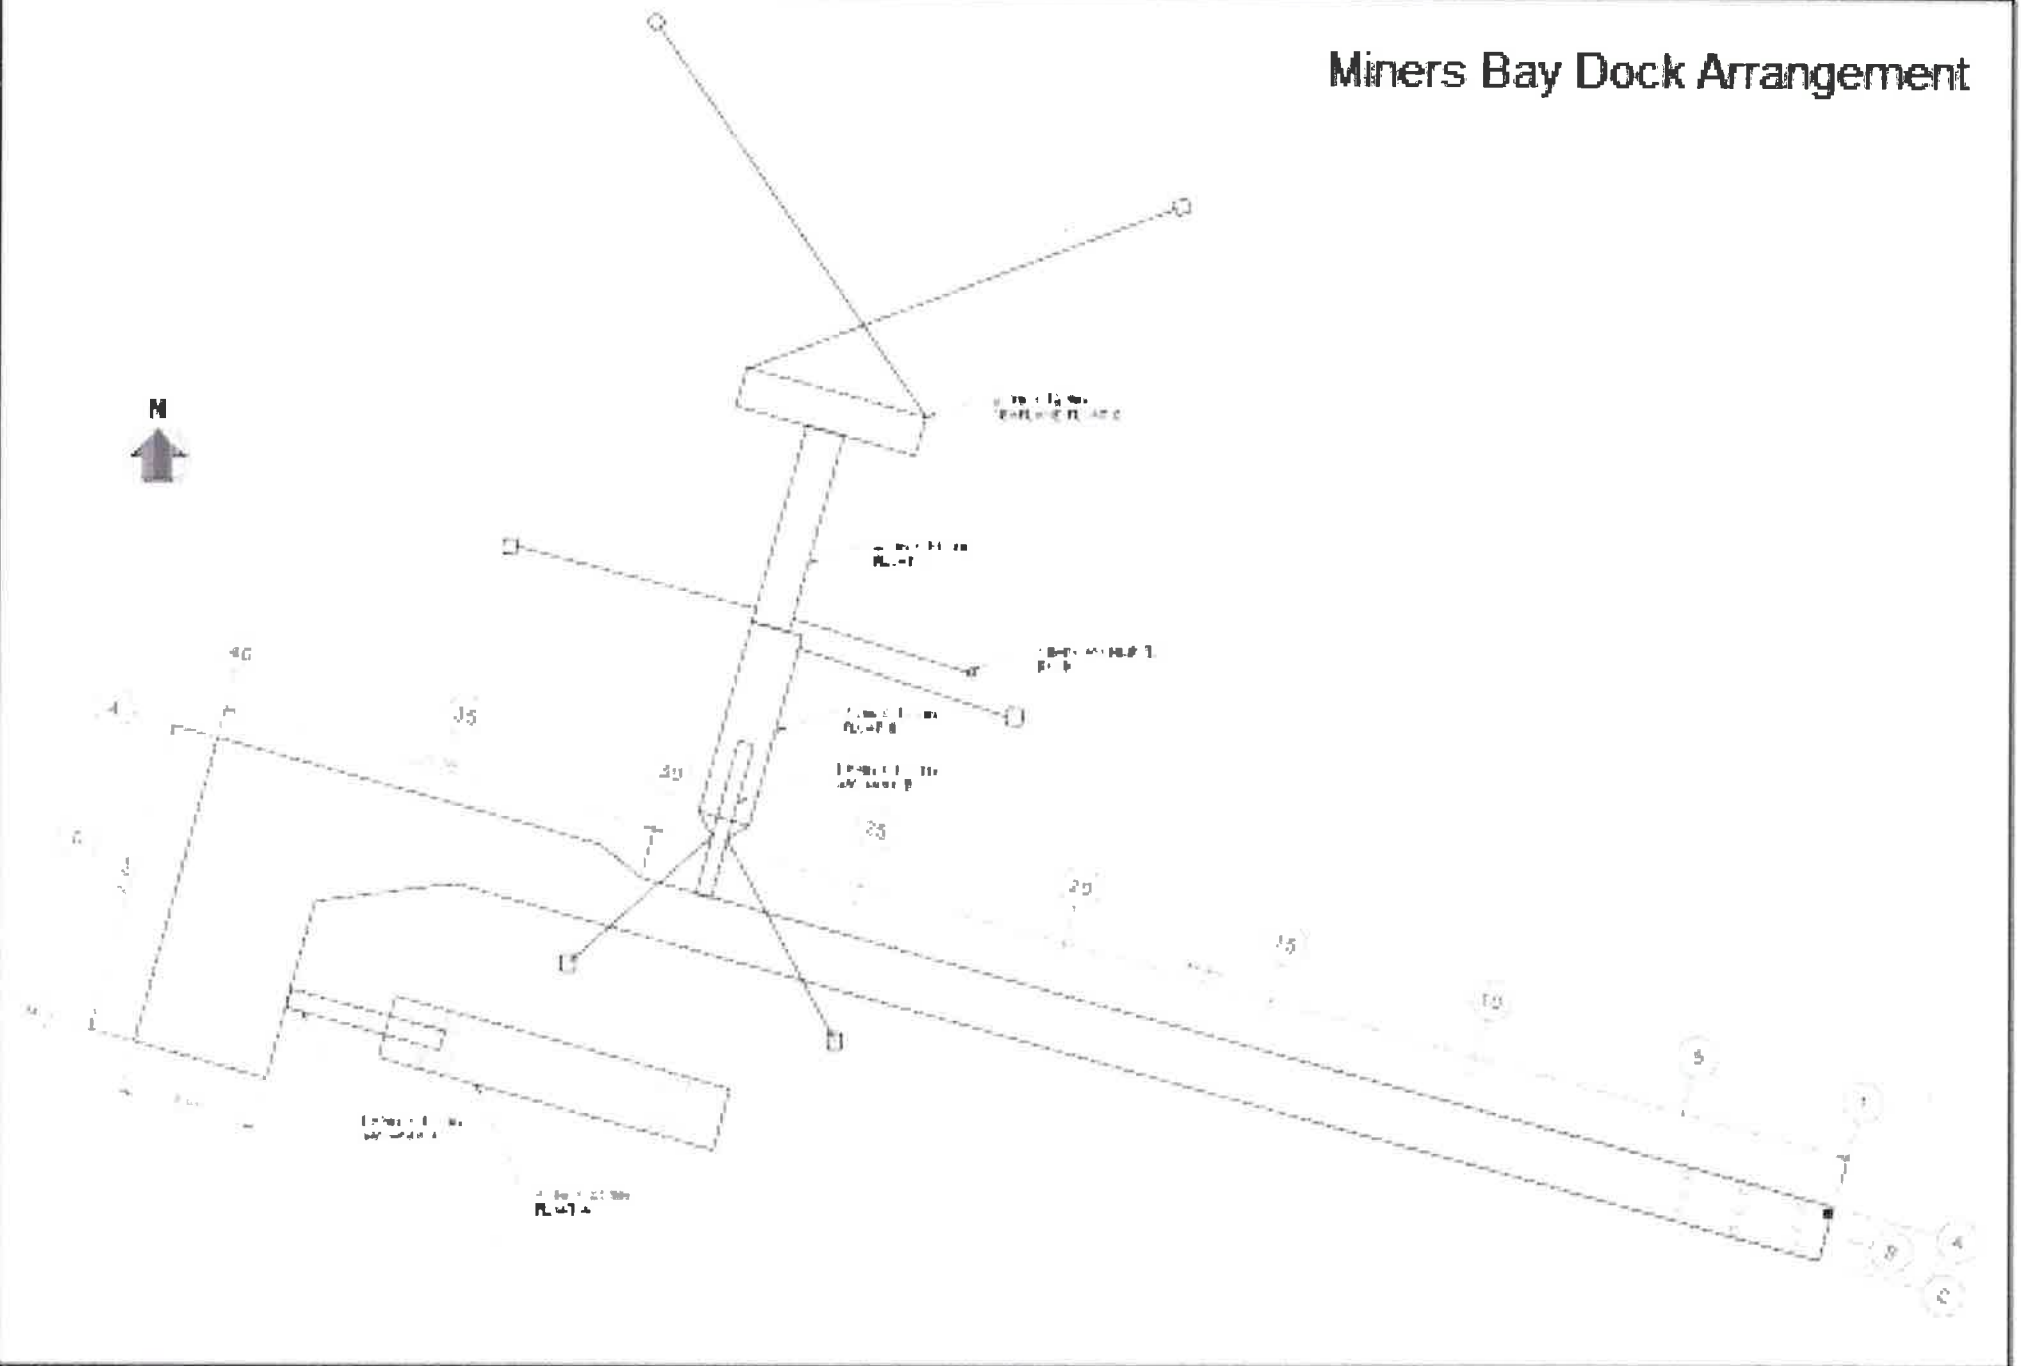
### Miners Bay Dock Arrangement

| <b>GANGWAY FLOATS</b> | <p>Gangway A is an older painted (faded) steel structure with areas of rust. There is new mini mesh decking. The old painted kick boards have some areas of rot at each end. The top and bottom transition plates are steel with non-slip and in good condition but the bottom plate requires a new UHMW skid shoe or runners. Painting is recommended. The steel roller, guide rails and pillow blocks are in good condition and service may be required at this time (difficult access).</p> <p>Float A is an older wood float with decking, rub boards and worn bull rails with some loose bolts on the south side and loose deck boards caused by the dry weather. Replacing the bull rails on the south side is recommended. The flotation is in fair condition. There are 4 closed pile wells with 6 wood/steel (2) piles/well that are in good to fair condition with 2 very worn piles in the wells next to the gangway, observed at low tide. The pile wells and the UHMW rub boards are in mostly good to fair condition.</p> <p>Gangway B is an older heavily built unpainted steel structure with an open steel grating in good condition. There is a floating steel top transition plate with non skid. The bottom apron is constructed the same as the gangway decking and is in good to fair condition. There is a steel roller on guide rails and pillow blocks that are in good condition.</p> <p>Float B is a newer float constructed of wood with concrete square tiles for the decking. There are 3 tiles with cracks showing but are stable as viewed. The wood bull rails are in good condition, the bull rail bolts are no longer tight and are very loose on both sides of the float, tightening is required. The float is anchored and the flotation is good. Painting has been done for the loading/emergency landing zone and seaplane landing zone. Long &amp; short term moorage along with the loading/emergency signs are deteriorating and new signs were provided to the wharfinger to install as required. There is a safety ladder that requires repair.</p> |

| <b>COMMENTS/INSTRUCTIONS</b> | <p>&gt; Replace the 4 rotten deck boards on the approach near the entrance to Float B.</p> <p>&gt; Replace UHMW skid shoe or install runners on gangway (Float A) bottom apron.</p> <p>&gt; Replace bull rails on Float A (worn/broken/missing and loose rail bolts).</p> <p>&gt; Safety ladders require cleaning on Float A, repair ladder on float B (short term side).</p> <p>&gt; Monitor the developing rot on the approach, wharfhead and wear of the wood piles of float A.</p> <p>&gt; Decking on Float A is loose and refastening is recommended.</p> |

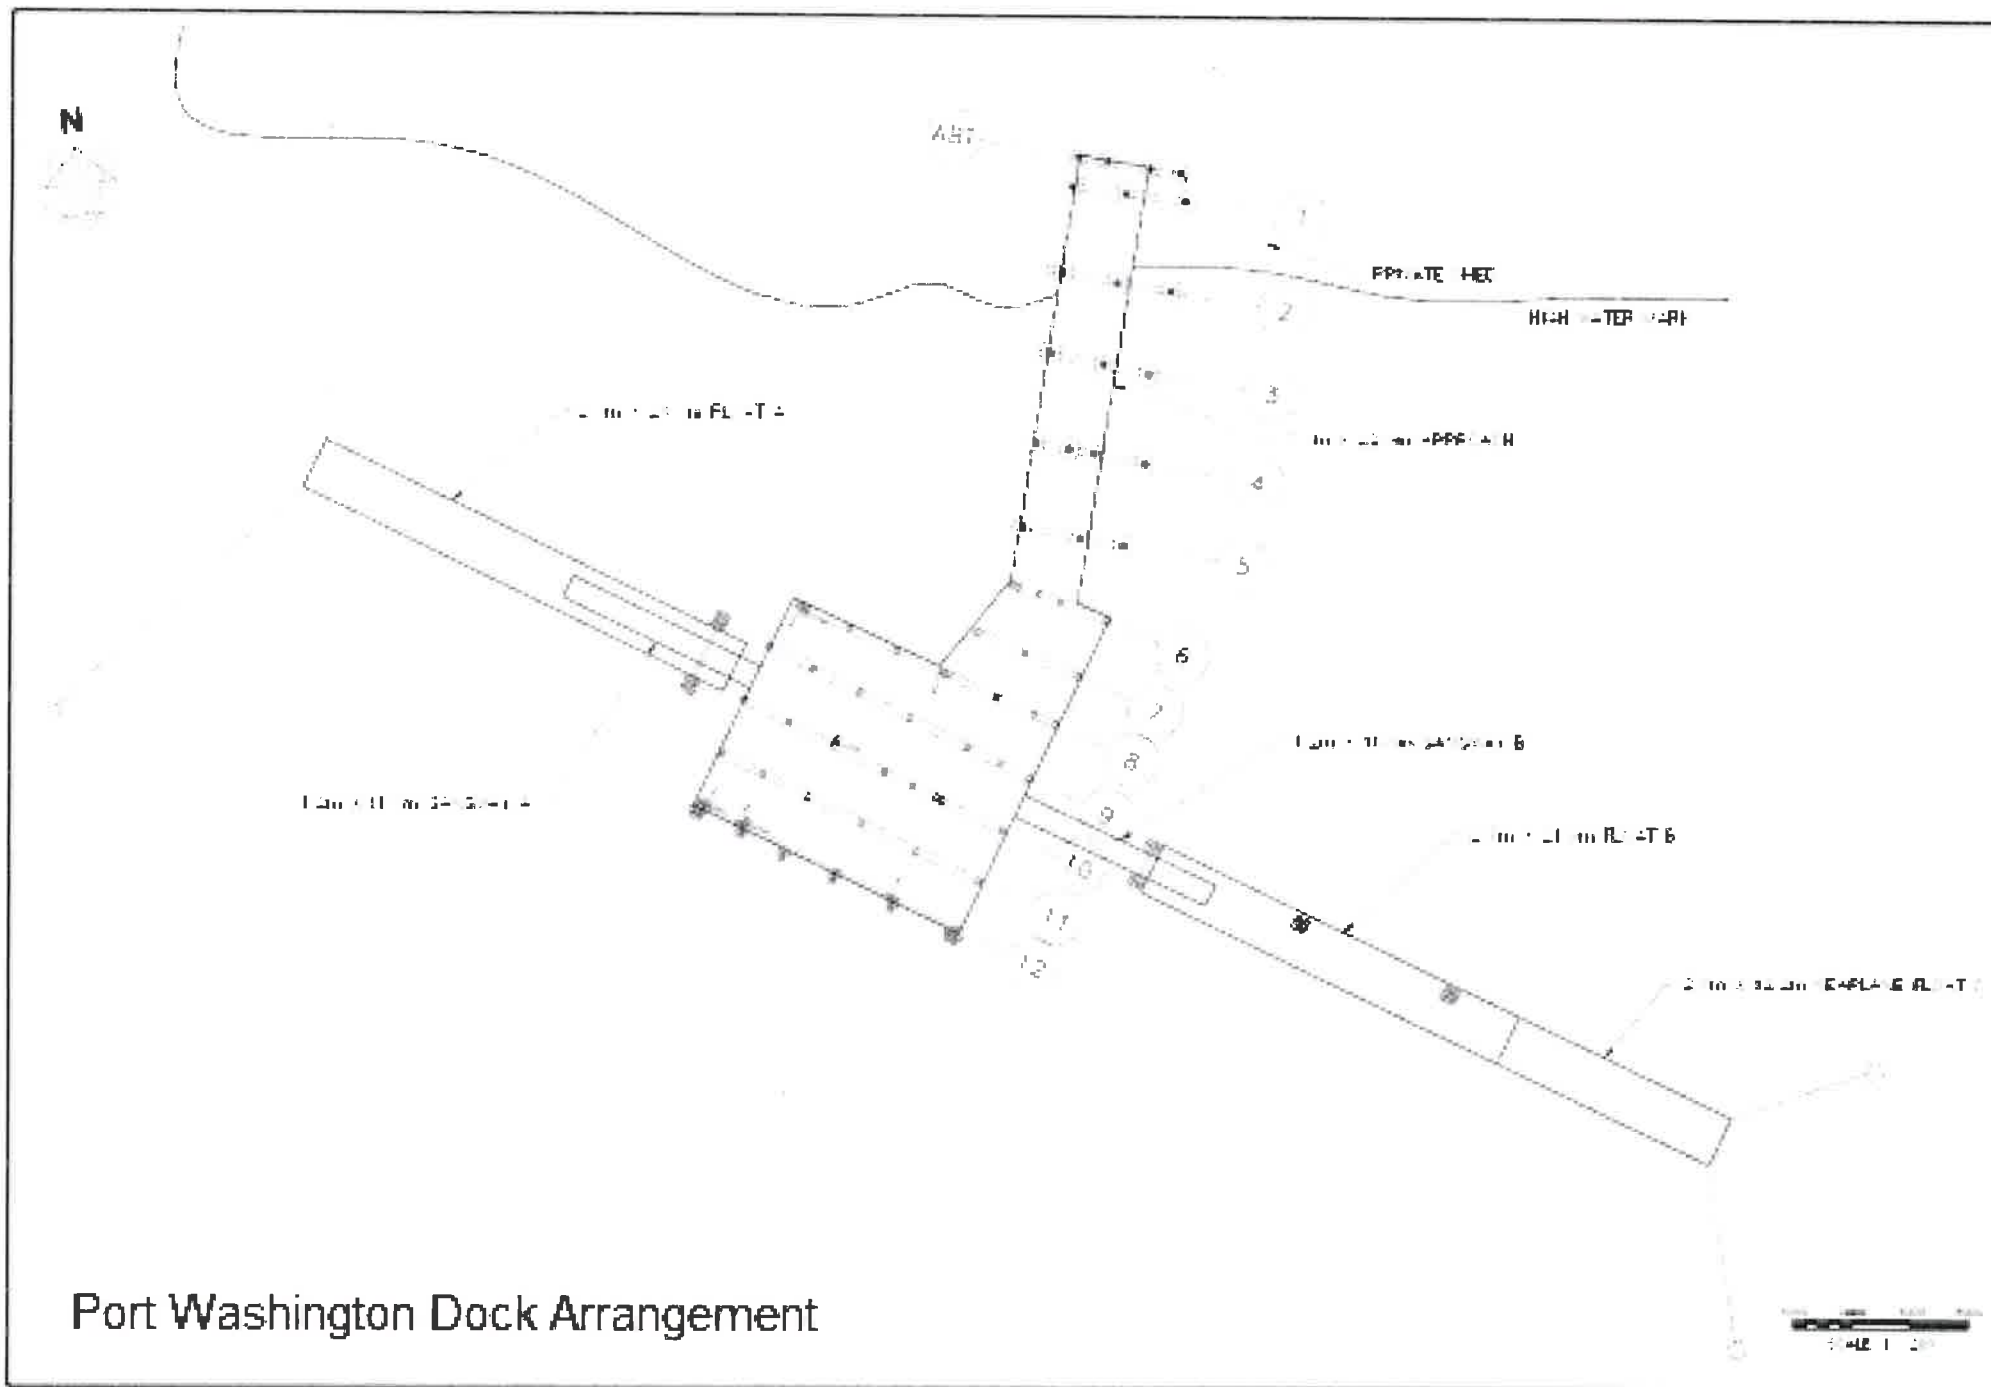
Port Washington Dock Arrangement

| <b>GANGWAY FLOATS</b> | <p>Gangway A is an older painted steel structure in fair condition, has typical rust at the bottom and on the under side of the steel frame. There is wood decking with half expanded metal grating for non-slip and wooden ladder rungs on the other half, this is in fair condition and replacement with mini mesh decking is recommended. The top aluminum transition plate with non-slip and the bottom aluminum apron with expanded metal grating are in good condition. This apron is running on the wood decking and UHMW runners are recommended. There is an older steel roller in fair condition with newer pillow blocks and rusty guide rails that are also in fair condition.</p> <p>Float A is an older wood float with decking, rub boards and bull rails with tight bolts. There are 2 open pile wells with 4 wood piles/well that are in good condition, showing minimal wear on the piles and the UHMW rub boards are in good condition. The seaplane landing bull rails have new yellow paint. The 2 safety ladders are in good condition. The flotation is good.</p> <p>Gangway B is also an older painted steel structure in roughly the same condition and with the same wood decking and non-slip arrangement as Gangway A. The older steel roller has developed a flat area that is worn right through the roller and requires replacement. The guide rails are rusty but are in fair condition and one pillow block is required, the other is in good condition. There is the same top transition plate with bottom apron as on Gangway A that is in good condition.</p> <p>Float B is an older wood float with decking, rub boards and new bull rails (shore side) with tight bolts. The flotation is also good with this float. There are 2 open pile wells under the gangway with 2 wood piles/well and 2 closed wells with 4 older wood piles/well, all in fair condition with minimal wear showing. There is older UHMW (?) in the wells that show checking but are in fair condition. The 3 safety ladders are in good condition and the flotation is good.</p> |

| <b>COMMENTS/INSTRUCTIONS</b> | <p>&gt; The gangway roller on B float requires replacement.</p> <p>&gt; A pillow block is required for the roller on gangway B.</p> <p>&gt; Replacing the decking on the 2 gangways with mini mesh decking is recommended.</p> <p>&gt; UHMW runners or a shoe are recommended for gangway A's bottom apron.</p> |

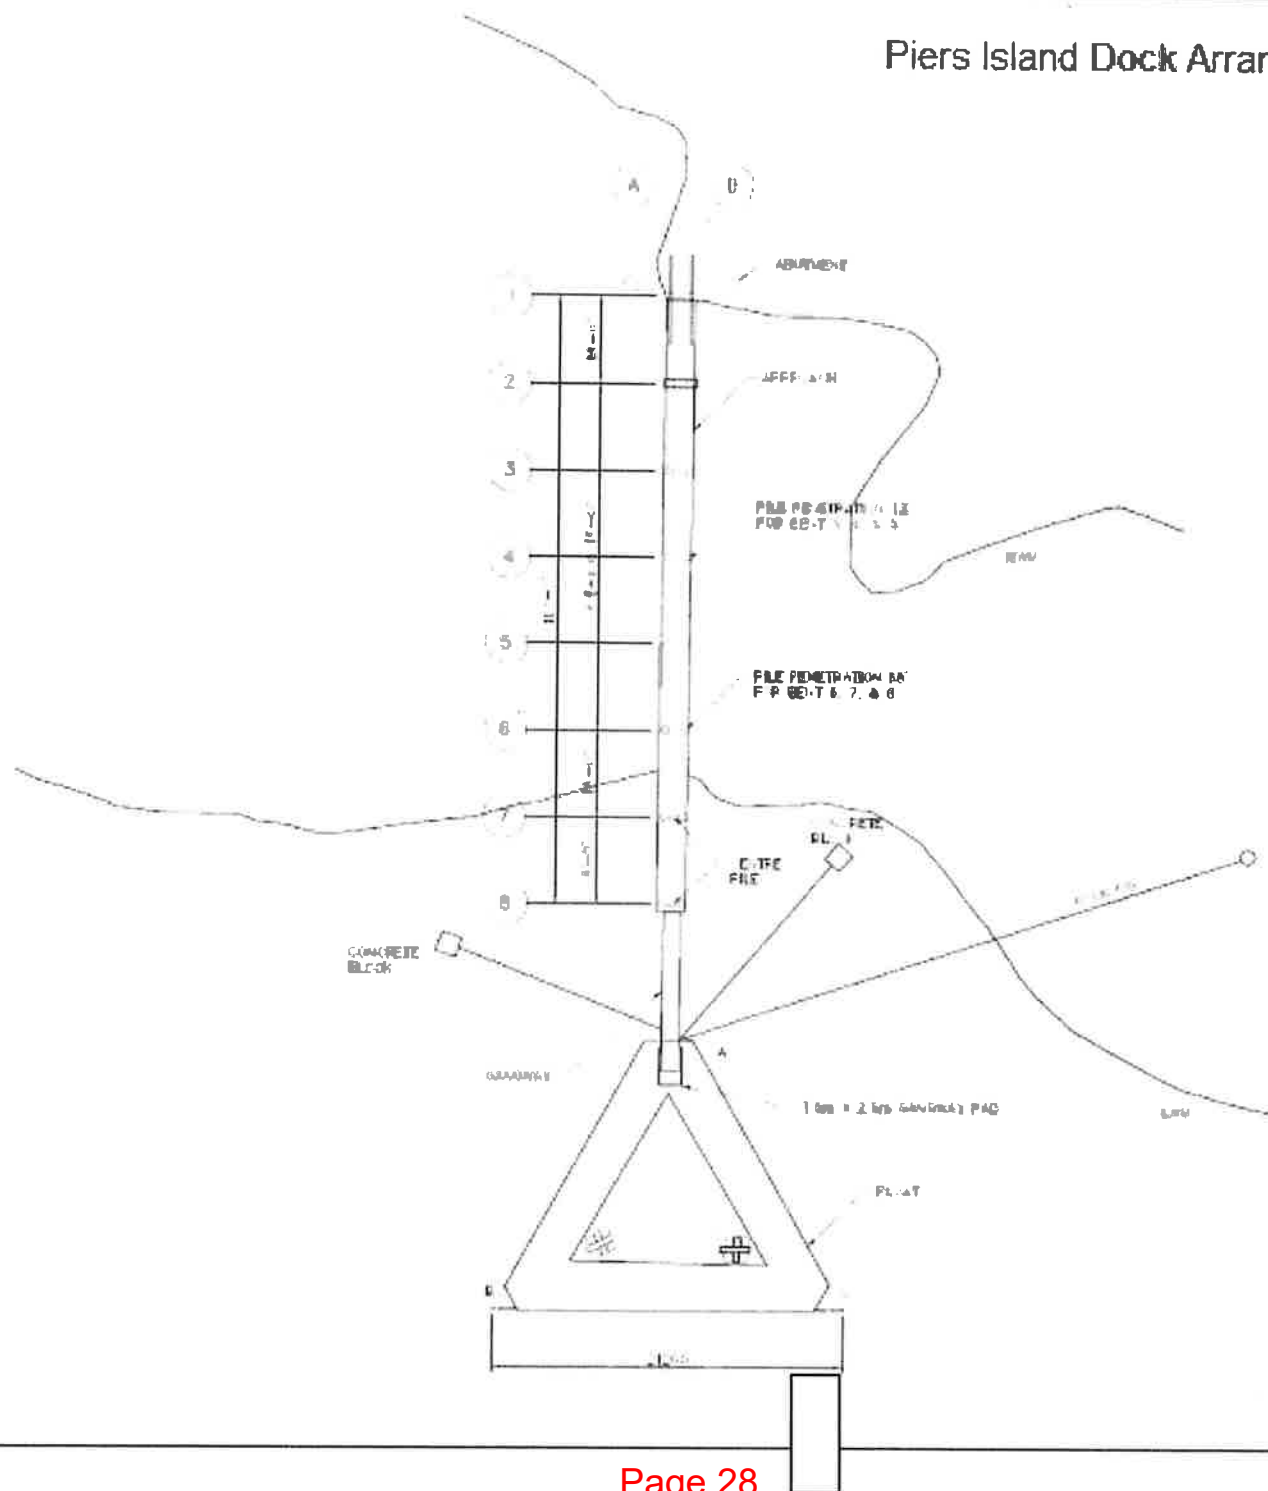
# Piers Island Dock Arrangement

| <b>GANGWAY FLOATS</b> | <p>The old painted (faded) steel gangway has new mini mesh decking and is in fair condition. There is an aluminum top transition plate with a non-skid surface in good condition and a bottom aluminum expanded metal grating apron also in good condition. The old roller bed boards have been replaced. There are large steel wheels running on large steel guide rails that are in good condition but the pillow blocks and axle arrangement make replacing the pillow blocks challenging. Servicing the bearings is recommended.</p> <p>THE NOTICE BOARD IS LOCATED ON THE MAIN FLOAT, all notices etc. and life ring are on it.</p> <p>The main float is an old wood triangular structure with good flotation, wood decking, rub boards and bull rails with fairly tight bolts that are in fair condition for its age. There are areas of developing rot on the decking and the aluminum expanded metal grating (non-skid) that runs along the 3 sides of the float is at the end of its serviceable life and removal is recommended. Replacing the old wood decking with Mini Mesh panels is recommended. There are 3 safety ladders that are in good condition. There is new yellow paint on the loading zone bull rails. There are 3 open pile wells with 3 wood piles in 2 of the wells and 2 wood piles in the one open well at the gangway end. These piles and the UHMW rub boards are in good condition with minimal wear showing.</p> <p>Float B is a new HPDE pontoon type float with mini mesh decking and wood bull rails that are in very good condition and has good flotation. There is a safety ladder at the end of the float that is in good condition. There is a large steel pile with an anode attached, in a closed well at the end of the float. This float is in very good condition.</p> |

| <b>COMMENTS/INSTRUCTIONS</b> | <p>&gt; Monitor for replacement, areas of developing rot on the main float or replace all decking with Mini Mesh decking.</p> <p>&gt; Removal of the expanded metal grating on the main float is recommended.</p> |
