## FULFORD WATER SERVICES COMMISSION

Notice of Meeting on **Tuesday, November 3, 2020 at 10:00 AM**  
Fulford Community Hall, 2591 Fulford-Ganges Road, Salt Spring Island, BC

# Fulford Water System Asset Management Plan

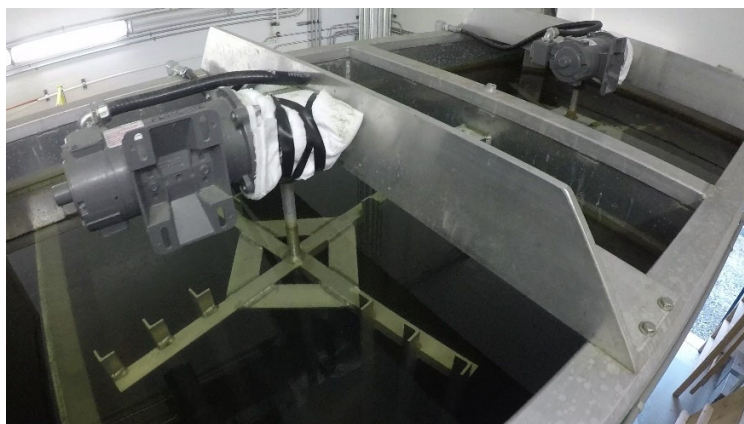
Top of the rapid mix and flocculation tanks. Both mixer motors are leaking. Temporary fix implemented by wrapping the motors with fabric cloths. Drip trays are required to prevent oil from dripping into the rapid mix/flocculation tanks.

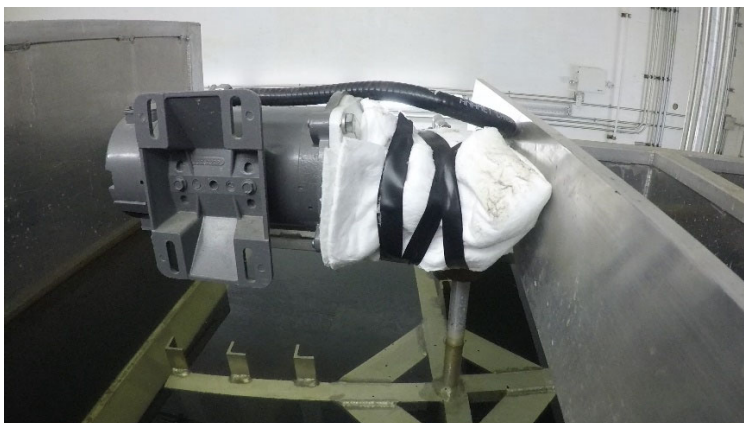
Top of the rapid mix and flocculation tanks. Both mixer motors are leaking. Temporary fix implemented by wrapping the motors with fabric cloths. Drip trays are required to prevent oil from dripping into the rapid mix/flocculation tanks.

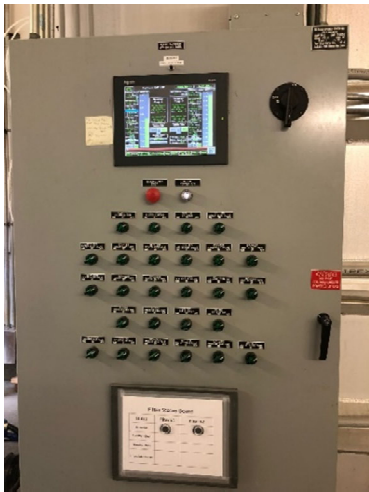
Description:
	DAF Process Control Panel
	Observation: Safety concerns, no ability to reset motor overloads without opening the Control Panel

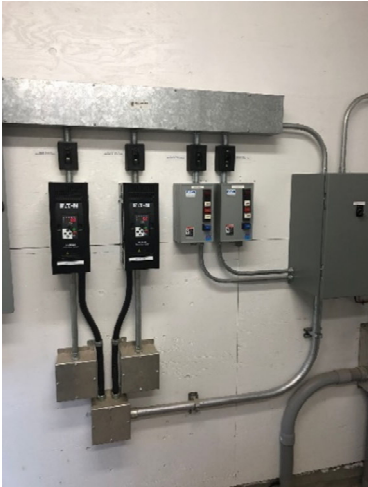
Description:	Booster Pump VFD's
	Observation:	Eaton model MVX no longer supported.
	CRD Personnel Observation:	No issues noted

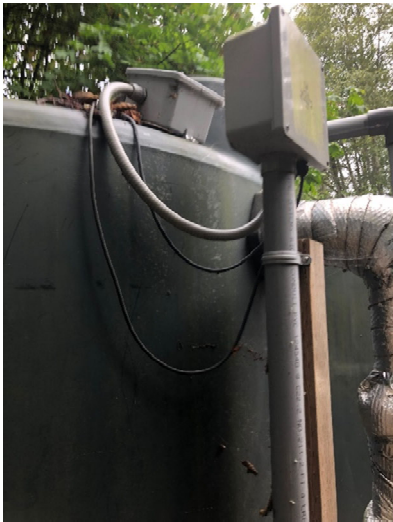
Description:
	Storage Tanks
	Observation:  Onsite storage tanks have exposed cabling for level transducers and floats, all subject to vandalism.
CRD Personnel Observation:	
No issues noted

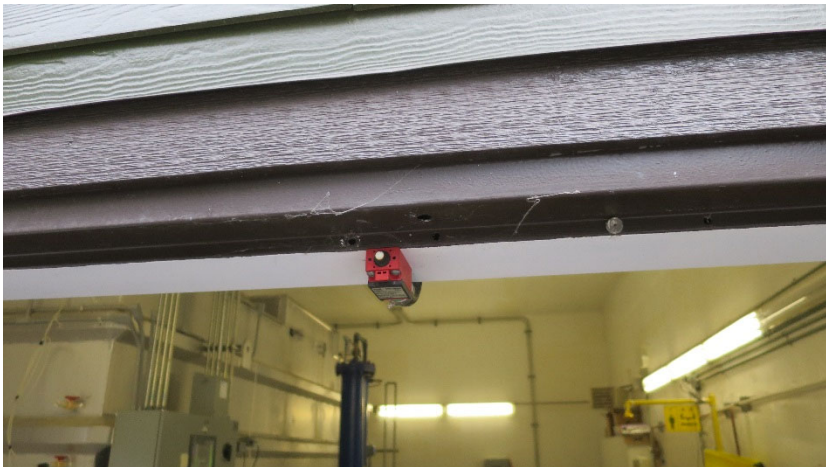
Description:
	Front of Water Treatment Building
	<p>Observation:</p> <p>Replacement of door alarm device and installation of weather stripping and/or door mutes is required to eliminate false alarms in stormy weather.</p>

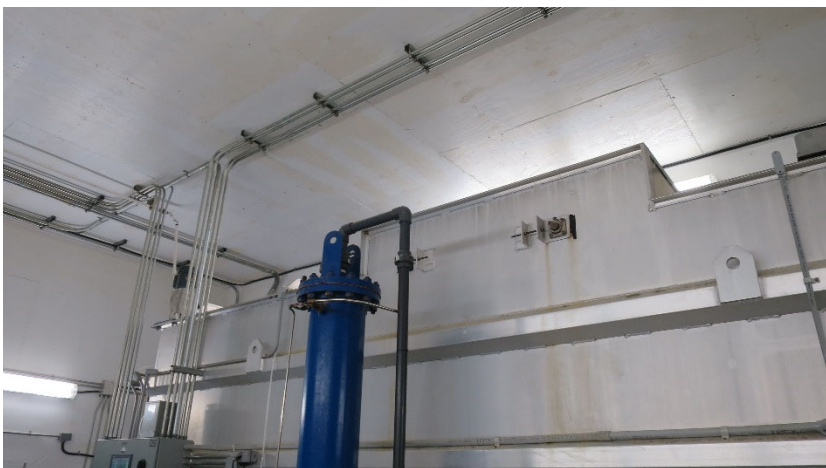
Description:
	Inside Water Treatment Building
	<p>Observation:</p> <p>Support for a lifting apparatus is required at ceiling level to lift the 80lb lid for the Saturator. Support for a confined space entry apparatus is required over the DAF treatment system to accommodate entry for cleaning and servicing.</p>
CRD Personnel Observation:	
No issues noted

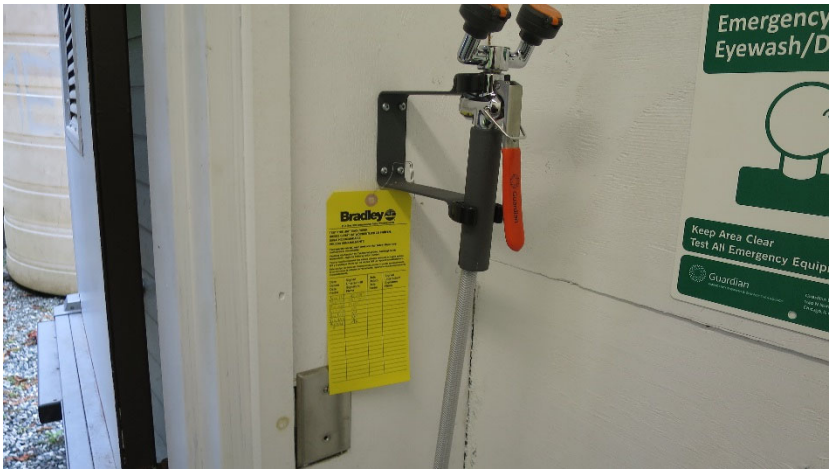
Description:
	Inside of chlorine room
	Observation: Eyewash station is serviced on a regular basis. There is no hot water to temper the water.

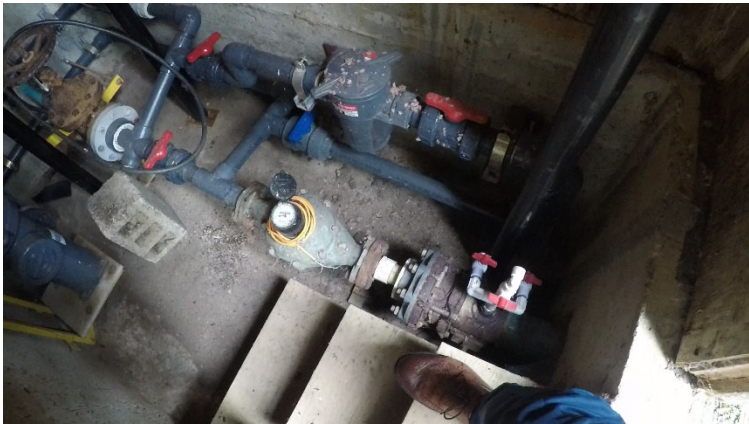
Observation:
	Shed interior. Signs of valve corrosion are visible.

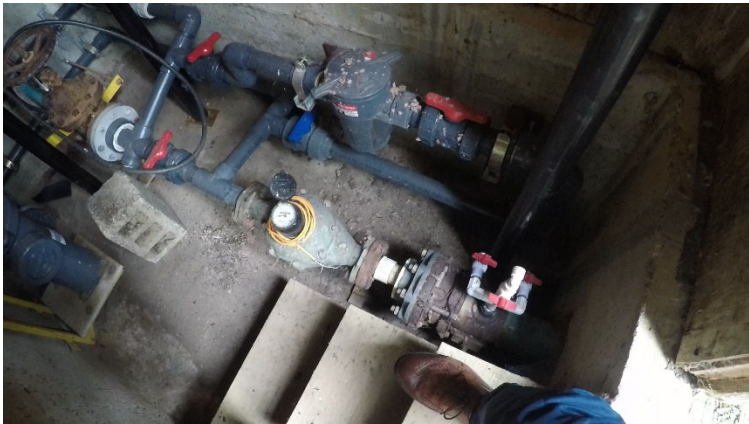
Observation:
	Shed interior. Signs of valve corrosion are visible.

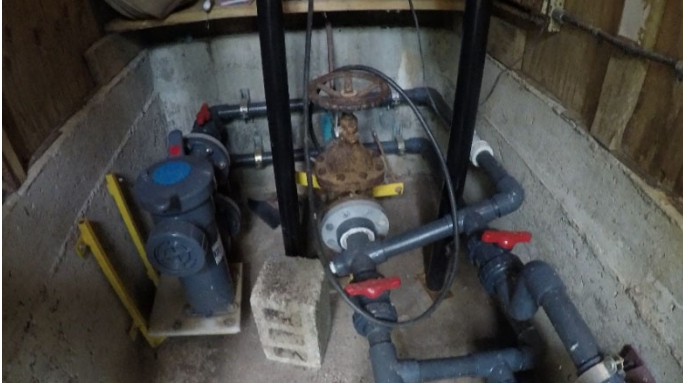
Description:
	Raw Water Flow Meter Shed
	Observation:  Shed interior. Signs of valve corrosion are visible.

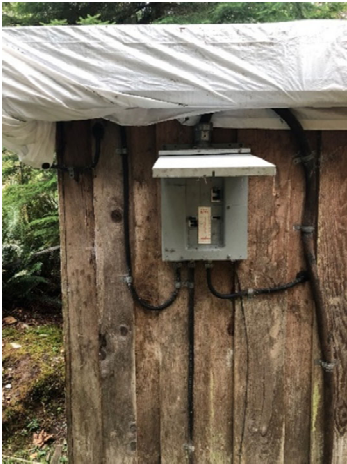
Description:
	Site Main Incoming Electrical Service
	Observation:  Service mounted external to building, exposed to vandalism.  Safety and Electrical code concerns with installation

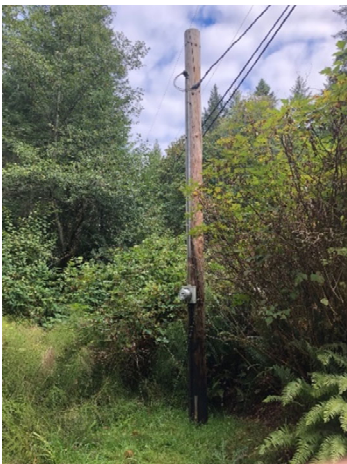
CRD Personnel Observation:
	No issues noted
	Description:
	Pole mounted BC Hydro meter
	Observation:  Feeder burial depth not to minimum 450 mm, Safety and Electrical code concerns with installation
	CRD Personnel Observation:
	No issues noted

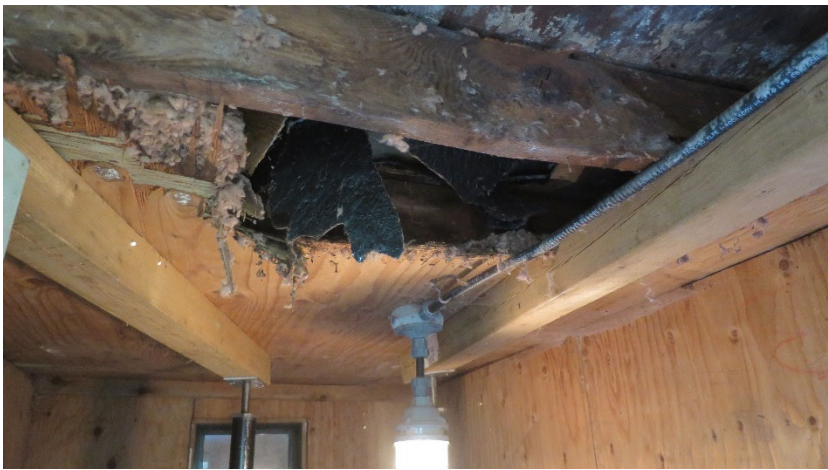
Roof is leaking and exterior finishes have exceeded life expectancy.
	CRD Personnel Observation:
	No issues noted

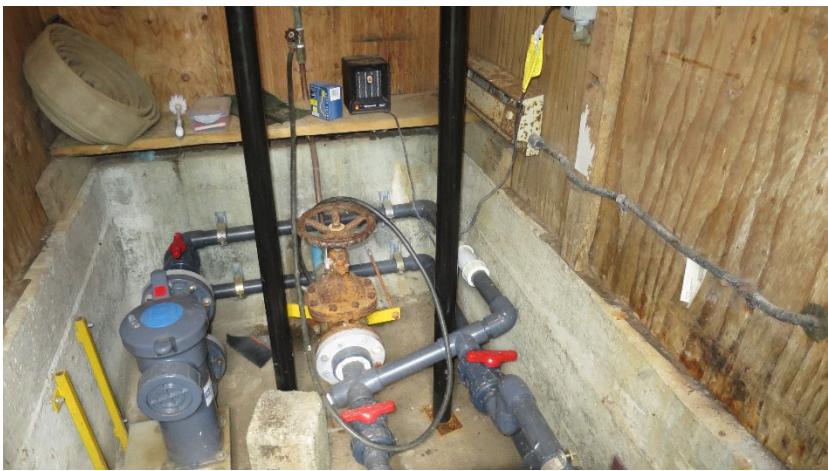
Space heater is being used as baseboard heater is not operational.
	CRD Personnel Observation:
	No issues noted

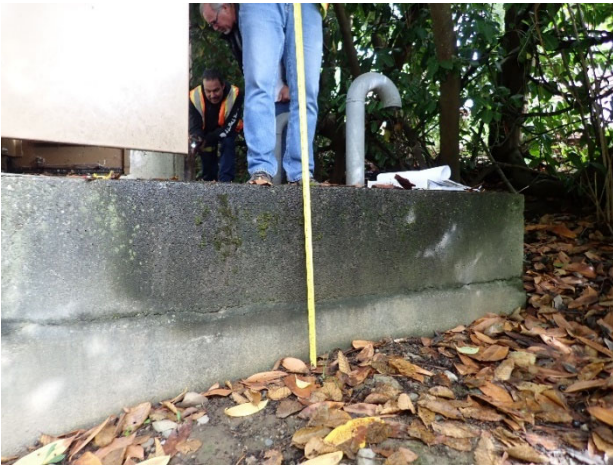
Description:
	Railing
	<p>Observation:</p> <p>Protective railing to be installed on the south side of the underground chamber, as there is an approximate 600 mm drop into a ditch on this side of the chamber.</p>
	<p>CRD Personnel Observation:</p> <p>No issues noted</p>

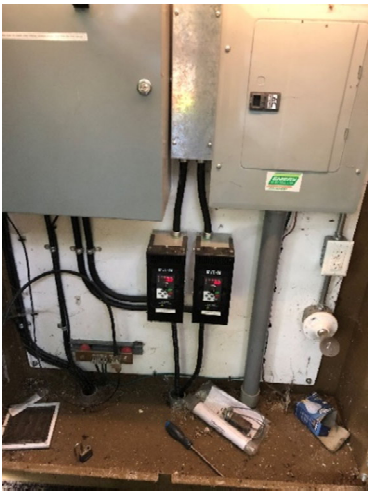
Description:
	Booster Pump VFD's
	Observation: Eaton model MVX no longer supported.

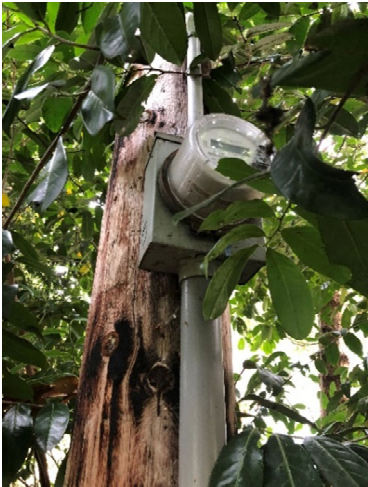
Description:
	Pole mounted BC Hydro meter
	Observation: Tree trimming needs to be performed
	CRD Personnel Observation:
	No issues noted

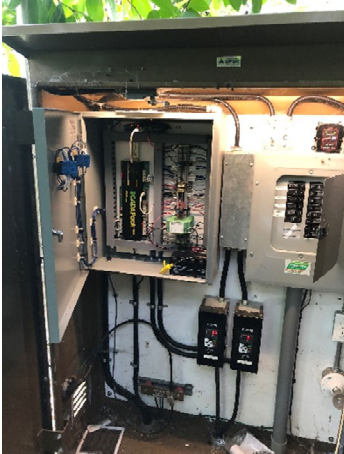
Description:
	Scada and Radio communications
	Observation: Radio antenna needs tree trimming performed
CRD Personnel Observation: No issues noted

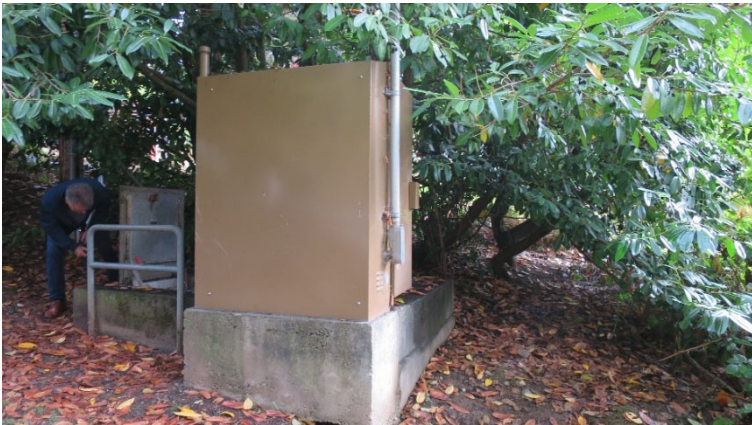
Description:
	PRS controls enclosure on concrete tank.
	Observation: Guardrail is not high enough to provide adequate fall protection.
CRD Personnel Observation: No issues noted

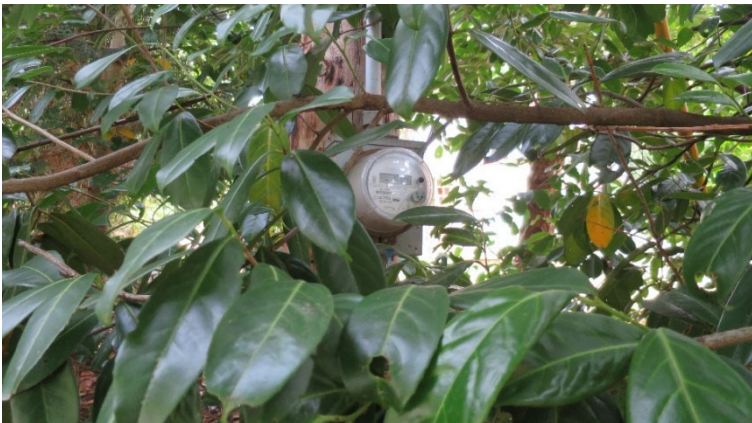
Description:
	Electrical meter on the power pole.
	Observation: Adjacent trees require trimming.
CRD Personnel Observation: No issues noted

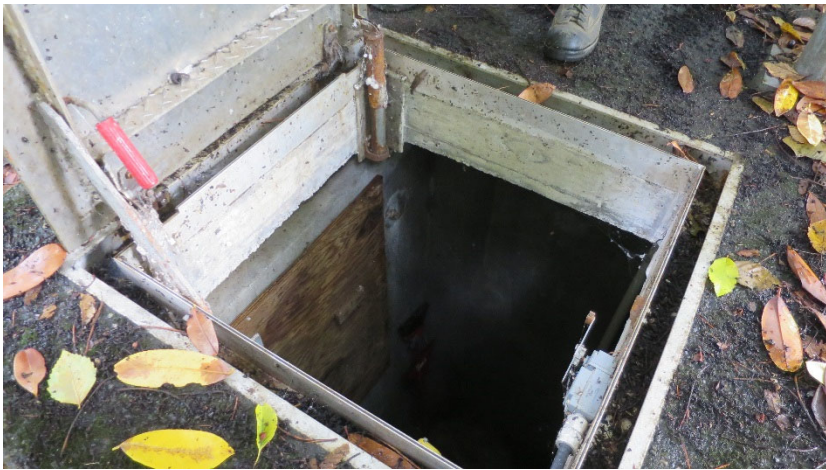
Description:
	Access hatch to the tank.
	Observation: Some rusting is occurring. Recommend cleaning of rust and painting. CRD Personnel Observation: No issues noted

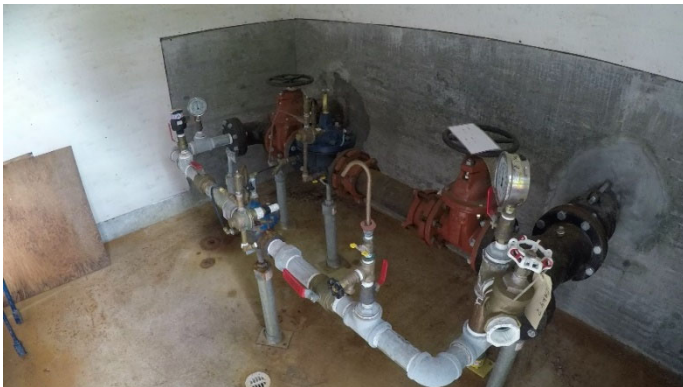
Description:
	Sunnyside PRV Station
	Observation: View of the PRV station in dual bypass/main configuration. In-line strainers are not installed in front of PRVs for protection from fine solids.

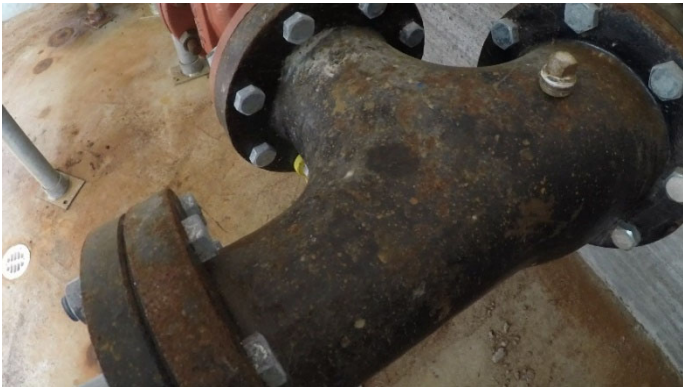
Description:
	Sunnyside PRV Station
	Observation: Signs of corrosion are visible.

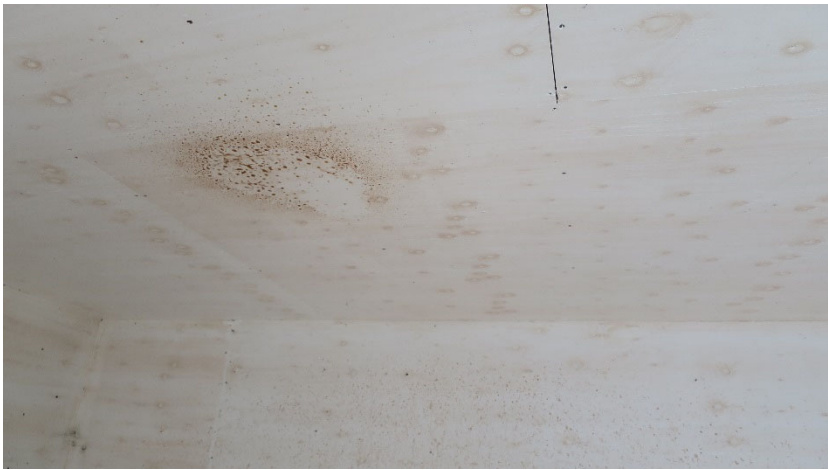
Description:
	Ceiling of pumphouse.
	Observation:
	Staining is from a previous leak in the system. Interior plywood finishes require repainting.
	CRD Personnel Observation:
	No issues noted
