## **CEDAR LANE WATER SERVICE COMMISSION**

# Cedar Lane Water System Asset Management Plan

Prepared By:  
**McElhanney Consulting Services Ltd.**  
[www.mcelhanney.com](http://www.mcelhanney.com)

Date:  
**April 2020**

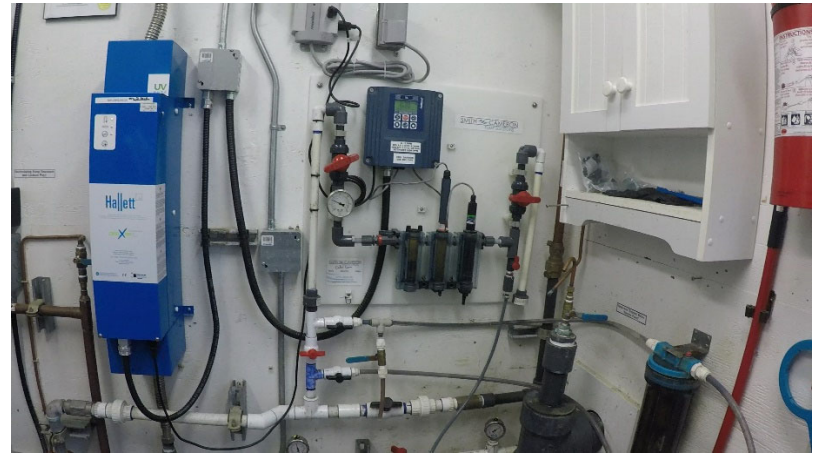
Description:
	Cedar Lane WTP
	Observation:
	View of the water treatment plant with 30,000 lgal (136 m <sup>3</sup> ) water reservoir in the background.
	Observation:
	Interior of the water treatment plant with UV disinfection (right-hand side), booster pump (left-hand side), and cartridge filtration (in the middle).
	Observation:
	Interior of the water treatment plant with UV disinfection (left-hand side) and chlorine recycle loop and analyzer (right-hand side).

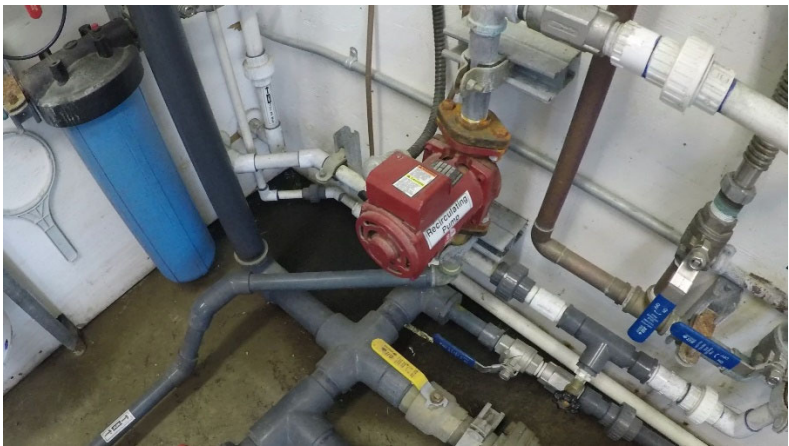
Description:
	Cedar Lane WTP
	Observation:
	Single chlorine recycle pump.

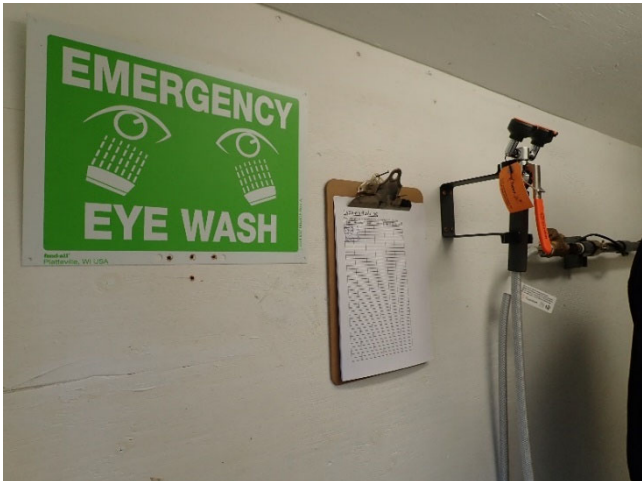
Description:
	Drench Hose Eyewash Station
	Observation: Replace eyewash station with saline-based eyewash station (plastic setup).
	CRD Personnel Observation: Operational staff noted the eyewash station is not sensitive to washing eyes.

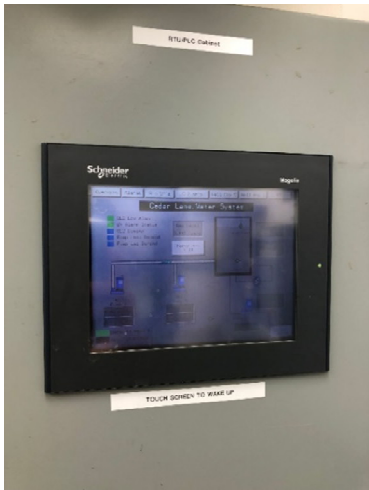
Description:
	Scada Process Control Panel and Communication
	Observation: No issues noted
	CRD Personnel Observation: No issues noted

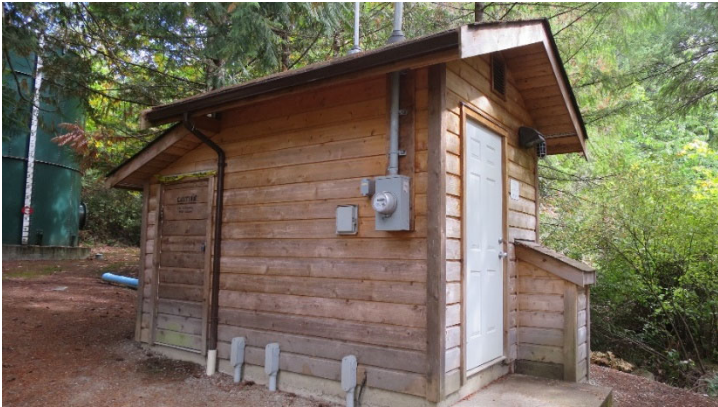
Description:
	WTP Cedar Lane (Left) with PST Cedar Lane (right).
	Observation: Pump station is behind the metal clad door. All exterior finishes require staining to prevent deterioration of finishes and supporting structure.

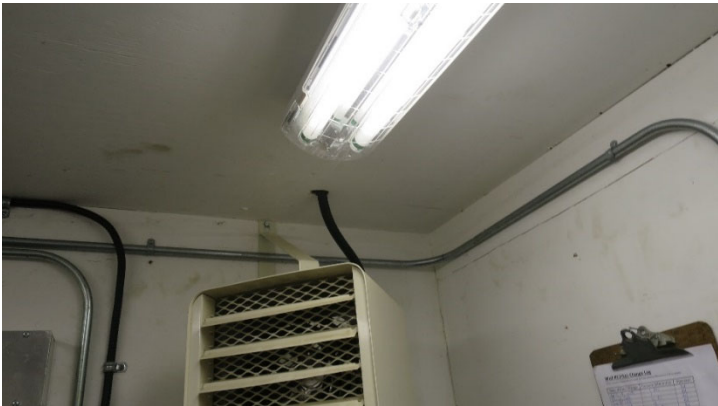
Description:
	Inside of Pump Station Building
	Observation: Heating is with electric unit heater. No issues noted.
	CRD Personnel Observation:
	No issues noted

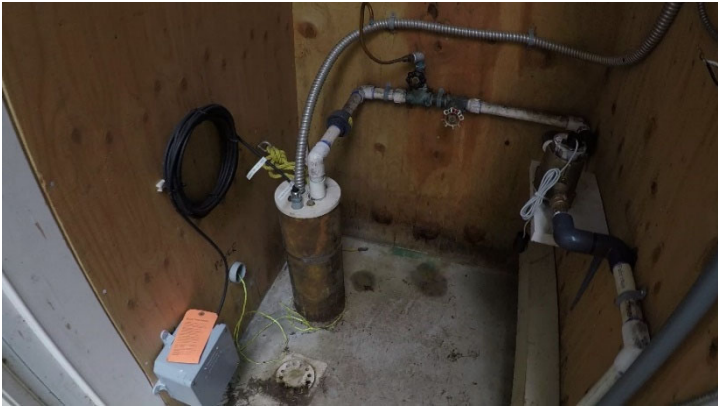
Description:
	Cedar Lane WTP
	Observation: GW Well #5 head located inside a wooden shed next to the WTP.

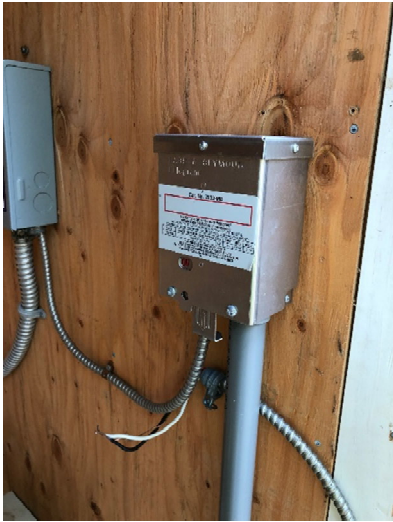
Description:
	Well disconnect switch
	Observation:
	<p>Well pump branch circuit can only connect to well pump motor.</p> <p>If electric heat is required a separate branch circuit needs to be provided from the WTP building.</p>
CRD Personnel Observation:	
No issues noted

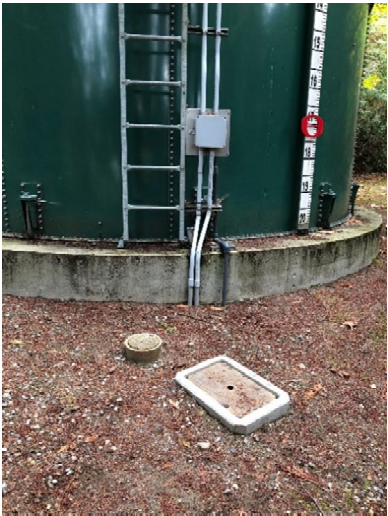
Description:
	Reservoir Level Sensing
	Observation:
	Level Transducer and Floats No issues noted
CRD Personnel Observation:	
No issues noted

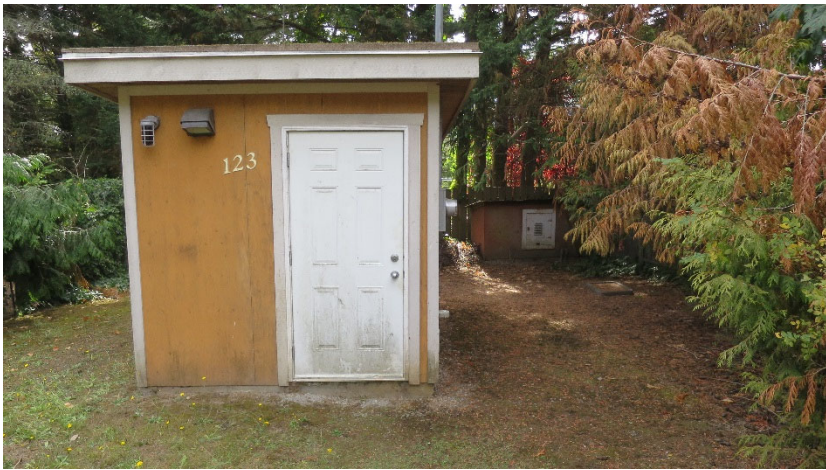
Description:
	Front of pumphouse.
	Observation: Grounds are well maintained. Tree trimming is required to prevent damage to roof and siding. CRD Personnel Observation: No issues noted
 	Description:
	Rear corner of pumphouse.
	Observation: Repainting is required for all exterior finishes. Backfilling is required to prevent further erosion at the concrete slab. CRD Personnel Observation: No issues noted
 	Description:
	Rear of pumphouse.
	Observation: Moss control and debris removal is required at the roof. CRD Personnel Observation: No issues noted

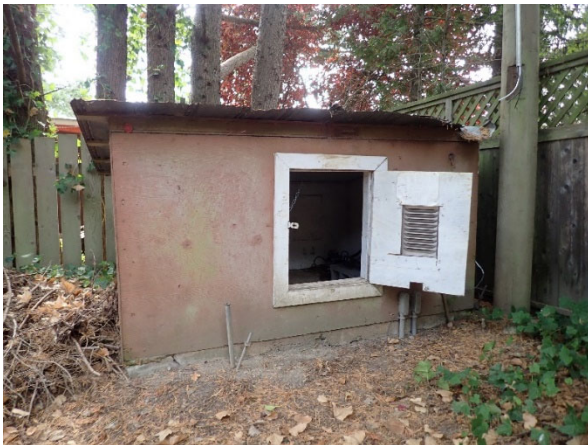
Description:
	WELL Mansell #1 Building
	Observation:
	Remove existing wooden lid and retrofit new lid with easier access / shocks / cover-stay mechanism. If there is budget for a new building structure, remove structure and reinstate new structure.
CRD Personnel Observation:	
Wooden rod / access is difficult to lift.

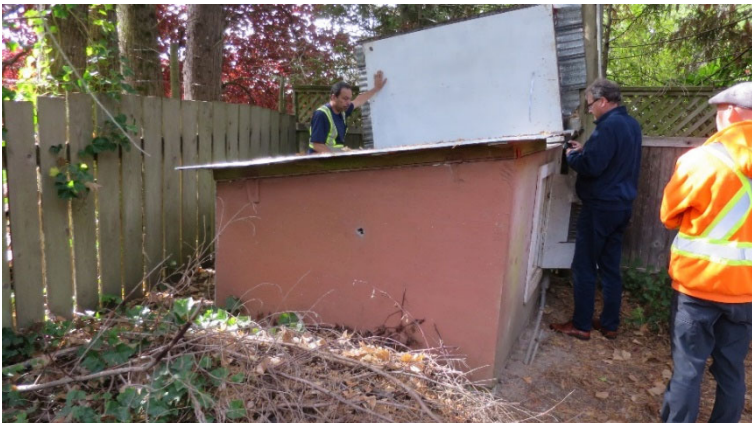
Description:
	Well structure with roof lid open.
	Observation:
	Enclosure requires painting. Roof hatches require stays to keep them open when maintenance personnel are in enclosure.
CRD Personnel Observation:	
No issues noted

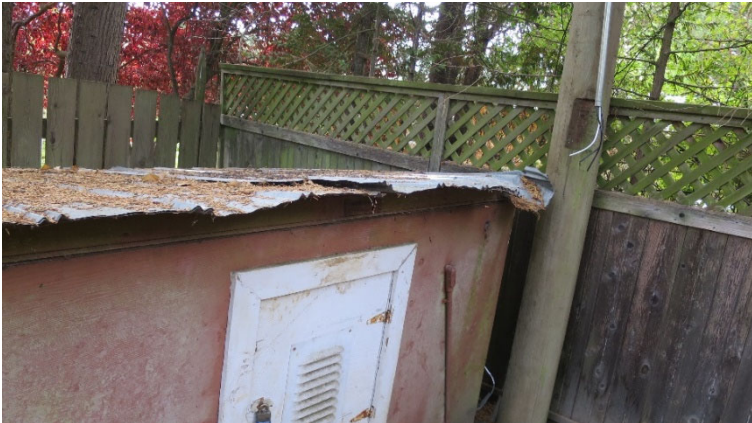
Description:
	Roof of enclosure.
	Observation:
	Roofing is damaged and requires replacement.
CRD Personnel Observation:	
No issues noted

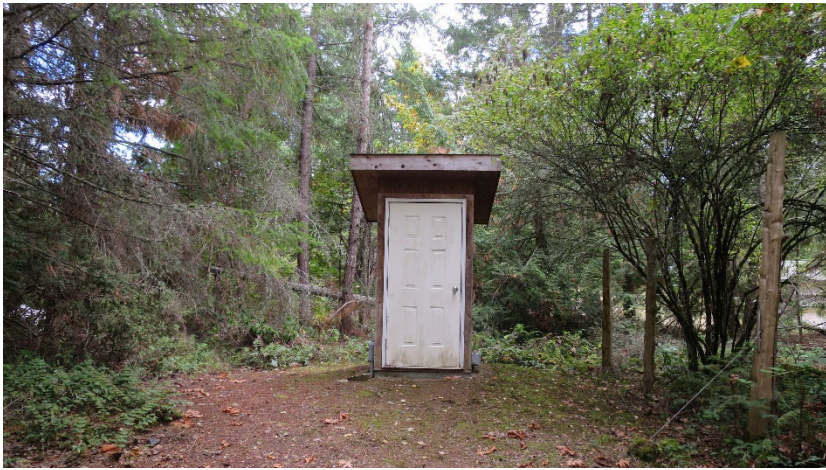
Description:
	Front of Well building.
	Observation: Grounds are maintained on a regular basis by CRD personnel.

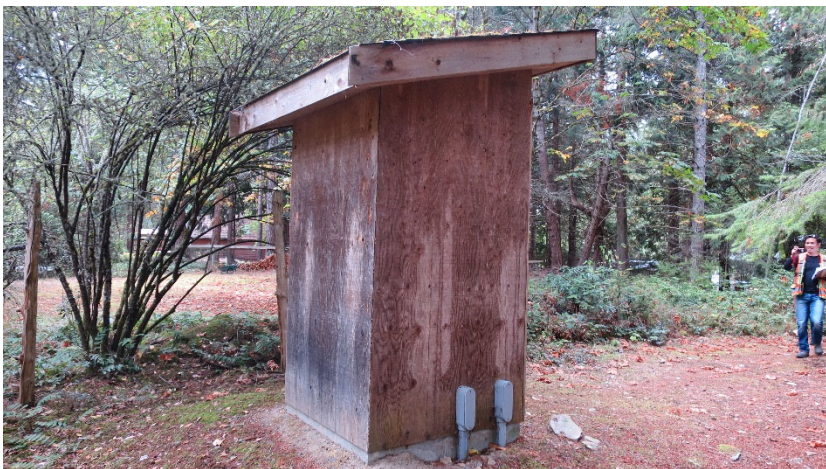
Description:
	Rear of building.
	Observation: Roof requires clearing of debris. All exterior finishes require staining to prevent deterioration of finishes and supporting structure.

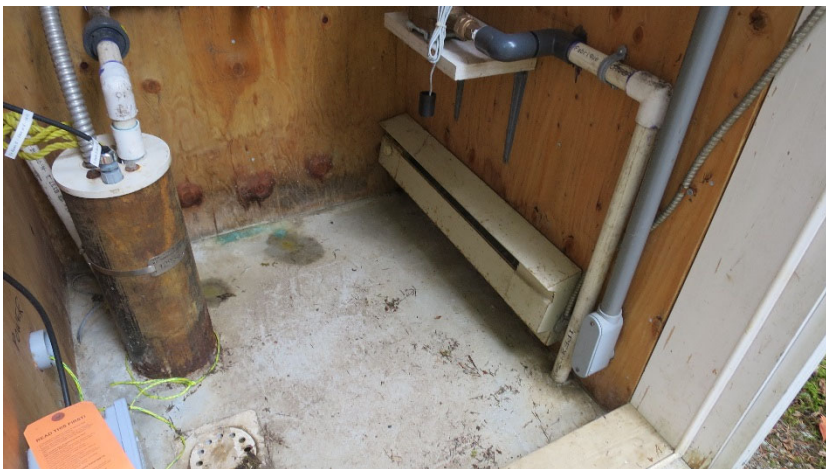
CRD Personnel Observation:
	No issues noted
	Description:
	Inside of building.
	Observation: All interior finishes require painting to prevent water damage to finishes and supporting structure. Baseboard heater is not connected to an electrical source.
	CRD Personnel Observation:
	No issues noted
