GVWSA Seasonal Drought/Rainfall

Regional Water Supply Commission Report 20-07

September 16, 2020

Fire Cause – Lightning Storm

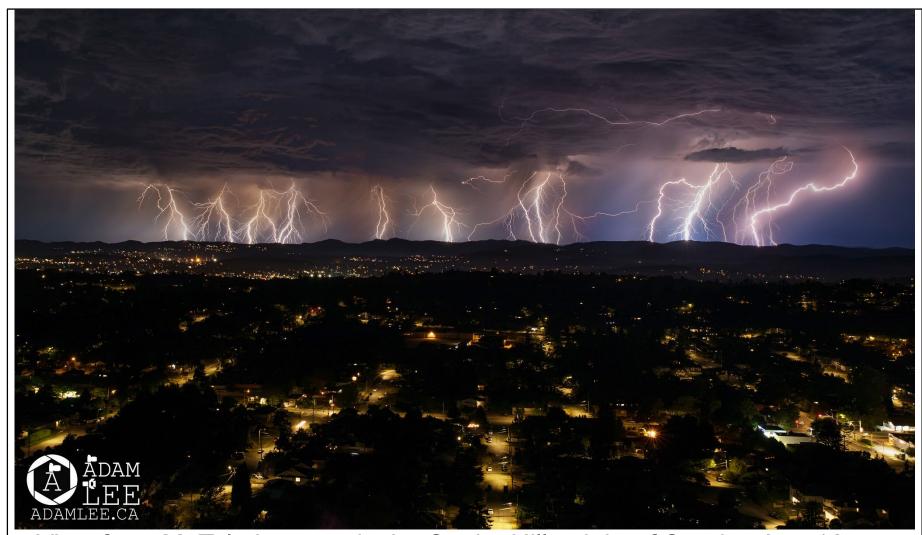
View from Mt Tolmie towards the Sooke Hills night of Sunday Aug 16 photo compiled from strikes beginning at 10:30 pm

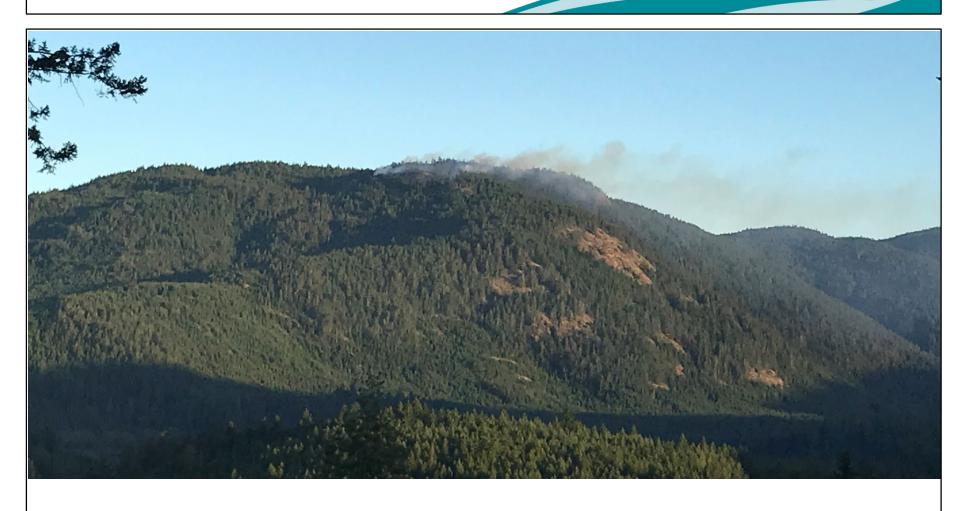
First view of Mt Healey Fire at 7:14 am Monday

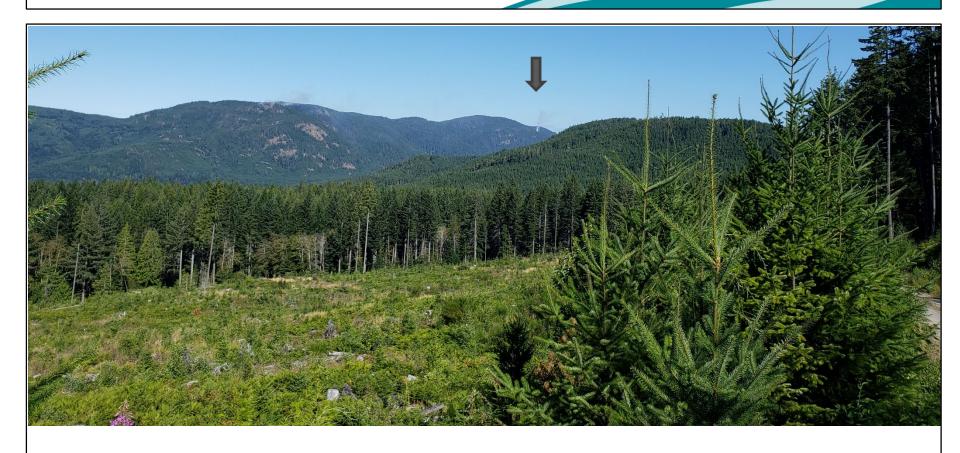
First view of Rithet fire at 10:18 am Monday (Mt Healey also visible)

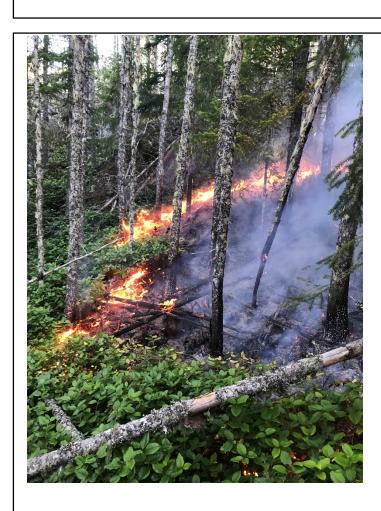
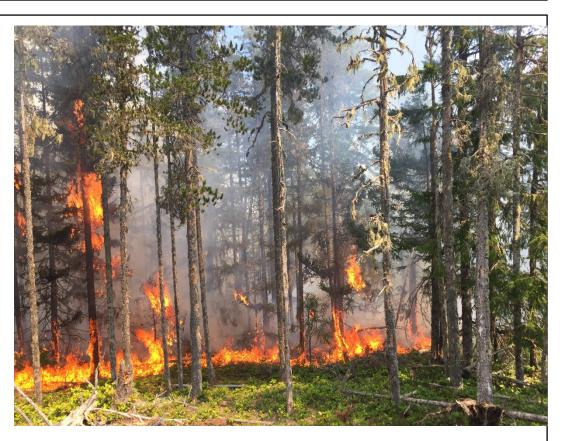
Fire behaviour observed

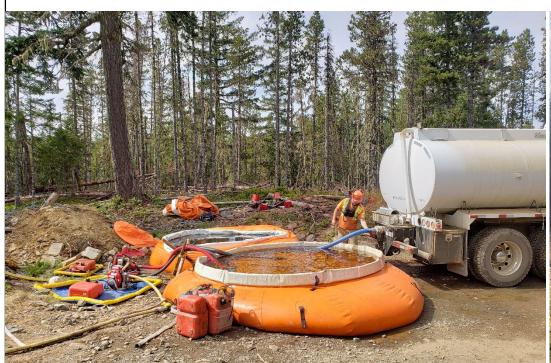
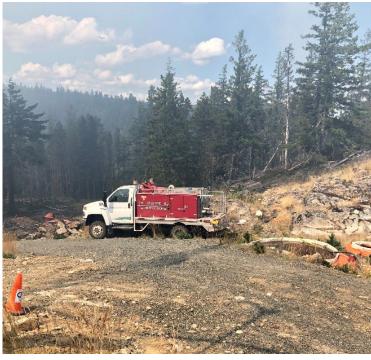
Direct ground suppression with water using tenders, bladders, hose lays at Healey

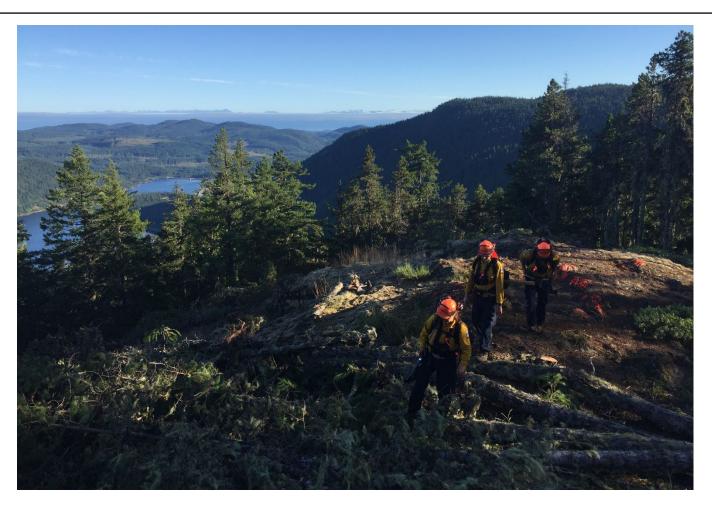
Trail and heli land spot construction at Rithet – difficult access

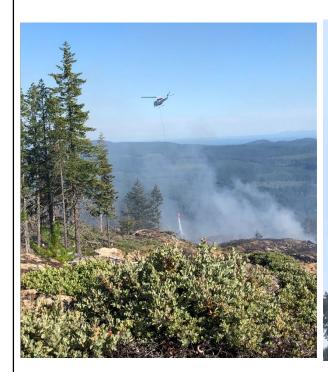
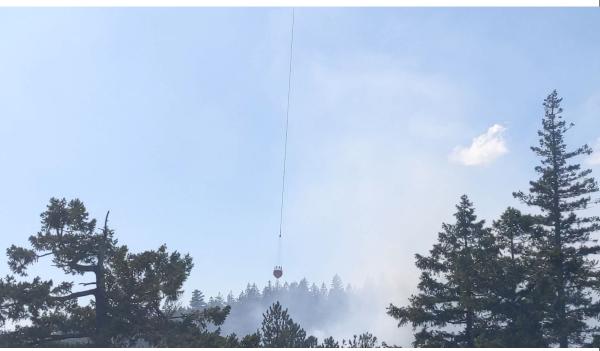
First response – heli bucketing (CRD and BCWS)

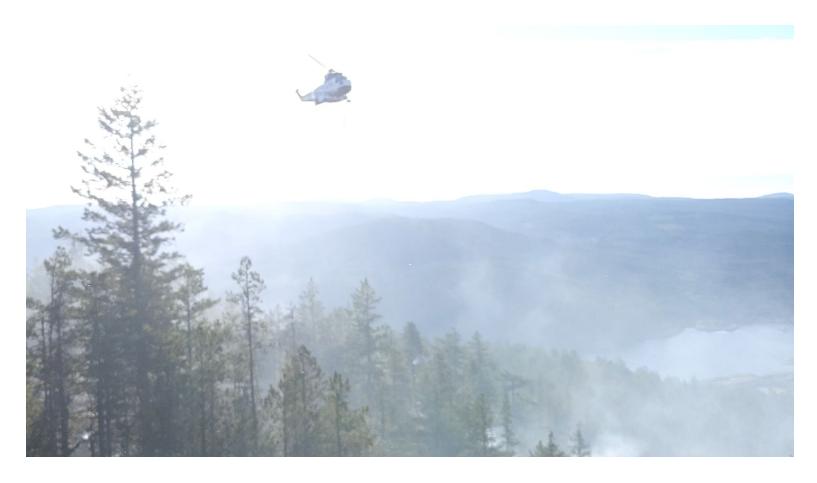
First response – heavy helicopters with tank and snorkel (BCWS)

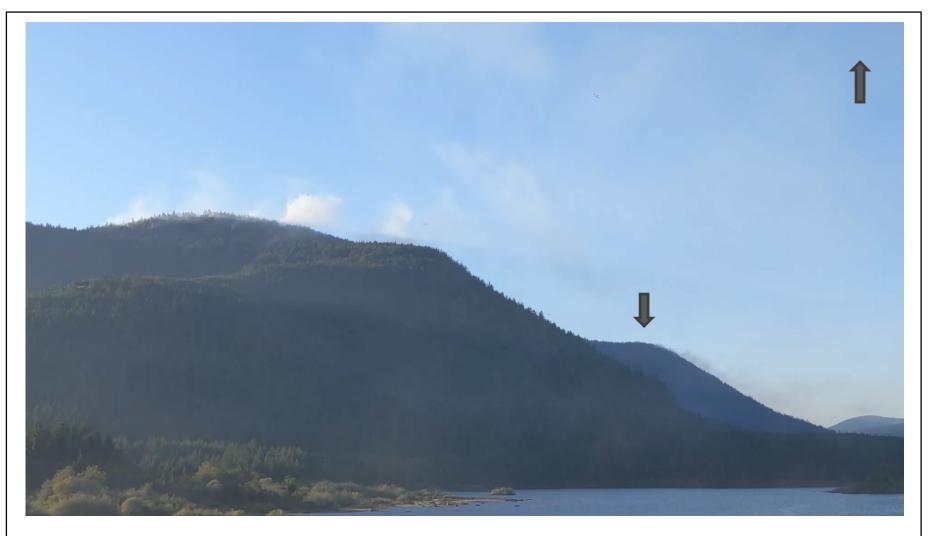
Evening amphibious (skimmer) air tanker support

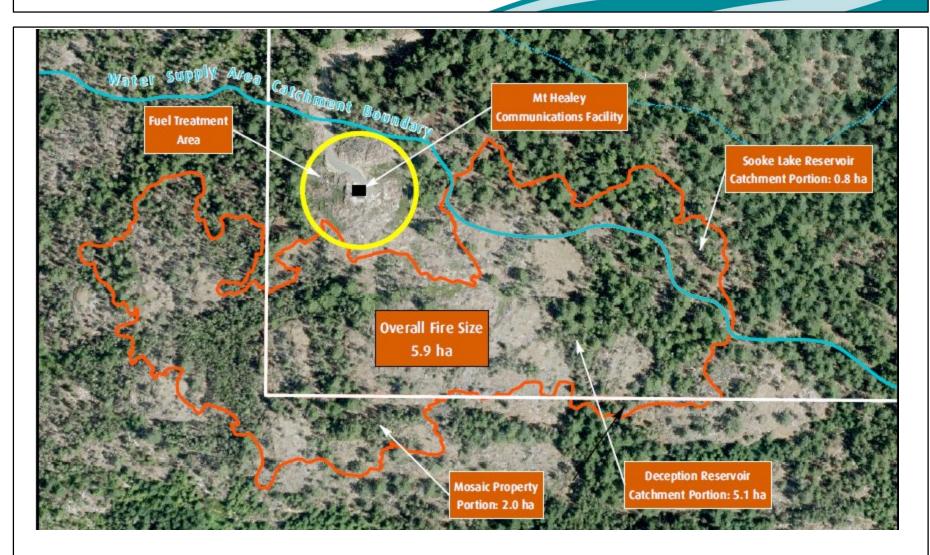
Mt Healey fire size

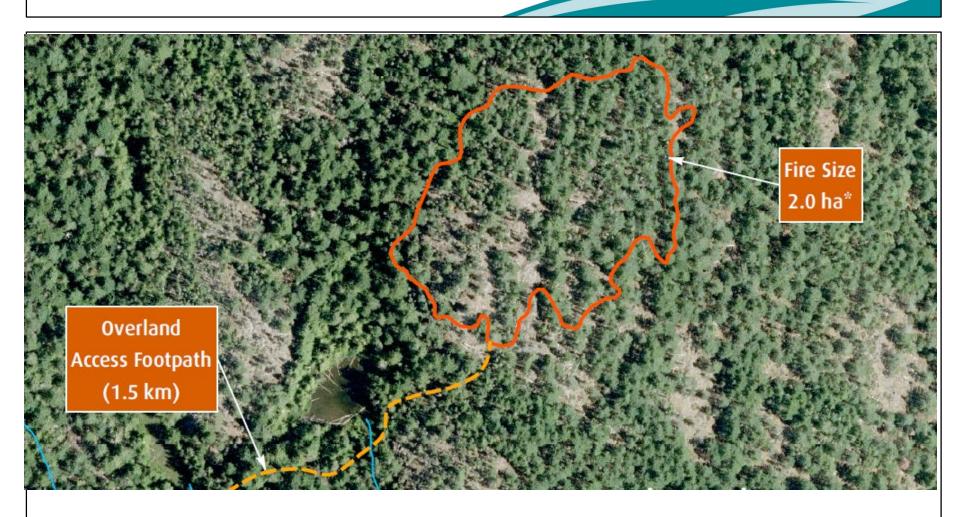
Rithet fire size

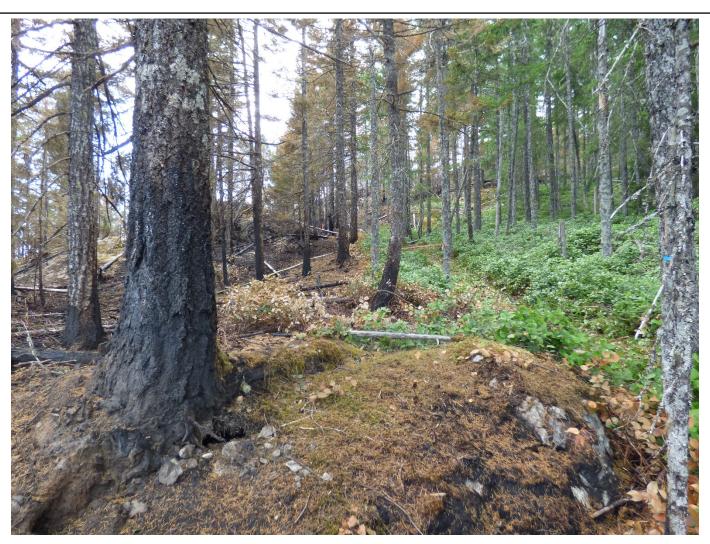
Mt Healey burned vs. unburned comparison

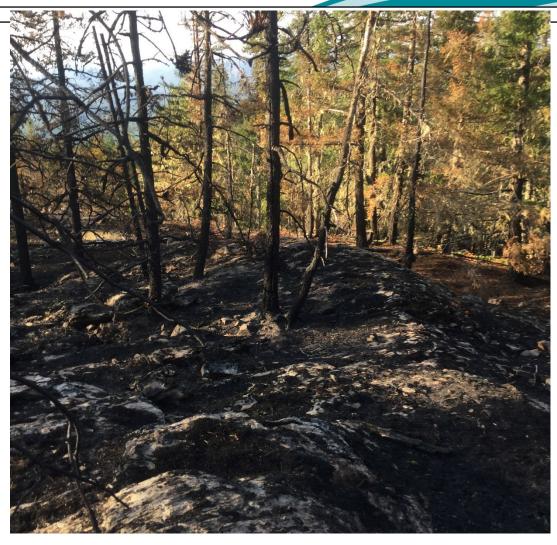
Mt Healey high and moderate severity burn

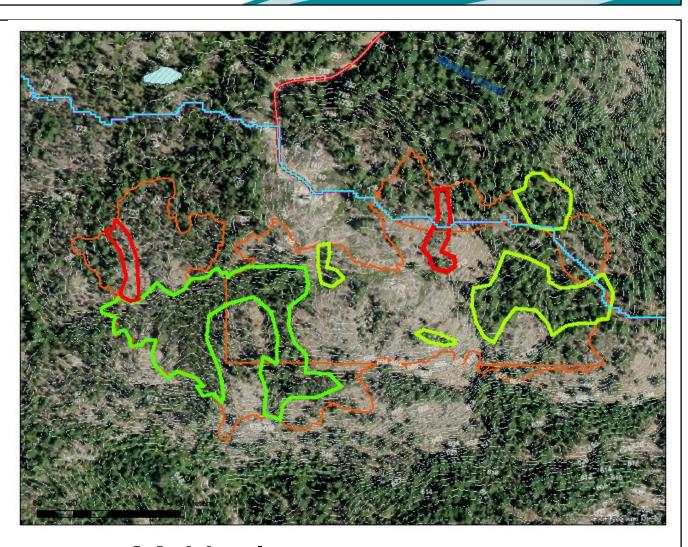
Mt Healey

Burn Severity
Red = high
Orange = moderate
Green = low

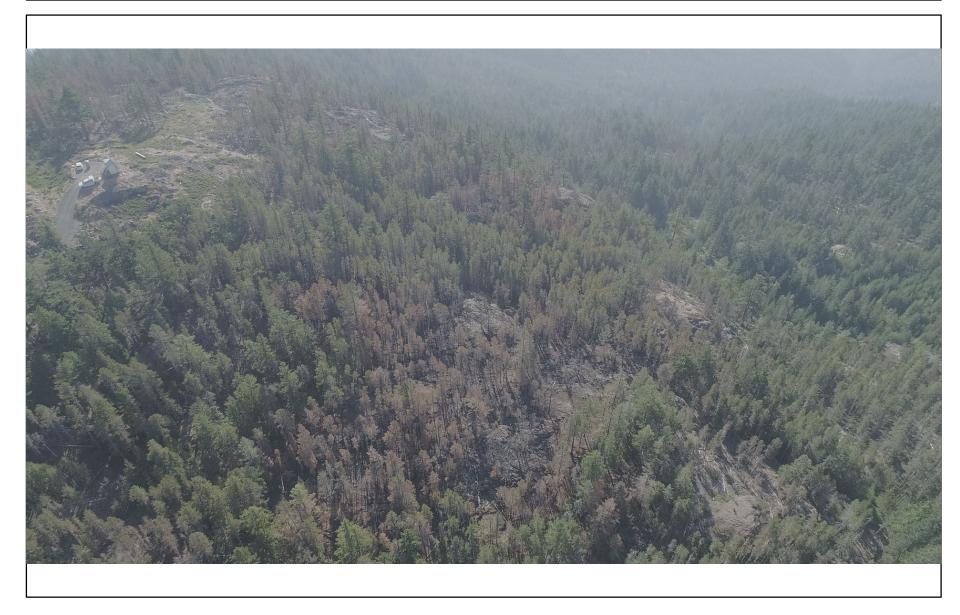
Post fire overview - Healey
