SOUTHERN GULF ISLANDS HARBOURS COMMISSION
Notice of Meeting on **Thursday, May 29, 2025 at 9:30 a.m.**
Saanich Peninsula Wastewater Treatment Plant Meeting Room,
9055 Mainwaring Road, North Saanich, BC

Southern Gulf Islands Harbours DOCK INSPECTION REPORT

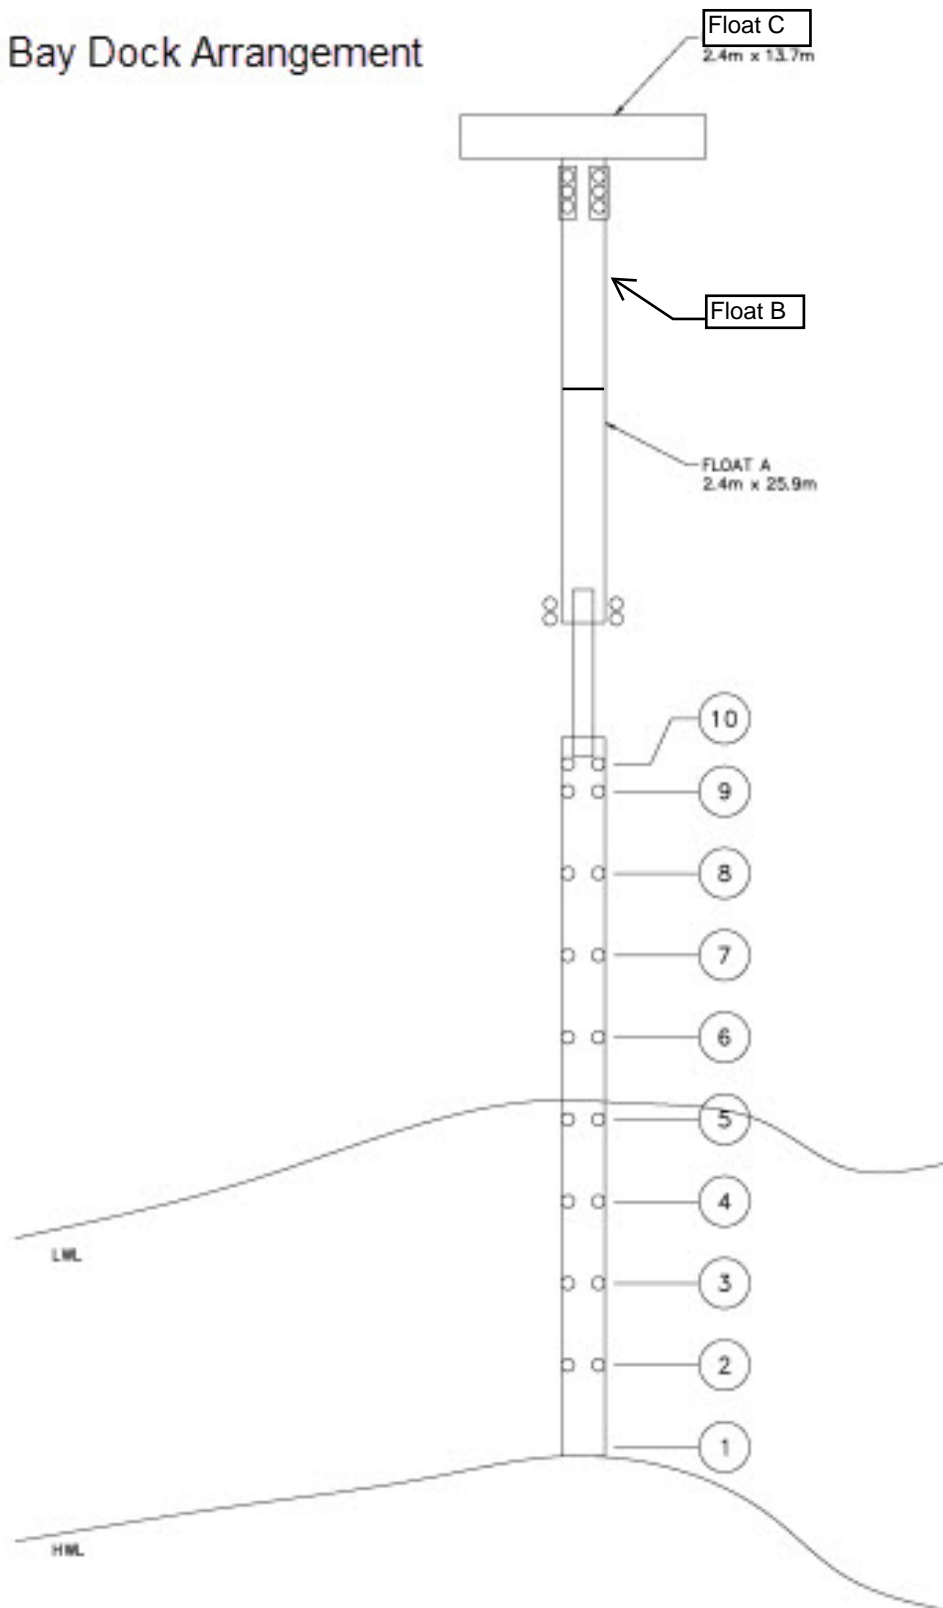
Horton Bay Dock Arrangement

APPROACH	<input checked="" type="checkbox"/> Signage <input checked="" type="checkbox"/> Envelope Supply <input checked="" type="checkbox"/> Notices Posted <input checked="" type="checkbox"/> Rates Posted
	<p>The is an older wood structure with wood decking, painted bull rails and railings that are in fair condition. Pressure washing is required for the bull rails and railings. There was damage to the railing and the light standard with the electrical panel that requires repair. There are a few deck boards with minor rot and monitoring for replacement is recommended. A new aluminum notice board has been installed. The old gas lines have been removed.</p>

WHARF HEAD	<input checked="" type="checkbox"/> Signage <input type="checkbox"/> Envelope Supply <input type="checkbox"/> Notices Posted <input type="checkbox"/> Rates Posted
	<p>WHARFHEAD Roughly 80% of the old wood decking has been replaced and new unpainted wood railings now surround the wharfhead. The large bull rails are unpainted and are in good condition and there are still a number of deck boards that require monitoring for developing rot and future replacement. GANGWAY A is an older painted steel structure in fair condition and the decking has recently been replaced with mini mesh decking. There is a steel top transition plate with painted non-slip and a similar bottom apron in good condition. The steel roller, steel guide rails and the pillow blocks are in fair condition. Float A is an older wood float with wood decking, rub boards, bull rails with some loose bolts on the south side and this is in fair condition. The bull rail on the south side is quite worn and replacement is recommended. The flotation is good.</p>

GANGWAY FLOATS	<p>Float A (continued) There are 2 closed pile wells next to the gangway with 6 wood piles/well. The piles are in fair condition with some piles showing as much as 20% wear and others have minimal wear. The pile wells are in fair condition and the UHMW rub boards are in fair condition considering that this has a modified design. At the end of the float there are 2 closed wells with 6 wood piles/well that are in good to fair condition with minimal to 10% wear showing and one pile that has a developing hole visible at low tide. The UHMW rub boards are in good condition. Gangway B is an older steel structure with an open steel grid decking that is in good condition. There is a floating steel top transition plate with painted yellow non-skid and the bottom apron is the same as the gangway decking and running on steel runners. There is a steel roller and guide rails that are in good condition along with the pillow blocks. This is sitting on a section of wood decking before the concrete tiles begin. Float B is a fairly new wood float with 2'x2' concrete tiles, wood rub boards, bull rails with mostly tight bolts and the float has good flotation. The loose bull rail bolts are along the east side, in the middle area and can be monitored for tightening. The condition is good and things to be fairly stable for this location. Yellow paint is required for the Loading / Emergency & Sea Plane Landing zone. The safety ladders are cleaned and in good condition. Replace long term moorage signs required.</p>

COMMENTS/INSTRUCTIONS	<p>> The damaged railings & electrical panel on the approach require repair.</p> <p>> Replacing the bull rail on the south side of Float A is recommended.</p> <p>> Yellow paint is required in the Loading/Emergency & Sea Plane Landing zones.</p> <p>> Long Term Moorage signs are in poor condition and replacement is recommended.</p> <p>> Monitor the decking on the approach and wharfhead for replacement.</p> <p>> Monitor the bull rail bolts.</p>
------------------------------	---

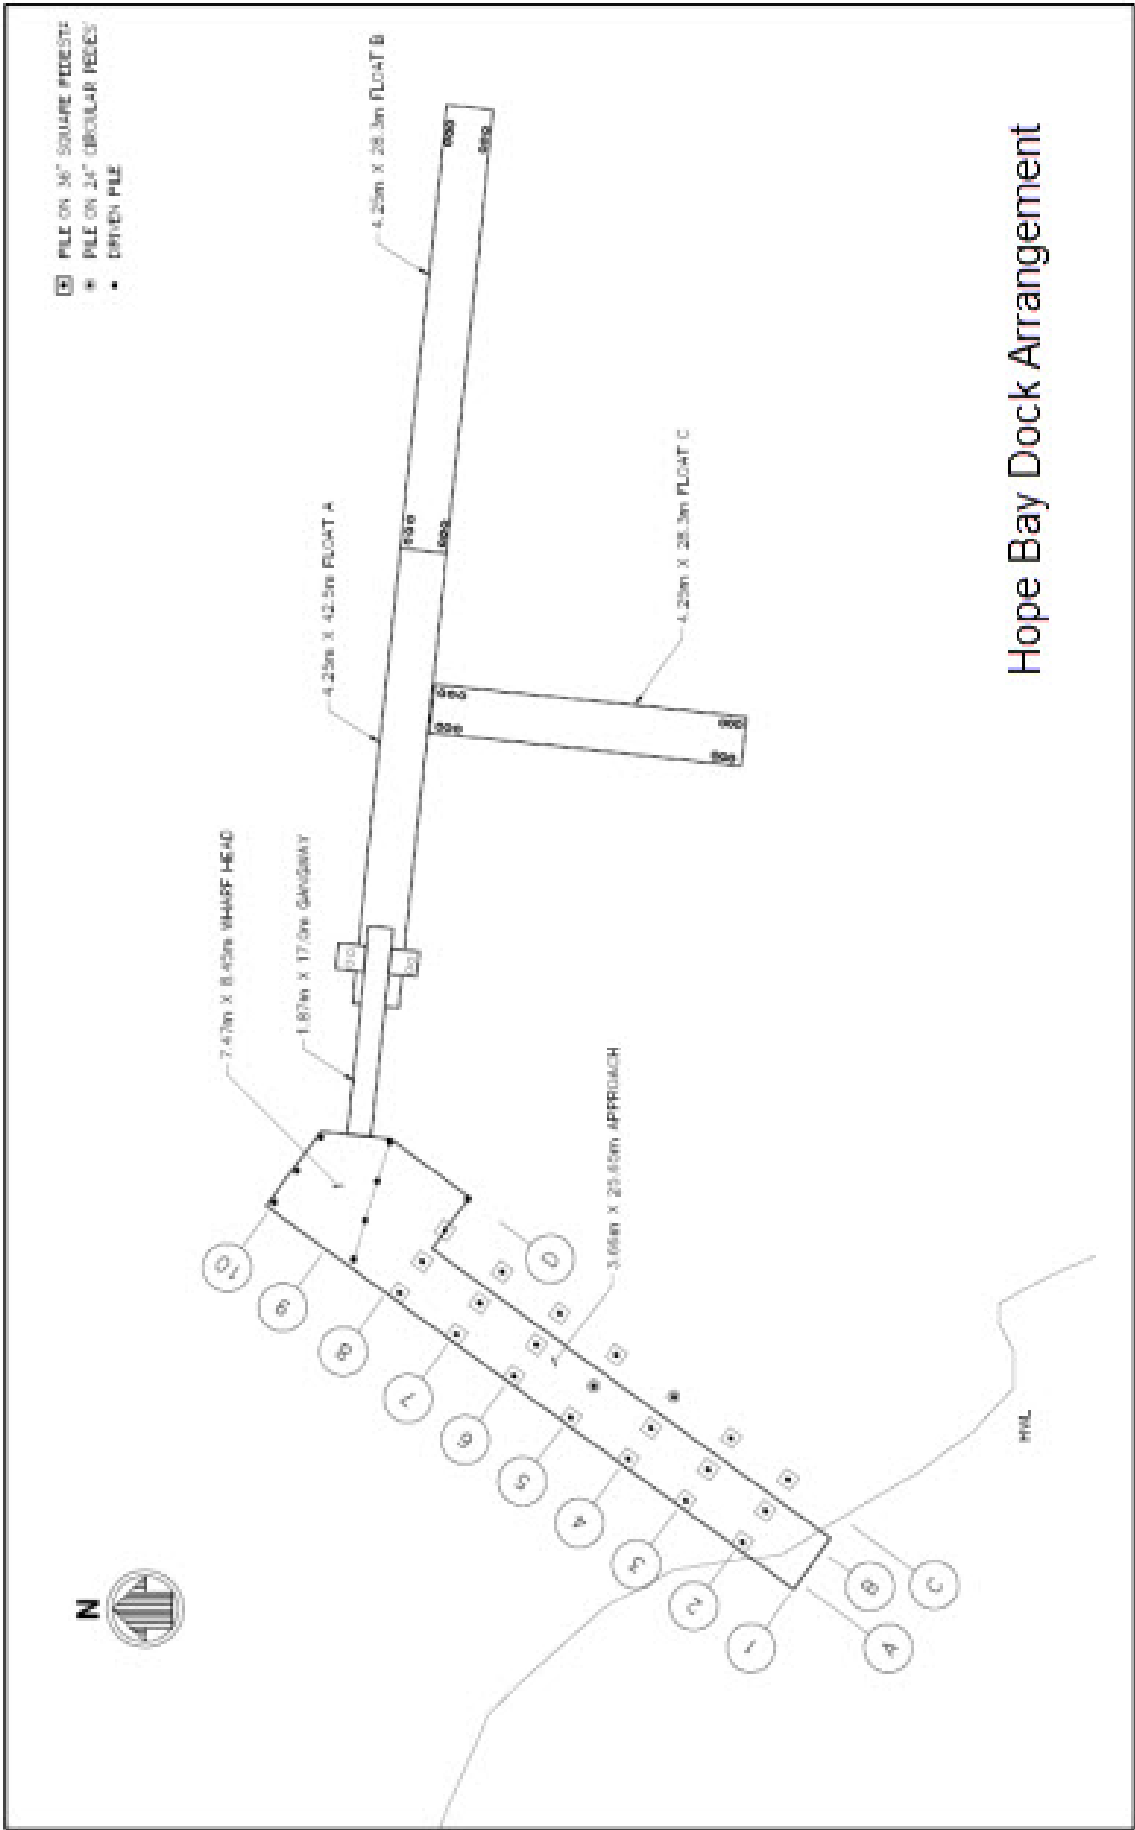
Hope Bay Dock Arrangement

APPROACH	<input type="checkbox"/> Signage <input type="checkbox"/> Envelope Supply <input type="checkbox"/> Notices Posted <input type="checkbox"/> Rates Posted
	<p>The wood railings and bull rails have some remaining paint and other sections have new unpainted wood and are generally in good condition. The wood decking is in mostly good condition with roughly 12 to 15 deck boards with developing rot and monitoring for replacement is recommended. The mud grate is clear of debris.</p>

WHARF HEAD	<input checked="" type="checkbox"/> Signage <input checked="" type="checkbox"/> Envelope Supply <input checked="" type="checkbox"/> Notices Posted <input checked="" type="checkbox"/> Rates Posted
	<p>The wood railings and bull rails are in the same condition as the approach with only a few deck boards with developing rot that require monitoring for replacement. The wood notice board is in good/fair condition.</p> <p>There is a broken pile brace that requires replacement.</p> <p>The light standard requires painting.</p>

GANGWAY FLOATS	<p>The old painted steel gangway has wood decking, half wood rungs and expanded aluminum grating for non-slip that is in fair condition. There is the usual amount of rust on the frame and guide rails but the roller & pillow blocks are recent replacements in good condition. There is an aluminum transition plate at the top with painted yellow non-slip and an expanded aluminum grating apron running on aluminum runners that are in fair condition. Float A is a new wood float with wood decking, rub boards and bull rails with tight bolts and is in good condition with good flotation. There are 2 outside closed pile wells with 3 wood piles/well. The piles are in good condition with minimal wear showing and the UHMW rub boards are in good condition. Yellow paint is recommended for the Loading Zone. This float is connected to Float B with a hard rubber mat and is an older upgraded wood float with wood decking, rub boards and bull rail bolts with tight bolts and good flotation that is in good condition. There are 4 closed pile wells with 3 wood piles/well that are in good condition with minimal wear showing. The wells and the UHMW rub boards are also in good condition. Float C is an older wood float with wood decking, rub boards and bull rails with tight bolts and good flotation that is in good condition. There is a floating aluminum transition plate connecting Float A to Float C. There are 4 closes pile wells with 3 piles/well that are in good condition with minimal wear showing. The wells and UHMW rub boards are also in good condition.</p> <p>The safety ladders have all been cleaned.</p>

COMMENTS/INSTRUCTIONS	<p>> Repair the broken pile brace under the wharfhead.</p> <p>> The light standard requires painting.</p> <p>> Yellow paint is recommended for the loading zone on Float A.</p> <p>> Monitor the developing rot in the deck boards on the Approach & Wharfhead.</p>
------------------------------	---

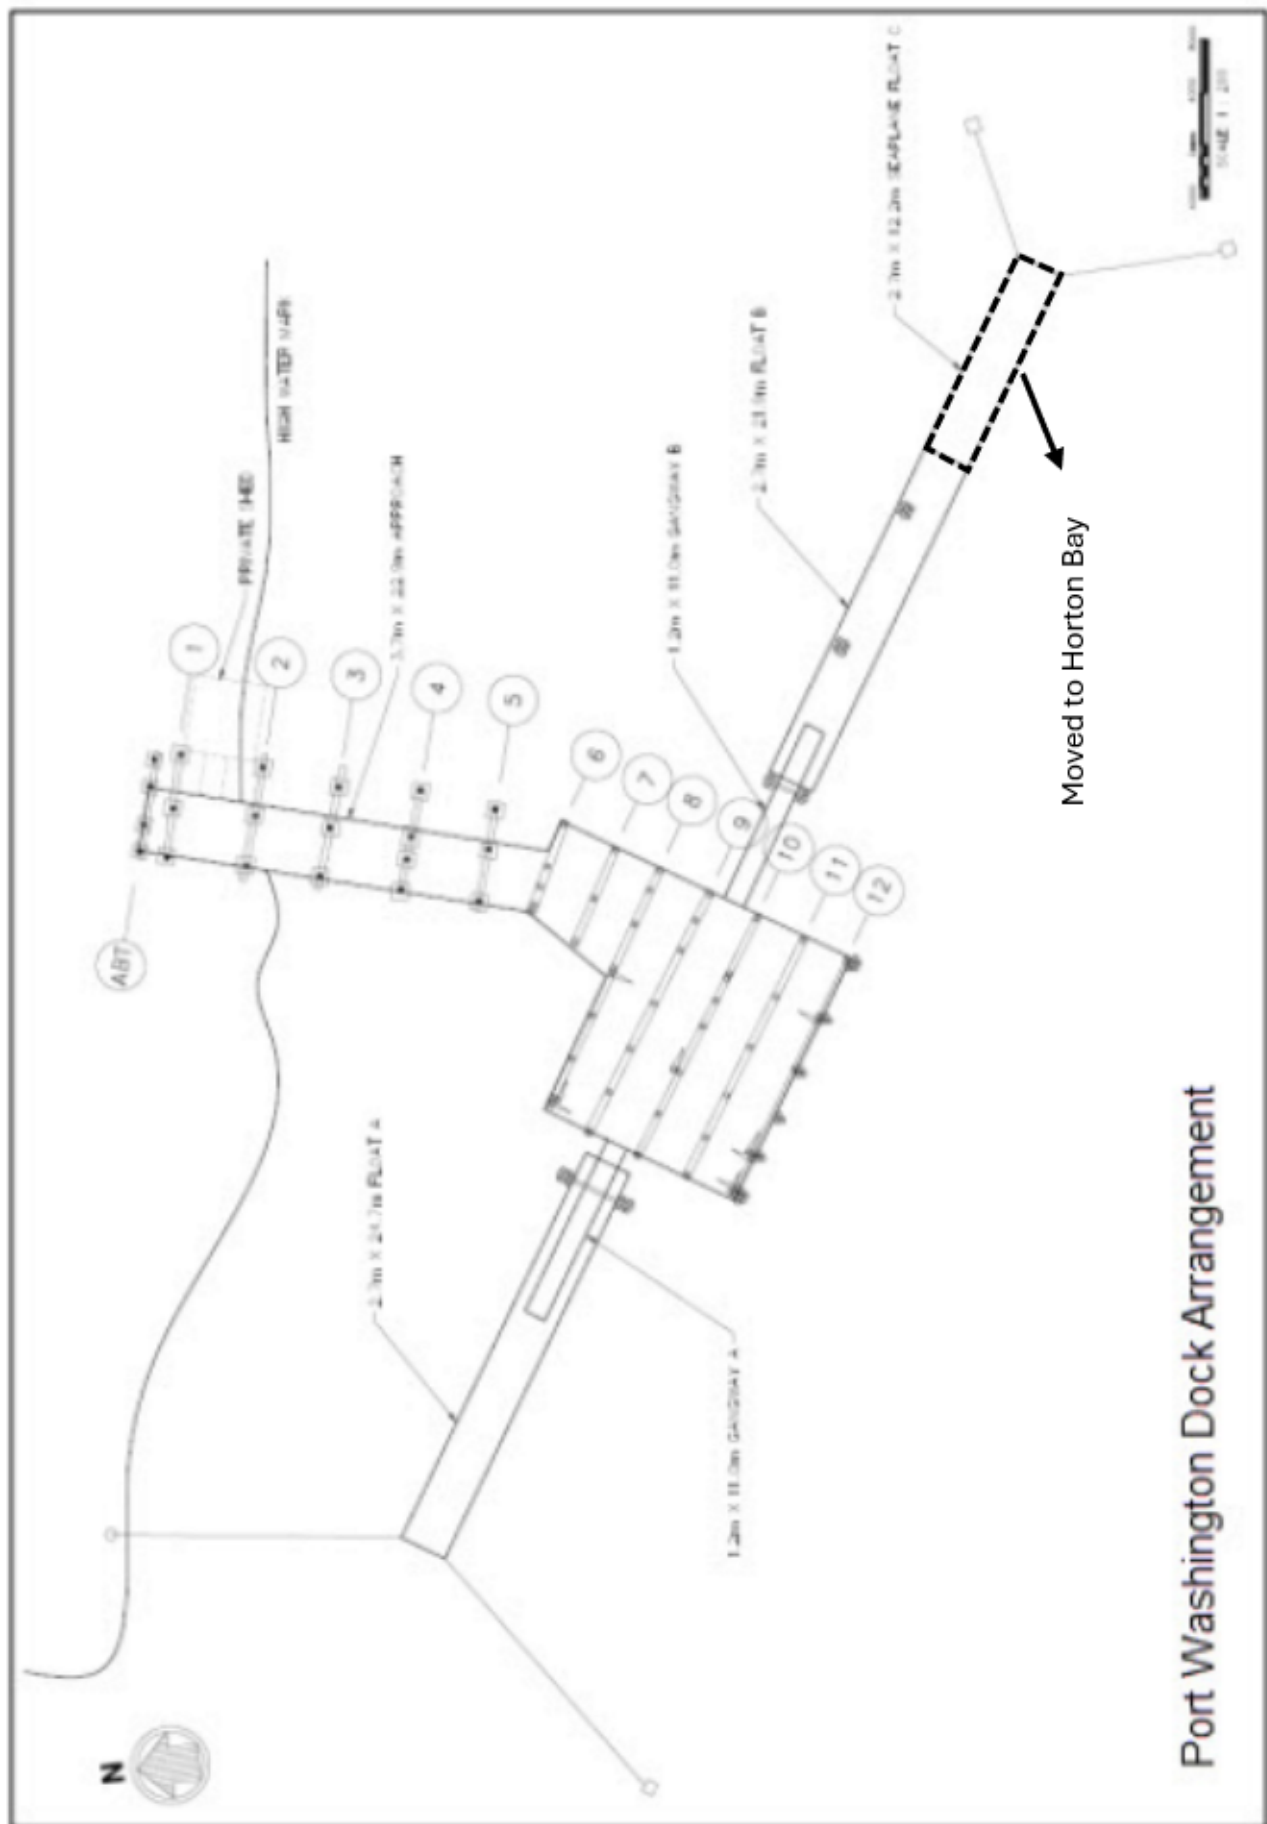
Port Washington Dock Arrangement

APPROACH	<input checked="" type="checkbox"/> Signage <input checked="" type="checkbox"/> Envelope Supply <input checked="" type="checkbox"/> Notices Posted <input checked="" type="checkbox"/> Rates Posted
	<p>There is an aluminum notice board located on the main float that is in good condition. Signage is posted.</p> <p>The railings and bull rails are unpainted and in good condition other than a small section of bull rail with developing rot that requires monitoring for replacement.</p>

GANGWAY FLOATS	<p>There is an old heavy painted steel gangway in fair condition and new mini mesh decking. The bottom apron is old expanded aluminum grating and replacement is recommended. There are steel wheels welded to the axle and pillow blocks that are difficult to access and running on steel guide rails that are in fair condition. The wood gangway bed boards are in poor condition and replacement is recommended. The float decking underneath could also be rotten.</p> <p>There is an old wood triangular shaped float with wood decking (there are a few boards with minor rot showing), rub boards, bull rails with tight bolts, all in fair condition and very good flotation. The expanded aluminum grating that is used for a non-slip surface is old, breaking up and is creating a potential tripping hazard. Removal is recommended. Extending the Emergency/Loading zone is recommended and yellow paint is required on the bull rail.</p> <p>Float B is a new HDPE tube float with mini mesh decking, wood bull rails and rub boards. There is a single steel pile in a closed well, all in very good condition.</p>

COMMENTS/INSTRUCTIONS	<p>> Removal of the expanded aluminum non-slip grating on the main float is recommended.</p> <p>> Extend the Emergency/Loading zone and yellow paint is also required.</p> <p>> Inspect the wood decking at the bottom of the gangway and replace if required.</p> <p>> Monitor the gangway bottom apron for further breakage.</p> <p>> Monitor the rot developing on the approach bull rails, decking and deck boards on the main float.</p>
	Empty space for Comments/Instructions
