Notice of Meeting and Meeting Agenda Regional Parks Committee

6.2. [23-141](#) Island View Beach Regional Park - Ditch Maintenance

**DITCH MAINTENANCE 2022
ISLAND VIEW BEACH REGIONAL PARK**

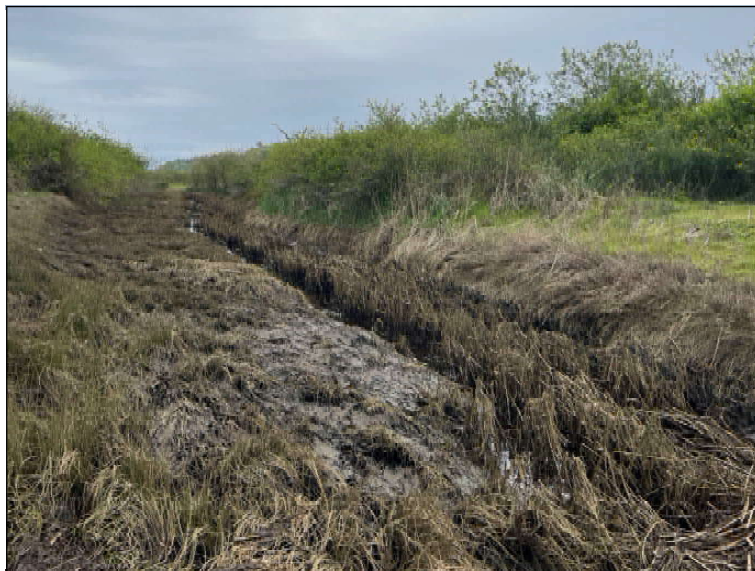
Photo 12:

Description: Main channel of ditch Section 6.

Long grasses are observed within the channel thalweg.

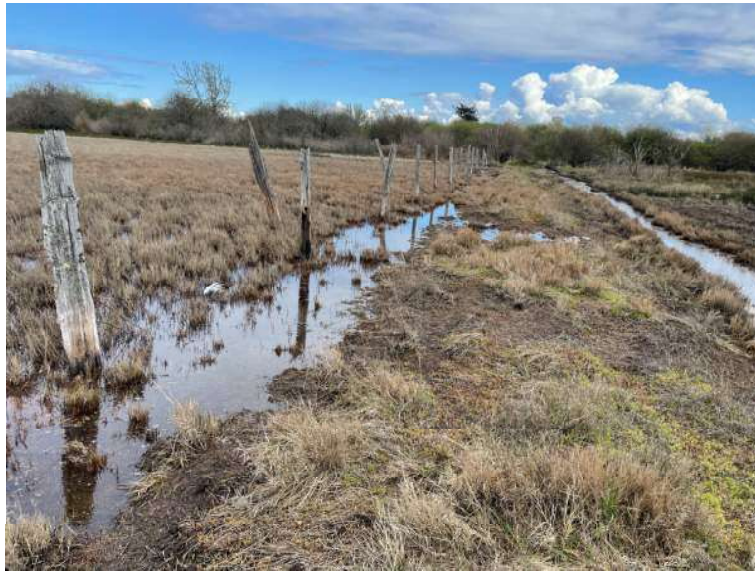
Photo 21:

Description: Inundated Tsawout lands (at left) in relation to Ditch 1 (at right)

Direct drainage connectivity was observed between the inundated area and Ditch 1, although the extent/contributory area draining to the ditch was not ascertained.

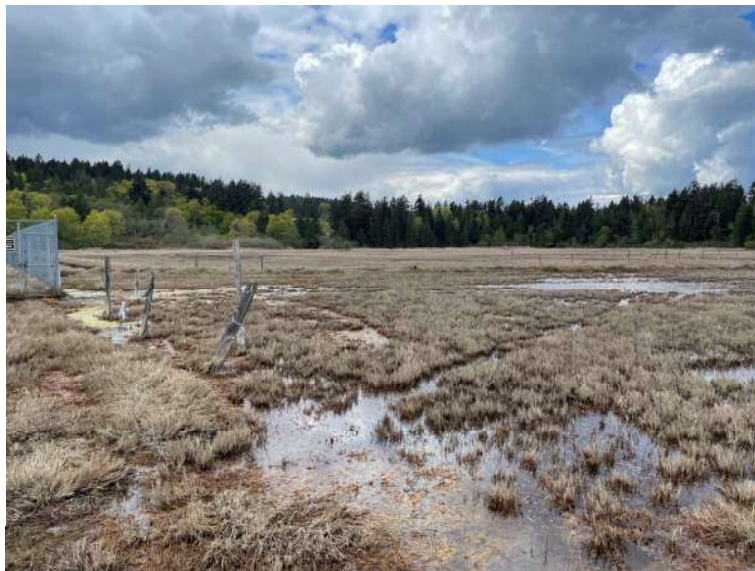
Photo 22:

Description: Looking northwest towards Tsawout lands from Ditch 1. Significant extend of inundation is observable.

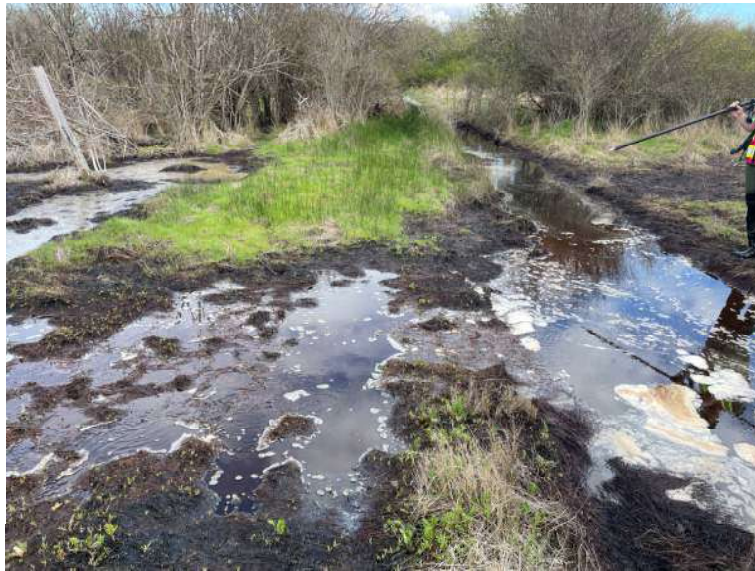
Photo 23:

Description: Observed overland flow from the inundated Tsawout lands (left) to Ditch 1.

Photo was taken on the afternoon of April 22, during low tide conditions approximately 14.5 hours after a tidal high of 3.16 m Chart Datum (Sidney Predictions).

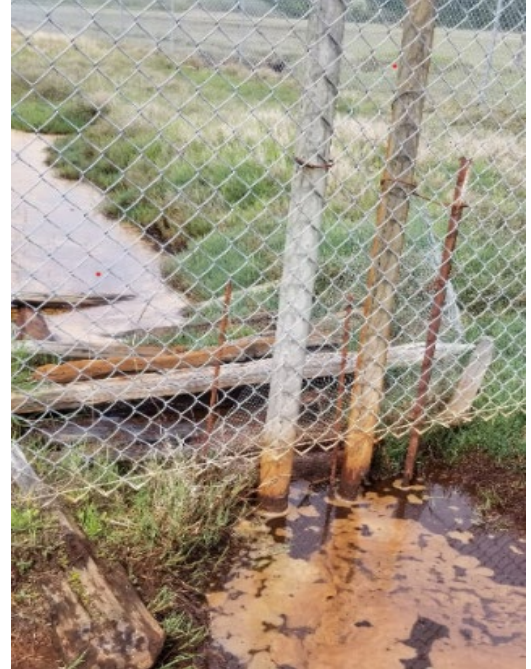
- The ditch system starts on CRD land but one section of the ditch extends under a fence to private land. The photo to the right shows debris in the ditch on the private property (see also map on next page – black line indicates the location of this private property).
- Staff have observed what are believed to be stickleback fry in the ditches. This hinders further work being done in the ditches until a Section 11 permit from the Ministry of Environment and a permit from the Department of Fisheries and Oceans is obtained.

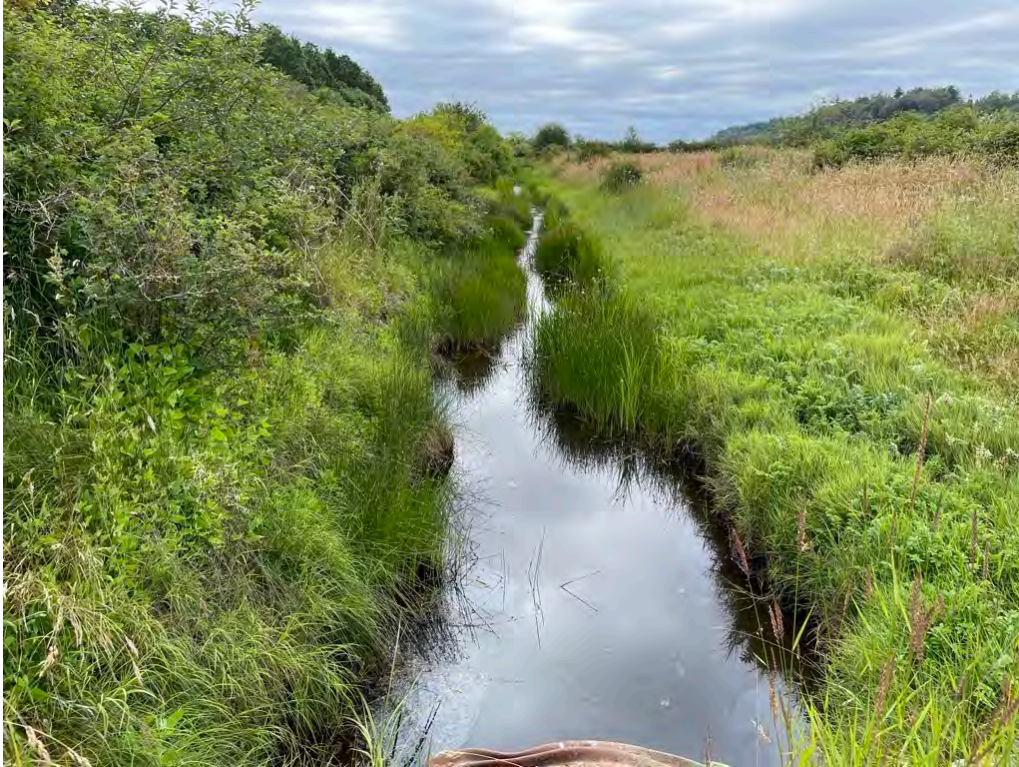
Campground ditch looking south from the trail crossing July 16, 2022.
Channel is clear with no impediments to flow.

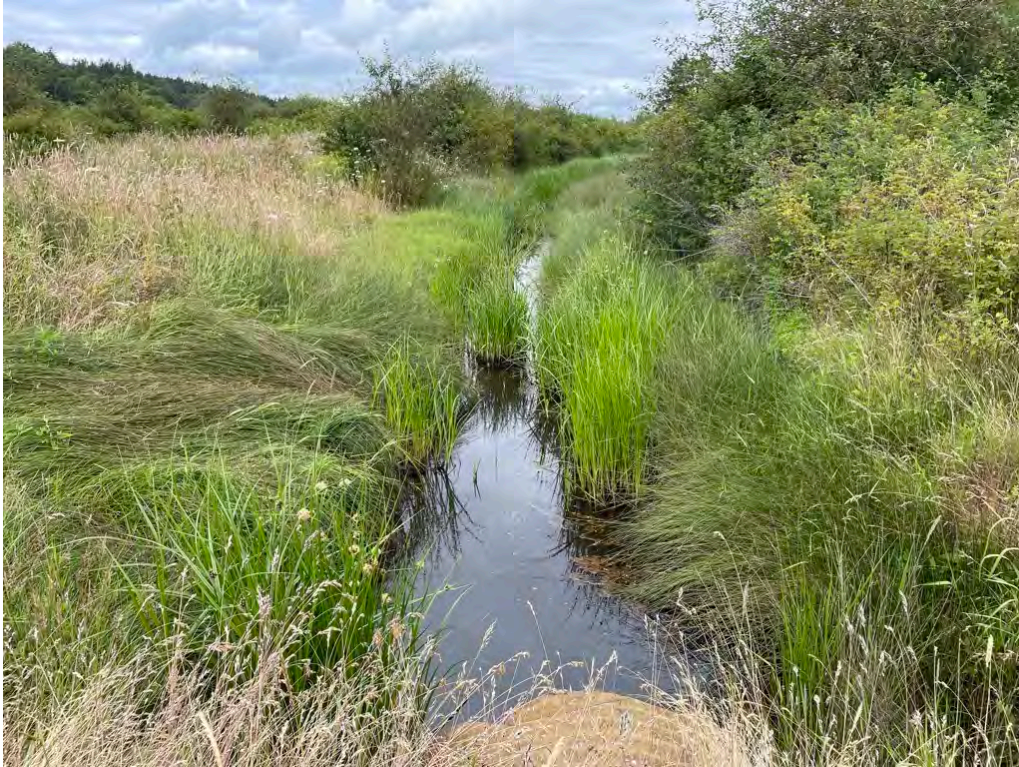
Campground ditch looking north from the trail crossing July 16, 2022.
There is minor ingrowth of vegetation but still a clear open channel.

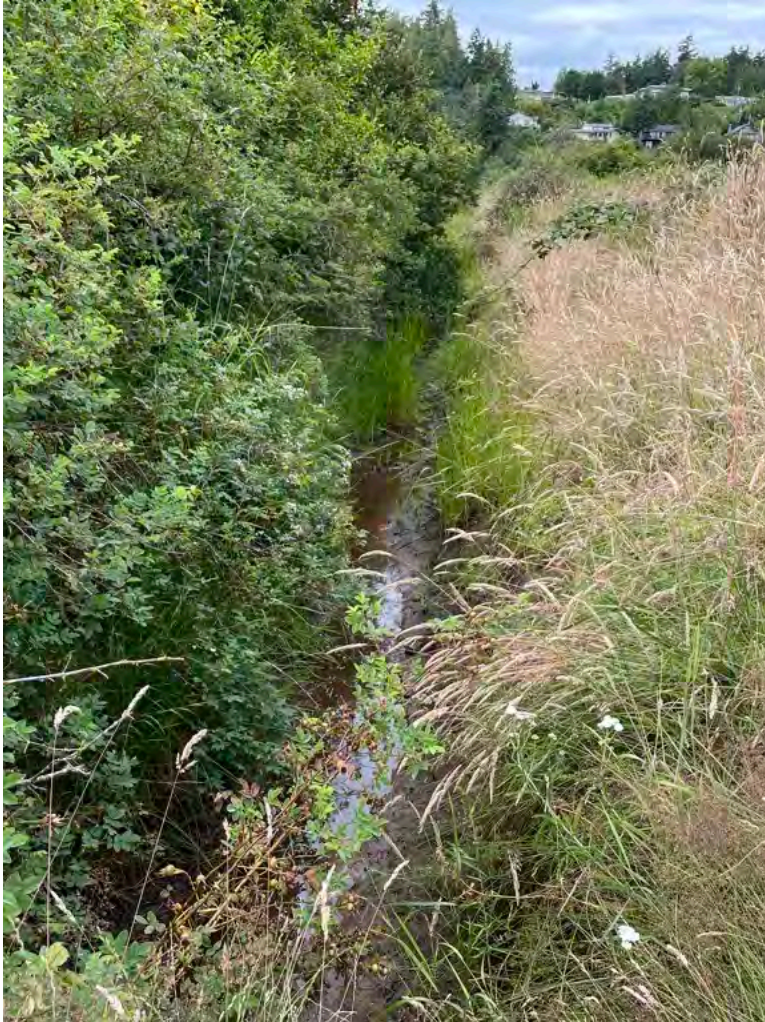
Lamont ROW ditch looking west, downstream end July 16, 2022. There was a very small amount of water in the channel and positive drainage was observed.

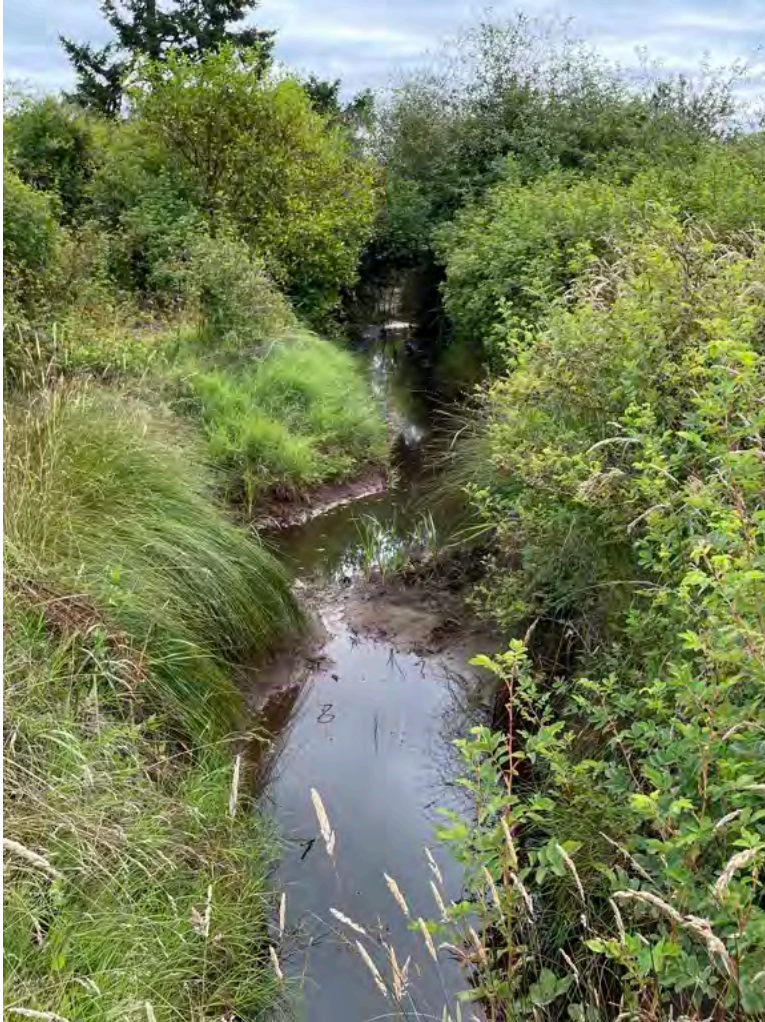
Confluence of Lamont Road ROW and Ditch 4 July 16, 2022. Note the clear open channel as a result of last year's maintenance.

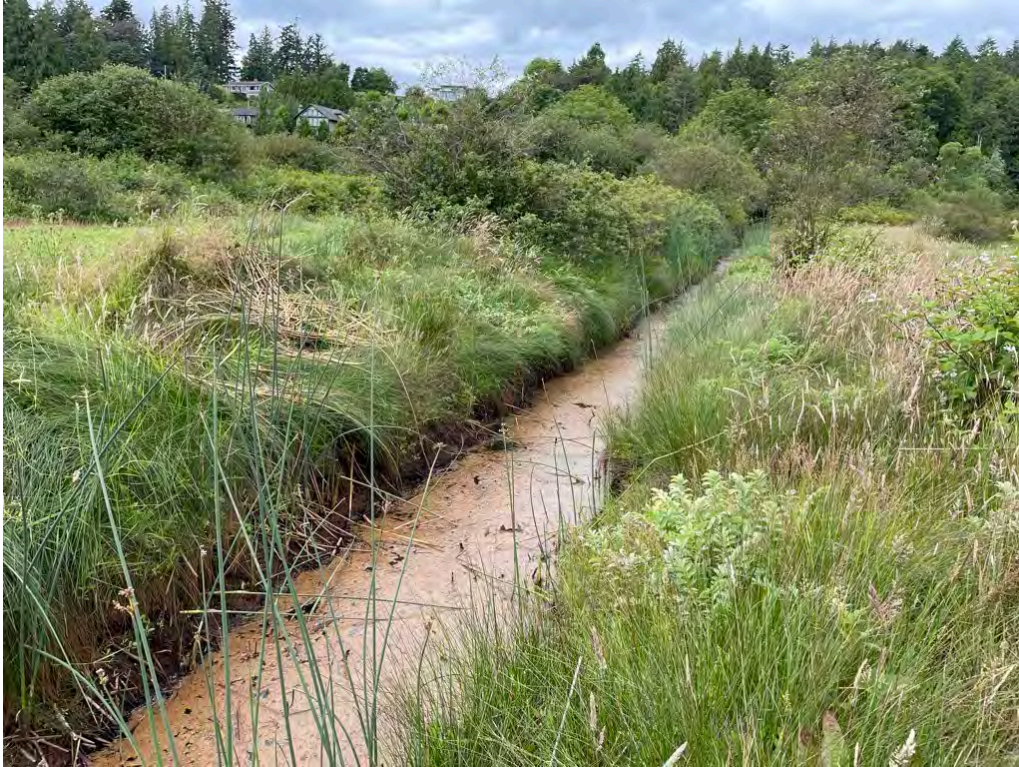
Above: Ditch 1 looking west from the midpoint of the ditch toward the confluence with Ditch 2 July 16, 2022. The channel was clear of vegetation.

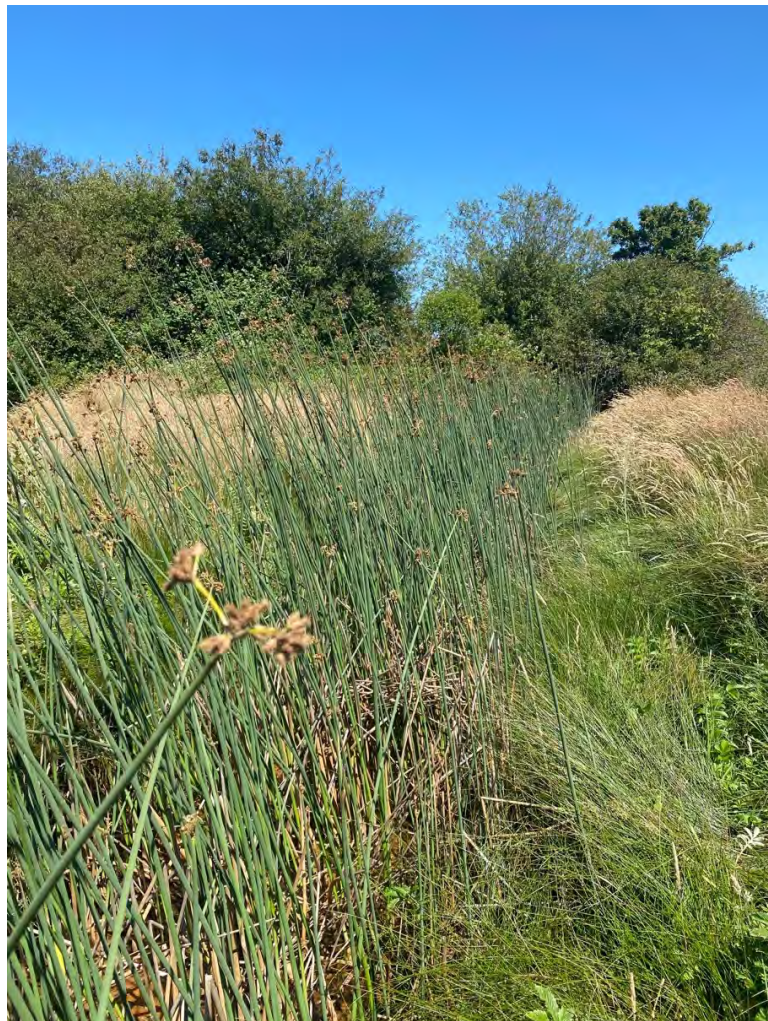
Right: Ditch 1 at the midpoint of the ditch July 5, 2021. These bulrushes were removed during 2021 maintenance.

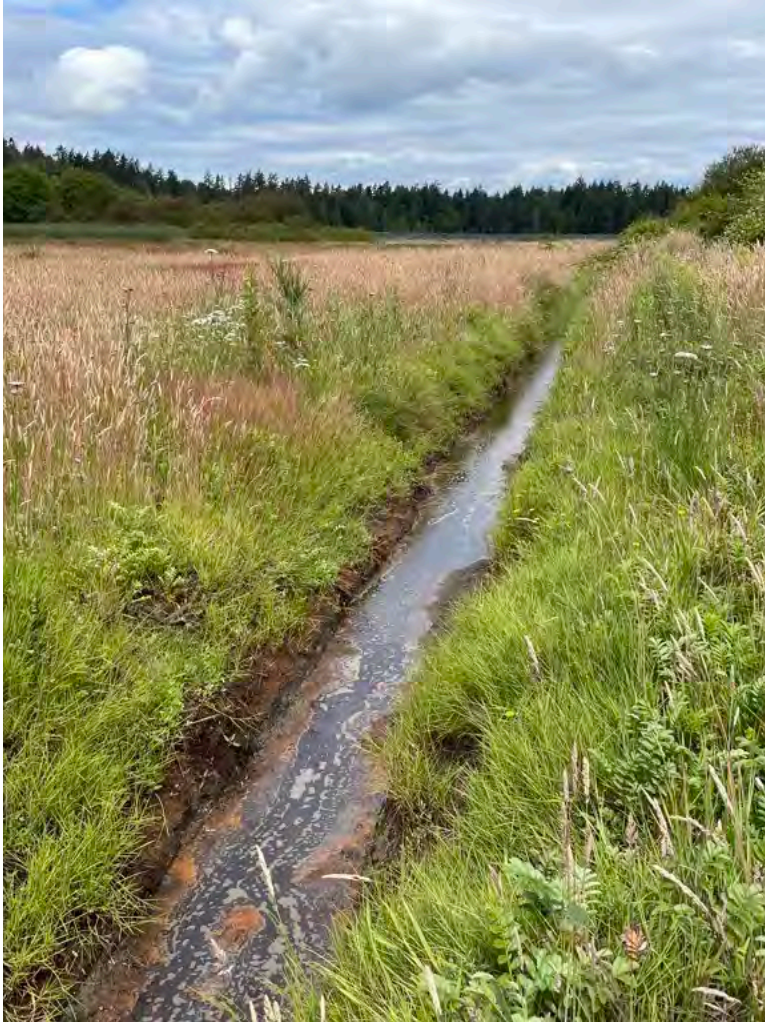
Downstream end of Ditch 2 looking northwest July 16, 2022. The channel is clear. The trail of bubbles were flowing south as expected. Iron bacteria were significantly reduced over last year.

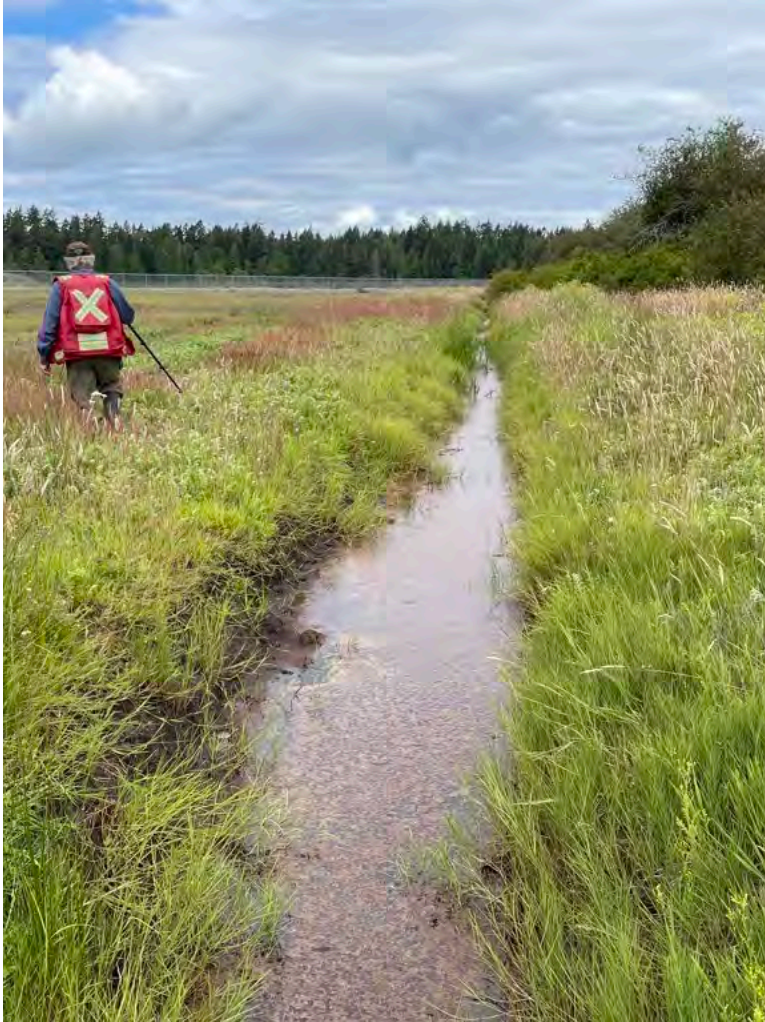
Ditch 2 from middle of the channel looking northwest July 16, 2022. The channel is more open and was draining well.

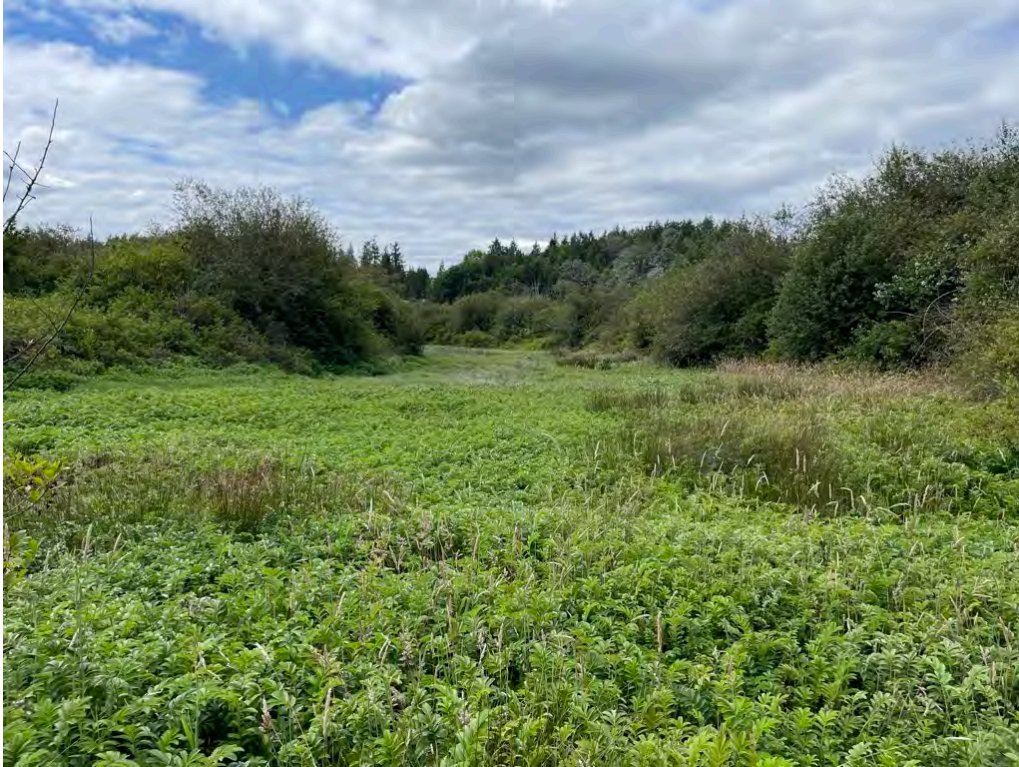
Photo taken from Ditch 3 looking southwest across the wet depression. The dominant plant is silverweed (*Potentilla*). Soils were dry on the surface.

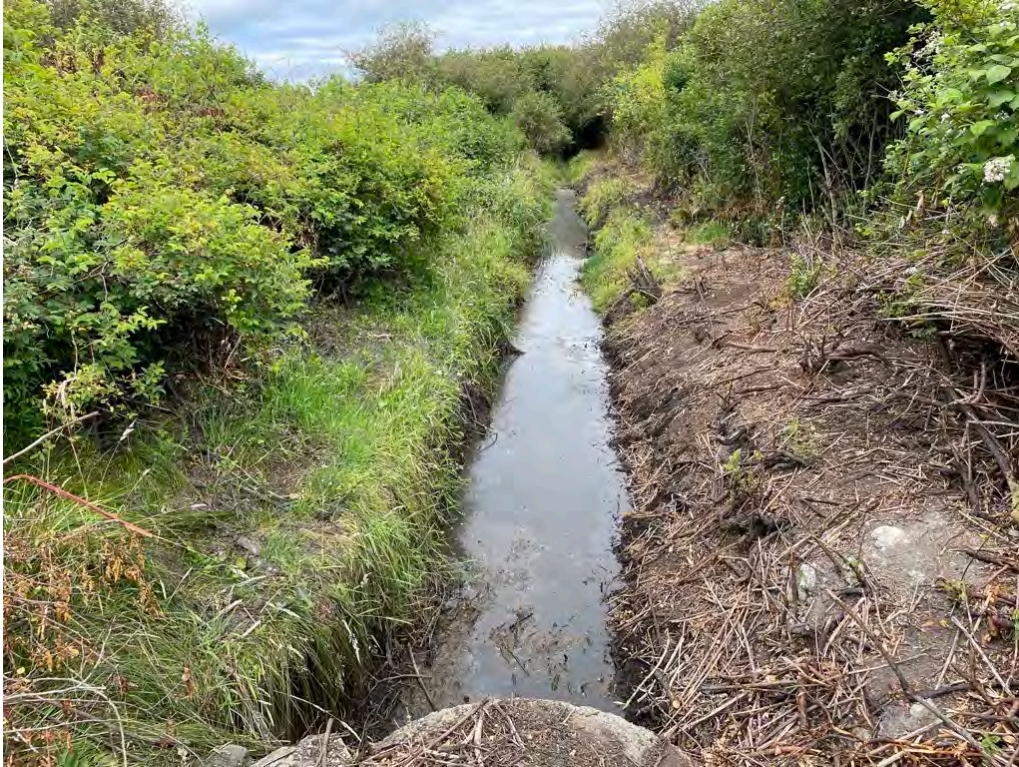
Looking north from trail crossing over intersection of Ditches 3 & 4 looking north up Ditch 3, July 16, 2022. The lack of vegetation along the channel may encourage new growth in the channel as light is no longer limited.

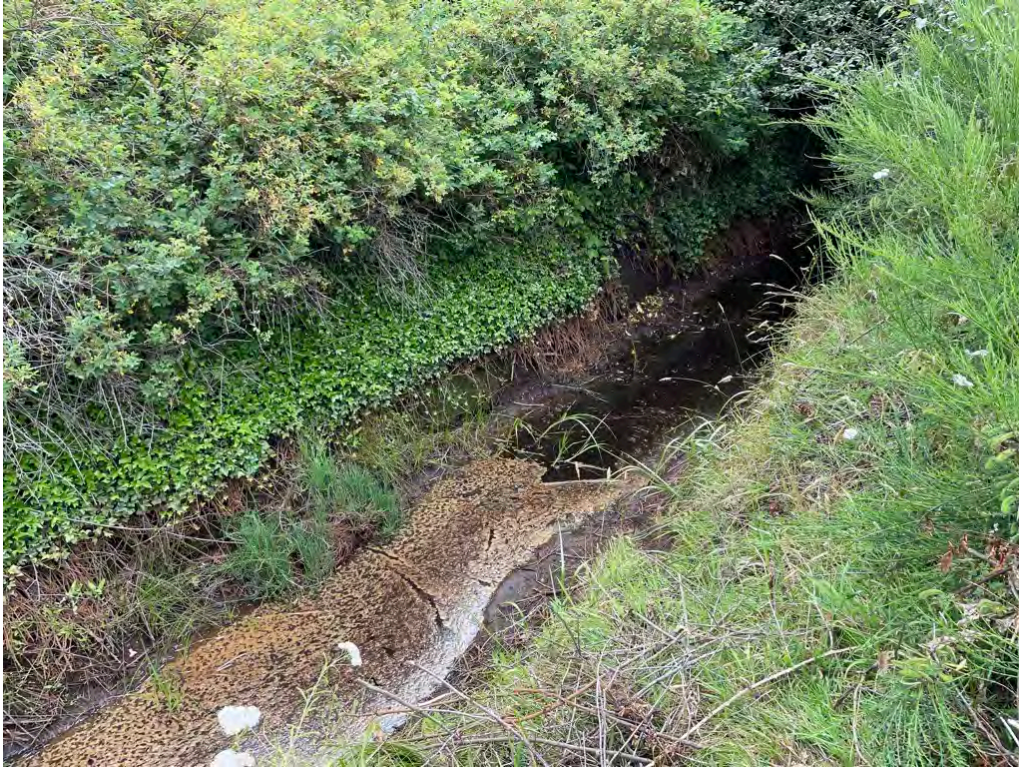
Ditch 4 near the midpoint. July 16, 2022. Note the extensive English ivy carpet (*Hedera helix*).
