## WILDERNESS MOUNTAIN WATER SERVICE COMMISSION

Notice of Meeting on **Tuesday, June 28, 2022 at 1:00 p.m.**  
Goldstream Conference Room, 479 Island Highway, Victoria, BC

**6.3. Wilderness Mountain Source Water Protection Plan 2022 ..... 18**

# WILDERNESS MOUNTAIN WATER SYSTEM

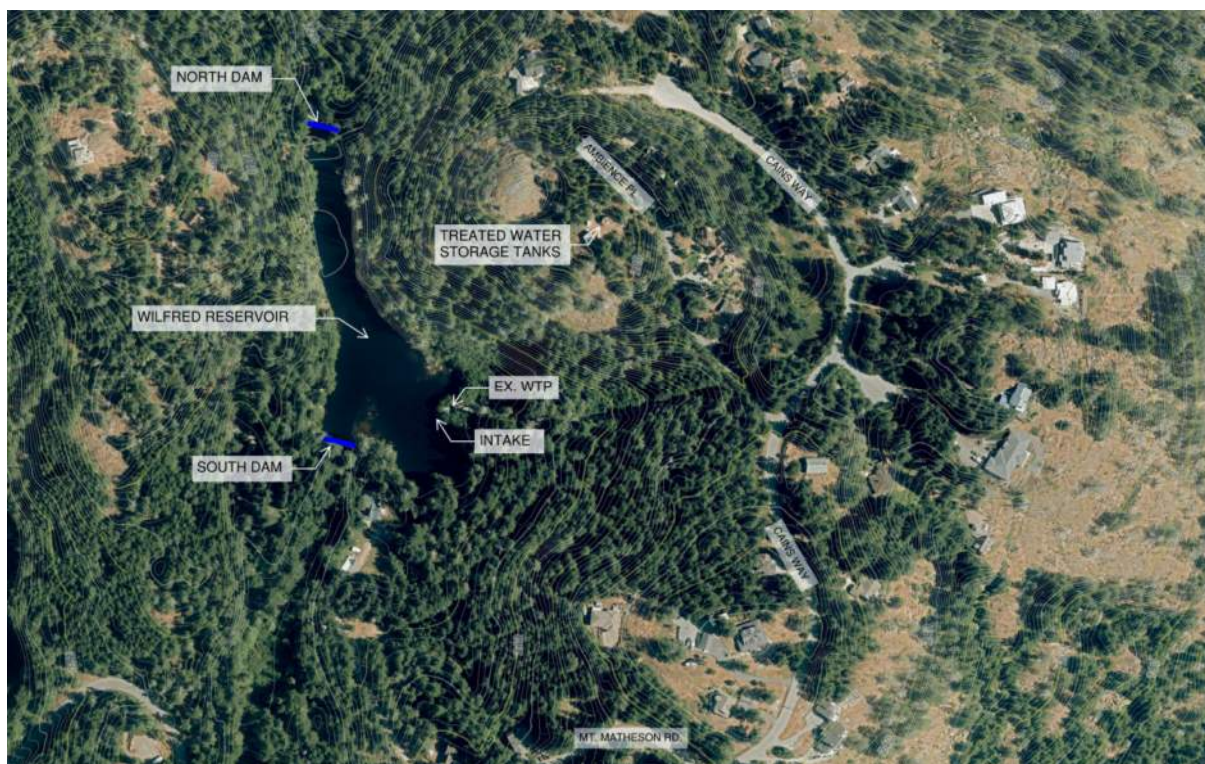
The WMWS is operated and managed by CRD since 2008. Figure 2-1 provides a general site plan of the Wilderness Mountain water system.

Figure 2-1 General Site Plan

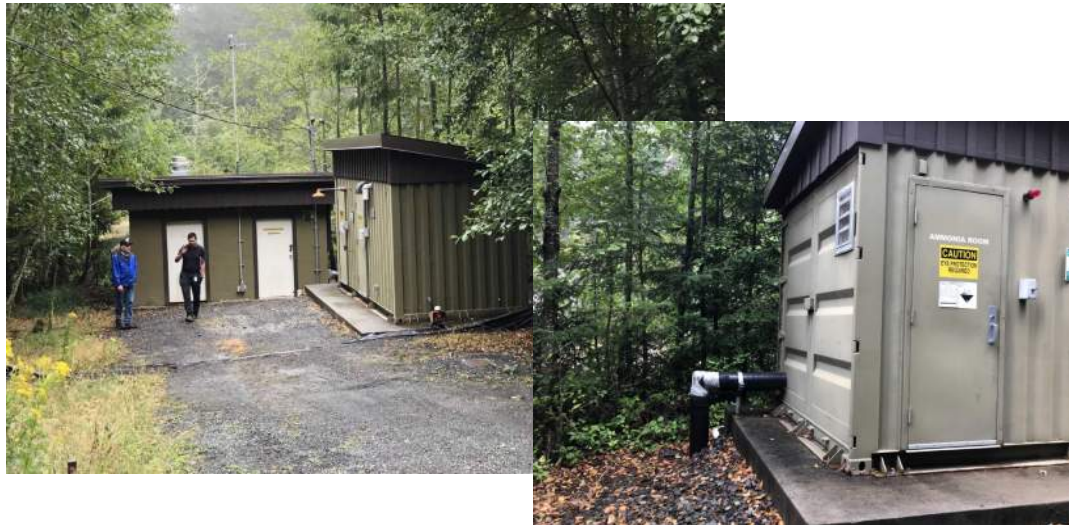
**Figure 2-2 Water Treatment Buildings: Filtration and UV Building (left) and Chloramination Building (right)**

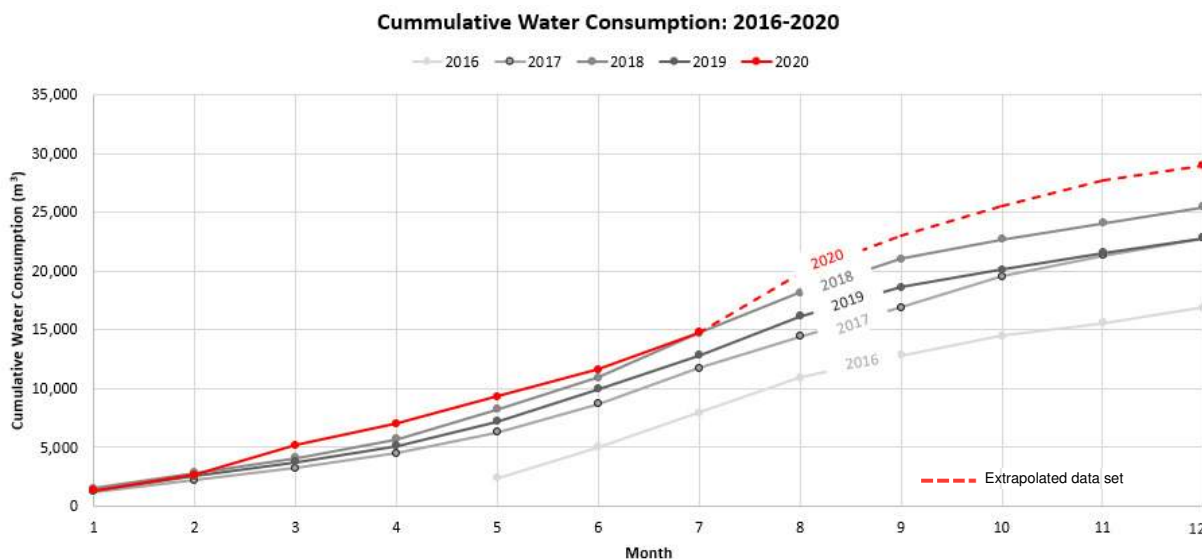
**Figure 2-4 Water Consumption for Mount Matheson Estates**

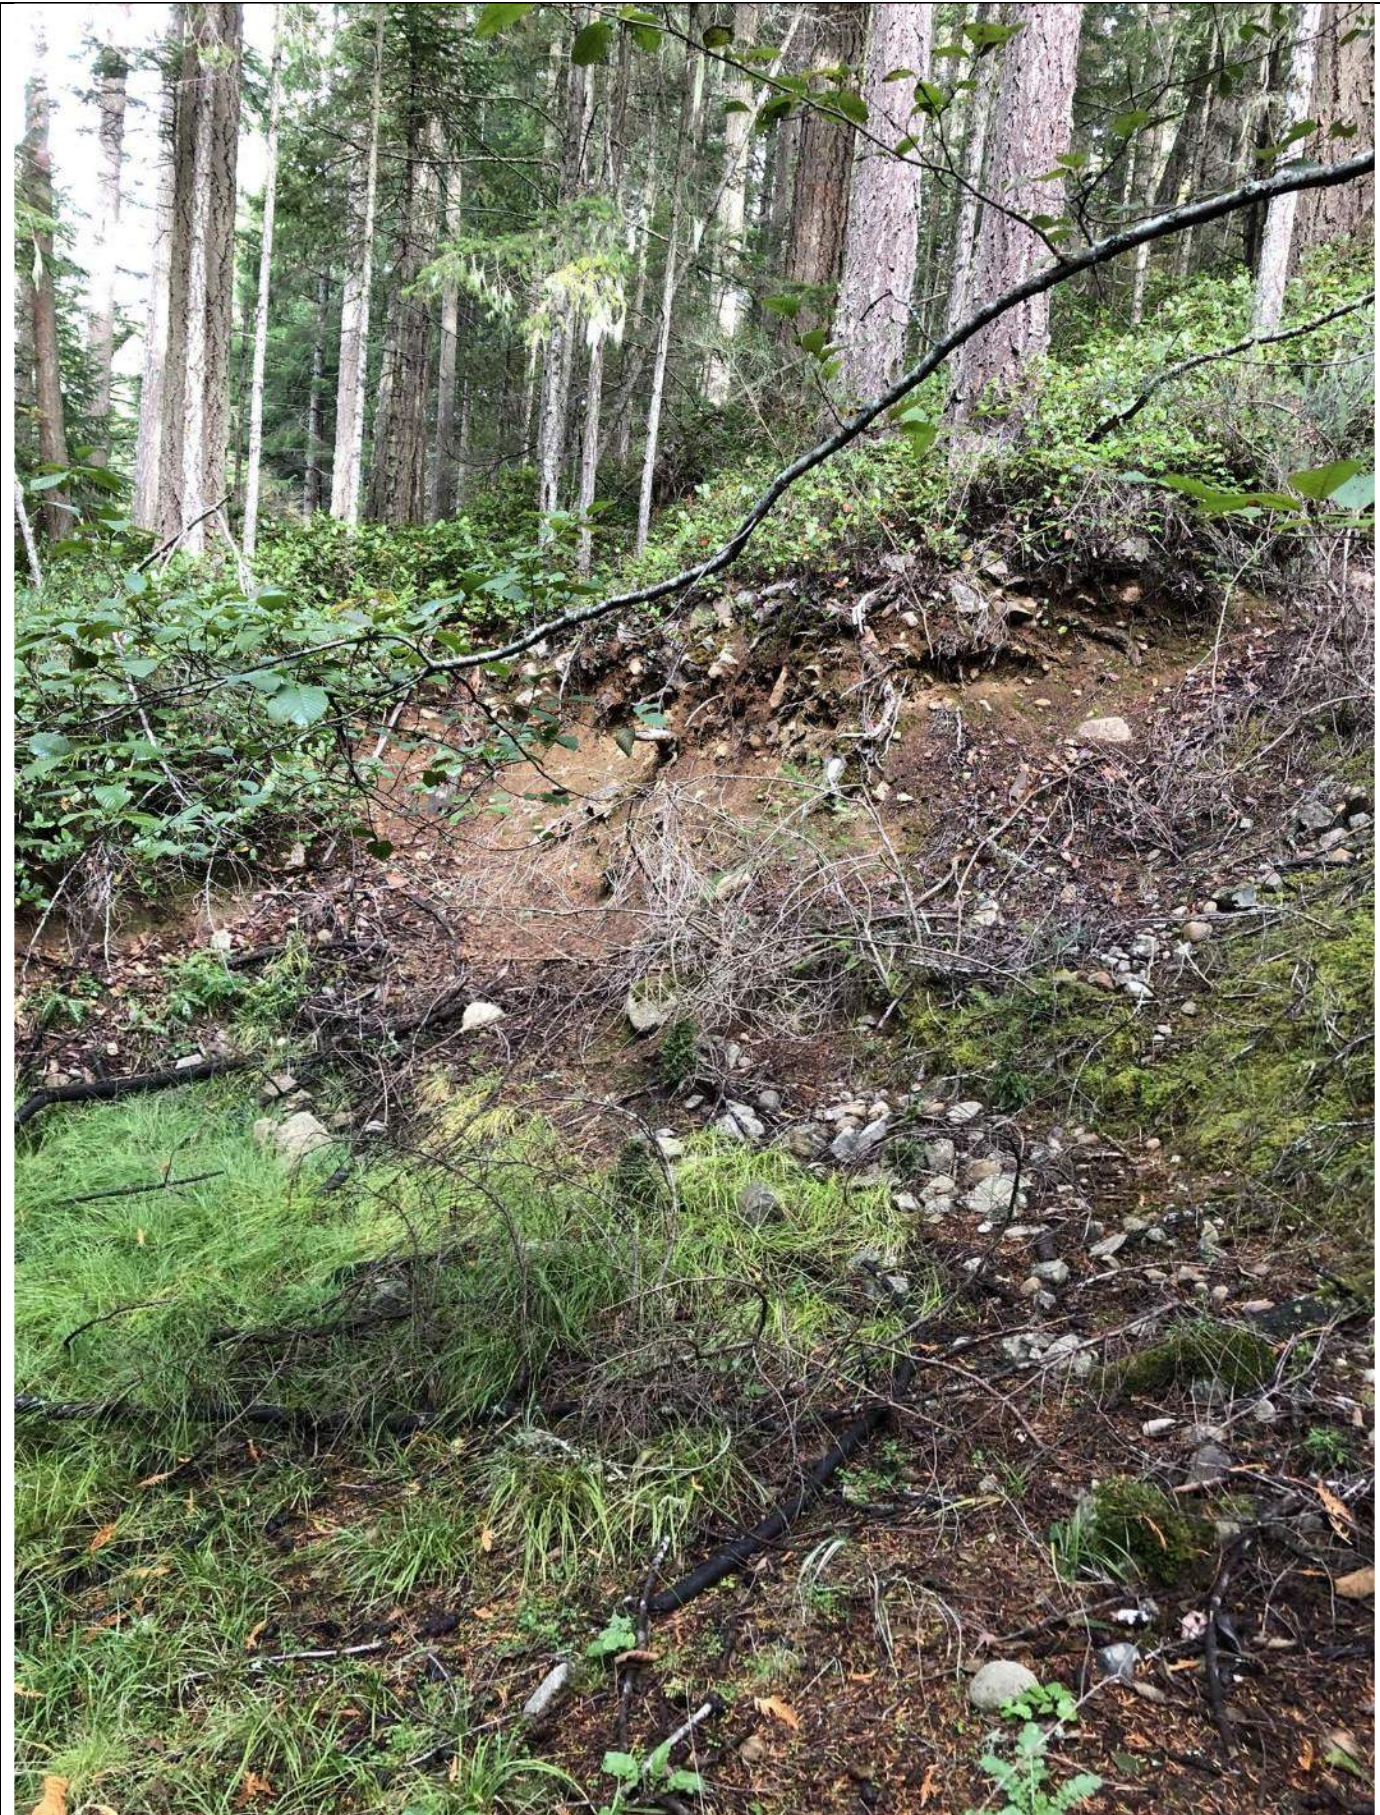
Photo 01: Sloughing and slope erosion near basin associated with ephemeral stream east of reservoir.

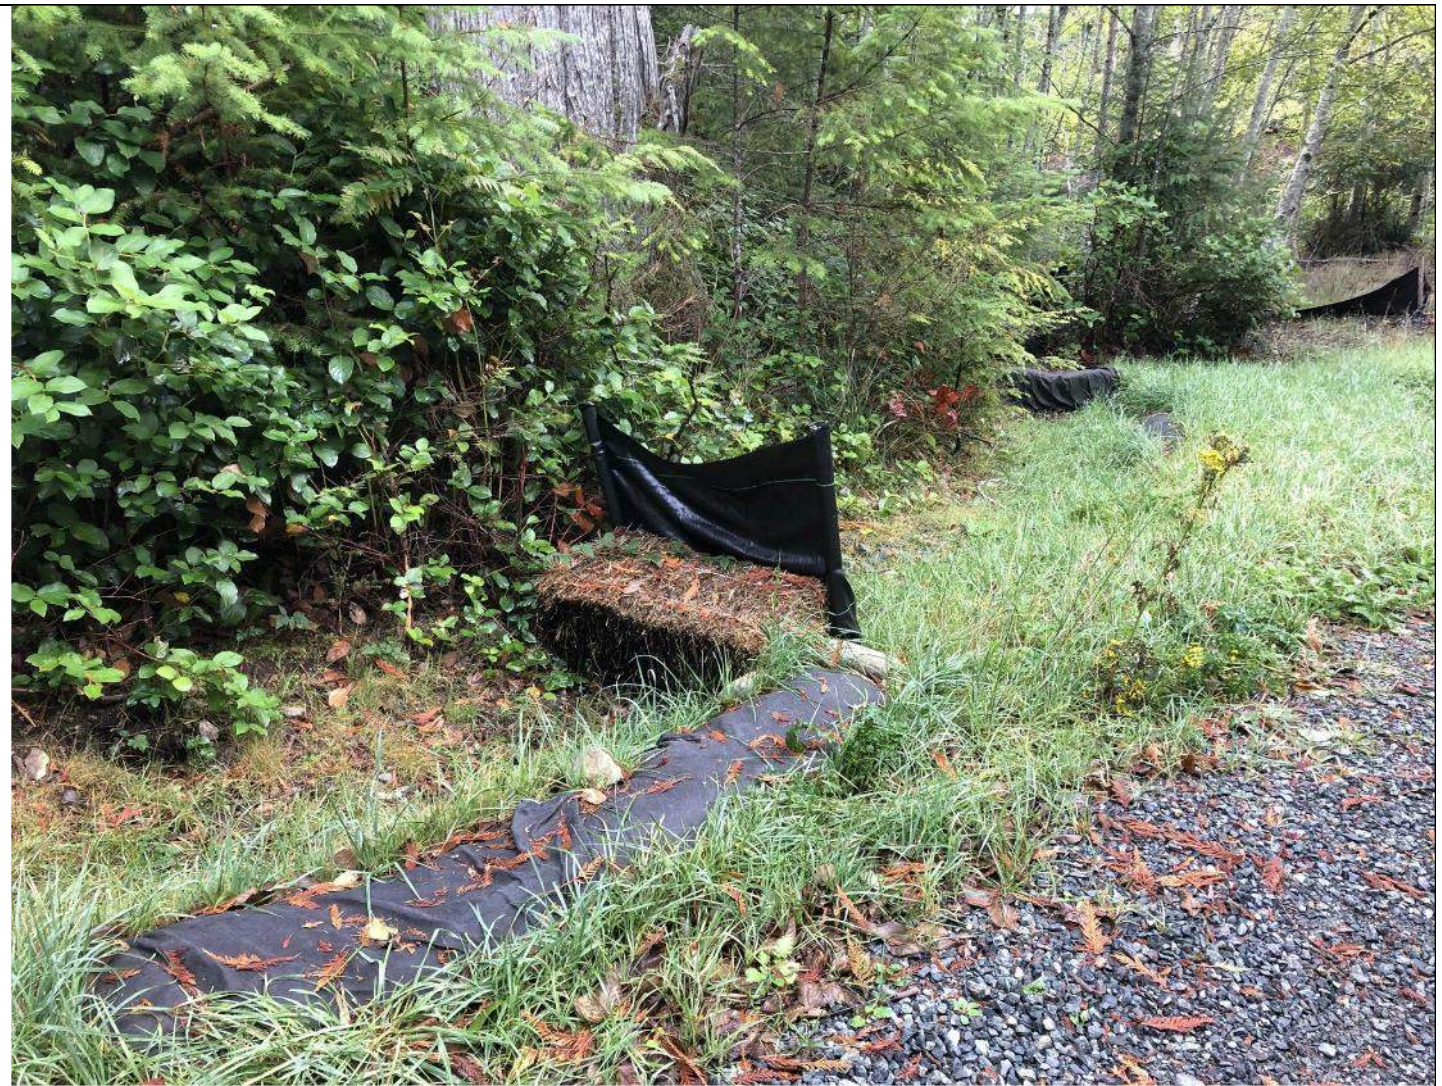
Photo 04: Straw bale check dams and silt fencing installed by the CRD in the southern ditch on the WTP access road to limit sediment transport into reservoir.

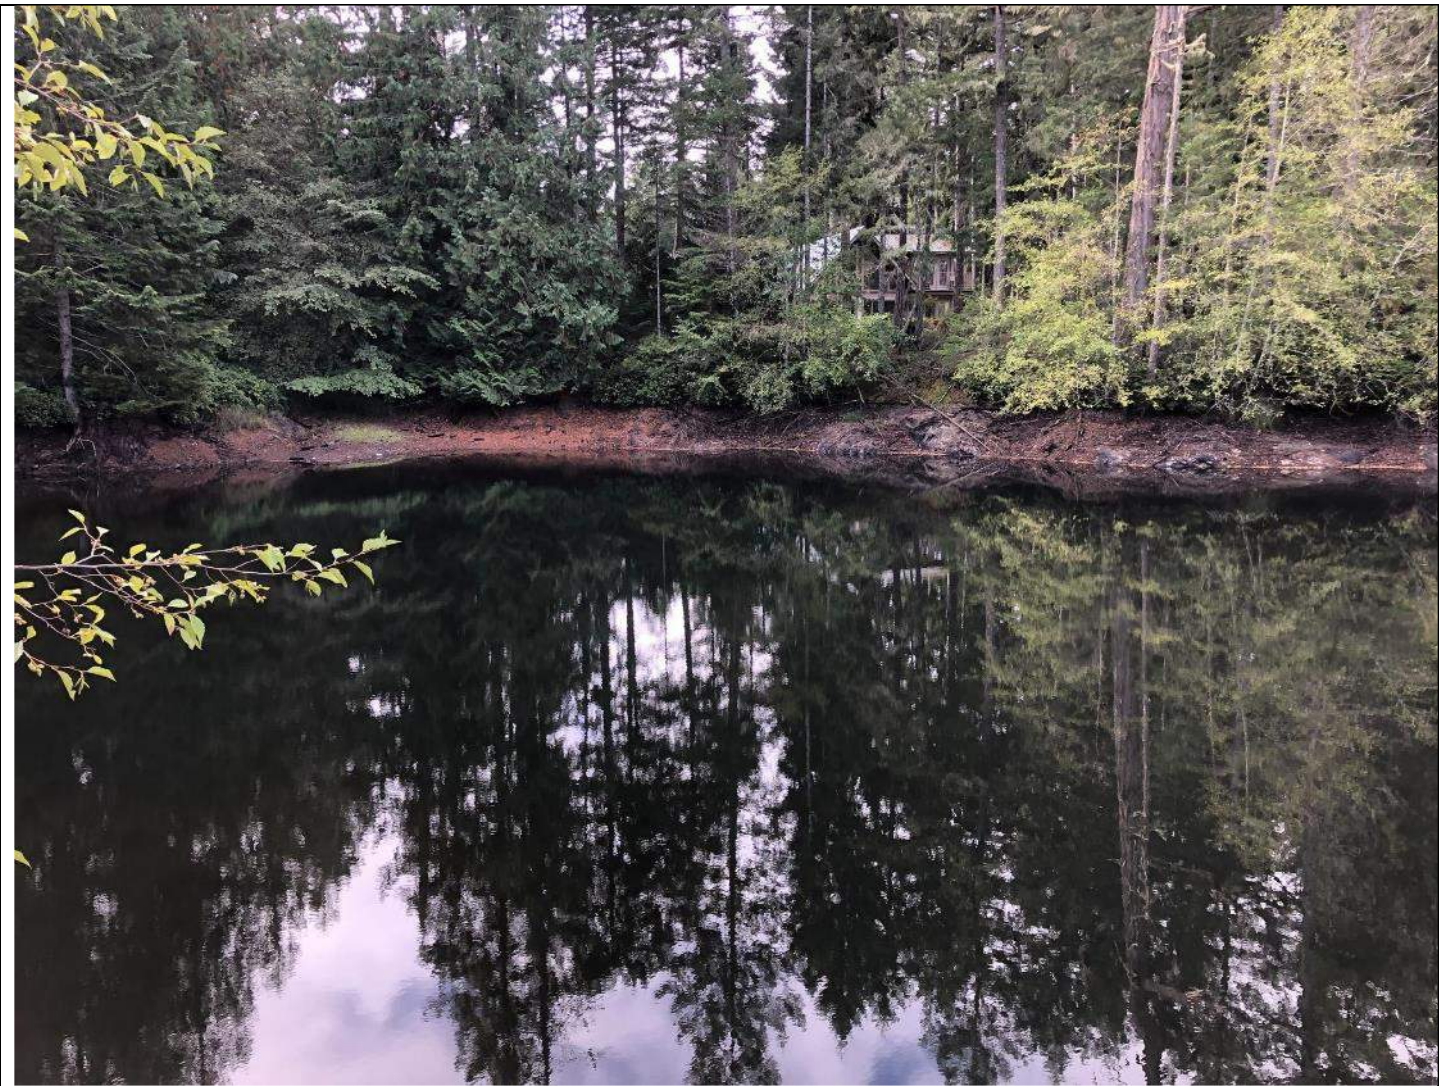
Photo 05: Looking southwest across reservoir from WTP. Deciduous vegetation can be seen overhanging the reservoir. Exposed soil can be seen near the waterline across from the WTP.

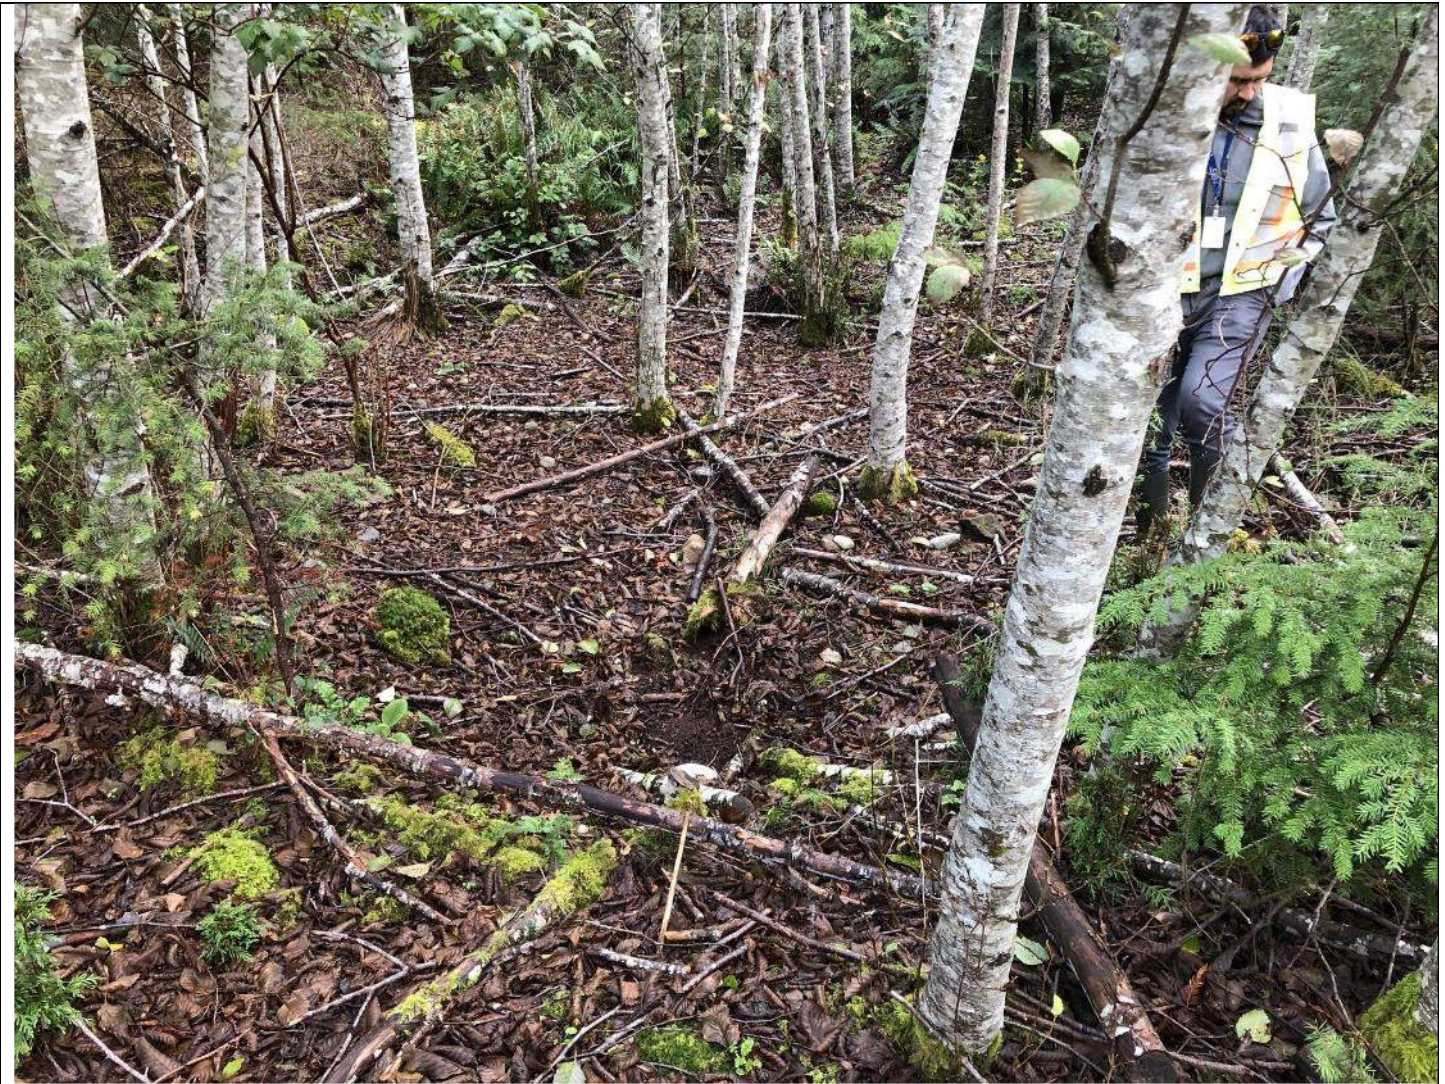
Photo 06: Depression (basin) in ephemeral stream near outlet to reservoir. Sediment and organic matter has accumulated in the basin. The basin outlet is a culvert constructed under an abandoned access road near the reservoir edge.

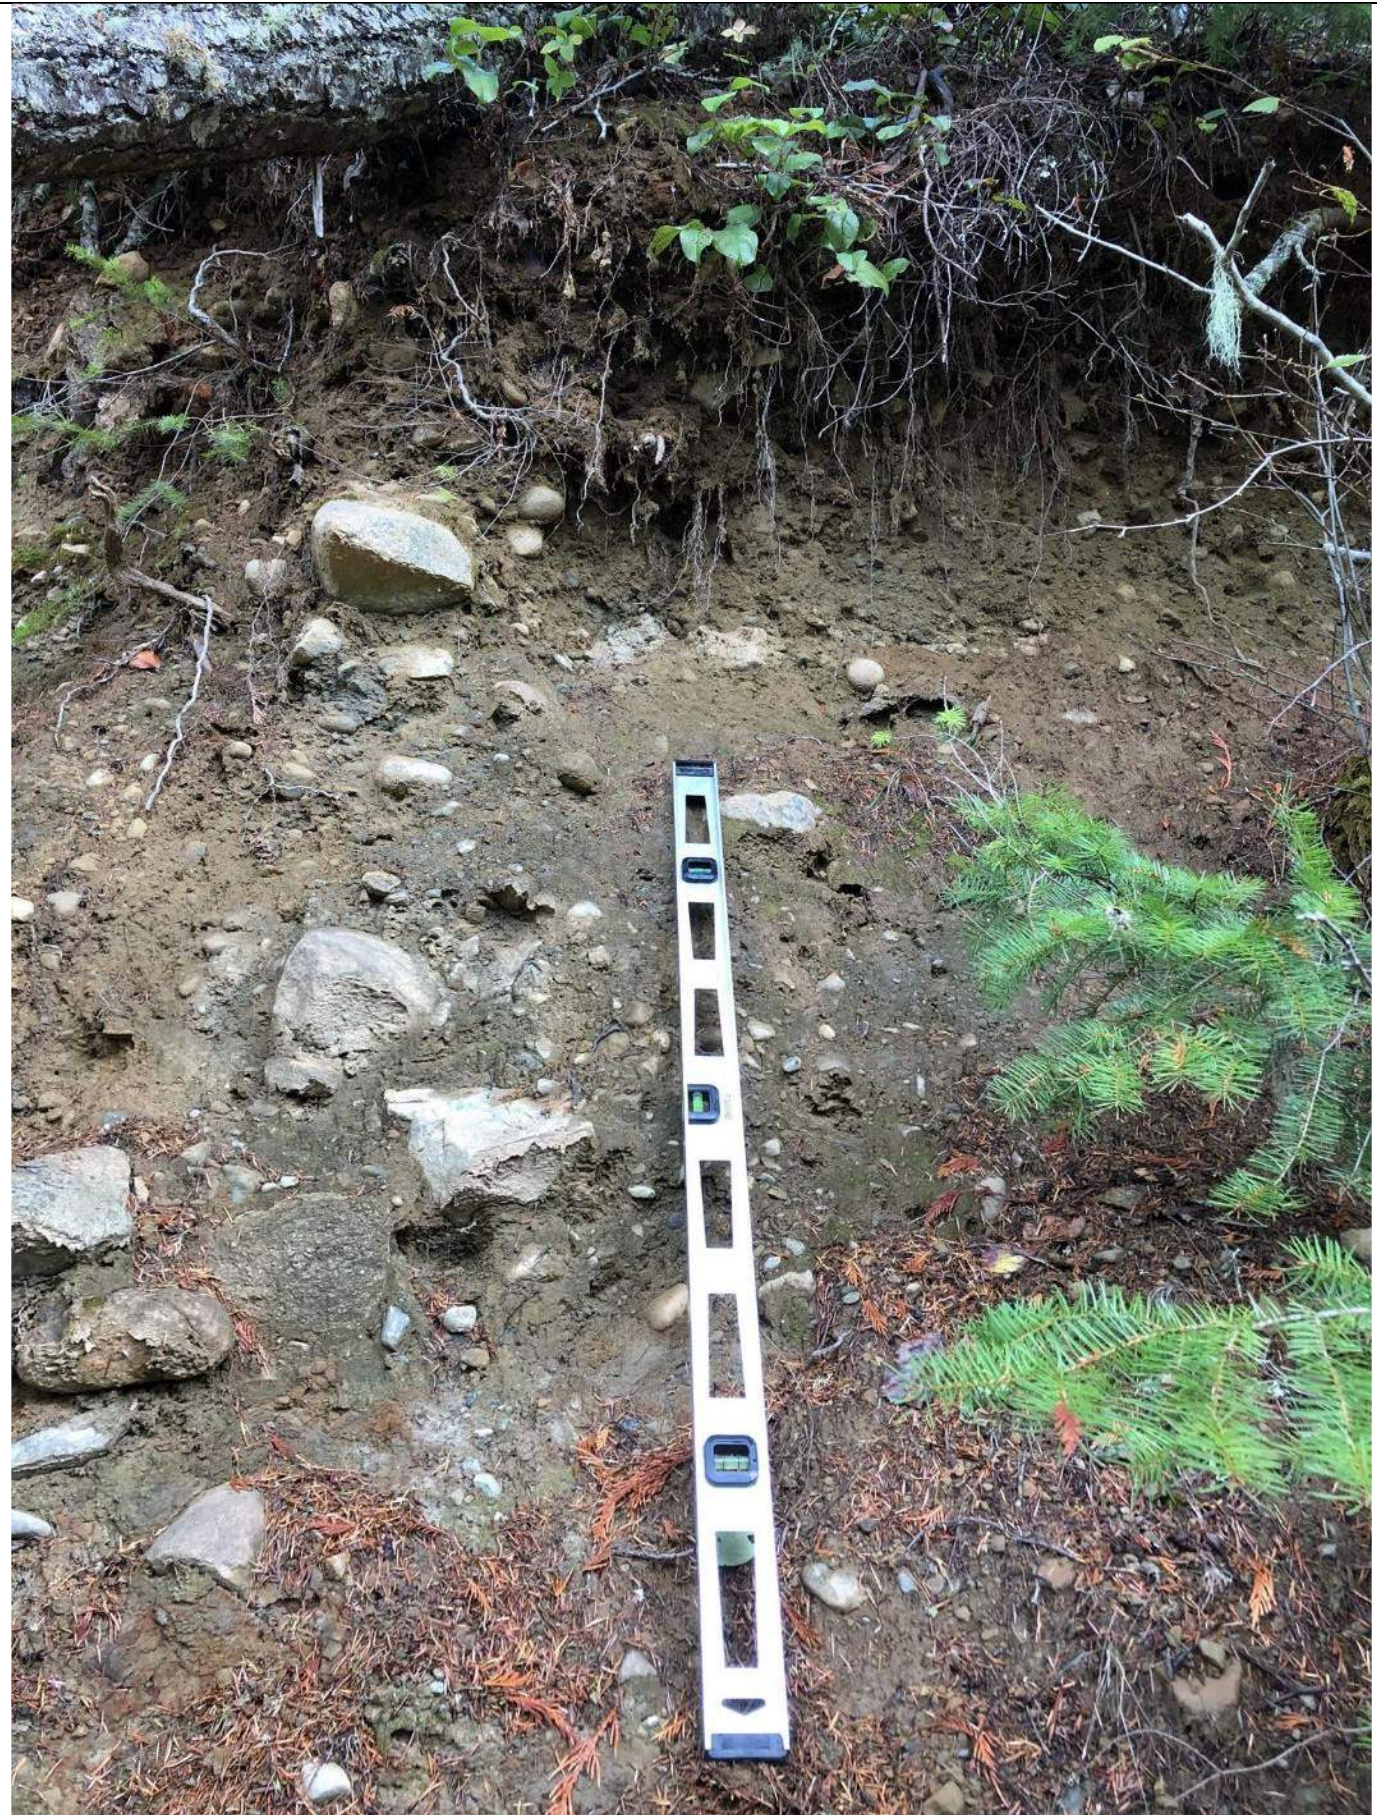
Photo 07: Sloughing/slope erosion observed just above the eastern waterline of the reservoir (Photo 1 of 2).

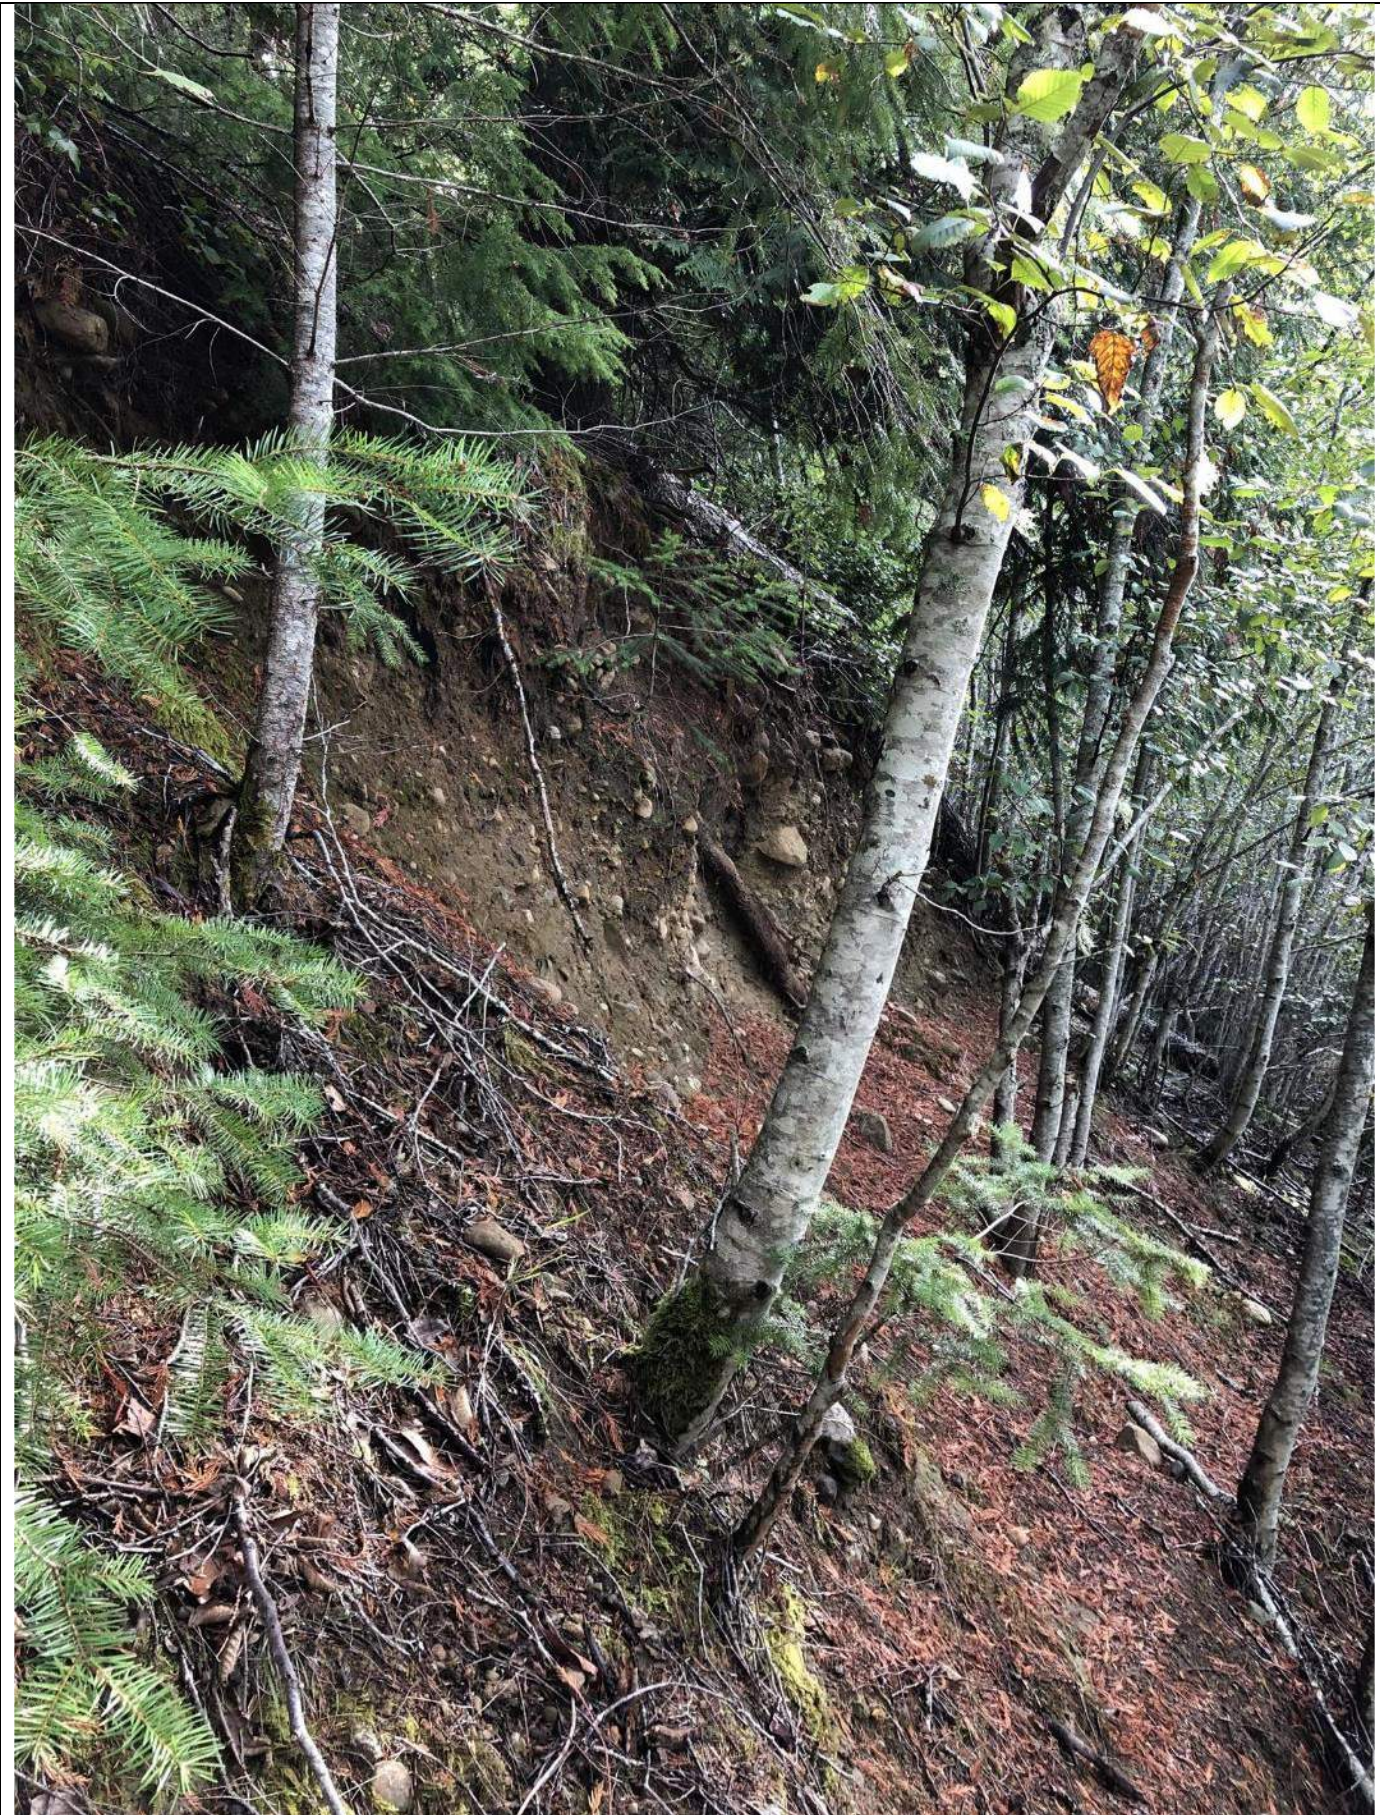
Photo 08: Sloughing/slope erosion observed just above the eastern waterline of the reservoir (Photo 2 of 2).

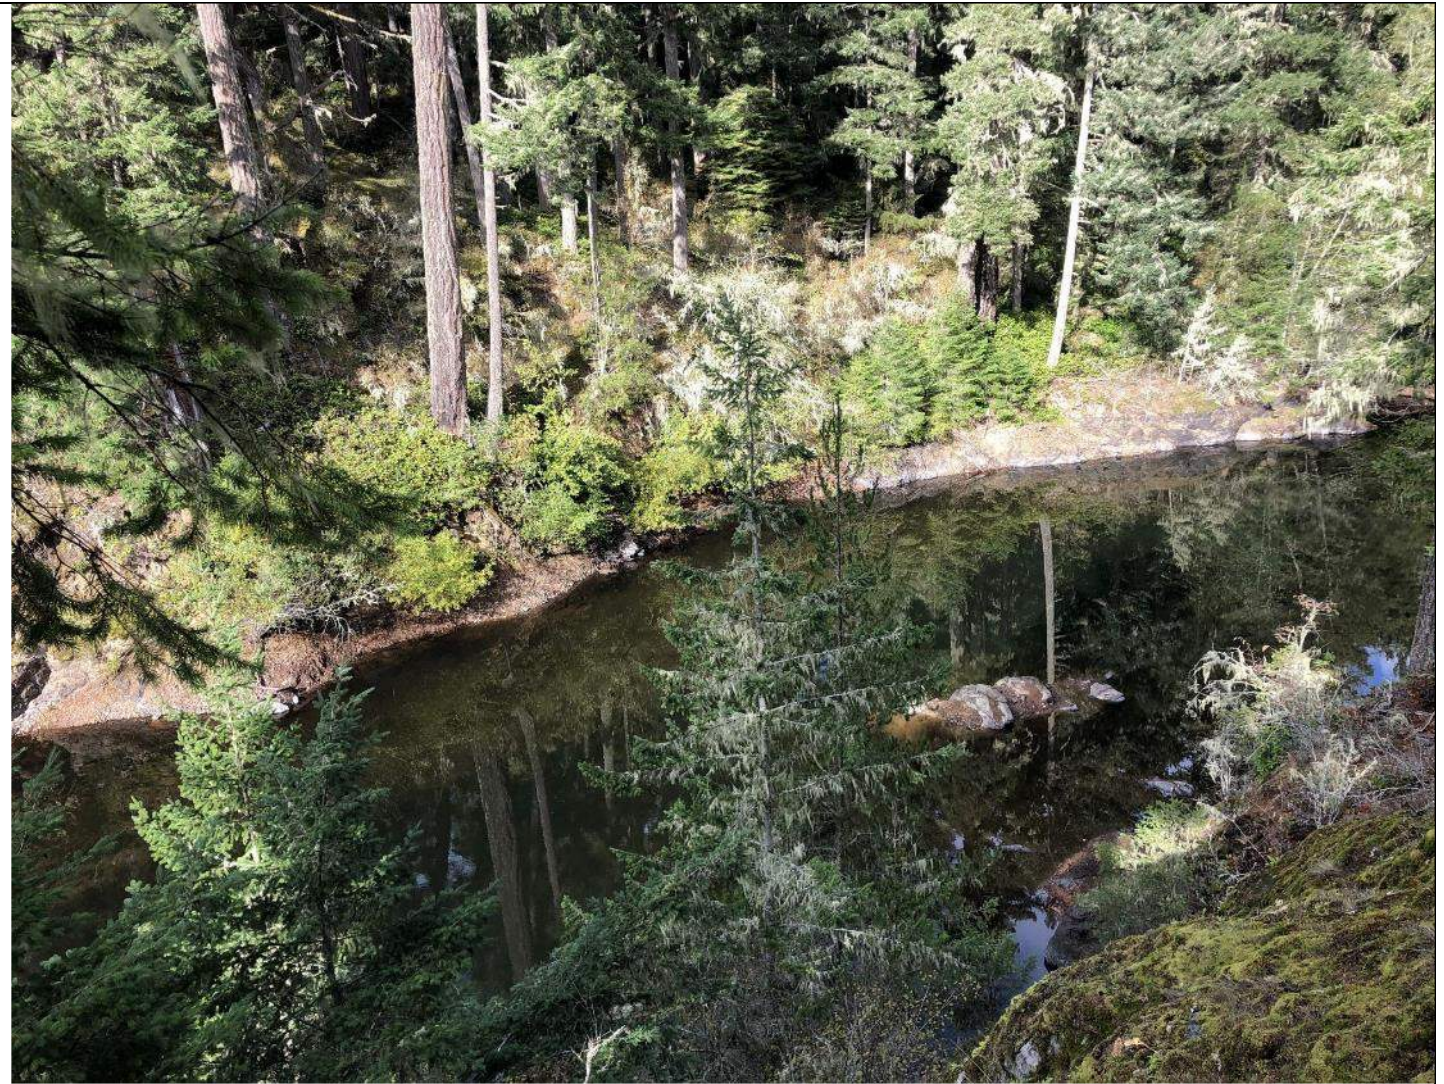
Photo 09: Loose soil near waterline just south of northern dam.
