BOWKER CREEK BLUEPRINT

A 100-year action plan to restore the Bowker Creek Watershed

August 2012
VICTORIA BC

Prepared by the Bowker Creek Initiative with support from
Westland Resource Group Inc., Kerr Wood Leidal Associates Ltd., and Murdoch de Greeff Inc.

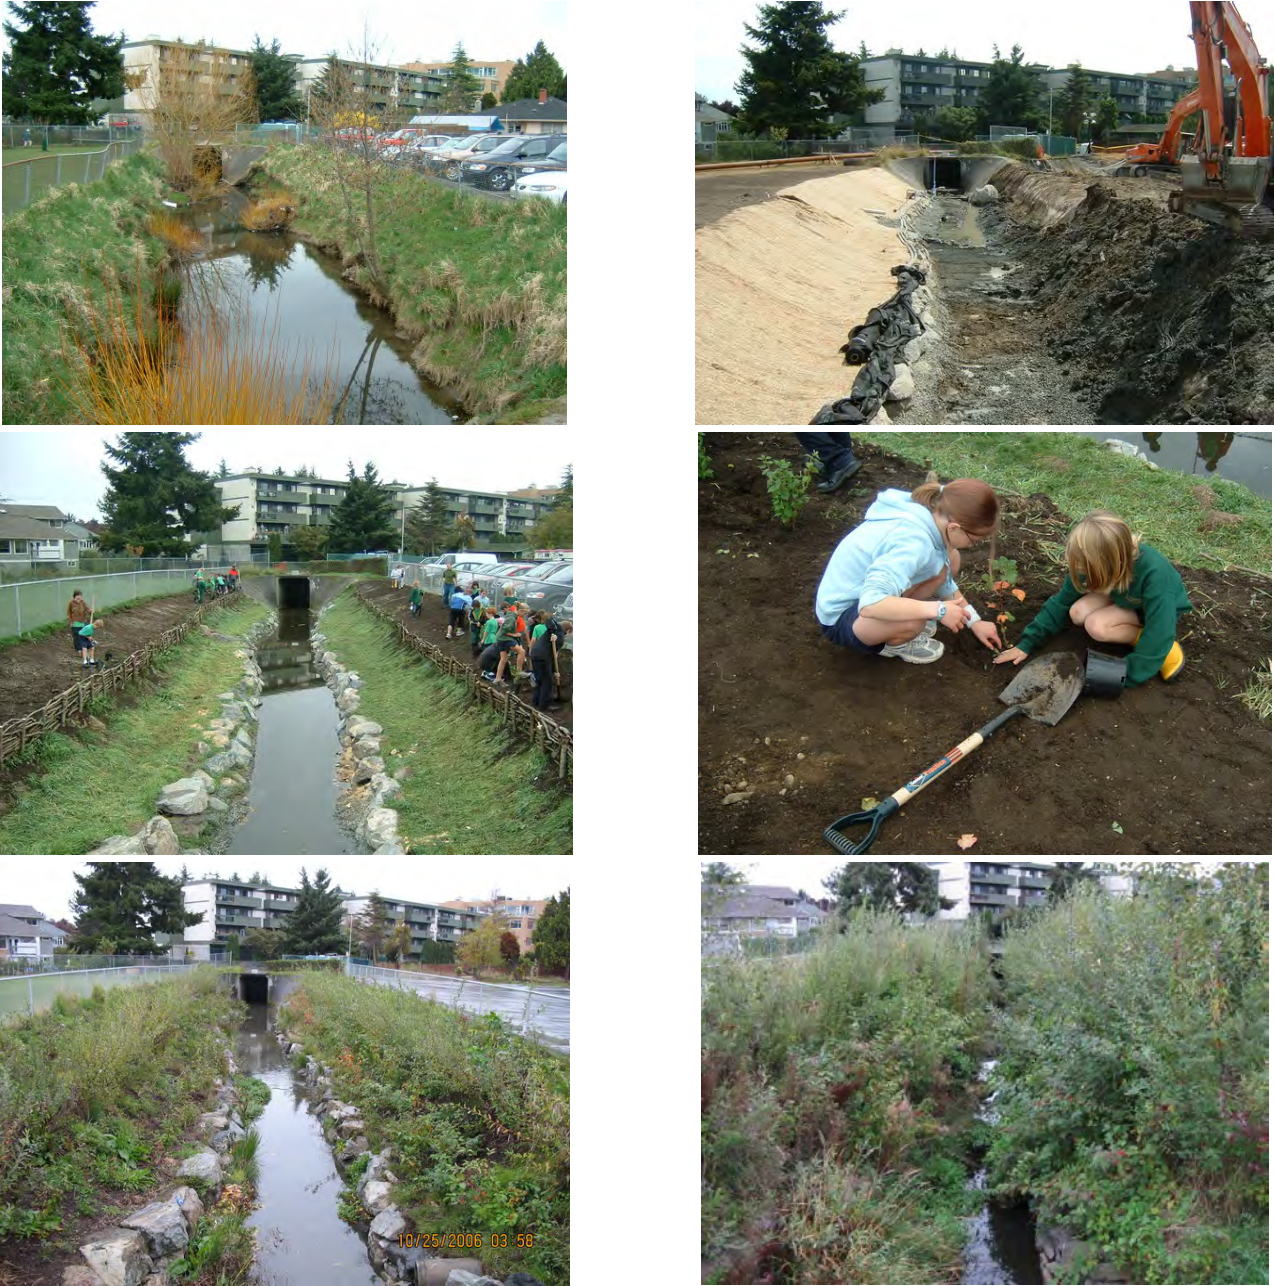
Figure 7. A demonstration restoration project at St. Patrick’s Elementary School. Before, during and after photographs. The project was completed in 2005. Final pictures were taken in 2008.

In general, restoration of above-ground sections would require widening the creek corridor to create more gradually sloped banks and an expanded riparian area, as well as the removal of invasive plant species and planting of native trees and shrubs. A widened creek corridor with gradual banks will expand the floodplain and reduce flooding in surrounding areas. If space is available, the creek channel can be made more sinuous to approximate its former pattern. Detailed restoration designs would be based on the available land and the ongoing land uses. Greenways (public paths for walking and in some cases cycling) should be incorporated wherever possible (Map 5). Figure 7 shows one major demonstration restoration project undertaken to date.

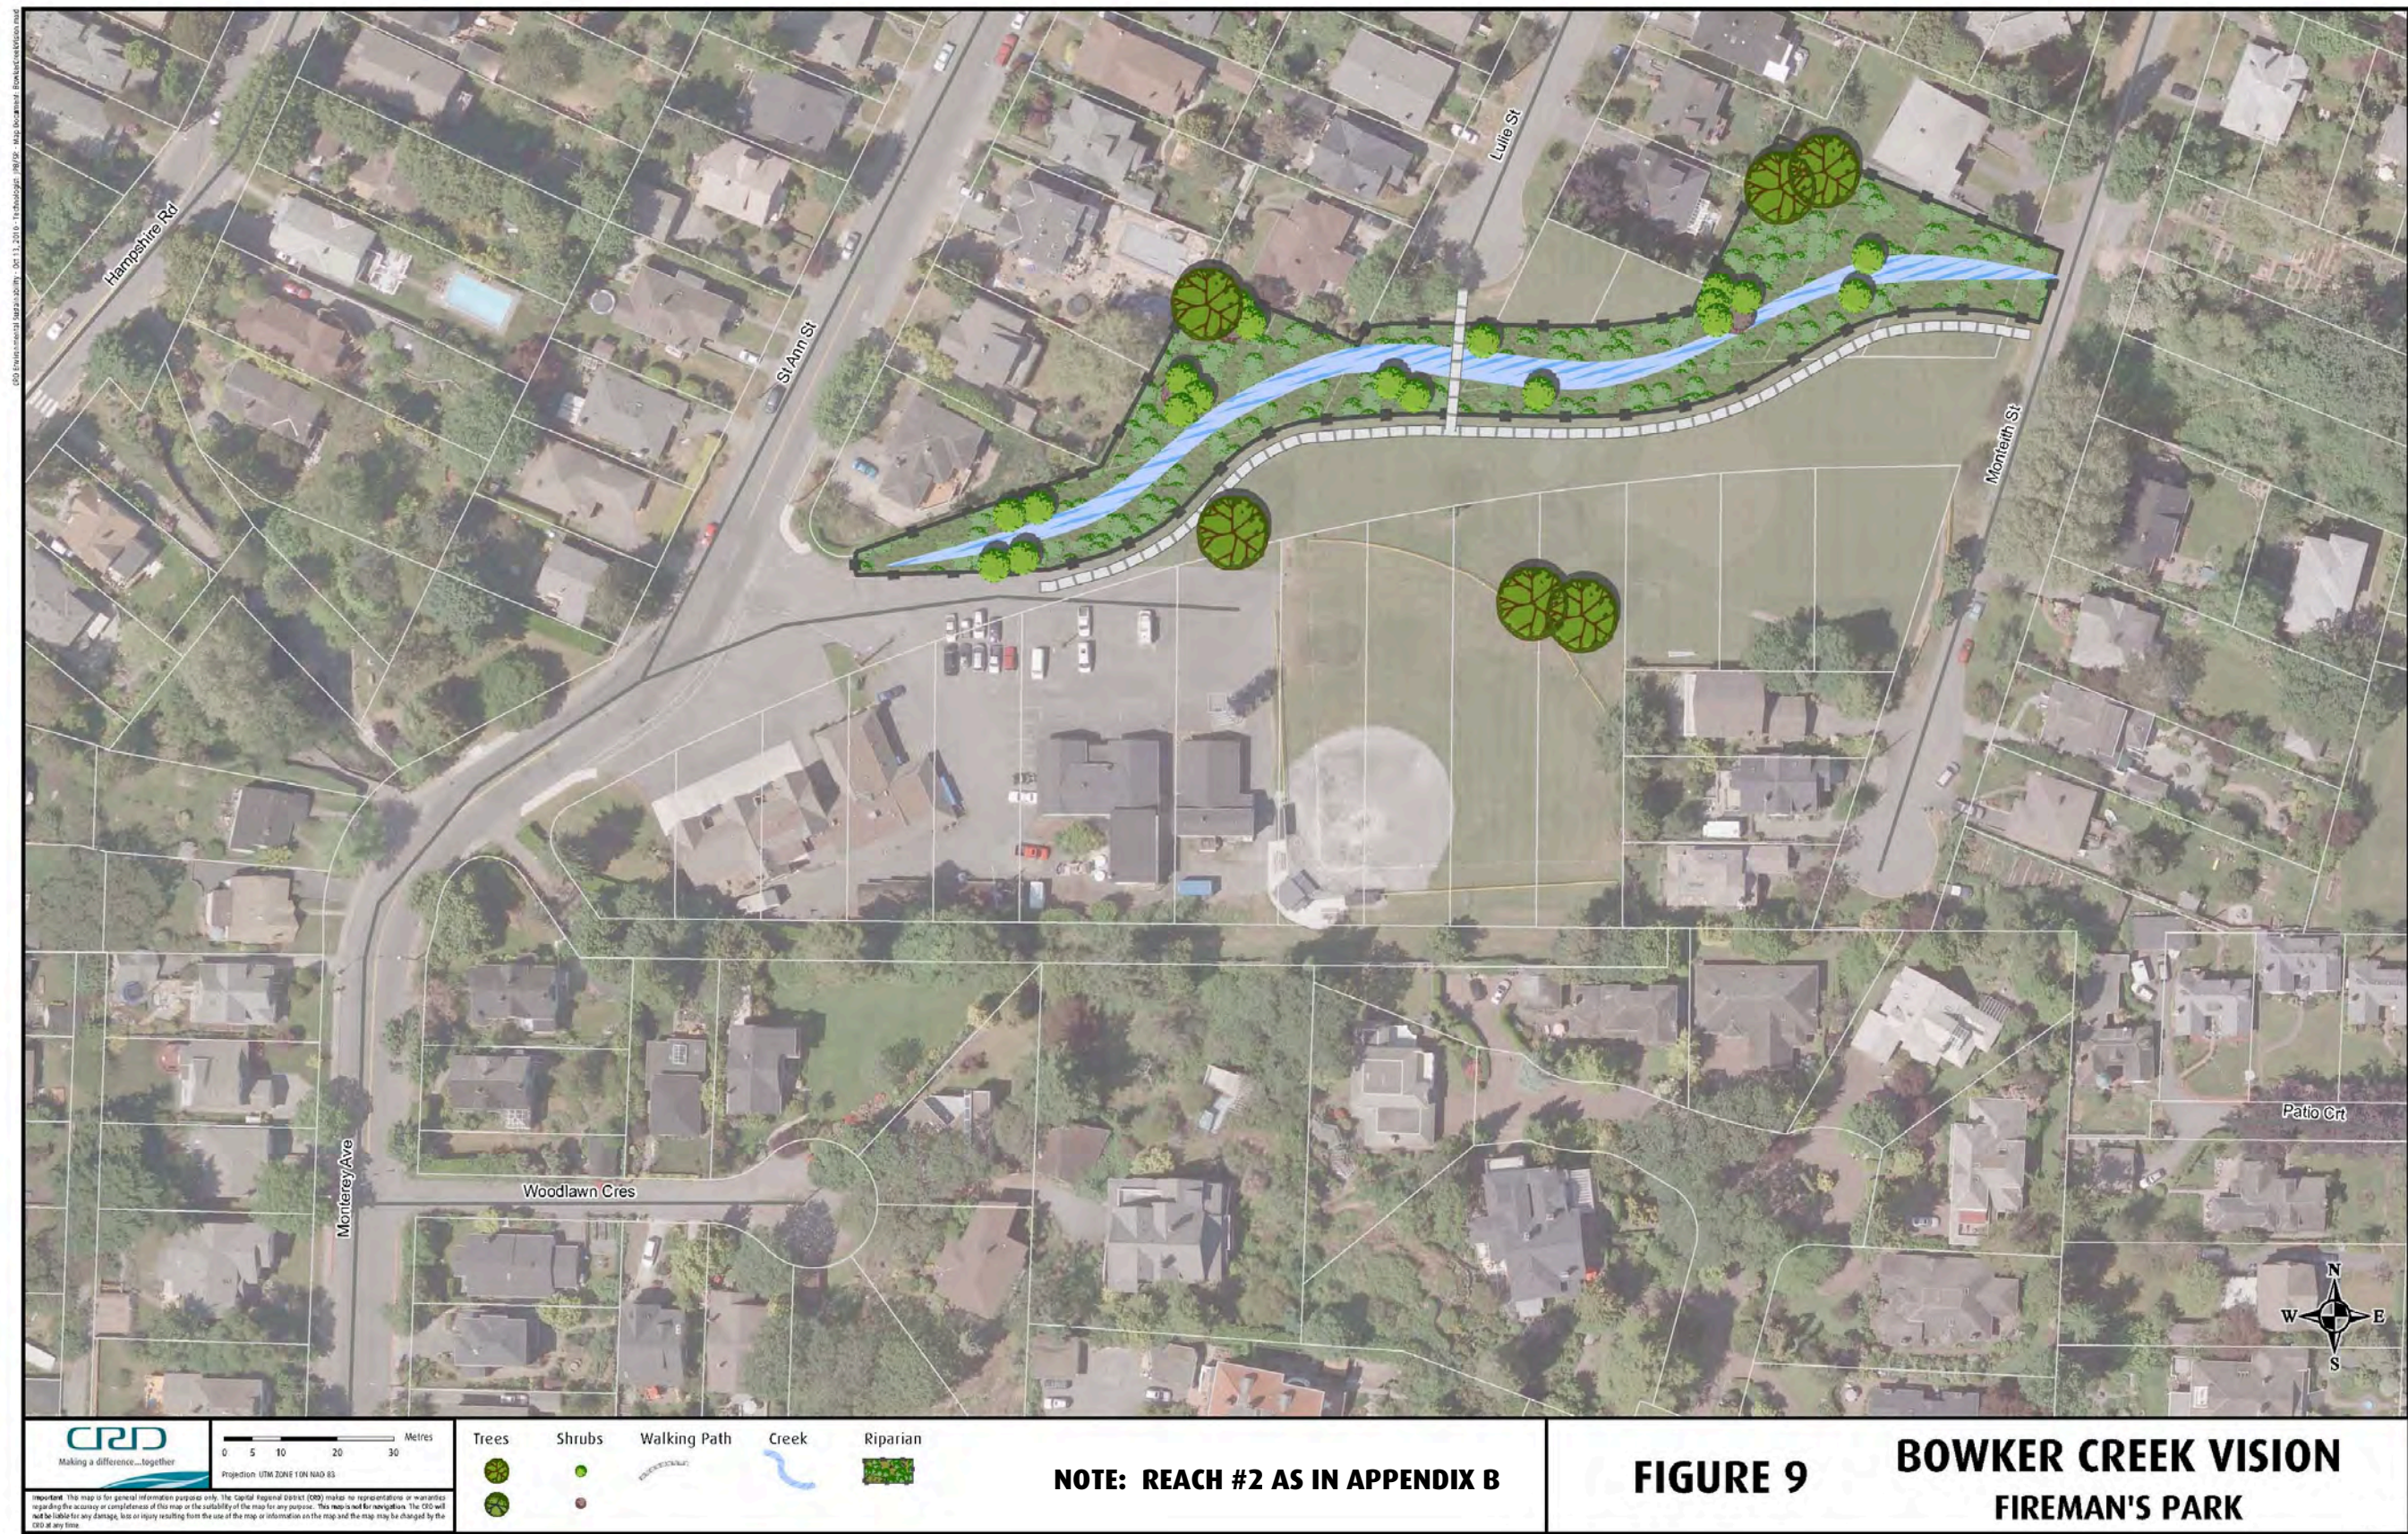
Figure 9. A Possible Long-Term Vision for Fireman’s Park in Oak Bay (Reach 2)

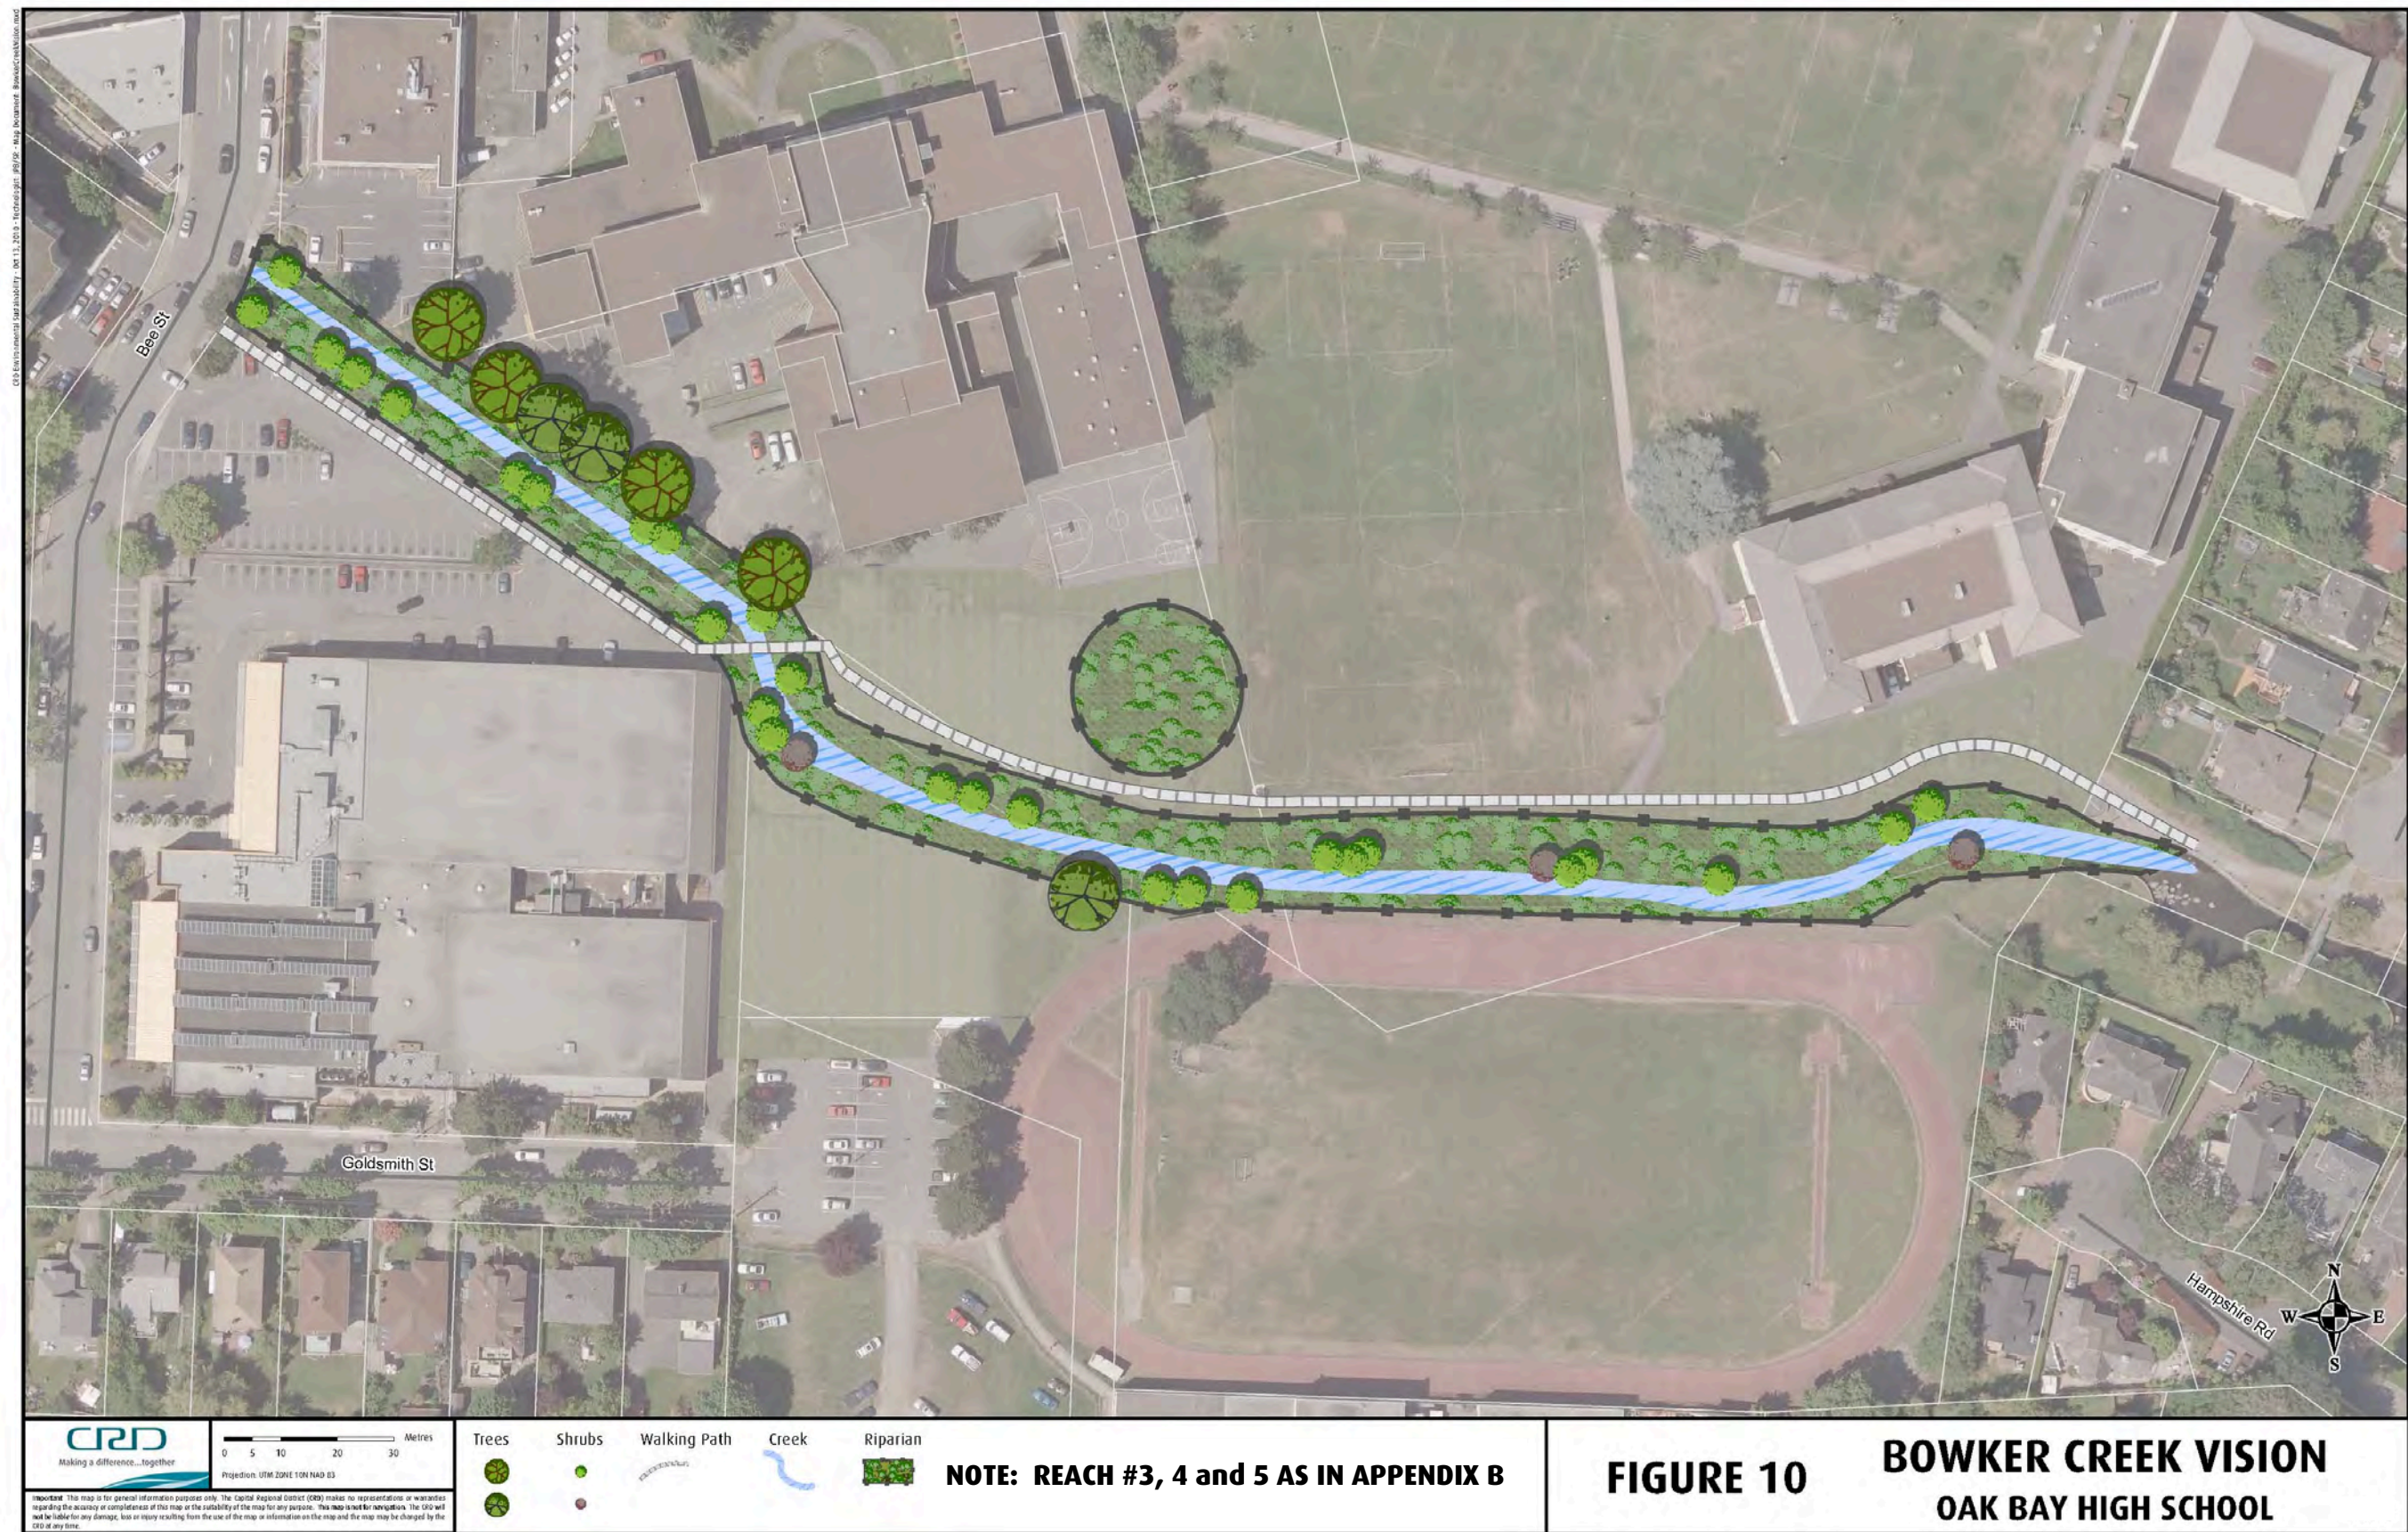
Figure 10. A Possible Long-Term Vision for Oak Bay High and Oak Bay Recreation Centre (Reaches 3, 4 & 5)

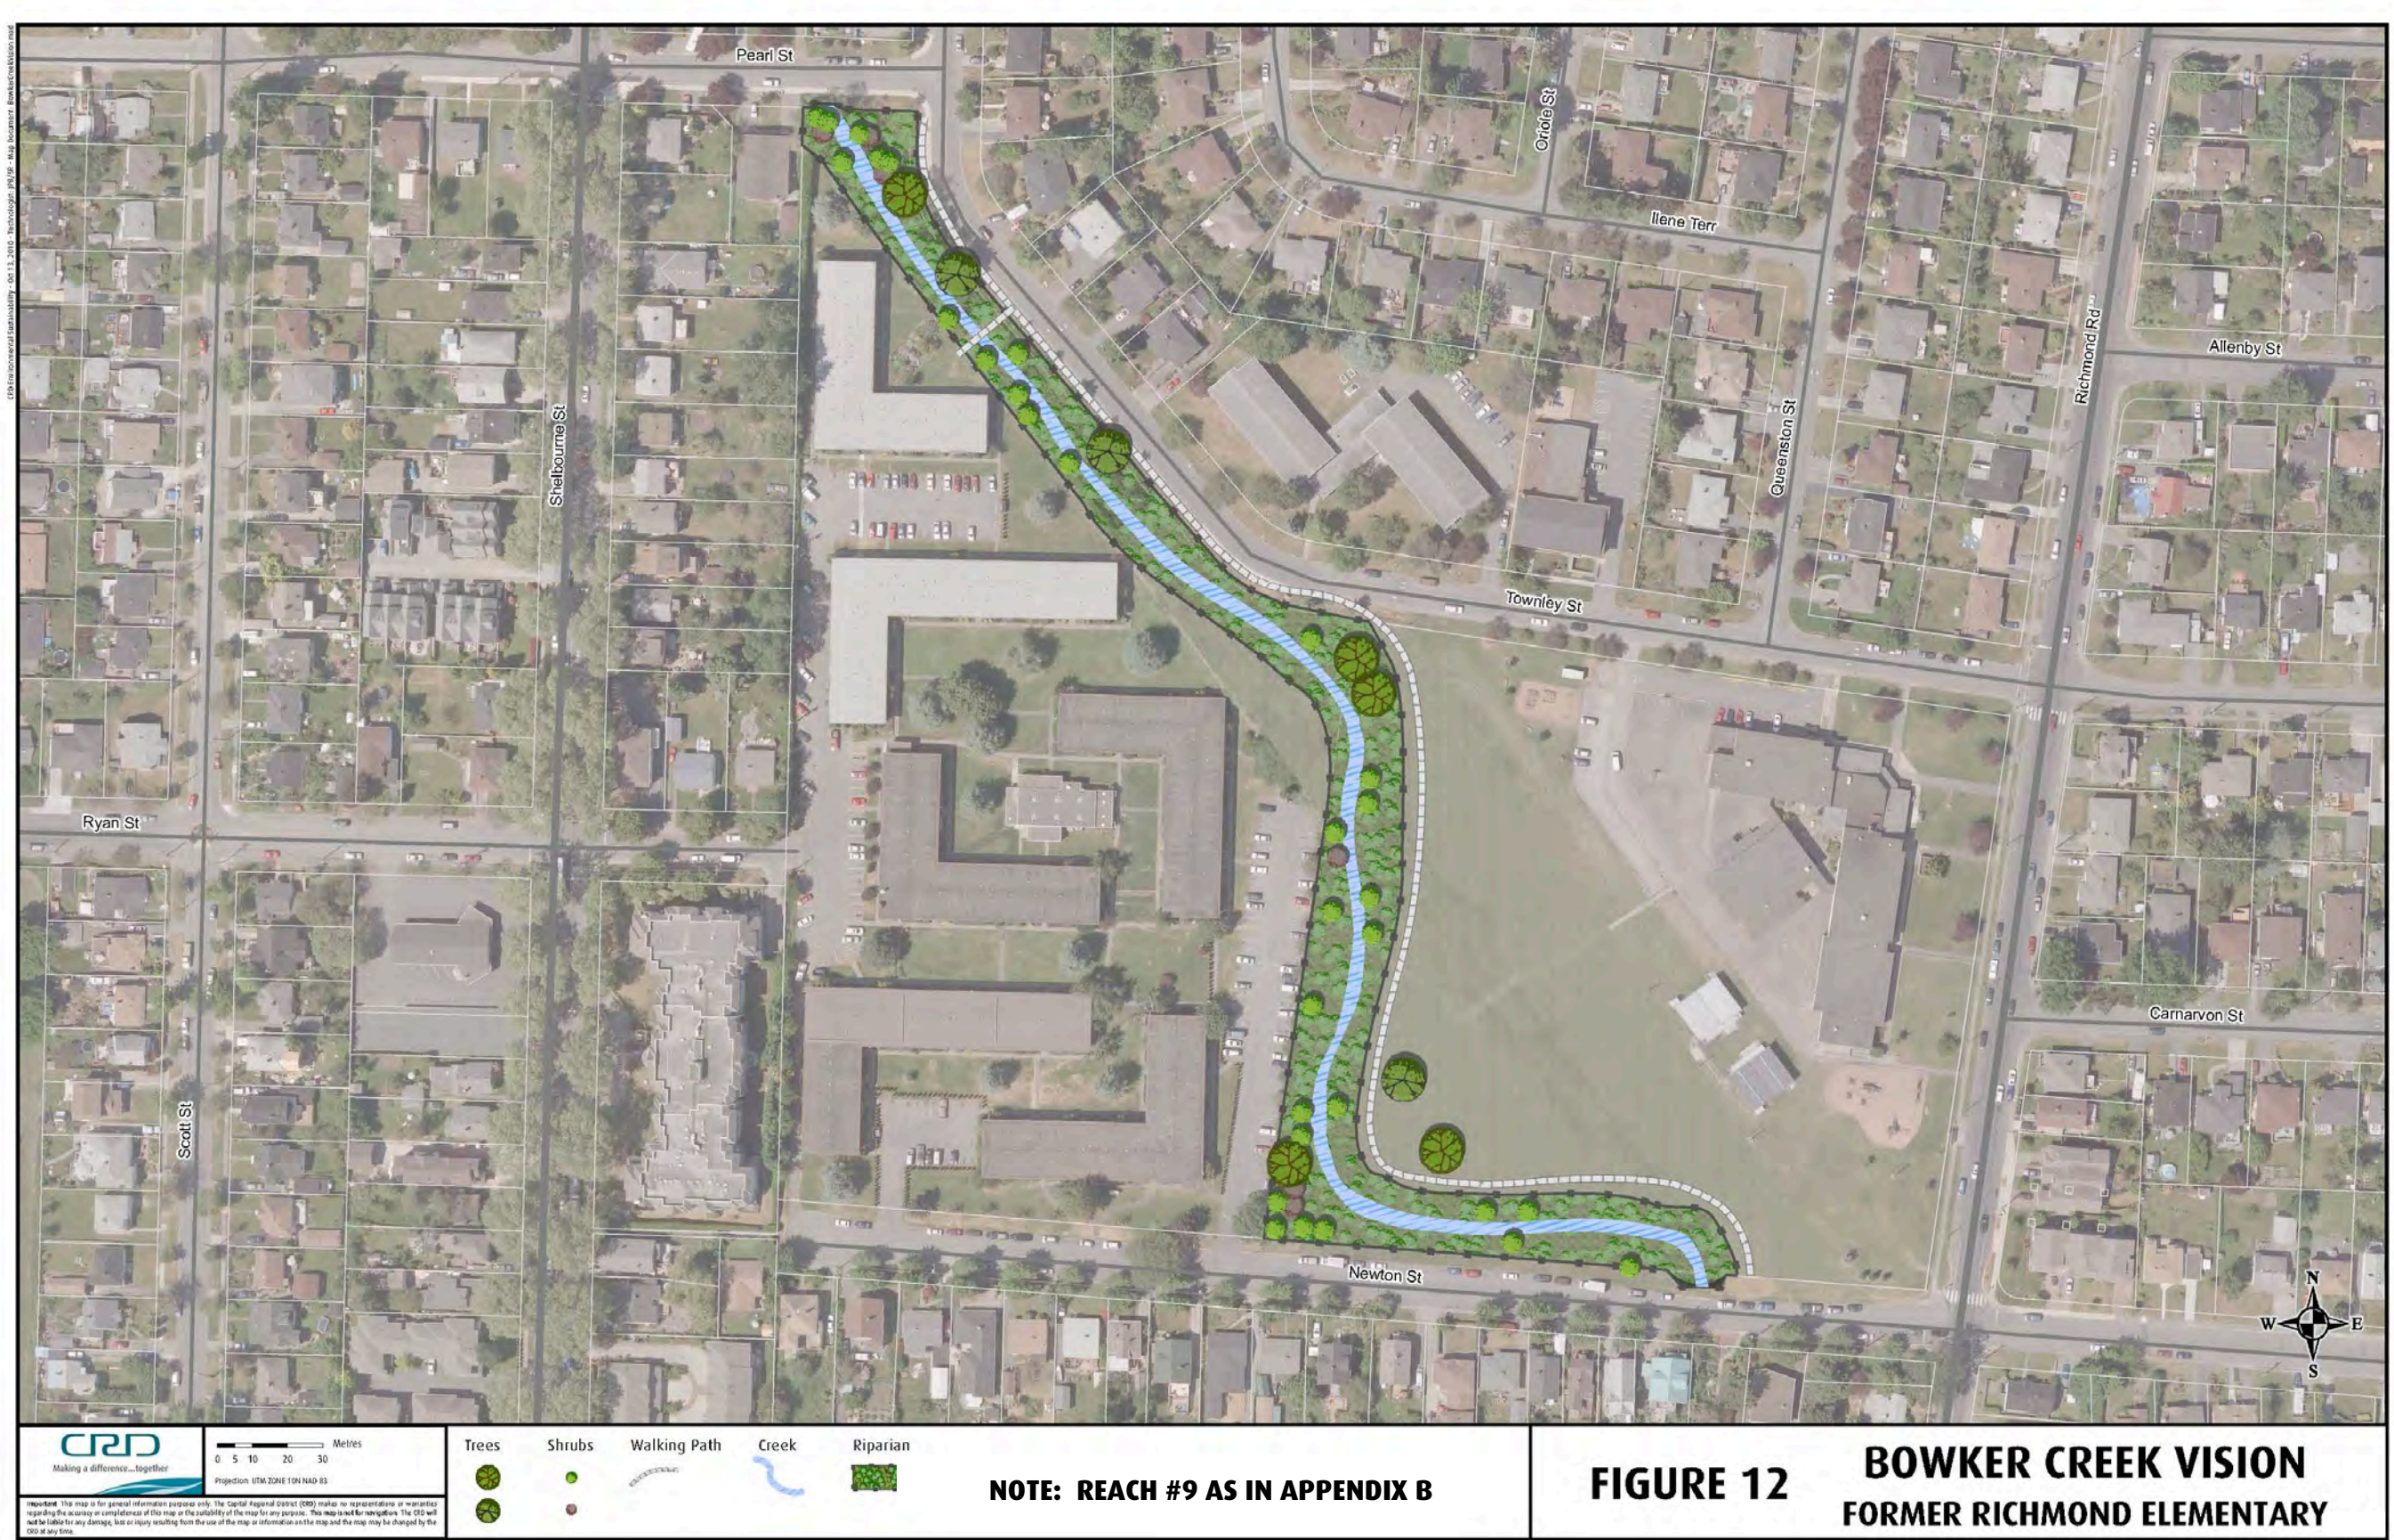
Figure 12. A possible long-term vision for the former Richmond Elementary School location (Reach 9)
(Note that the creek no longer bisects the property.)

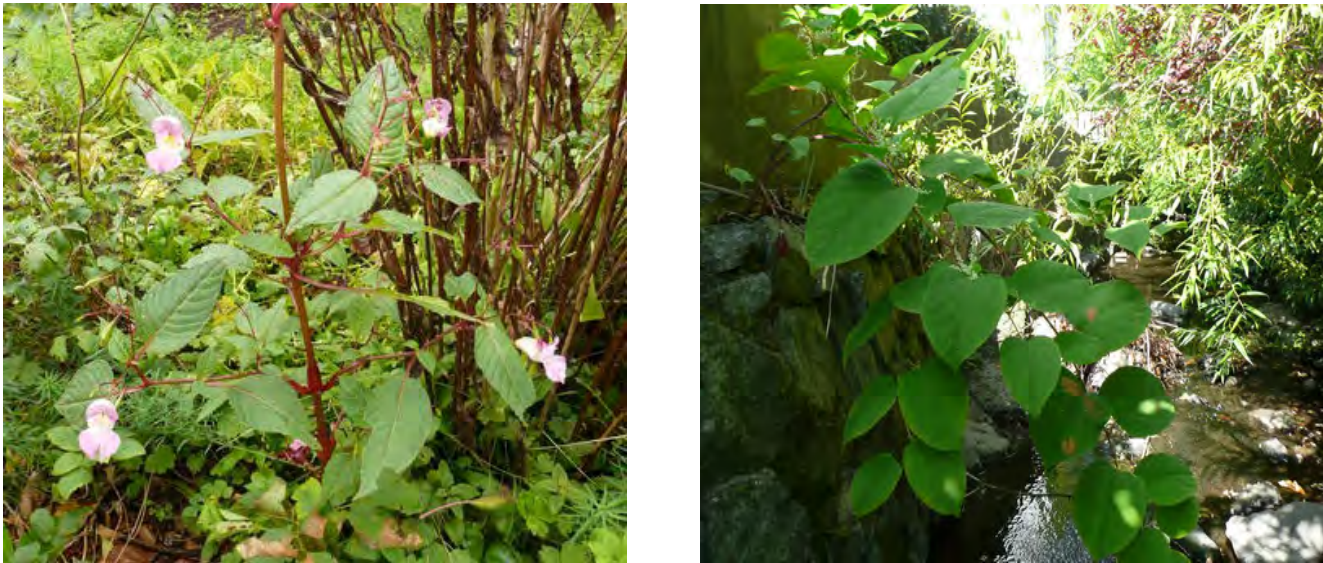
Figure 13. Policeman’s helmet (left) and invasive knotweed (right)
These two problematic invasive species (*Impatiens glandulifera* and *Polygonum spp.*, respectively) getting established in the watershed should be eradicated before they spread.

Invasive species are an issue throughout the watershed, as they displace native species that provide important ecosystem functions. Bowker Creek is lined with invasive species, particularly blackberry, ivy and yellow willow, and removing all invasive species in the watershed would be a daunting task. However there are two species: invasive knotweed (*Polygonum spp.*) and policeman’s helmet (*Impatiens glandulifera*) that should be removed before they become widely established (Figure 13). This effort should include outreach to residents regarding removing these from private property, as well as targeted removal efforts by municipalities in known locations along the creek corridor. To date, all known occurrences along the creek corridor are found in the District of Oak Bay east of Oak Bay High School.

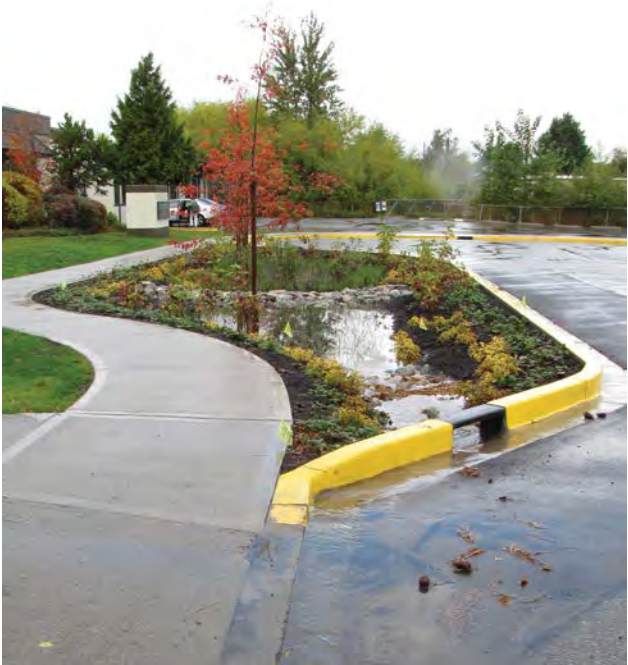
Figure 14. Trent Street Rain Garden, City of Victoria
Photo Credit: Murdoch de Greeff Inc.

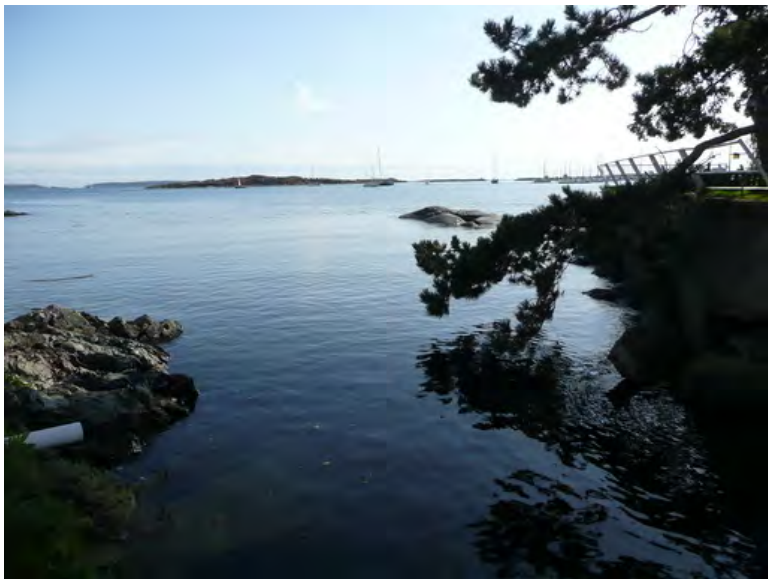
The creek mouth where it discharges to the ocean

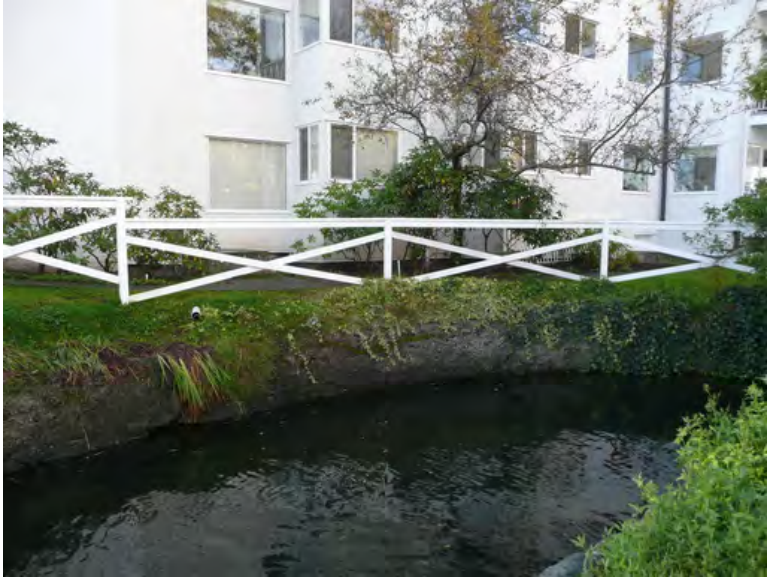
View of the rock wall showing proximity of the apartment building to the creek

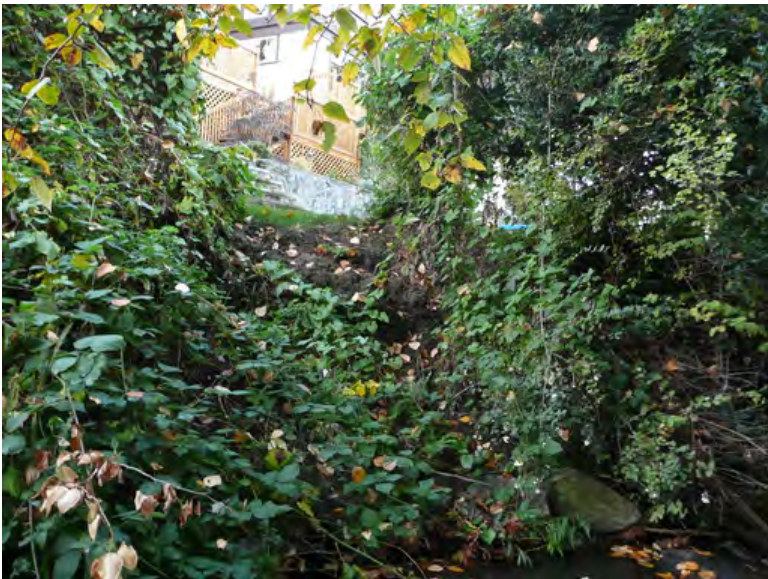
South-west corner of the Kachan property. Much of this corner has eroded away in recent years.

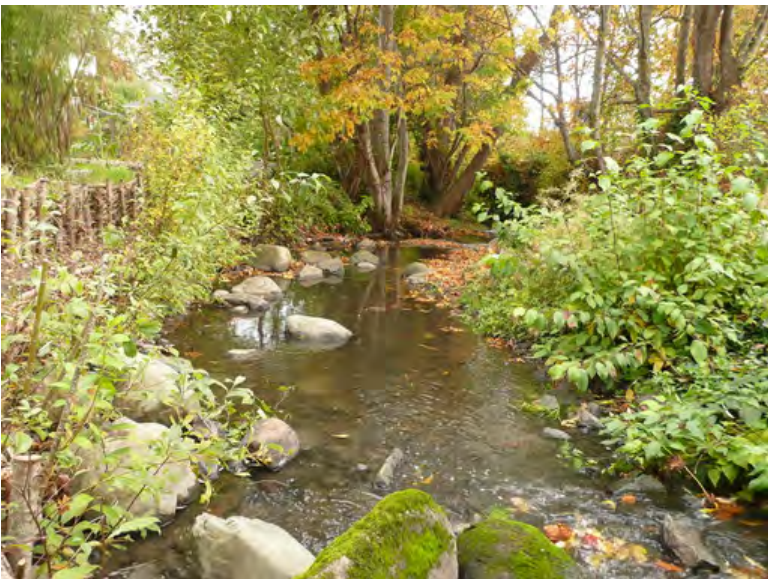
Downstream view of Reach 1 showing bioengineering on the left and a relatively new 'bar' in centre, created by an artificially dug channel.

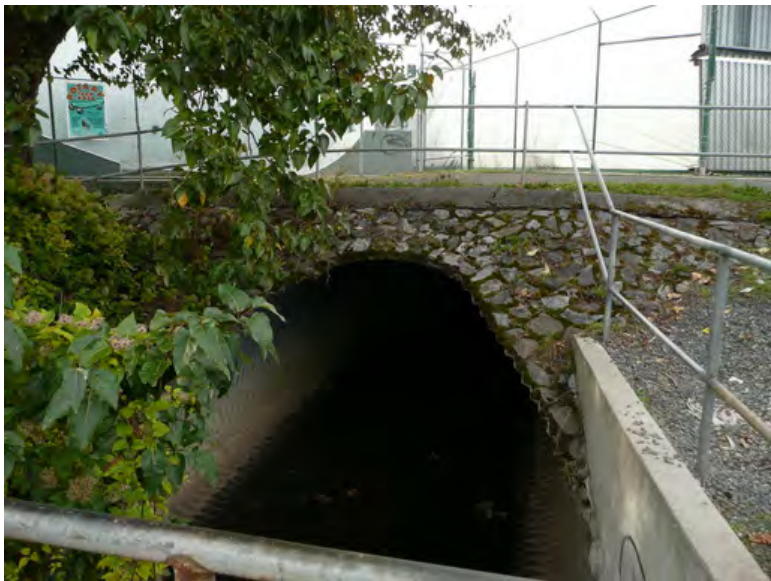
Culvert exiting from under the tennis bubbles at the top of Reach 3

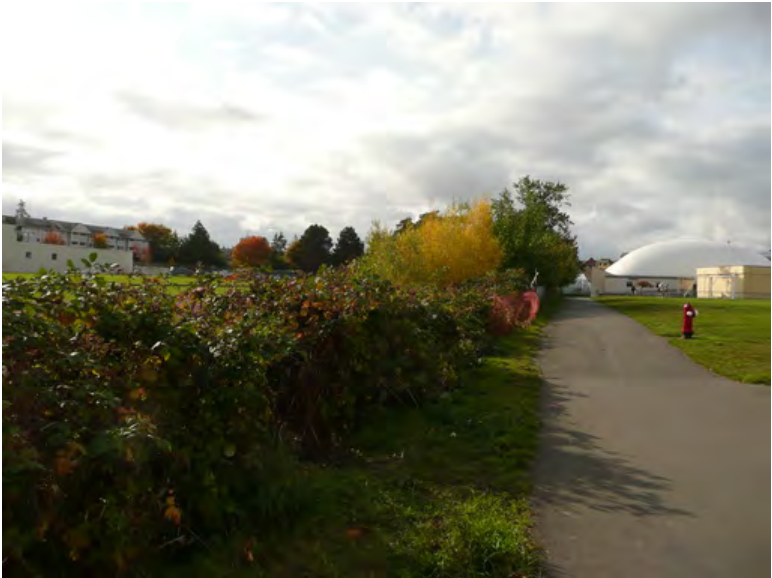
Narrow creek corridor between athletic track (left) and school property (right)

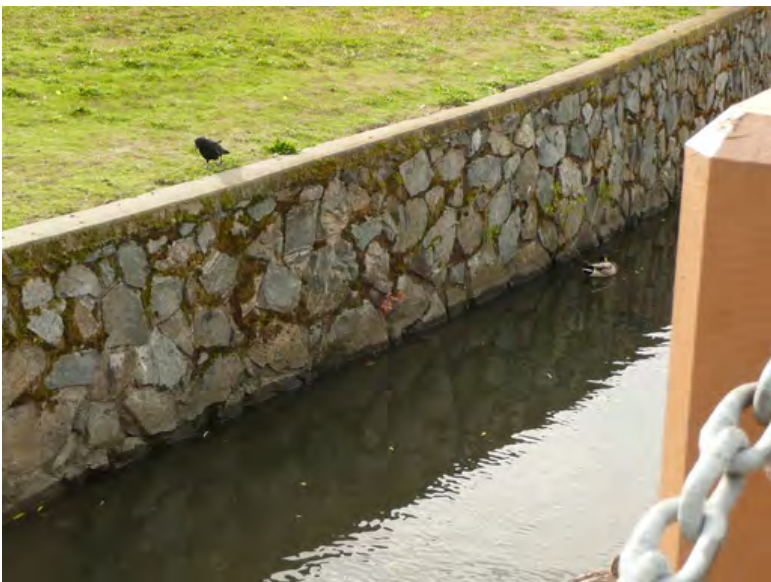
Typical concrete channel wall.

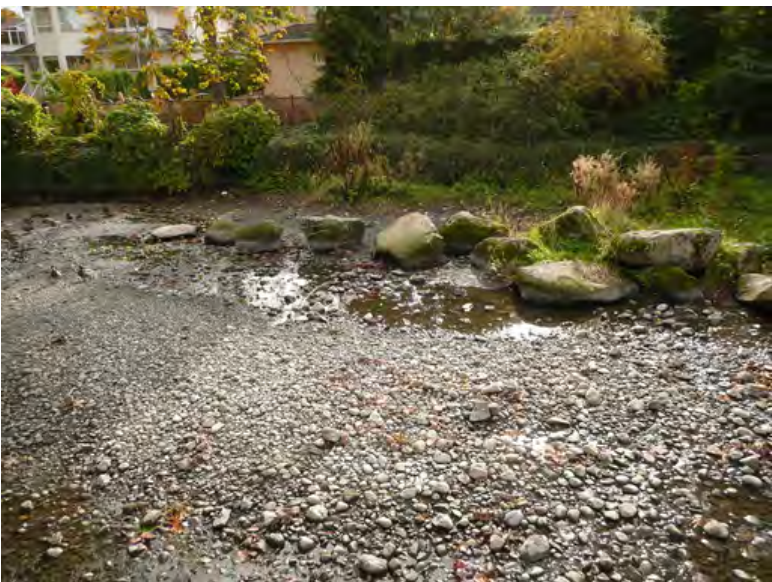
Natural sediments accumulate in the lower part of this reach

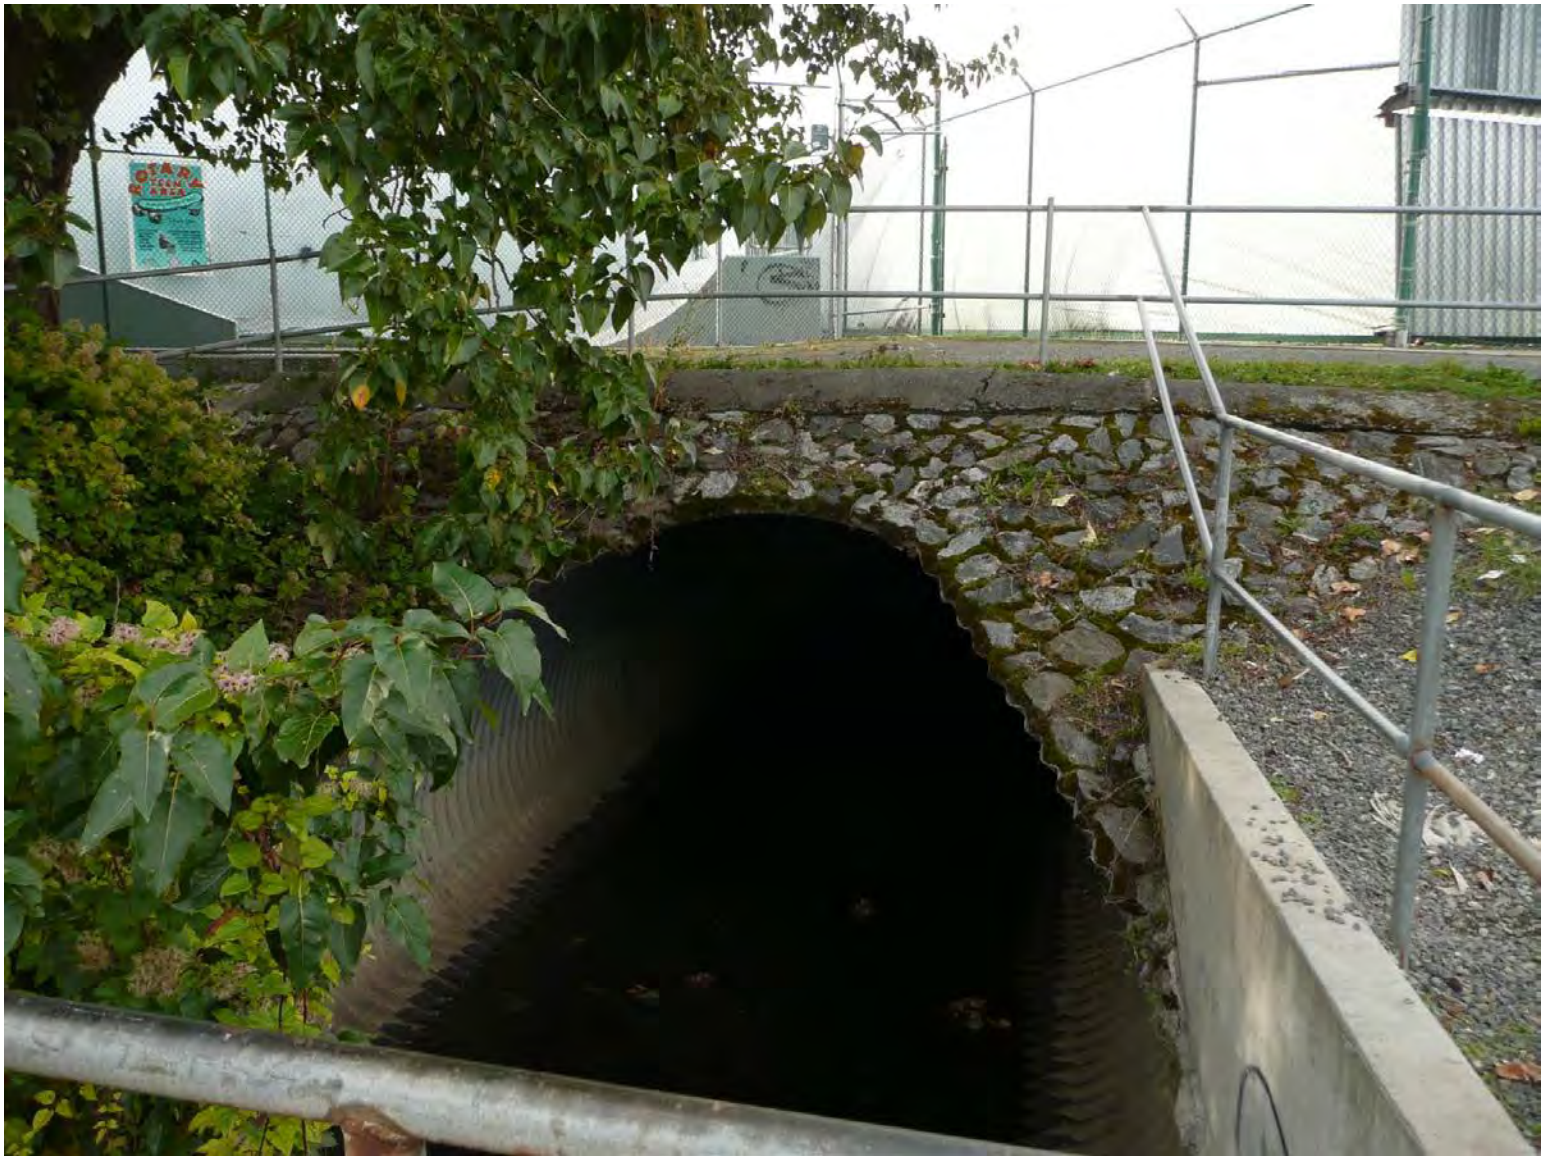
Bowker Creek emerging from under the tennis bubble

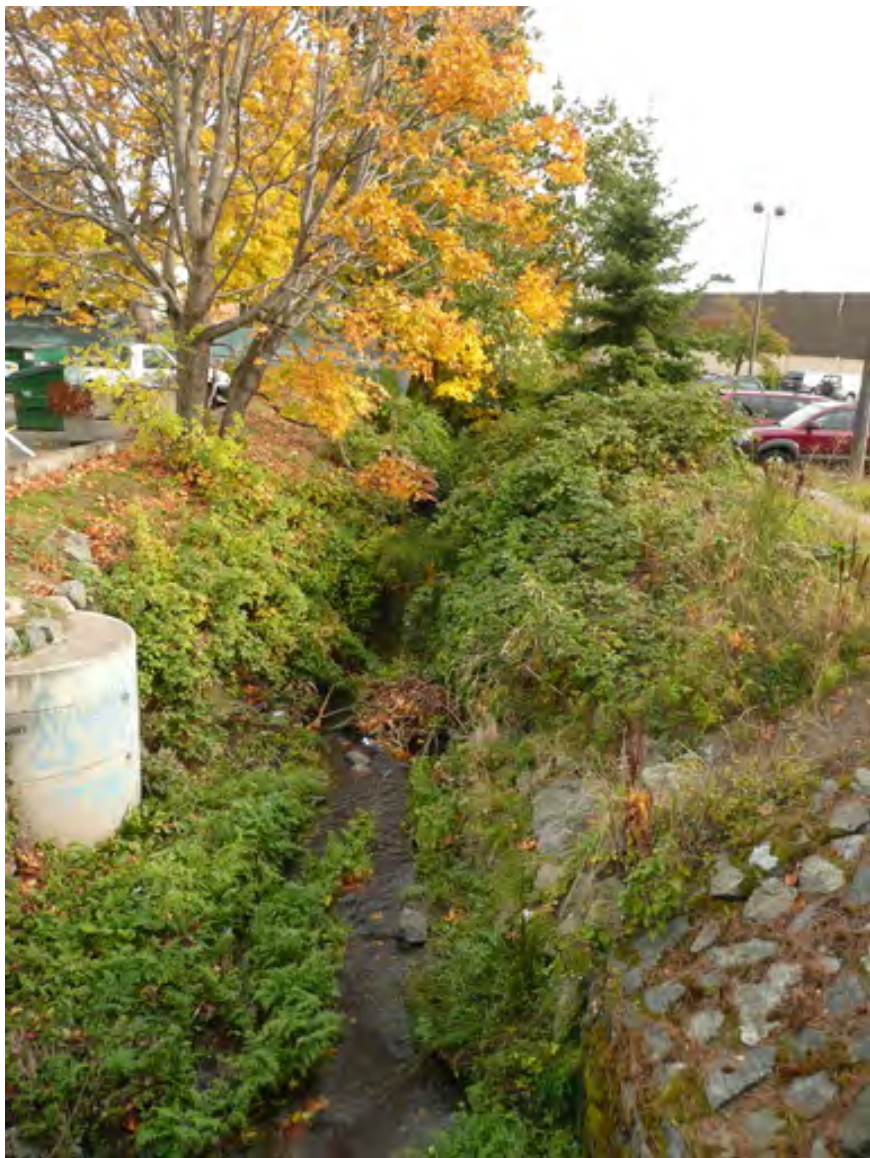
Reach 5 beside the Oak Bay Recreation Centre, looking downstream from Bee Street. Note the steep banks and mix of invasive and native vegetation.

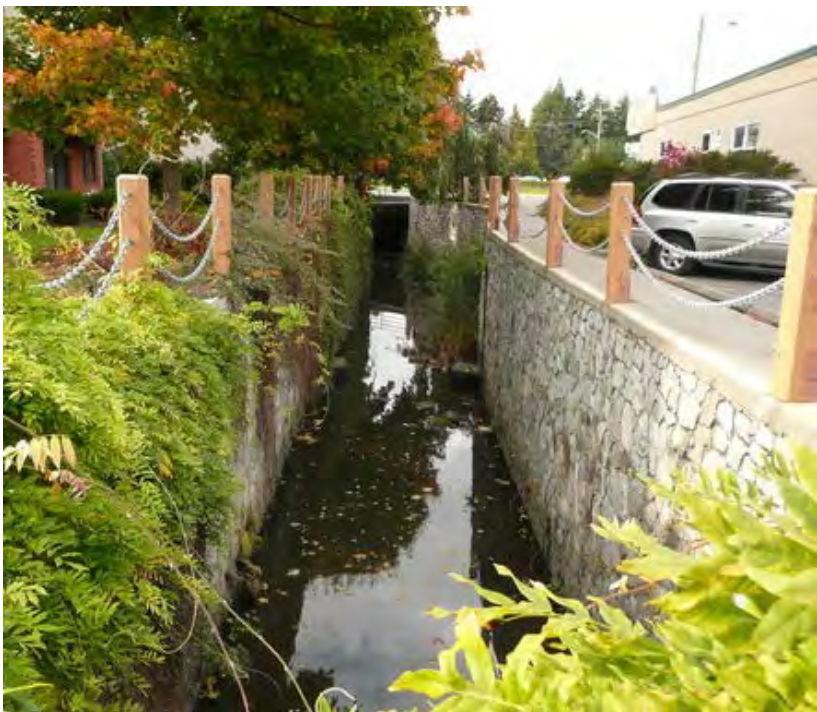
Looking upstream from Be Street. Few options exist to improve this reach. One possibility is installing in-stream baffles for complexity and aeration.

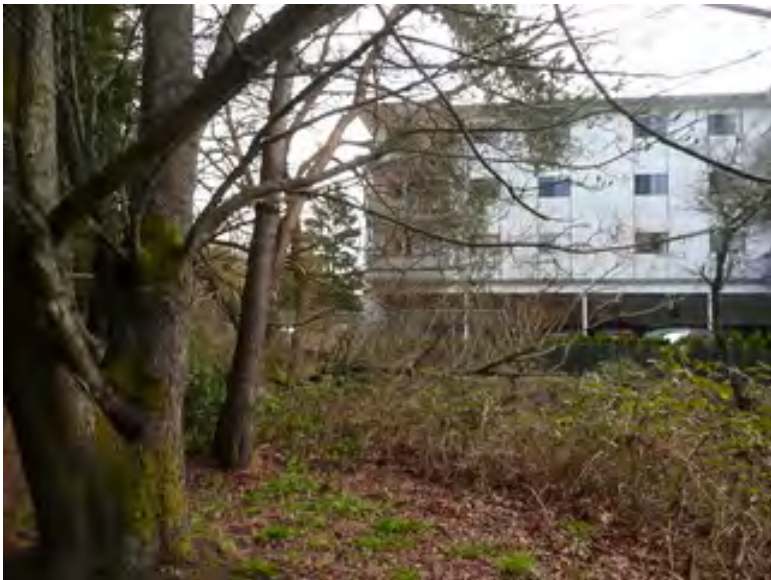
View across the creek toward the west bank. Bowker Creek is constrained along the west side of the Hydro property and restoration would entail expansion to the east.

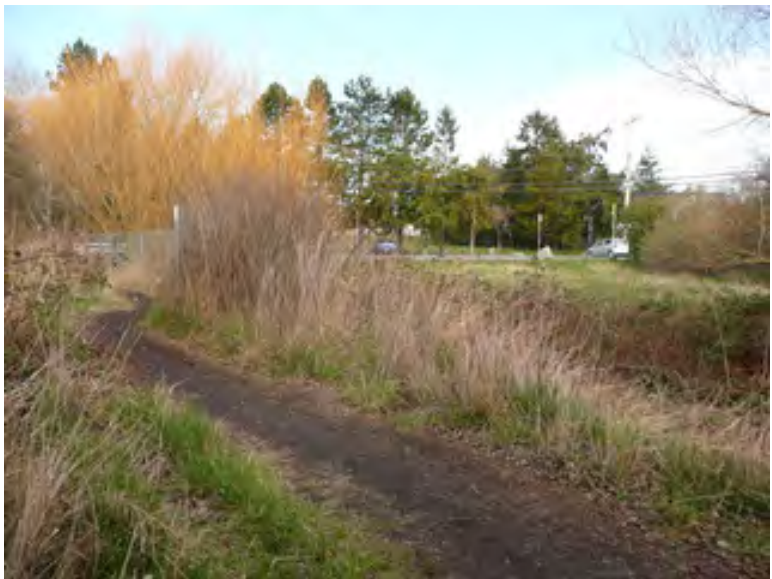
View from the west bank across the creek to the triangle of land south of Haultain on the east bank. This area provides potential for widening the creek corridor.
