BOWKER CREEK BLUEPRINT

A 100-year action plan to restore the Bowker Creek Watershed

August 2012
VICTORIA BC

Prepared by the Bowker Creek Initiative with support from
Westland Resource Group Inc., Kerr Wood Leidal Associates Ltd., and Murdoch de Greeff Inc.

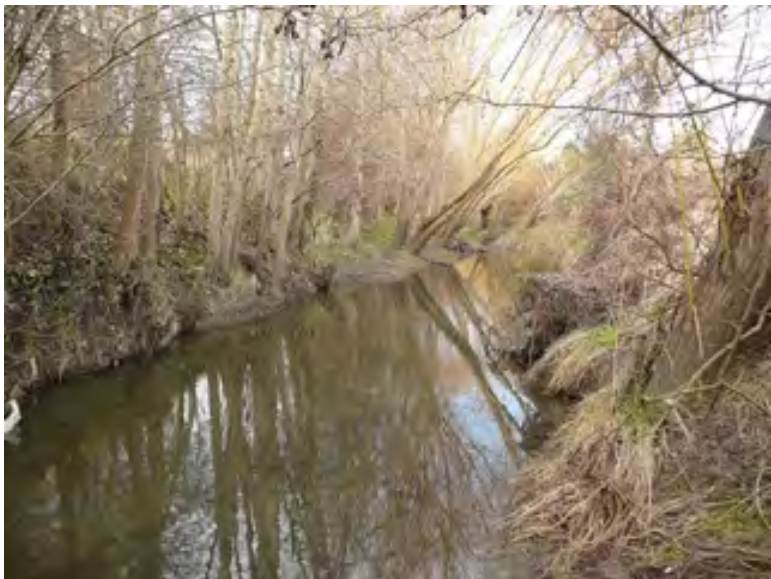
The portion of the reach alongside the Royal Jubilee Hospital has some native vegetation and other areas of eroding grassy banks.

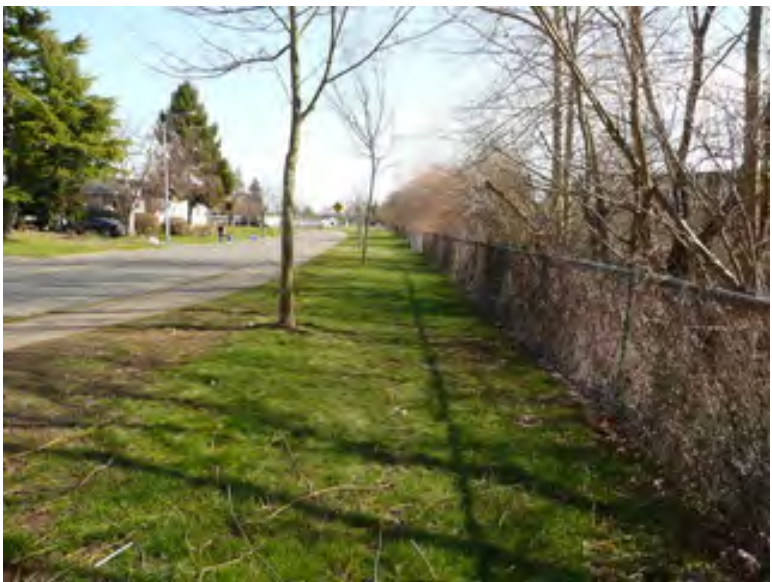
The right-of-way along Townley Street is relatively narrow, but still allows an opportunity to widen the creek corridor.

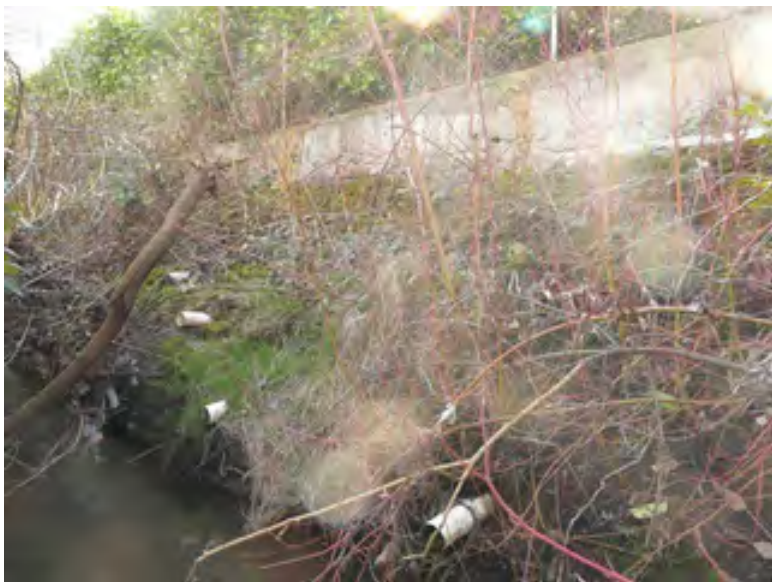
The west bank is constrained in the upper two-thirds of the reach by an extensive apartment complex at 1702 Newton Street.

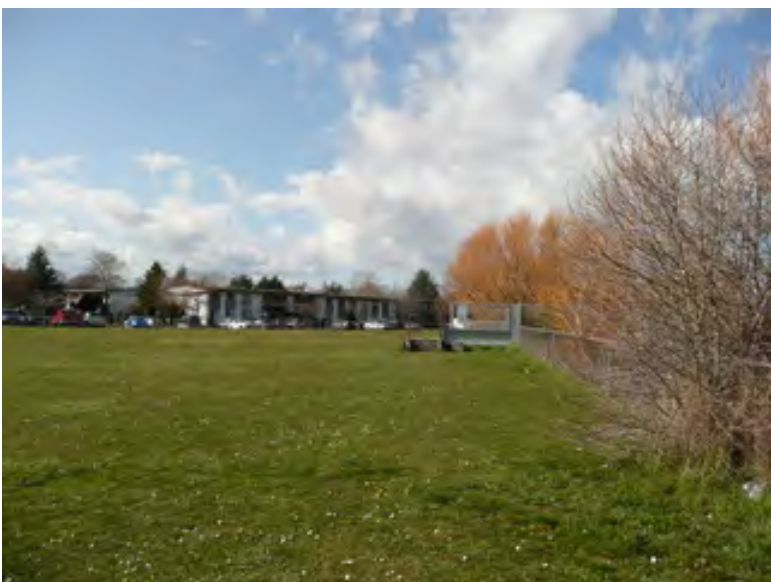
Bowker Creek cuts through the former Richmond Elementary school grounds and is surrounded by fencing and fields on both sides

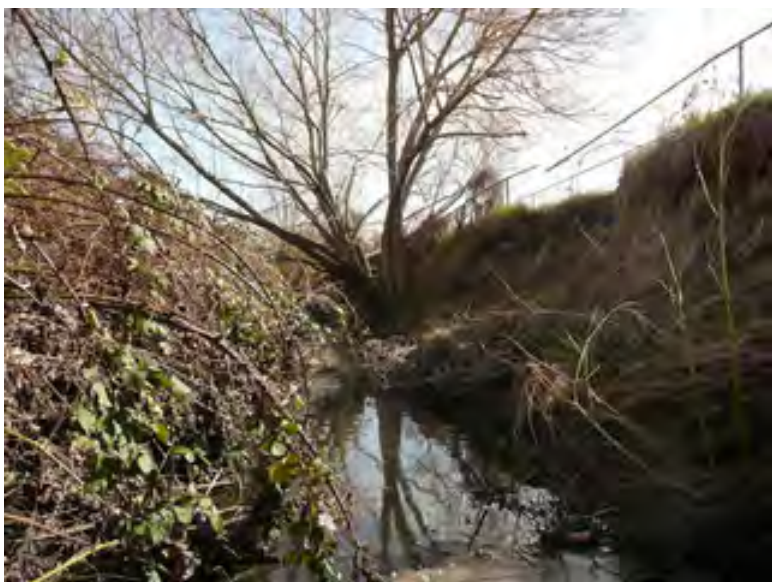
Erosion is an issue through the school grounds. The fence footings have been eroding and public access is worsening the issue.

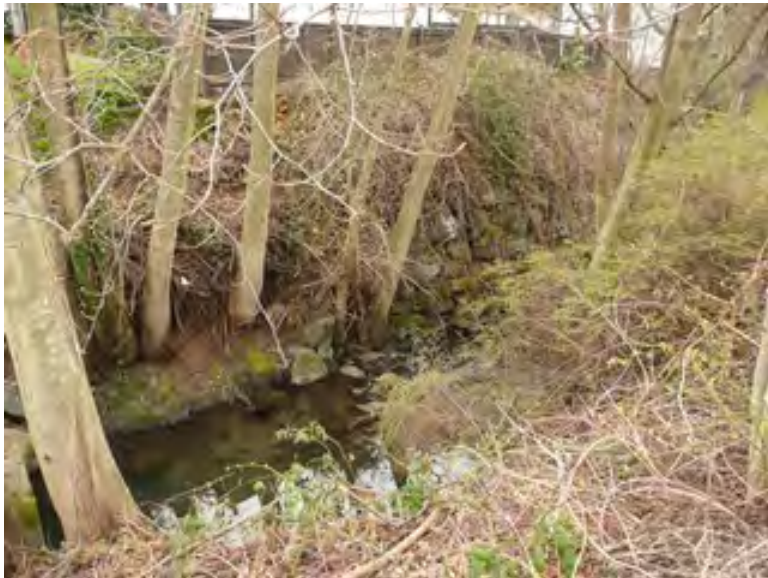
Looking across to an armoured east bank at the north end of Browning Park. The creek is highly incised at this point.

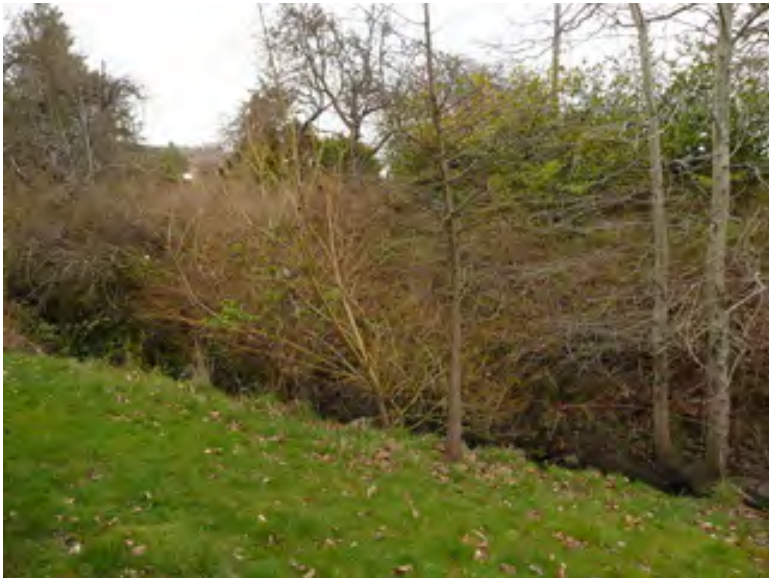
Grassy area in Browning Park along the west bank that is a candidate for riparian planting

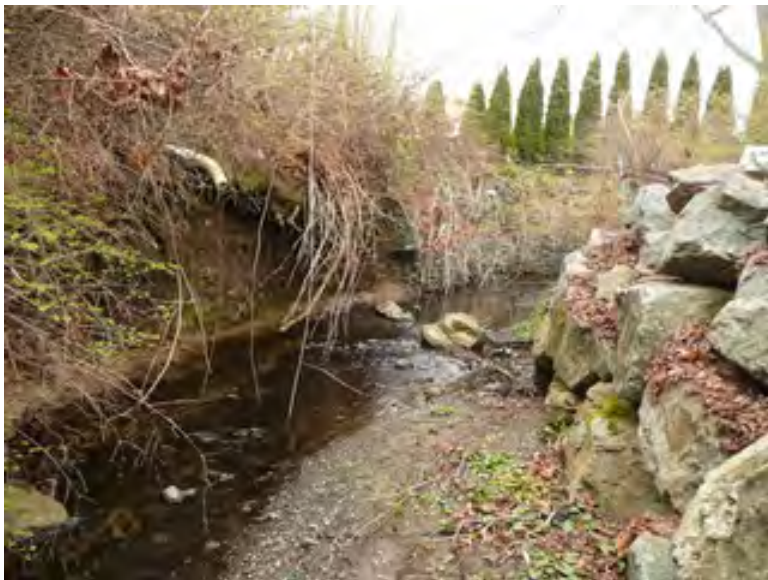
The section between McRae and North Dairy is constrained between private lots and has erosion issues.

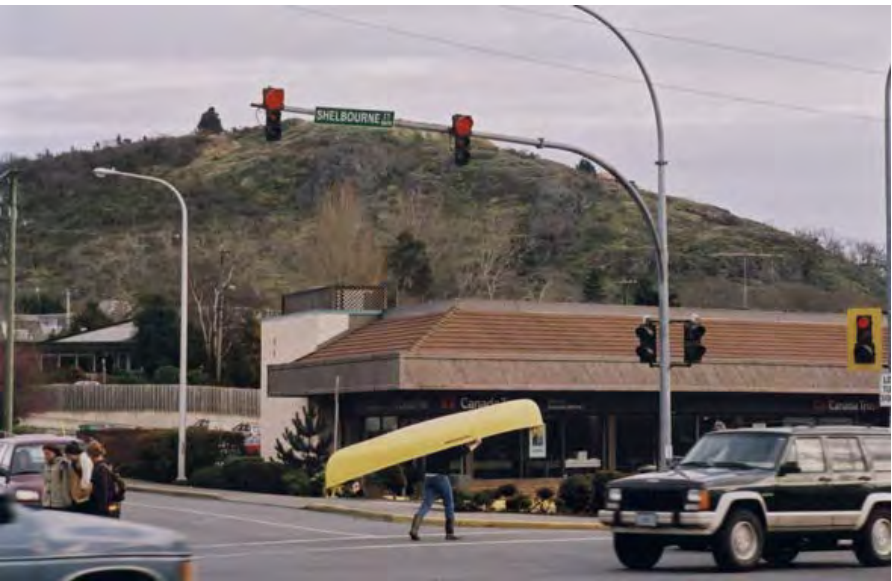
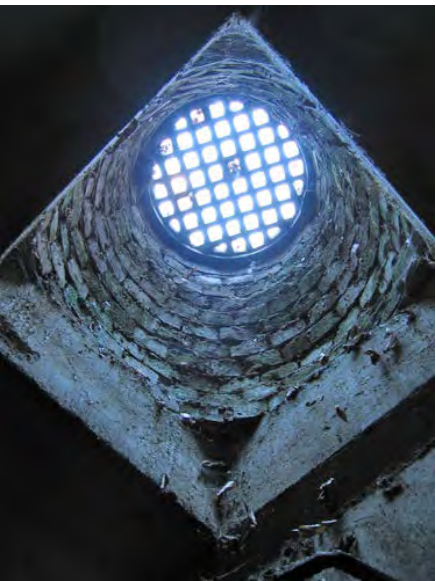
Reach 13 is entirely below ground, beneath a busy transportation corridor

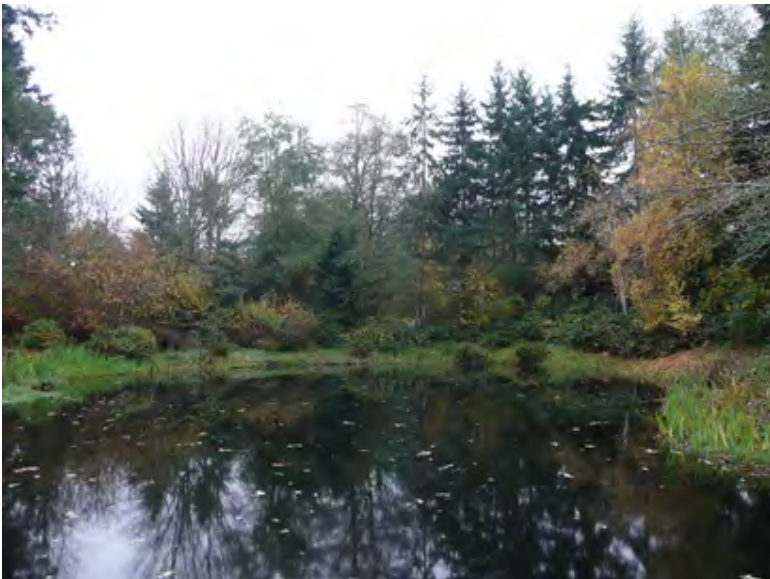
The pond at the Faculty Club. The perimeter is landscaped and native plantings could be increased.

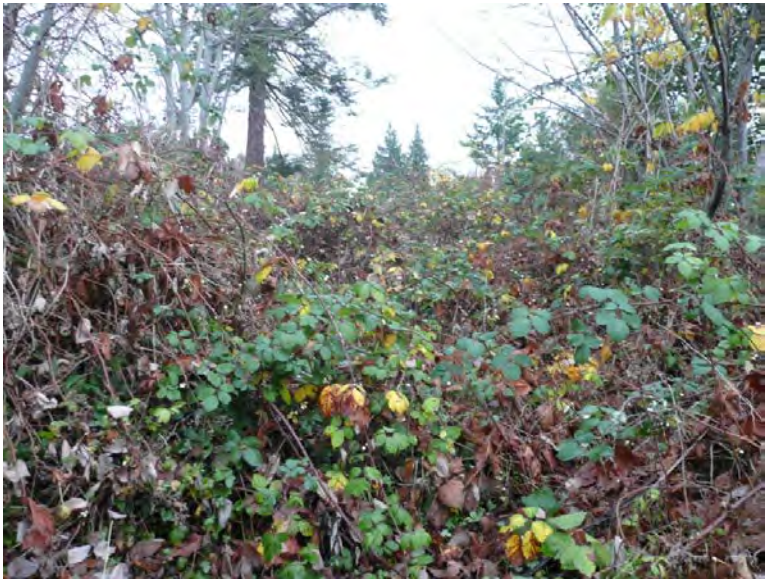
Blackberry patches within the forested area are an obvious target for invasive species removal efforts

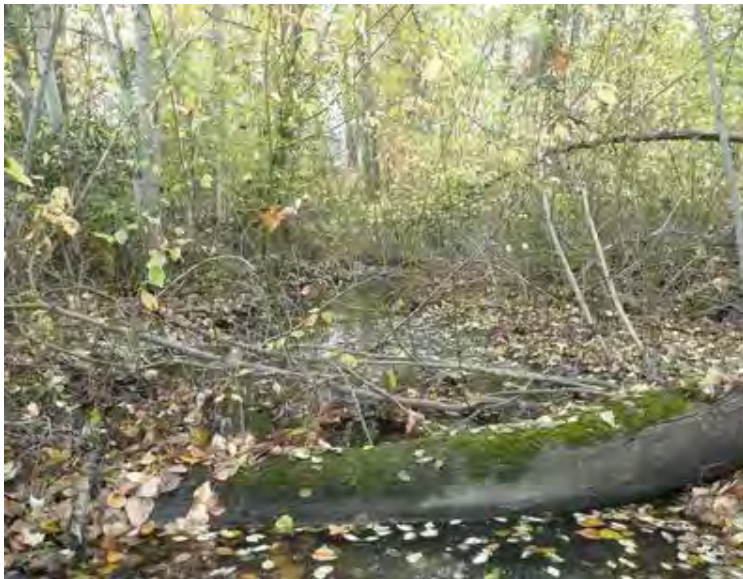
Much of Reach 15 is inaccessible within a forested floodplain

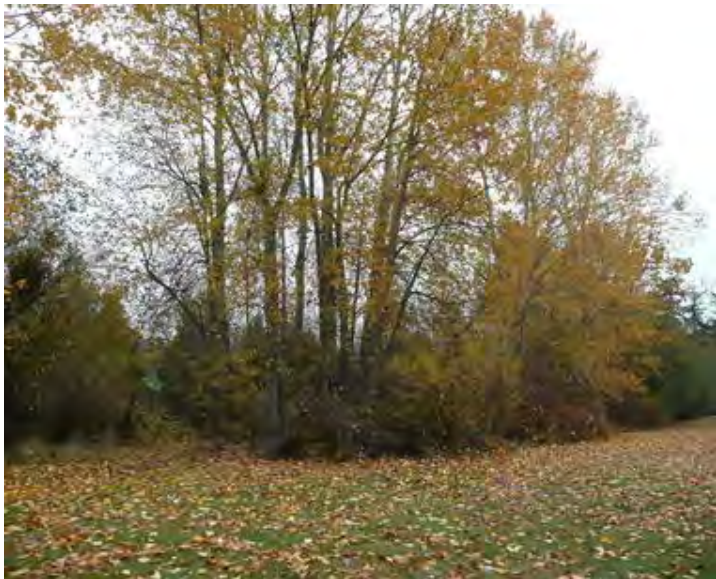
This feeder channel coming from the stadium is a good candidate for riparian restoration and for widening the riparian buffer

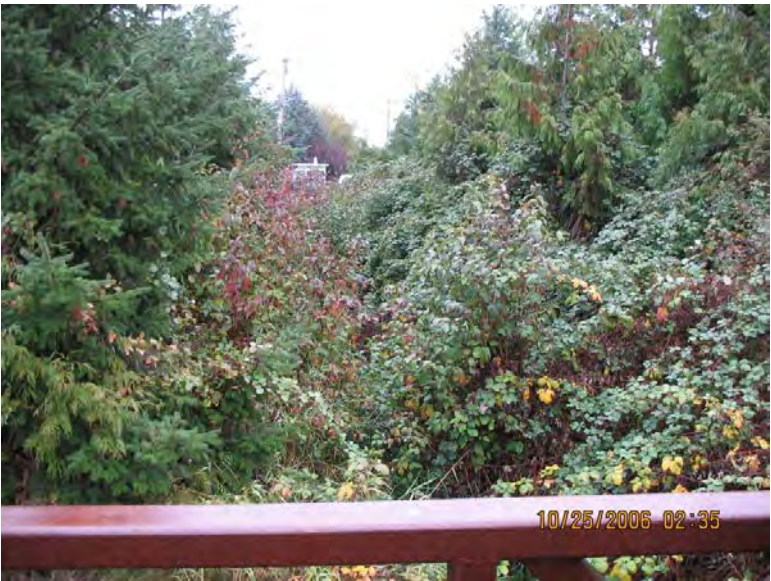
Downstream view from footbridge showing conifers, blackberry, and red osier dogwood

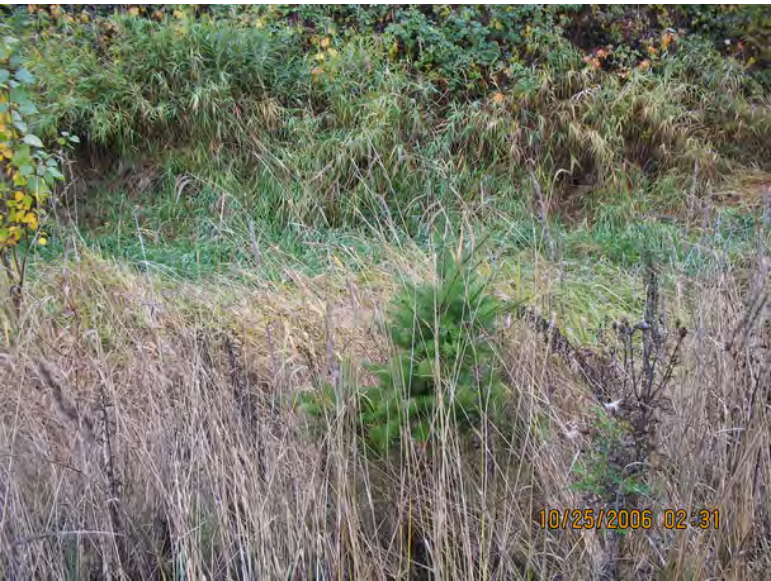
Planted conifers need ongoing care to thrive among reed canary grass and blackberry

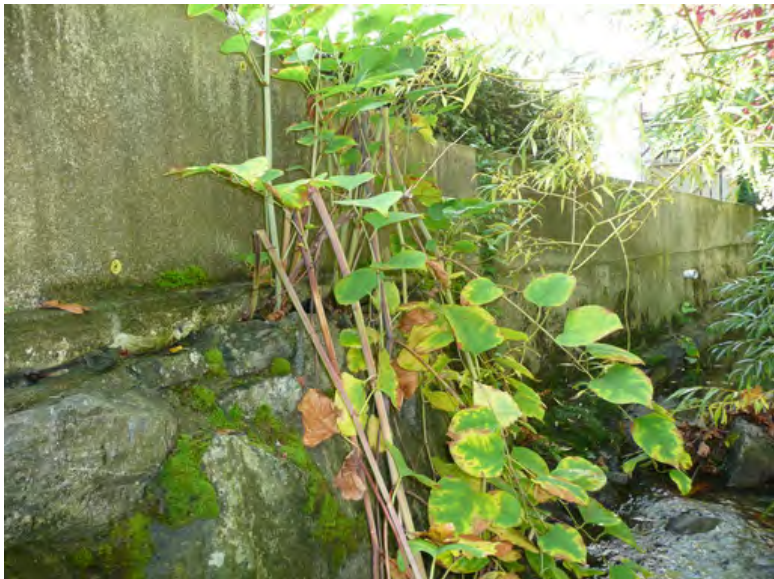
Plate 2: Knotweed growing from south bank retaining wall in Reach 1A

Remove ivy growing on private property along the south bank above and below Beach Drive. This would be particularly useful above Beach Drive where there is space for native plantings above the retaining wall. Remove blackberry and ivy along the Kachan property particularly where there is no bank hardening (no cement sand bags) and replace with native shrubs.

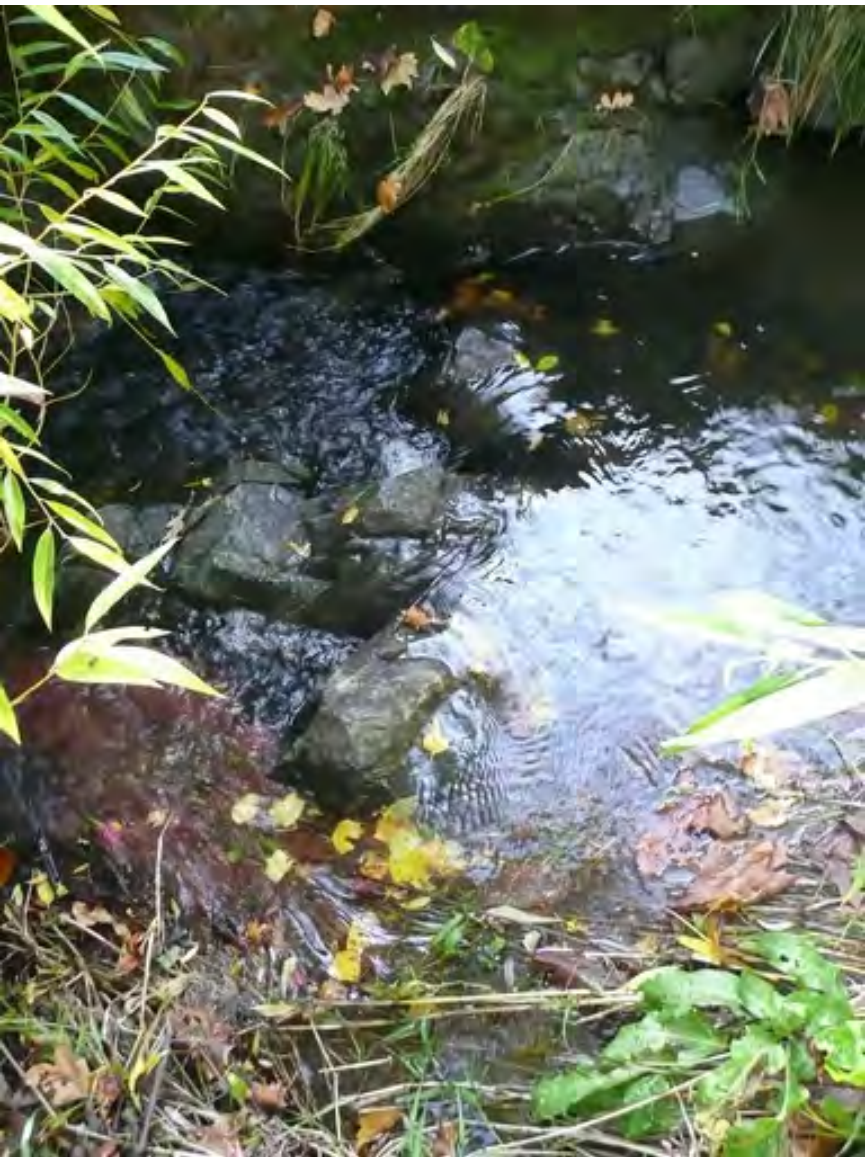
Plate 3: Natural cobble line providing complexity in Reach 1A. Reddish substrate on the left is yellow willow root mats commonly found in Bowker Creek.

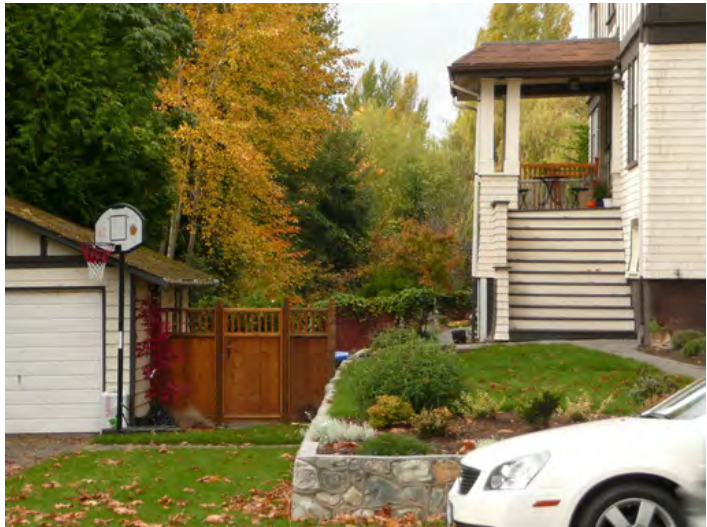
Plate 8: Kachan property at 1776 Beach Drive. The fence in the far distance marks the location where the creek narrows and bends around the fill that was historically used to create/extend the side yard on this property.

Long term channel and riparian restoration potential Relocating or removing some fences, and removing fill in order to reslope channel banks further back into the private property. This applies particularly to the north bank but both banks will benefit from removal of invasives and planting native trees and shrubs. If the space available is limited, the north bank could be terraced using willow wattles (bioengineering). Any work of this sort should tie in with the erosion issues happening at the Kachan property.
Observations/Notes As in many (if not most) places along the creek, streamside properties are built up with fill. The erosion problems at the Kachan property (1776 Beach Drive) are a result of a corner of the filled lot extending into the creek channel and causing a narrowing and a slight bend in the creek (Fig. 7). According to Lisa Kachan (pers. comm.), she would like to stabilize the property using ‘soft’ techniques like bioengineering if affordable, though it currently appears to be too expensive to accomplish without outside support. Lisa Kachan’s two upstream neighbours also have some interest in doing something for the creek where it runs past their properties. Any action taken by the Kachans would be best accompanied by action by their upstream neighbours as well.

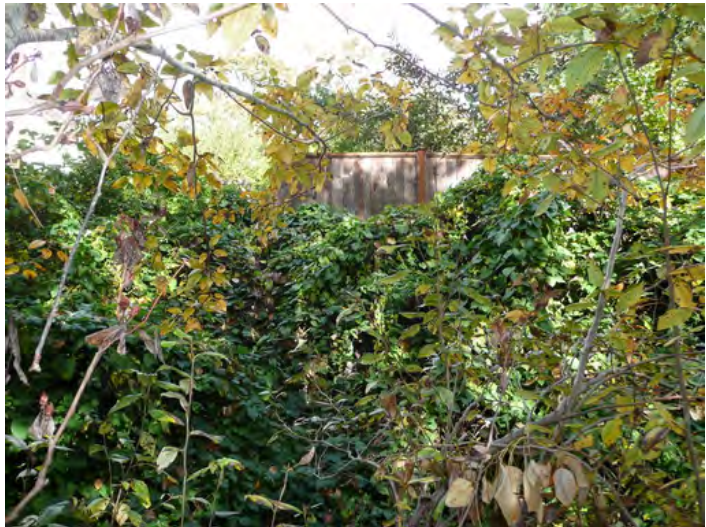
Plate 7: The steep north bank on reach 1B, covered in blackberry and morning glory. Fence shown is from panhandle of property at 1790 Cranmore Road.

Short term riparian restoration potential and techniques Removing ivy and other invasives on south bank, and maintaining and improving the native plant mix in that area. Short-term action not recommended on the blackberry and morning-glory covered north bank.
Short term riparian restoration potential and techniques Removing ivy and other invasives on south bank, and maintaining and improving the native plant mix in that area. Short-term action not recommended on the blackberry and morning-glory covered north bank.
Short term channel restoration potential and techniques As in Reach 1A, the channel has a bedrock base, though it is less obvious in places. The substrate is bedrock/cobble/gravel/sand. No short term channel improvements suggested.

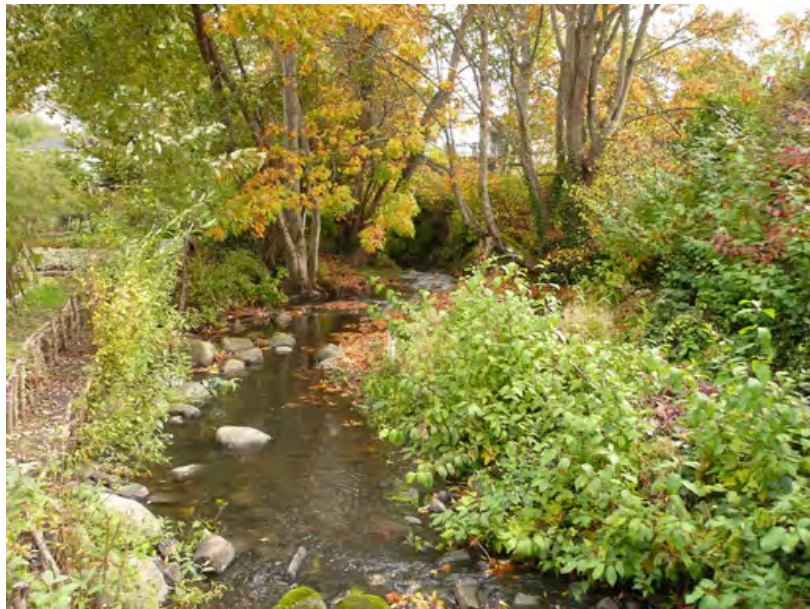
Plate 9: Downstream view of Reach 1C showing bioengineering on the left and a relatively new ‘bar’ in centre, created by an artificially dug channel.

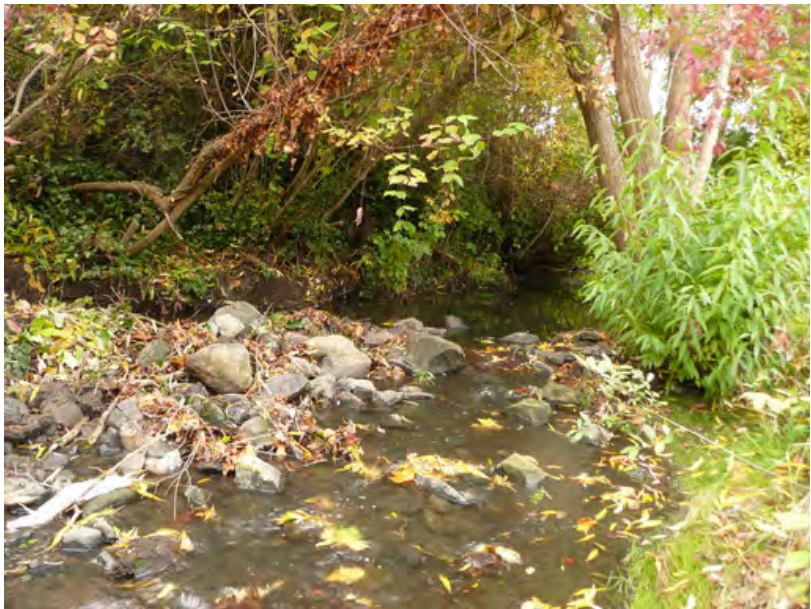
Plate 10: Upstream end of point bar showing top end of excavated channel, and looking towards Fireman’s Park culvert exit.

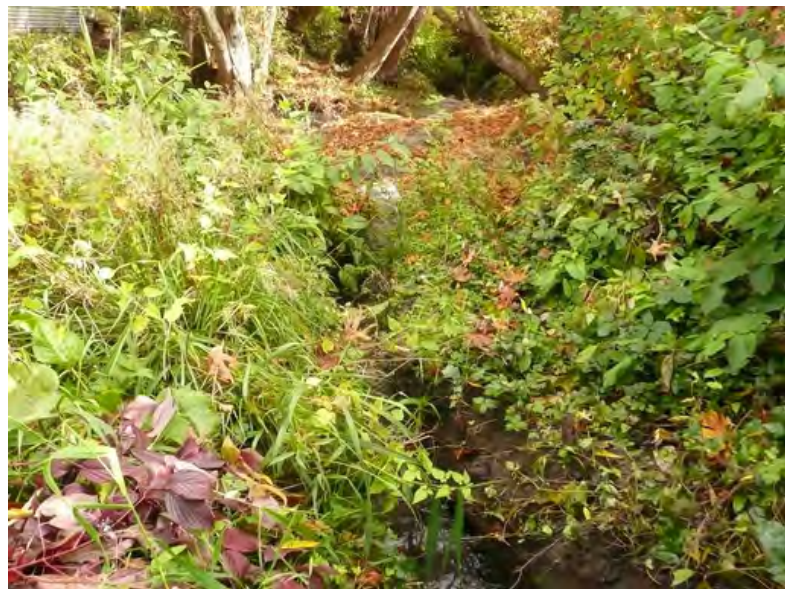
Plate 12: Artificially created ‘side channel’. This channel has been stable since its creation sometime in the winter of 2007/2008, presumably by an individual concerned about erosion and flooding at the community gardens. Invasive vegetation on the bar should be addressed.

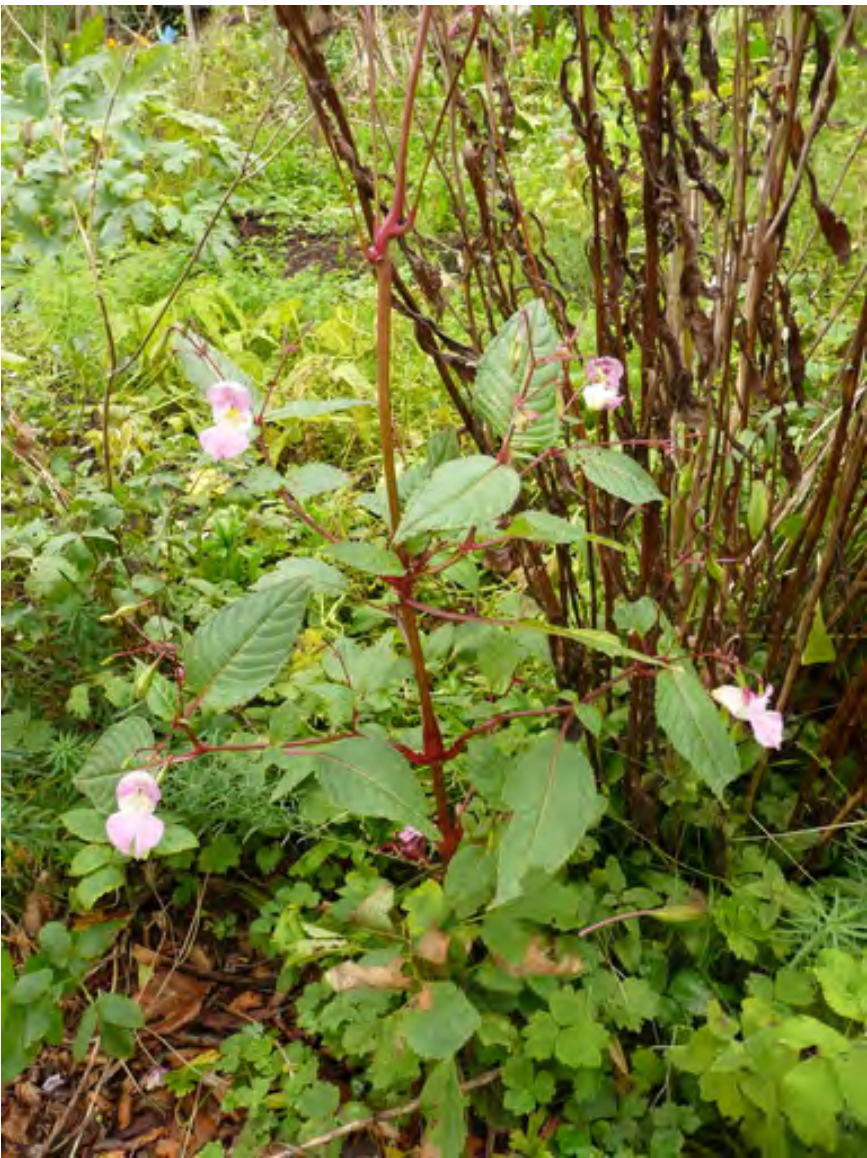
Plate 11: Policeman’s helmet (*Impatiens glandulifera*) is an invasive annual plant that needs to be controlled before it establishes in the watershed. A few plants were found along Bowker Creek in the Monteith Street community gardens

Short term riparian restoration potential and techniques Remove occasional occurrences of policeman’s helmet (<i>Impatiens glandulifera</i>) (Plate 12) from the community gardens on an annual basis until eradicated— <u>high priority</u> For the south bank, funding is in place to purchase native plants to improve the riparian buffer (10–15 meter wide strip) and remove invasives. No short term riparian restoration is possible on the north bank unless community garden plots can be removed along the streambank. Note: the bioengineering treatment is not thriving as previously, particularly in the central section. Some areas have been clipped by the gardeners to control shade and in certain locations it is possible this may have affected the viability of the stakes.
Short term channel restoration potential and techniques In-channel conditions have been altered (Fig. 11 and 12). The resultant ‘point bar’ needs to be treated to remove invasive species. Currently, the channel throughout the reach has some diversity with cobble, some boulders, and gravel in pockets.

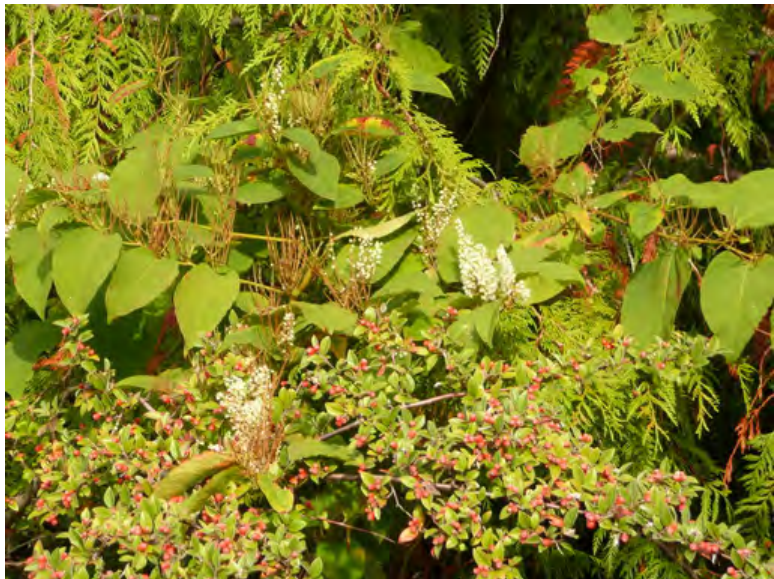
Plate 13: Knotweed intermixed with other vegetation on the west bank south of Hampshire Road.

Long term channel and riparian restoration potential
In some or all areas, remove the concrete lined bottom and sides, and grade the banks back and/or use terraces to support native vegetation along the banks. In locations where space is tighter, use setback retaining walls to create planting benches. Plant native vegetation. Recreate a natural-bottomed meandering creek bed. As per the PFC assessment (Barraclough et al., 2007), the general alignment and footprint of the channel and ponds can remain. Note: one area in particular that is not currently used by the public (west bank at south end of reach) has potential as a pilot project to create a naturalized bank and riparian area (Plate 16).
Observations/Notes
It is very important to eradicate knotweed from this reach. This is the largest occurrence seen to date.

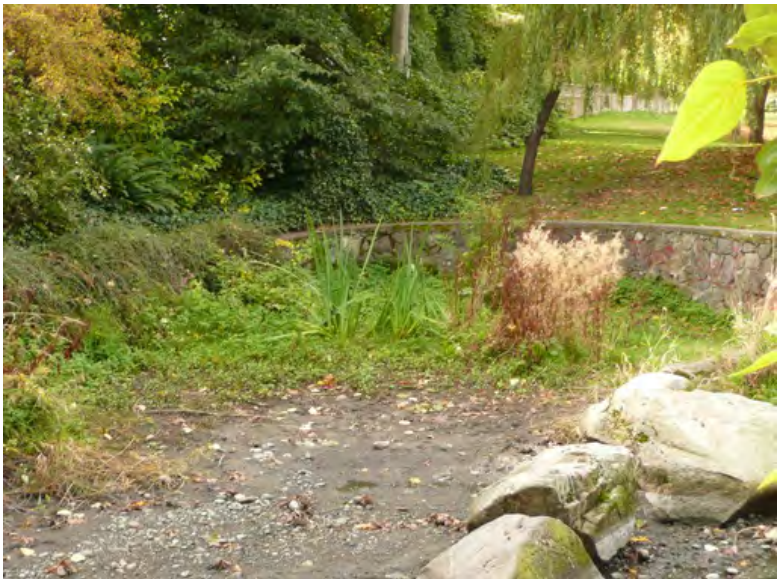
Plate 14: Partially vegetated in-channel area that could be enhanced with plantings of Spirea and/or other water-loving plants.

Percent coverage of invasive vs. native species
90% + invasive and non-native if lawn variety grasses included
Current width of vegetated riparian corridor and potential width of riparian buffer with private landowner involvement/redevelopment (comment)
While there is little or no riparian connectivity, there are variable widths of land alongside the concrete armoured channel. This land is owned by the District of Oak Bay and was ‘beautified’ to support its current public use back in the 1980s. There is space to redevelop the channel without concrete walls and bottom, and to reconnect a riparian area, should there be the political will and public support.
Short term riparian restoration potential and techniques
<u>High priority</u> : remove Japanese knotweed spotted in two locations (see Plate 13 and 14). Replace some grassed areas with overhanging vegetation. In the one widened pond area within the concrete lined channel, plant more native vegetation such as spirea or cattails (Plate 15) Over time increase the amount of native landscaping.

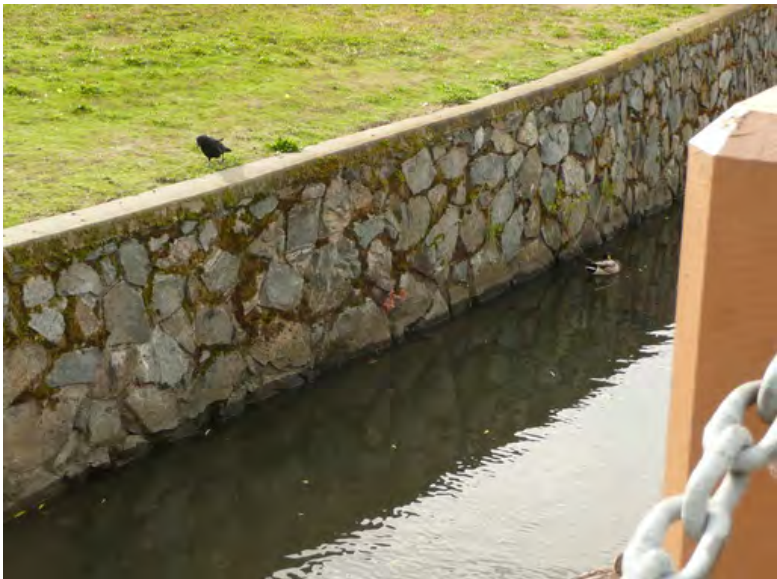
Plate 15: Typical concrete channel wall.

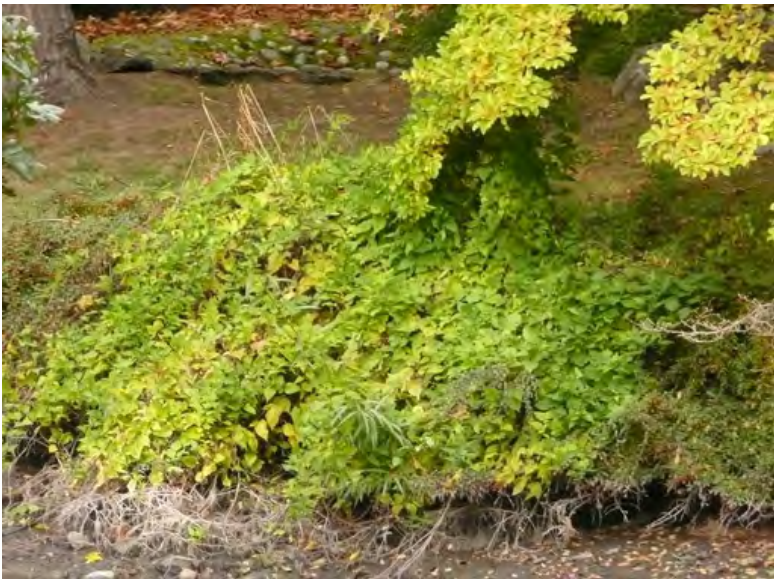
Plate 16: Large knotweed patch found within the channel boundaries, on the west bank north of Hampshire Road. All knotweed should be removed and monitored to ensure it is eradicated.

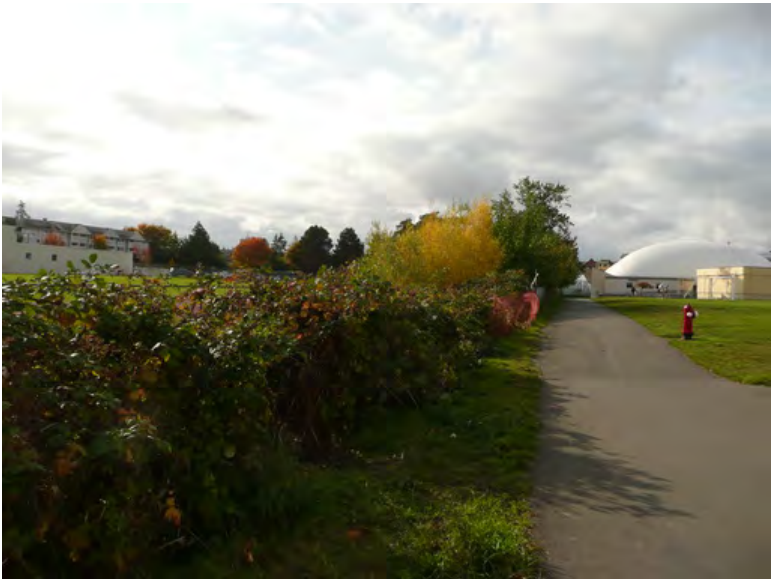
Plate 18: Narrow creek corridor between athletic track (left) and school property (right). Tennis bubble is in the background.

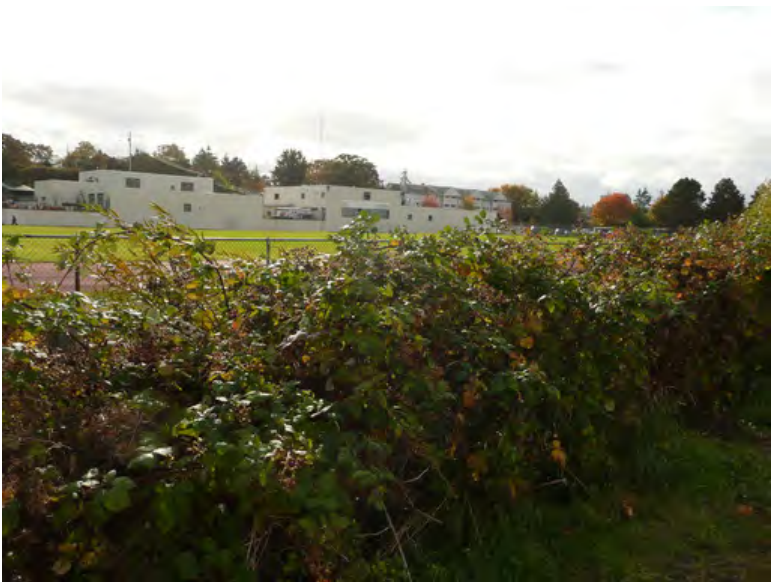
Plate 19: The narrow band of streamside vegetation on the north bank is a mix of blackberry and young cottonwood and yellow willow.

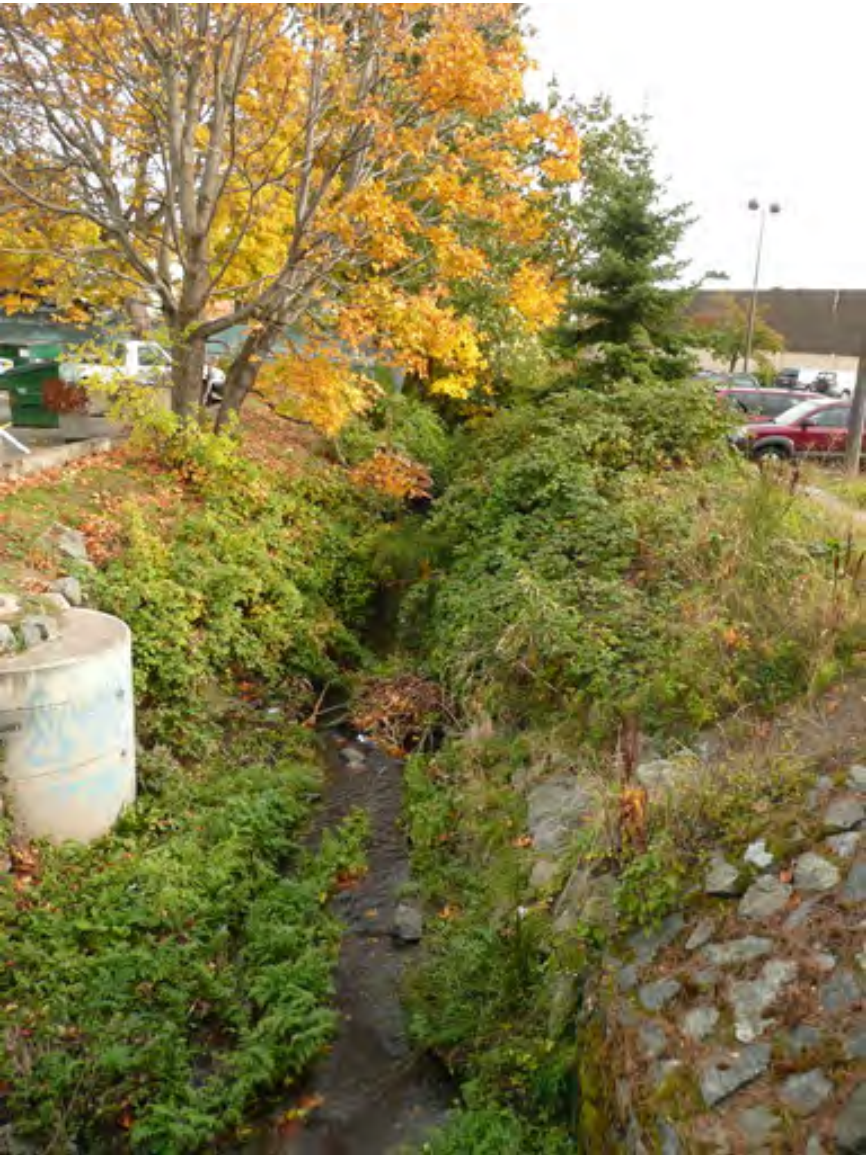
Plate 20: Reach 5A beside the Oak Bay Recreation Centre, looking downstream from Bee Street. Note the steep banks and mix of invasive and native vegetation.

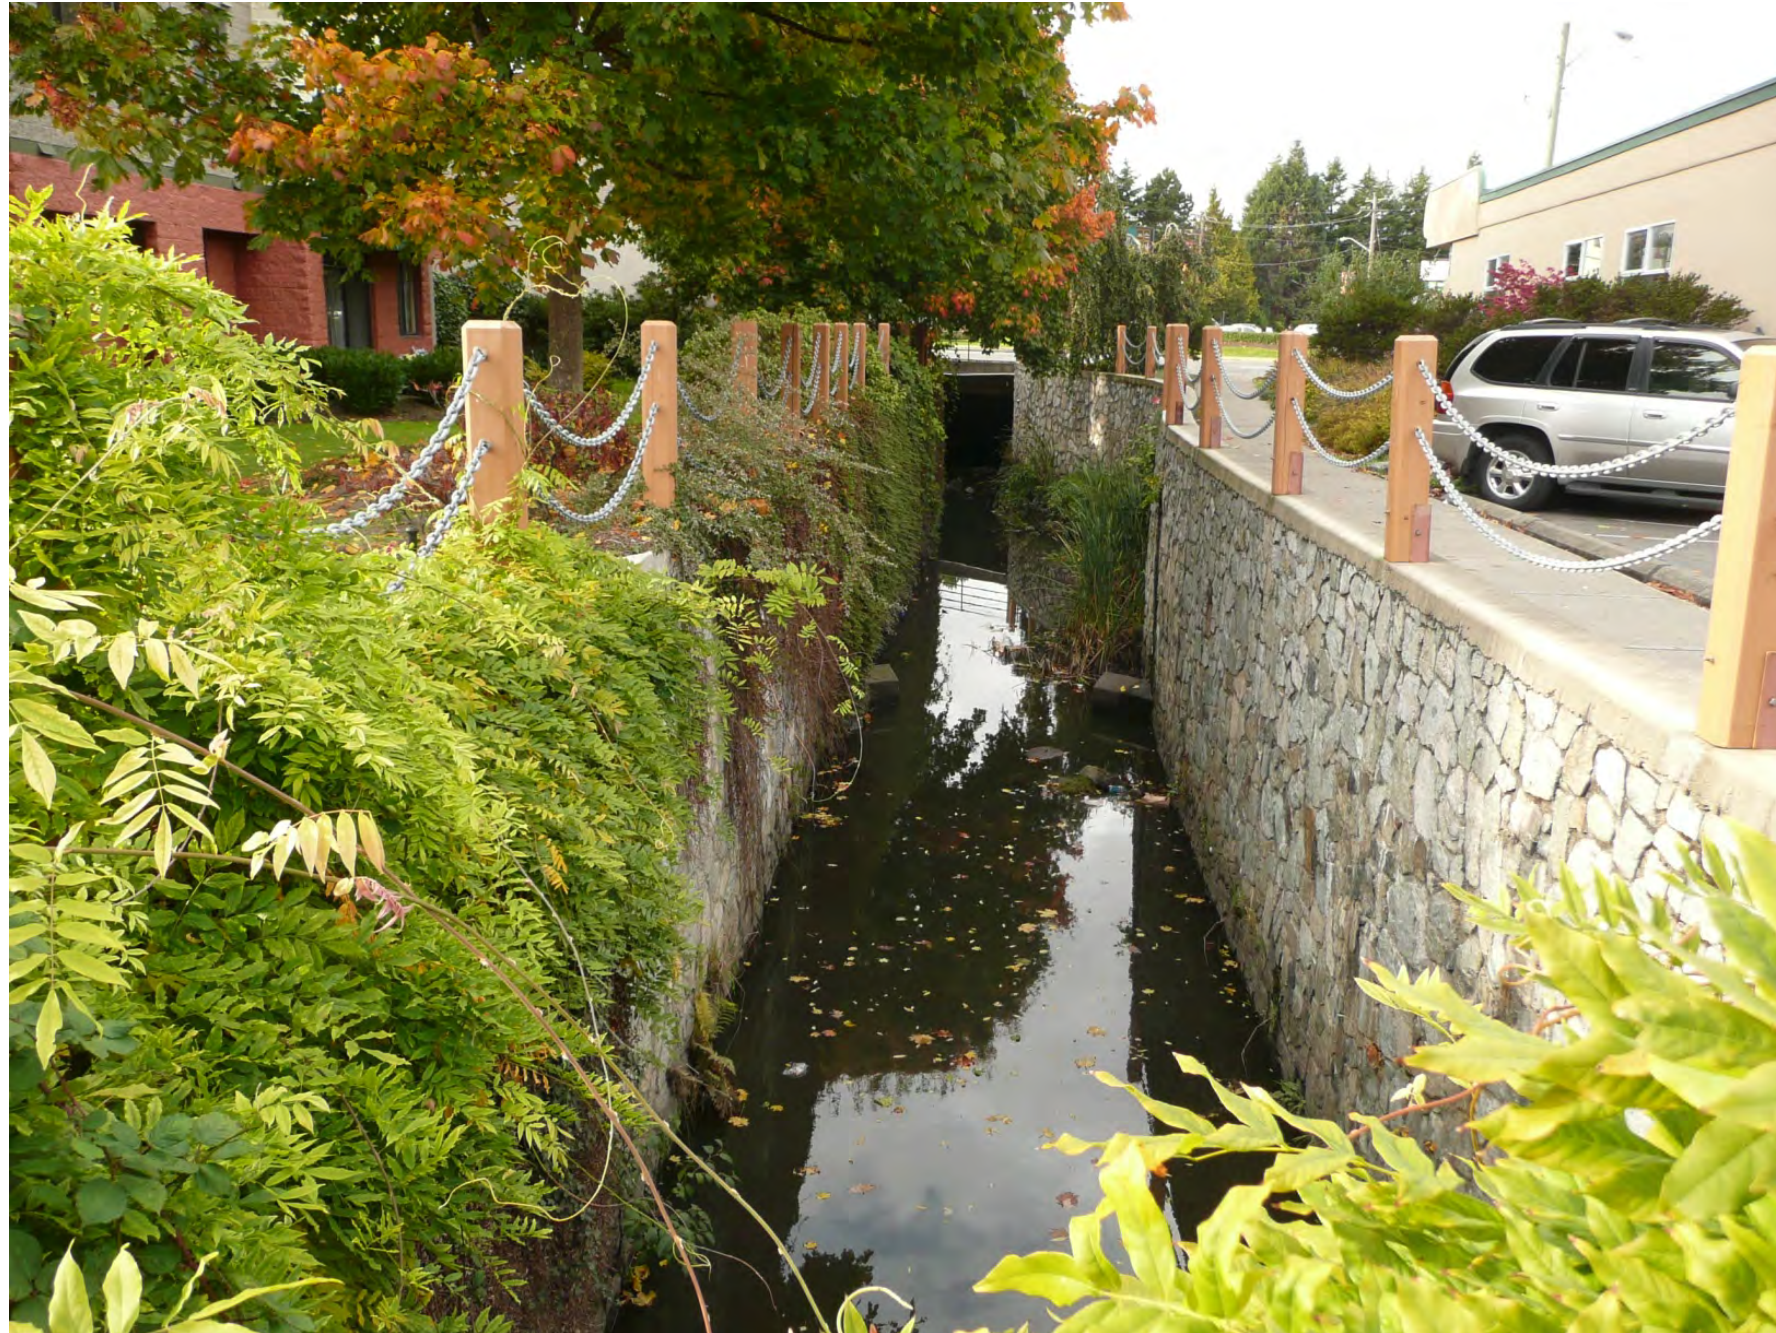
Plate 21: Reach 5B looking upstream from Bee Street. Few options exist to improve this reach. One possibility is installing in-stream baffles for complexity and aeration.

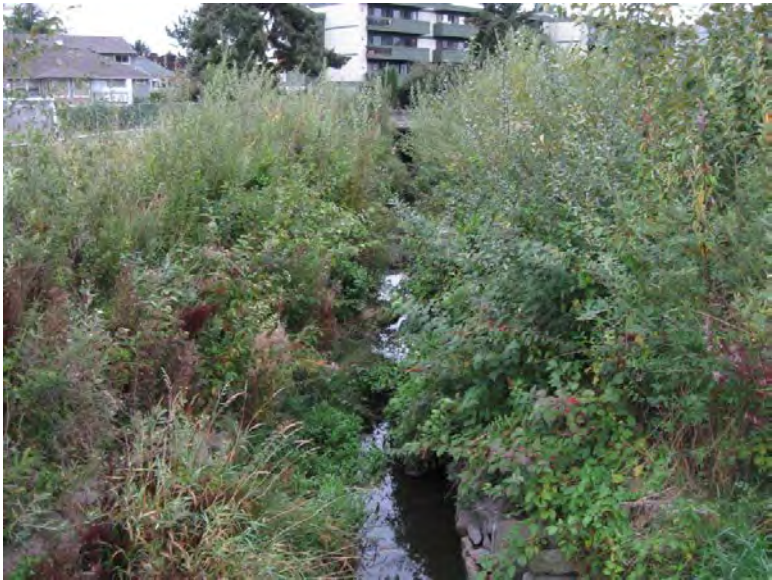
Plate 22: The 45-m long restoration demonstration section completed in 2005 is doing well and the willow/cottonwood wattles are thriving along with a variety of native shrubs (Photo October 2008).

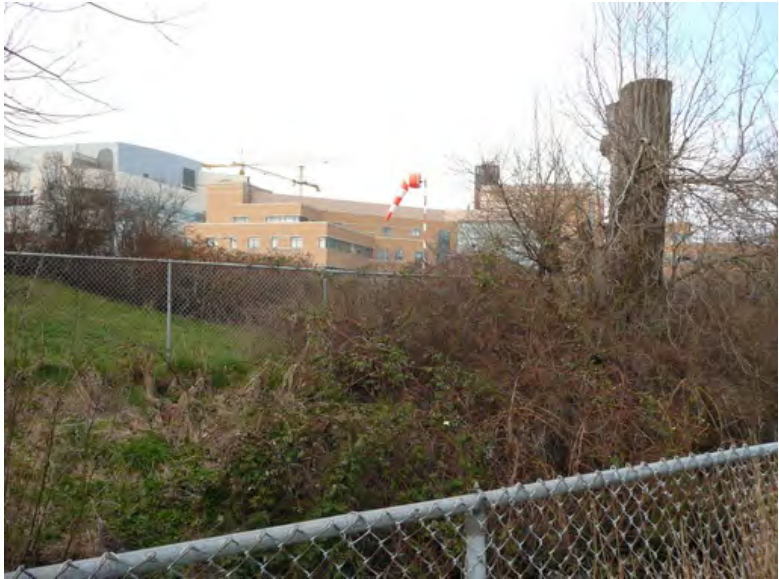
Plate 23: One of two ‘topped’ cottonwood next to the hospital heliport

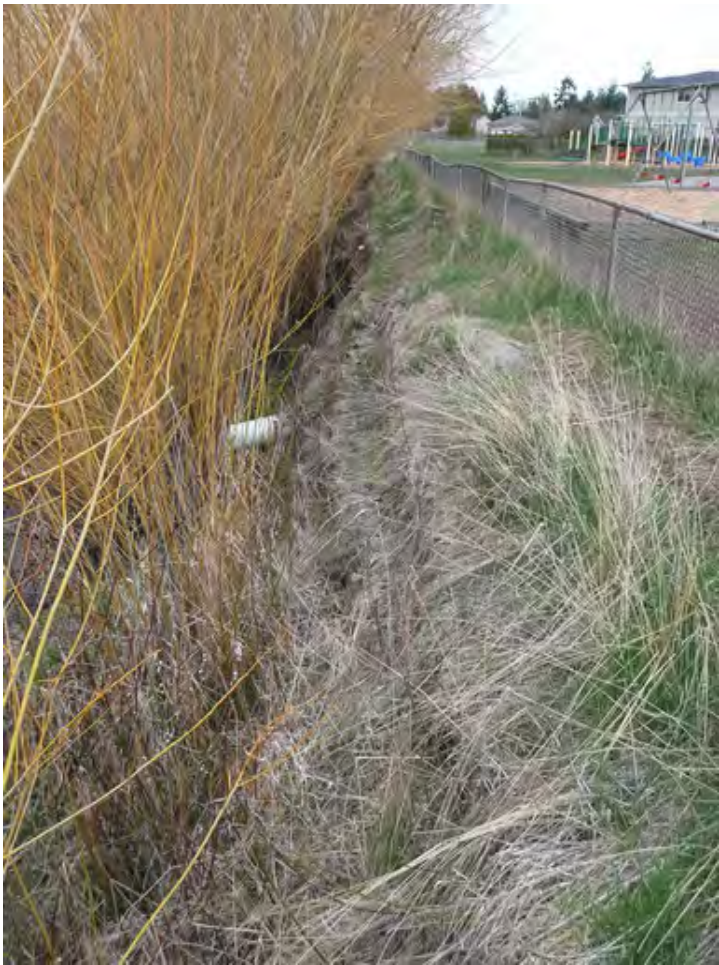
Plate 24: Upstream of the demonstration restoration section showing dead bioengineering along the east bank, behind thriving yellow willow growing on the channel bottom.

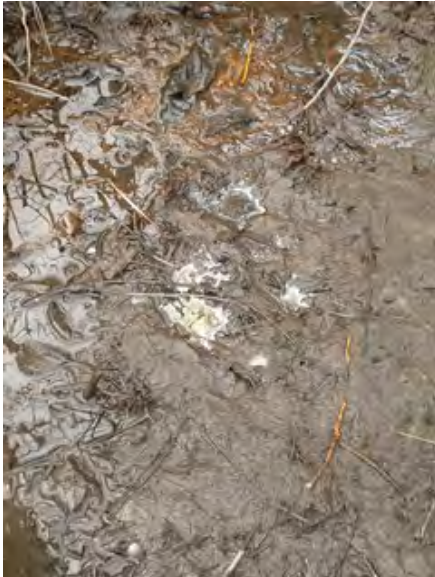
Plate 25: Runoff from the hospital includes hydrocarbons. There is an opportunity to improve VIHA’s Royal Jubilee stormwater runoff facilities next to Bowker Creek.

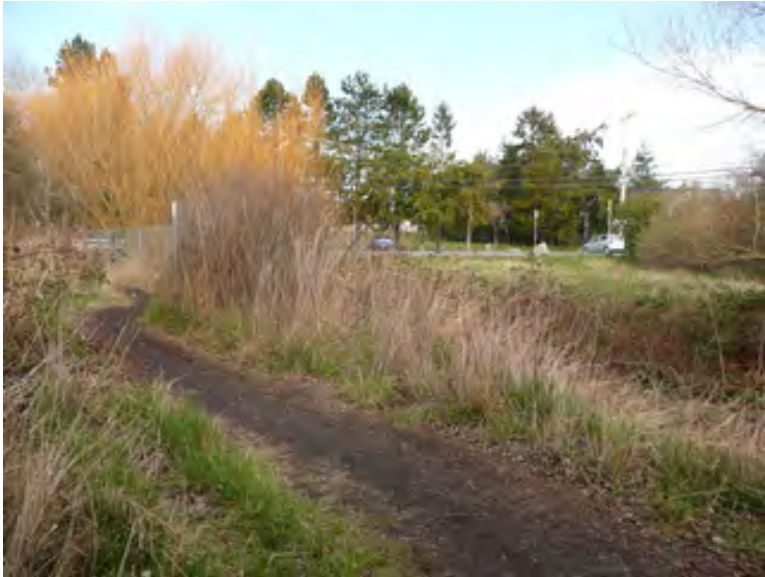
Plate 26: looking from the west bank to the triangle of land south of Haultain on the east bank. This area provides potential for widening the creek corridor.
