BOWKER CREEK BLUEPRINT

A 100-year action plan to restore the Bowker Creek Watershed

August 2012
VICTORIA BC

Prepared by the Bowker Creek Initiative with support from
Westland Resource Group Inc., Kerr Wood Leidal Associates Ltd., and Murdoch de Greeff Inc.

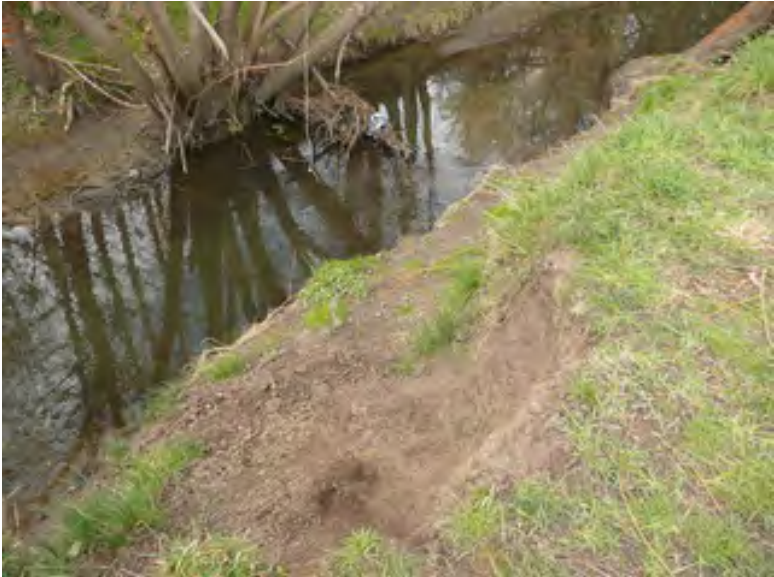
Plate 27: Eroding unvegetated banks on the Bishop of Victoria and Adanac right-of- way property provide an opportunity for short and/or long term restoration actions.

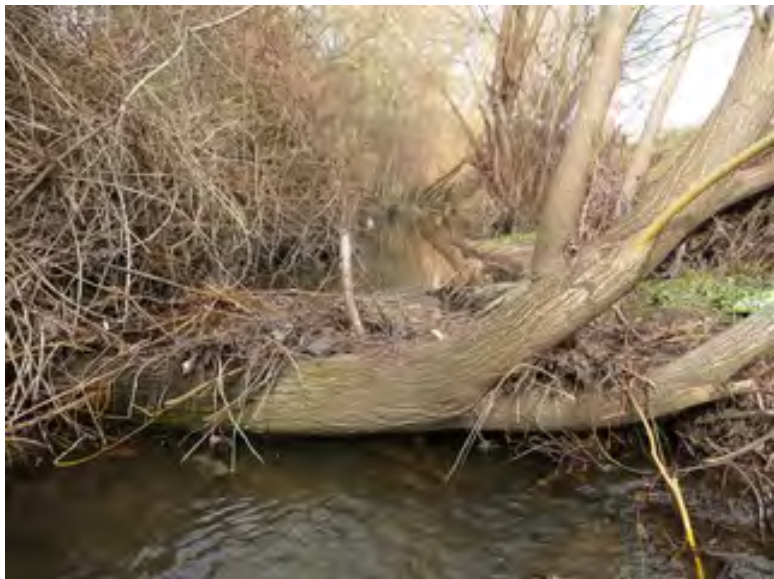
The creek throughout this reach is shallow and lacking complexity, with the exception of large woody debris from a fallen yellow willow (see Plate 26), which is the only significant LWD seen in Bowker Creek outside of UVic. The creek substrate in this reach is variable, with exposed clay and small gravels, extensive yellow willow root mats, areas with cobble, and areas with a silty/sandy soft bottom.

Plate 28: This fallen yellow willow offers rare large woody debris in Bowker Creek.

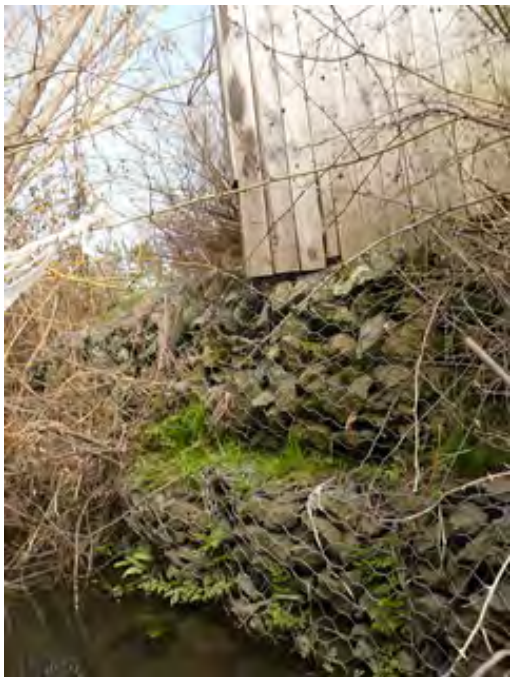
Plate 29: The property at 1875 Haultain comes to a point at the edge of Bowker Creek and is stabilized by gabions.

Short term riparian restoration potential and techniques Remove invasives on the west bank, and plant with a diversity of native trees and shrubs. Monitor the areas with dead bioengineering wattles to determine whether problems with erosion will develop over time. Plant native shrubs and trees on the upper reach east bank where no riparian vegetation currently exists (on triangle south of Haultain and on Bishop/Adanac ROW property). Improve the water quality running off the hospital property, by improving their stormwater infiltration/channel design (see Plate 25).
Short term channel restoration potential and techniques The following could be done in the short term or combined with longer term/larger scale actions: Use the triangle of land immediately south of Haultain, and the informal path on the west bank, to widen the creek corridor (Plate 27). This effort can result in a 15 meter wide corridor, even at the most narrow point. With the exception of the location where a fenceline comes directly to the streambank (see Plate 28), this would allow an opportunity to remove the gabions and create a terraced creek bank with native vegetation. This may require a retaining wall on the west bank and at the corner of the lot at 1875 Haultain—a detailed design would be required.

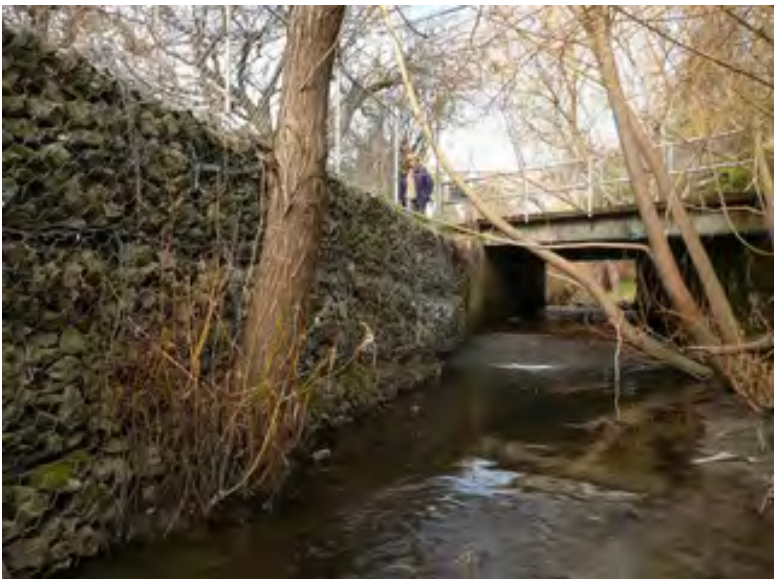
Plate 30: Gabions are controlling erosion at the top end of this reach, allowing for a streamside footpath on the west bank.

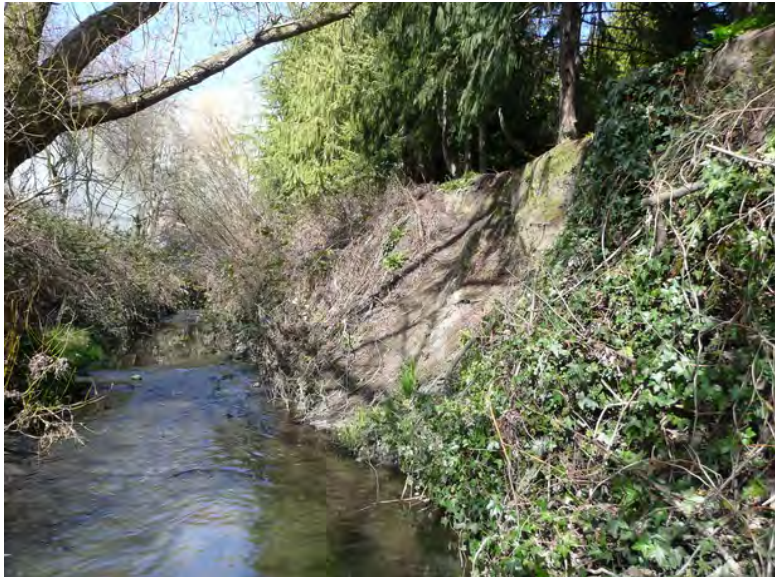
Plate 31: This reach is typified by steep, sparsely vegetated eroding banks and by blackberry on the west bank. It also has more riffle habitat than many sections of Bowker Creek.

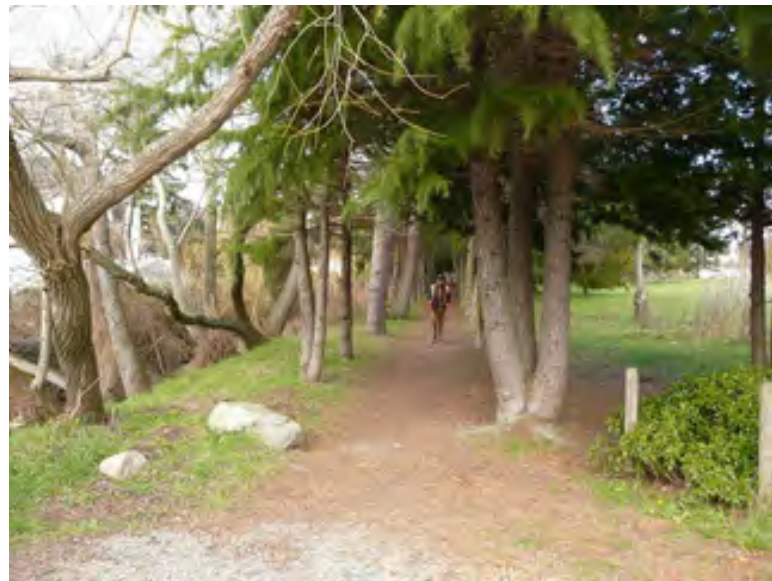
Plate 32: The path along this reach is popular with neighbours and the mature conifer trees that line the path are important to the community.

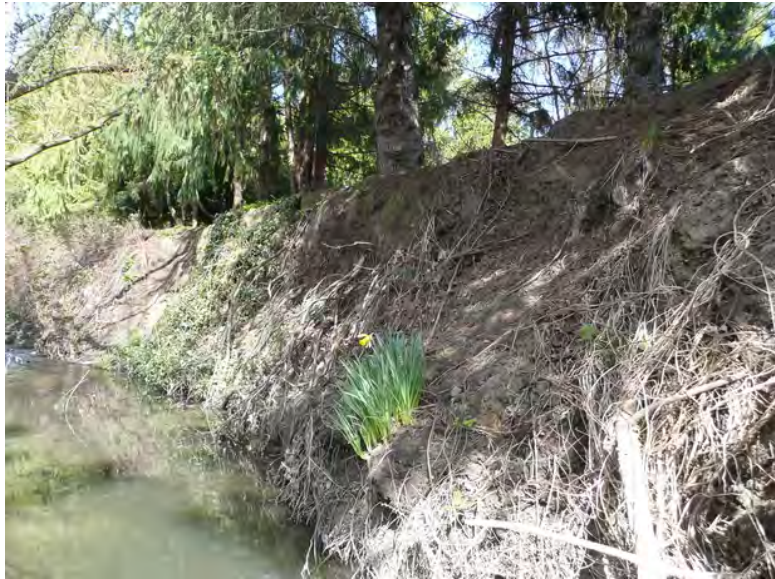
Plate 33: Typical view of the east bank, with the row of conifer trees visible at the top of bank.

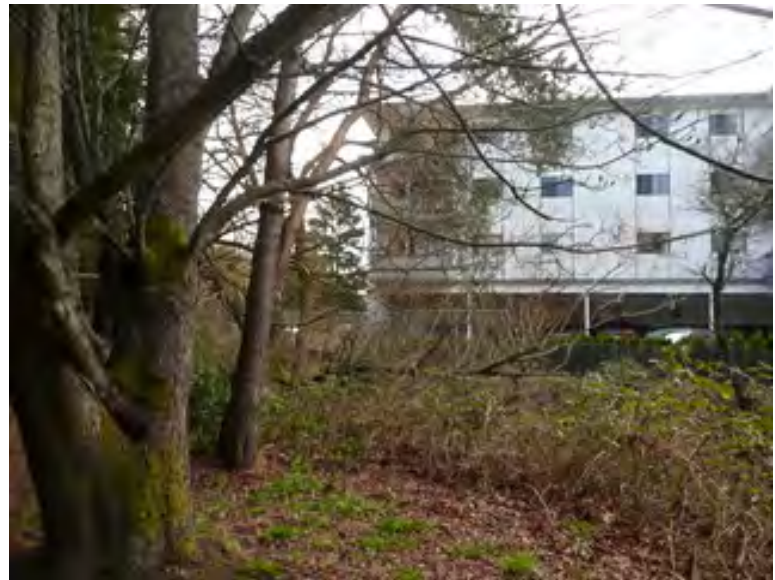
Plate 34: Looking toward the west bank. Bowker Creek is constrained along the west side of the Hydro property and restoration would entail expansion to the east.

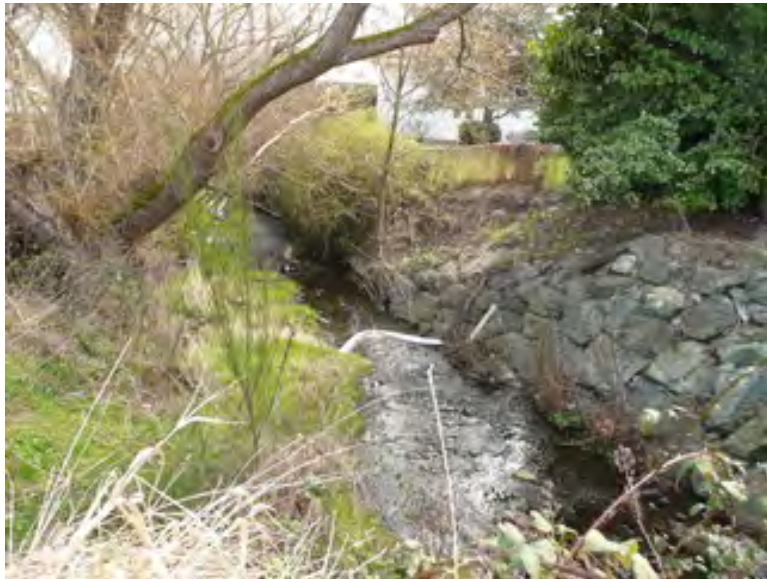
Plate 35: The upper part of the reach below Pearl Avenue is the healthiest in terms of substrate, channel configuration and riparian vegetation. Benthic invertebrate sampling is done here.

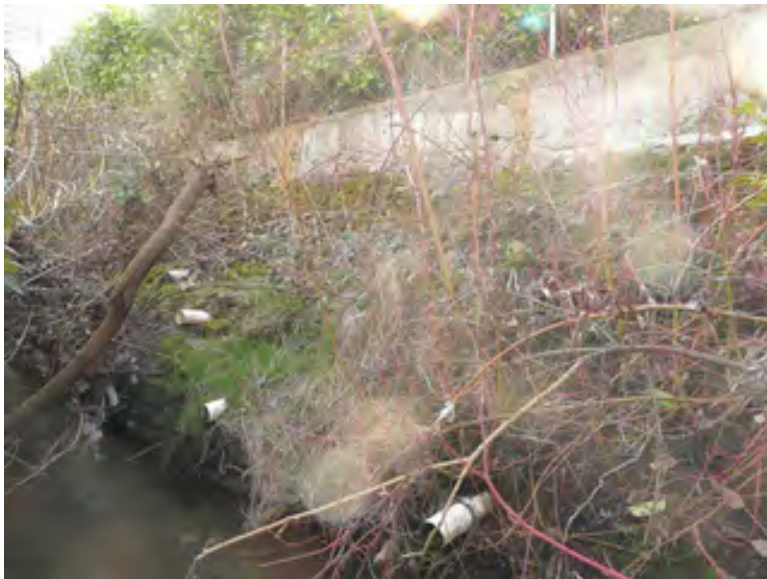
Plate 36: The west bank is constrained in the upper two-thirds of the reach by an extensive apartment complex at 1702 Newton Street.

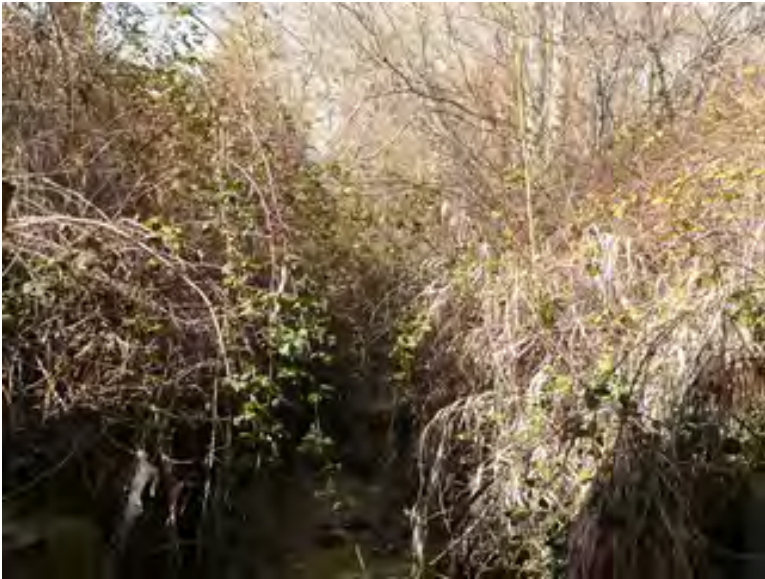
Plate 37: Extensive blackberry is a major feature of this reach.

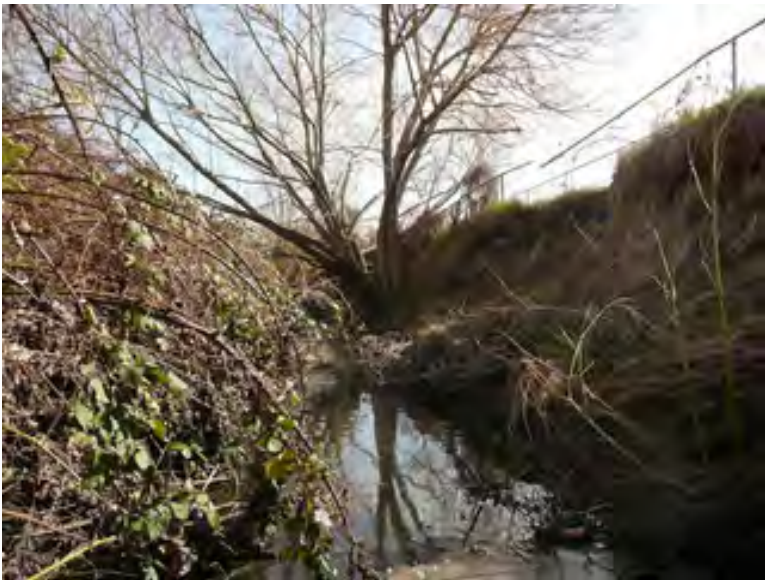
Plate 38: Erosion is an issue through the school grounds. The fence footings have been eroding and public access is worsening the issue.

Observations/Notes This section has the worst erosion anywhere along the creek, and is the most entrenched. Working with the school district to restore this section will create excellent PR. Substrate in this reach is variable and ranges from cobble and gravel to sand to silt to clay. Willow mats cover significant sections. There were two sinkholes encountered, one with an unknown depth. Fish were seen in this reach. They appear to be sticklebacks but the species has not yet been identified. There were hydrocarbons stirred up by walking in this reach, as well as gas from decaying leaves and sediment. On the day the reach was walked, Saanich had a single absorbent oil boom below the Pearl Street outlet. At the top of the reach, there are some native shrubs planted as part of work done to control erosion. These require further maintenance.

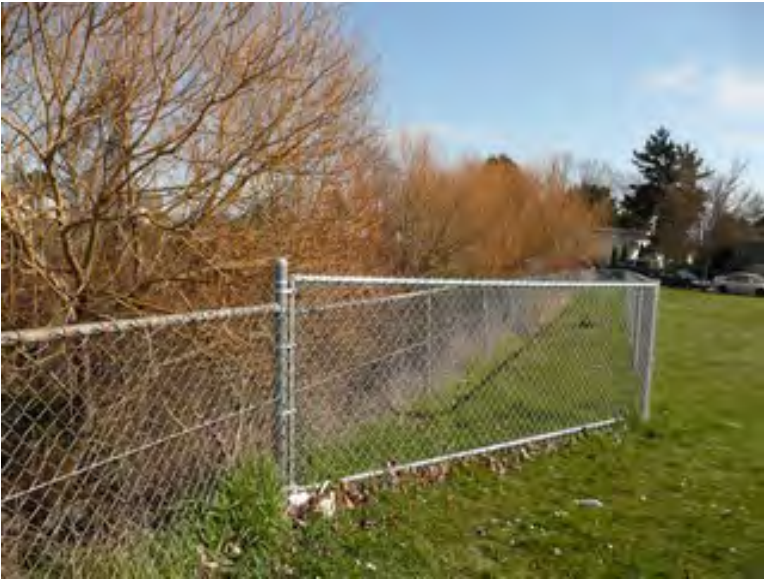
Plate 39: The school district has put extra fencing around eroding sections as a public safety measure.

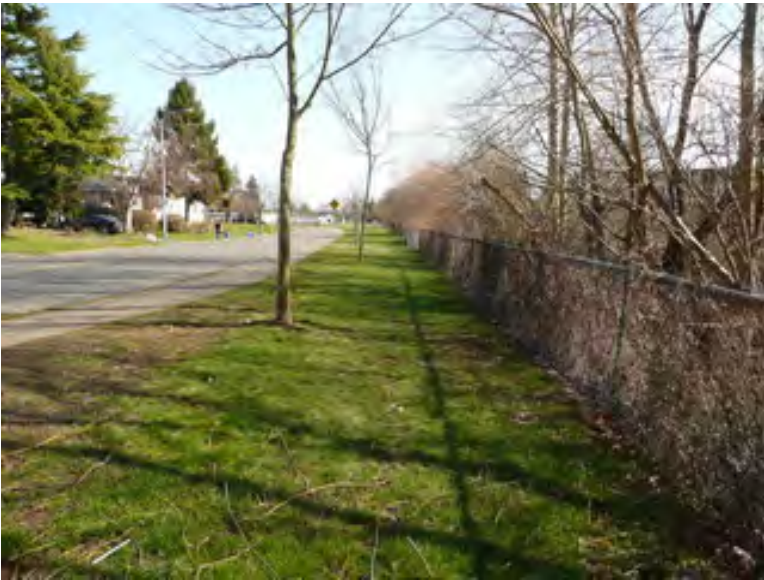
Plate 40: The right-of-way along Townley Street is relatively narrow, but still allows an opportunity to widen the creek corridor.

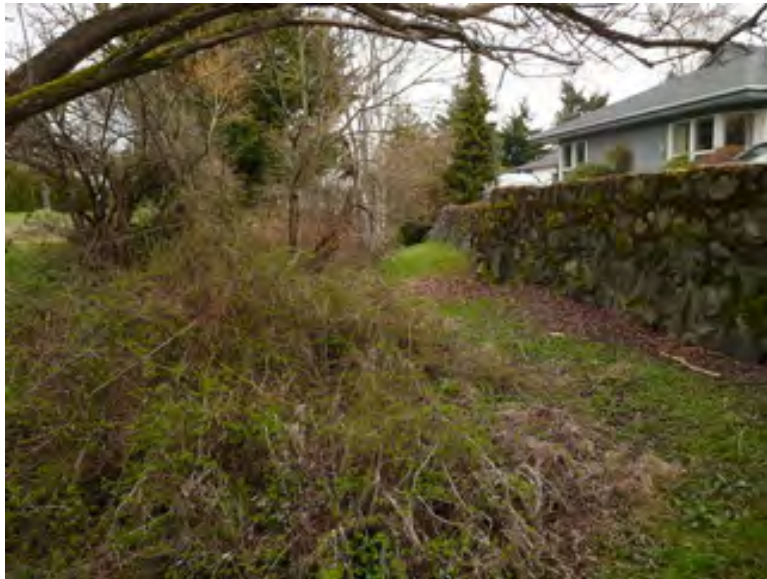
Plate 41: Reach 12A looking north. The patch of grass on the left is the Wordsworth Street right of way accessed from McRae street. The lawn below the rock wall on the right has potential for riparian restoration if the property owner agrees. This could entail some bank resloping.

Percent coverage of invasive vs. native species 95% invasive or unvegetated.
Current width of vegetated riparian corridor and potential width of riparian buffer with private landowner involvement/redevelopment (comment) Corridor width is approximately 8 meters or less, with a very narrow to no riparian buffer. The creek winds between residential properties, and without redevelopment significant restoration will be impossible. However, some worthwhile work could be done if certain property owners agree. The Wordsworth Street right-of-way also offers opportunity.
Short term riparian restoration potential and techniques Remove the small patch of lamium on the west bank downstream of the upper footbridge. Vegetate the west bank riparian zone along the Wordsworth Street right of way accessed from McRae Avenue. Reslope the bank to the degree possible while leaving room for a greenway path. Work with the private property owner across from the right of way (1607 McRae Avenue), to vegetate the grassed terrace below their upper rock wall, and to reslope the bank as necessary. Part of the lower terrace is also armoured and part is a bare clay bank. See Plate 41.

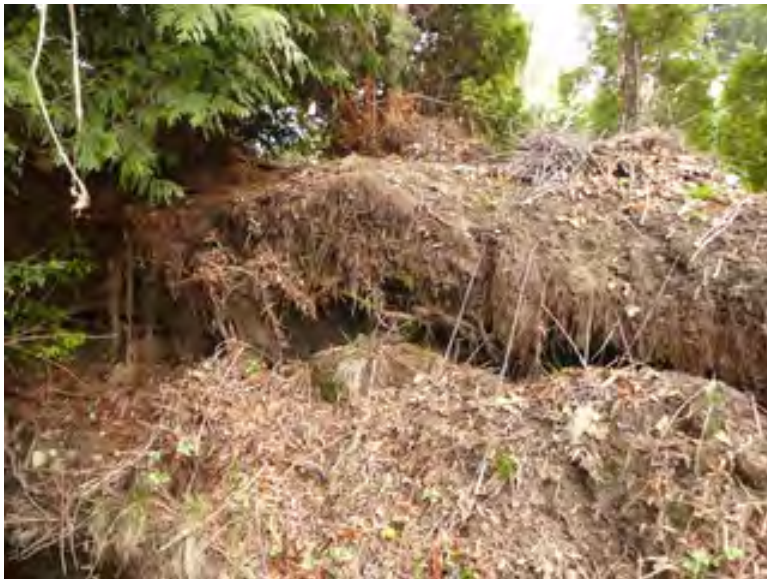
Plate 42: Erosion behind 1599 McRae Avenue. If the property owner agrees, the section along this property is a candidate for bank and riparian restoration.

Short term channel restoration potential and techniques If the property owners at 1599 McRae Avenue agree, grade the bank back, and plant with native species to a buffer distance agreeable with the property owners. The backyard at this address is quite large and extends to the top of bank of Bowker creek with a cedar hedge and fence. The property comes to an angle here and this area is likely not much used. There is erosion all along this section. See Plate 42.
Long term channel and riparian restoration potential Acquire several properties and/or rights-of-way along properties to create floodplain and a riparian buffer. Move the creek into the right-of-way along Keats Street. This would depend on requirements for the electricity line currently in this space. The creek could gain four to five meters of space if this right of way could be made available. The gabions would be removed and the bank resloped, blackberry removed, and planted with native species. There is a fenced property at the south end of Shelley Street, which is part of the lot at 1564 North Dairy. See Plate 46. This area is isolated and unused, and the concrete wall could be removed and a riparian buffer installed. The new streambank would have to be engineered however (e.g. with terraces), as the space is limited and the bank is high. It is unclear whether the city cares for this property or if it is the responsibility of the homeowner at 1564 North Dairy. This action could be taken in the shorter term but would make the most sense as part of a larger program.

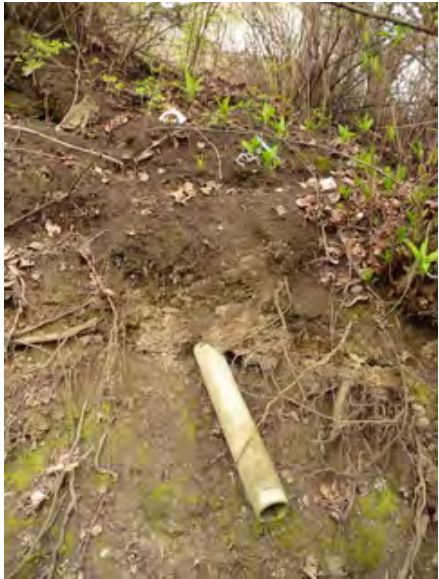
Plate 43: Discrete areas on both banks, particularly the west bank, have erosion problems.

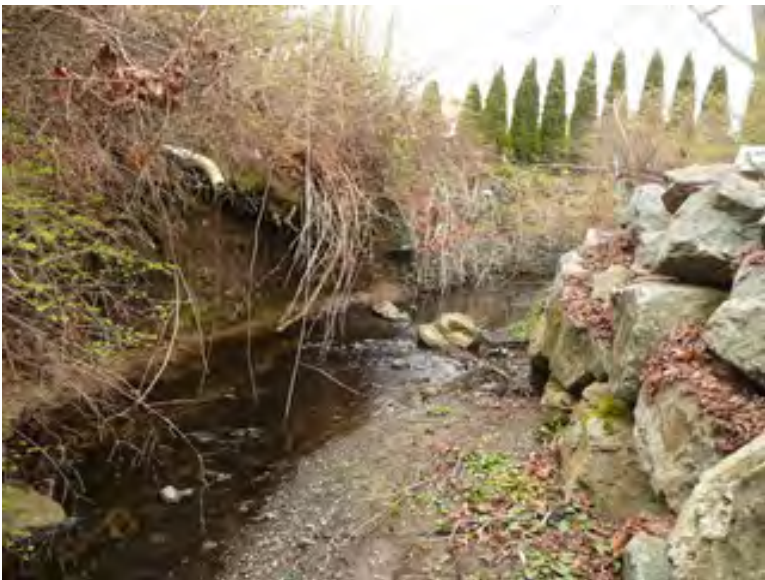
Plate 44: Upstream view. The creek does a sharp turn around this property. This would be a key property to acquire for creek restoration as the house footprint is very close to the creek.

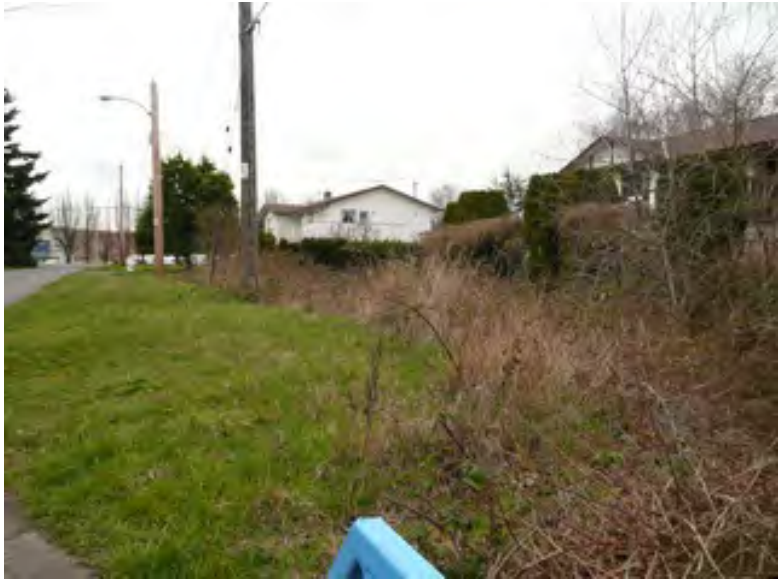
Plate 45: Looking south along the right of way on Keats Street. Depending on whether the power line could be moved, the creek could be extended into the right of way, allowing the gabions on the east bank to be removed and natural riparian vegetation planted.

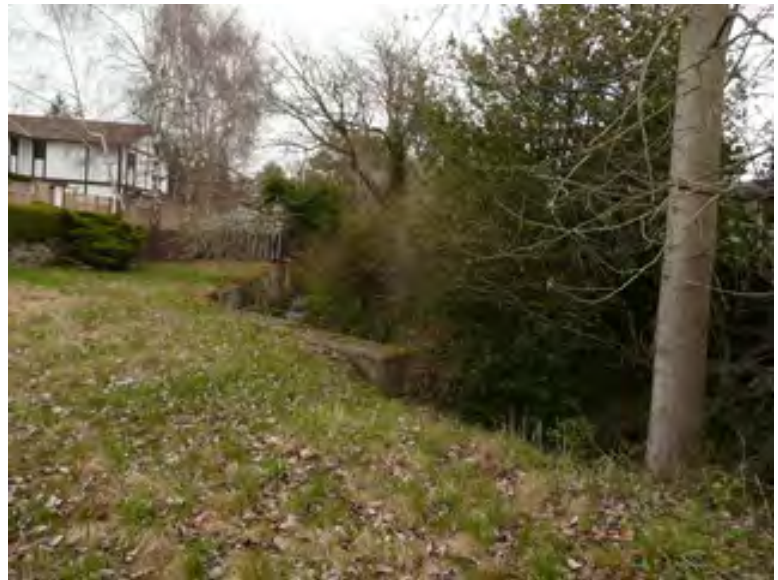
Plate 46: This streamside property appears to be part of the lot at 1564 North Dairy. It could be reconfigured as part of short or long term restoration plans

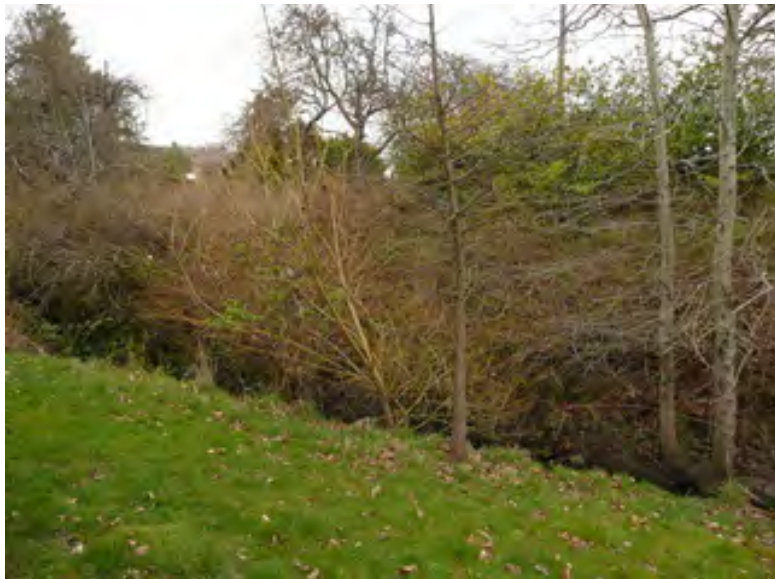
Plate 47: Grassy area along west bank that is a candidate for riparian planting

Plate 48: The top of the reach looking across to the armoured east bank. The creek is highly incised here.

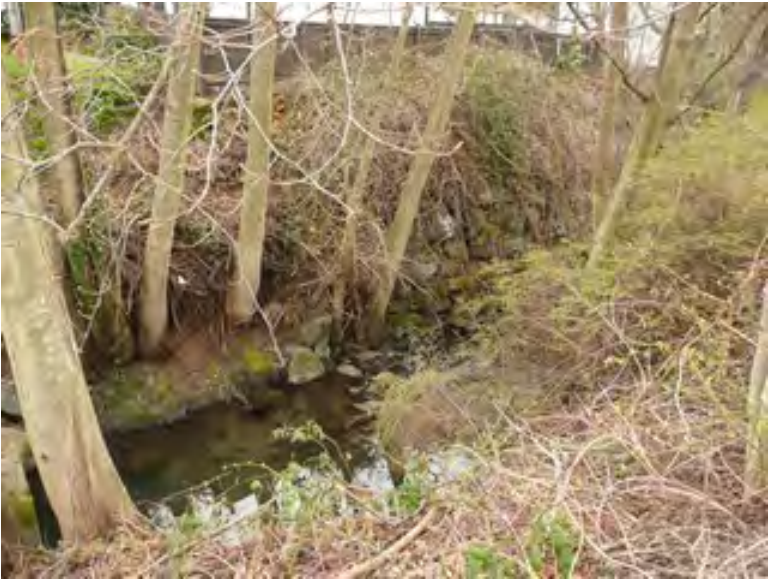
Plate 49: Looking south from the top of the reach. The current path curves towards the creek and with park redevelopment will be moved west to provide space for a riparian buffer, including a resloping of the creek bank.

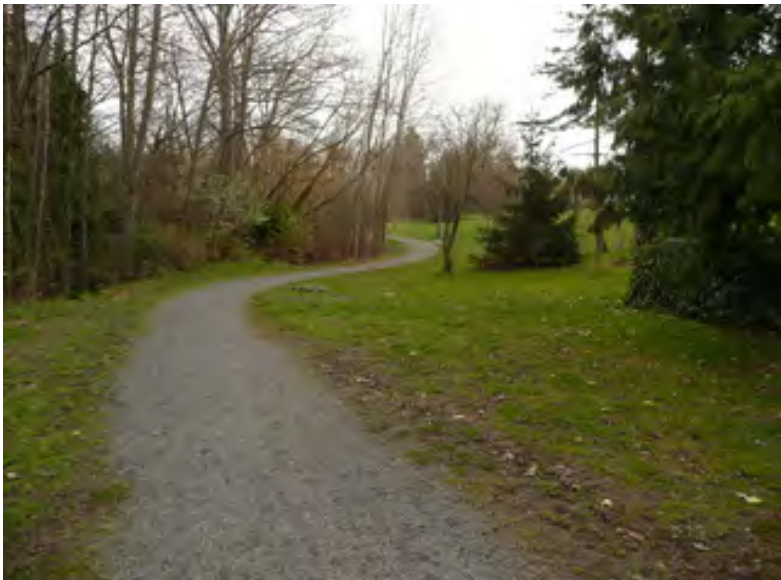
Plate 50: looking across to the east bank where homes have been removed to expand the park. Even if the creek is not moved further east to accommodate a wider riparian buffer on the west bank, the east bank can be re-graded and have riparian buffer on the west bank, the east bank can be re-graded and have riparian vegetation planted, and the rock wall removed.

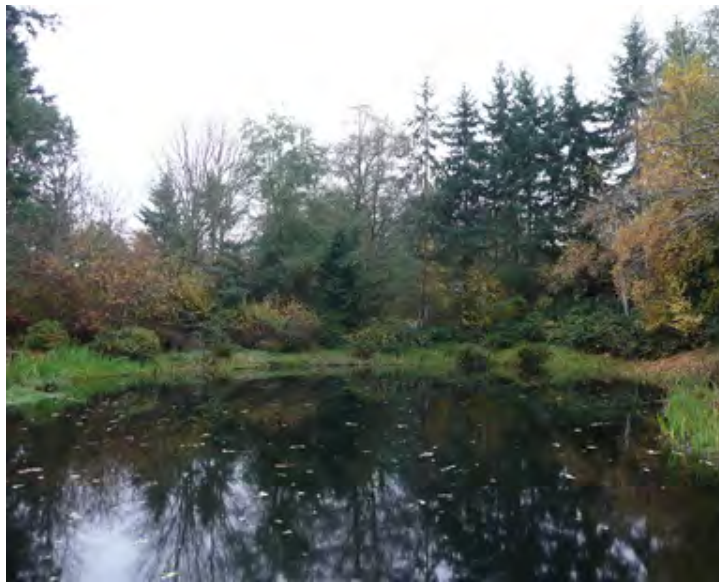
Plate 51: The pond at the Faculty Club, Reach 15A. The pond edge is somewhat landscaped and native plantings could be increased.

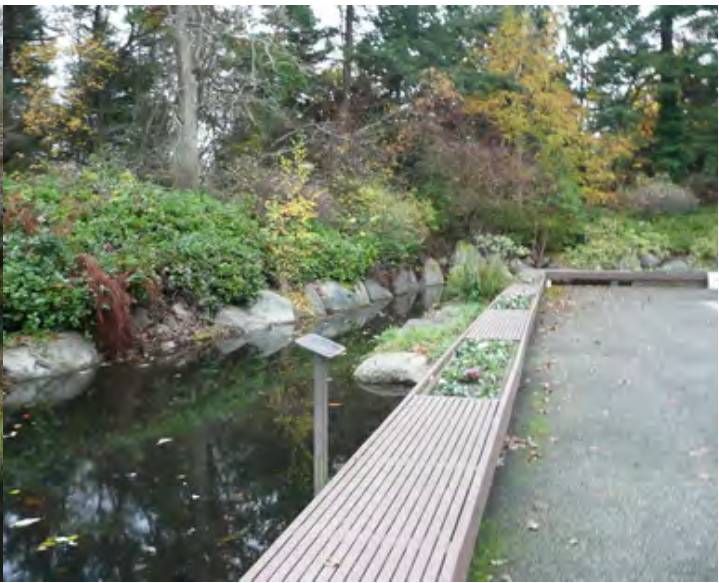
Plate 52: The pond edge is the concrete patio at the Faculty Club. Looking downstream to beginning of outlet channel.

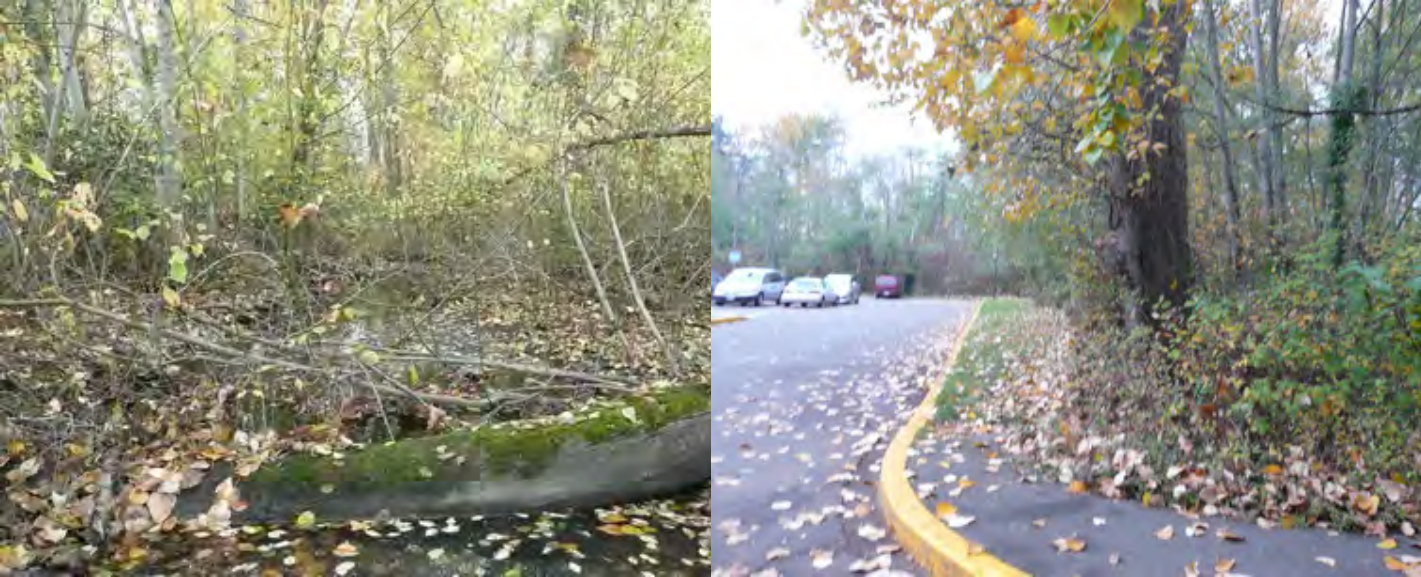
Plate 55: Creek channel behind Faculty Club parking lot

Plate 56: Location of creek channel beside Faculty Club parking lot. The riparian buffer could be extended into the grass ROW.

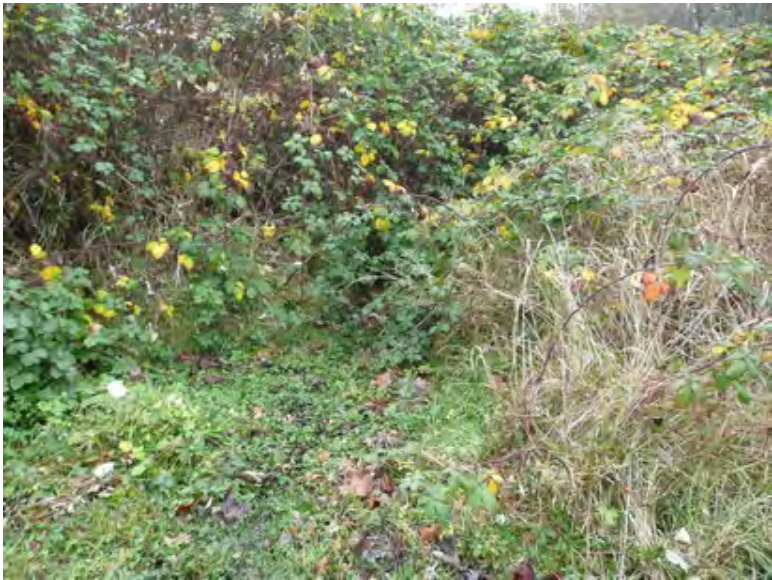
Plate 57: Blackberry lined drainage channel from parking lot 10 (near Visual Arts building) to vicinity of Reach 15B. This presents an opportunity to create a more natural channel with native plants and interpretive signage about runoff and Bowker Creek.

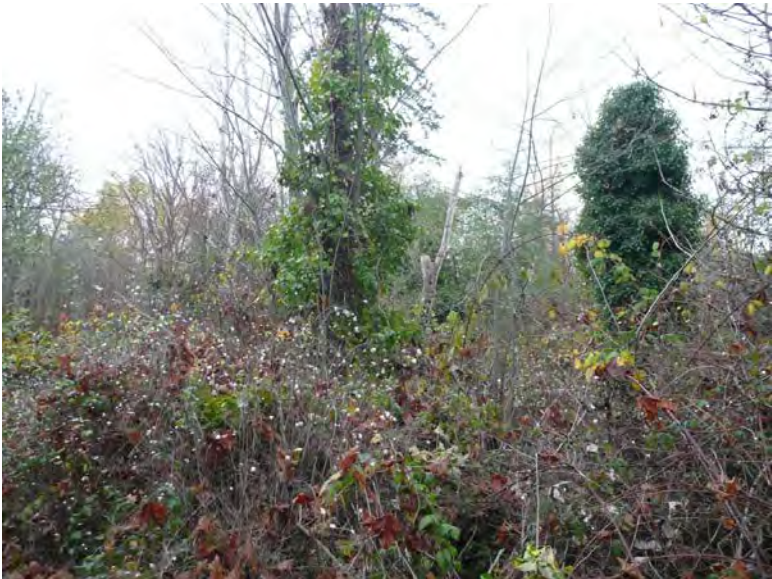
Plate 58: ivy covered trees and blackberry mixed with native vegetation. This is in the area where the forested section of Reach 15C joins with Reach 15B.

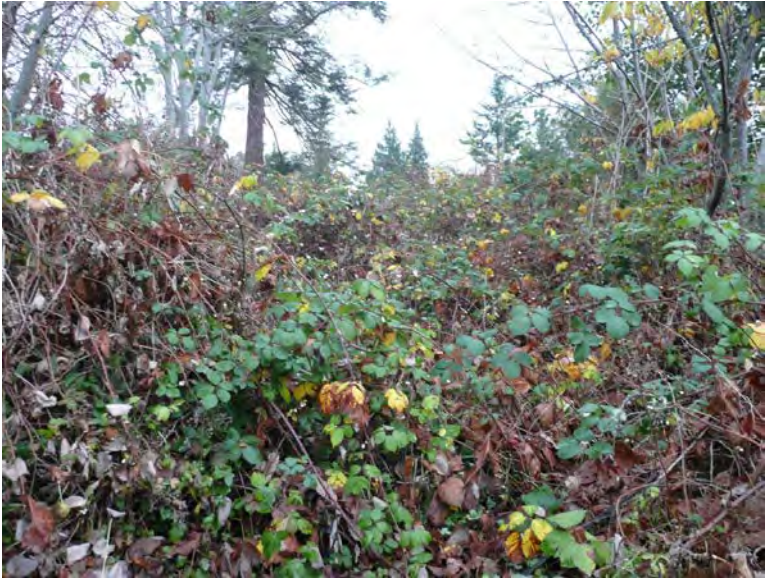
Plate 59: Some pure blackberry patches (in the area of confluence between Reach 15B and 15C, close to the Fraser Building parking lot) are obvious targets for invasive species control

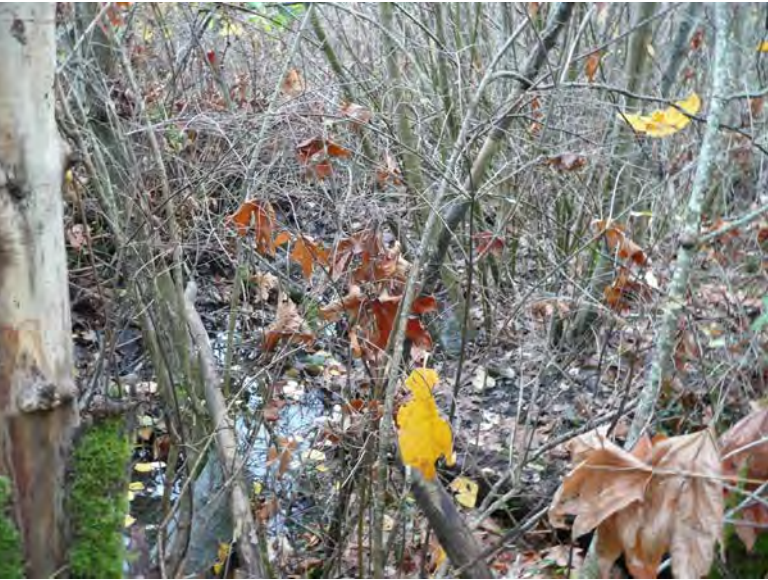
Plate 60: Much of the channel in Reach 15B and the forested area of Reach 15C is impenetrable and inaccessible, and its course has not been accurately mapped.

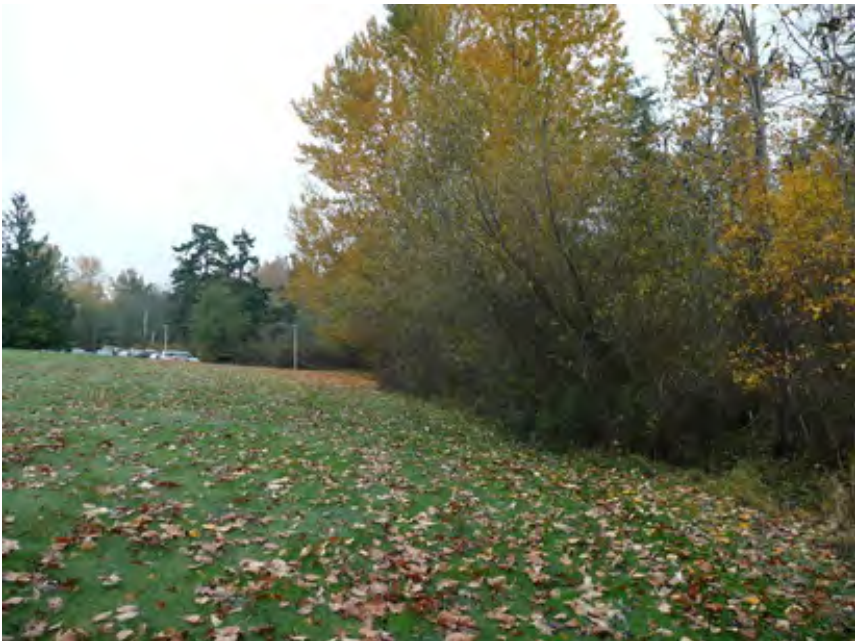
Plate 61: Reach 15C, Section A, has no apparent barriers to restoration. The main restoration action is to increase the width of the riparian buffer.

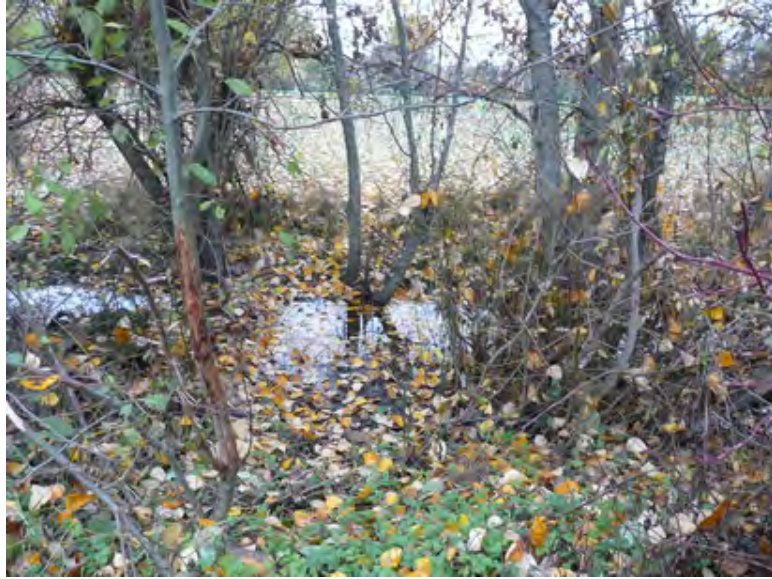
Plate 62: The riparian buffer is quite narrow in some locations, due to mowing near to the creek edge.

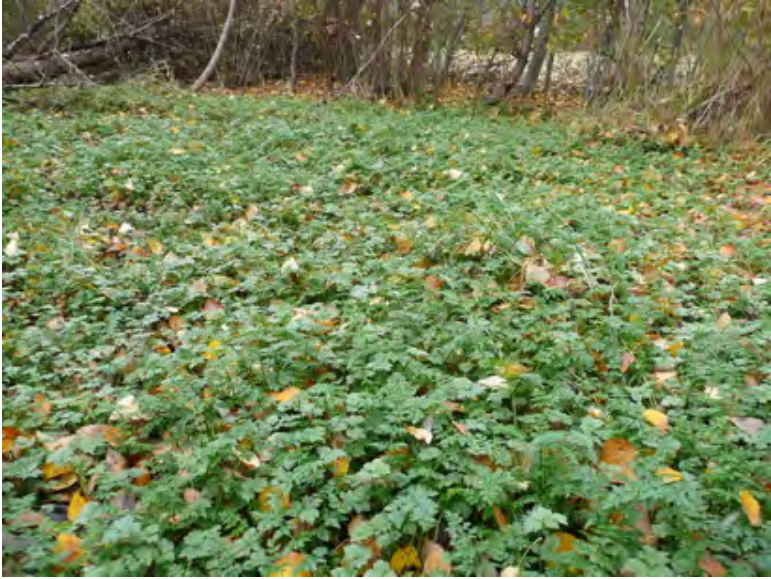
Plate 64: Invasive buttercup occupies a significant area, in some cases mixed with pacific water parsley.

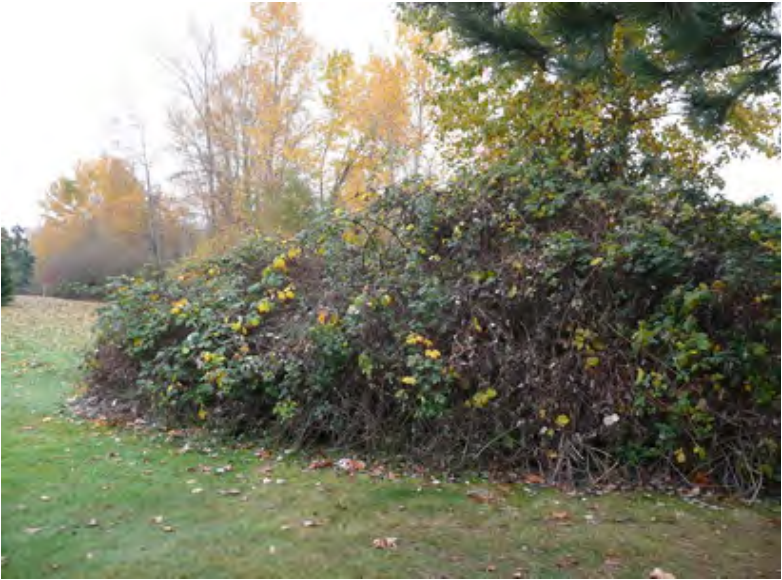
Plate 63: Looking south down Reach 15C (Section A). Stormwater (or groundwater) emerges from inside the blackberry patch to water the reach.

Observations/Notes Flow emerging from the upstream blackberry thicket indicates that pipes are feeding into this reach. However the extent and location of this drainage network is not obvious, and would require more information from Facilities Management to determine.

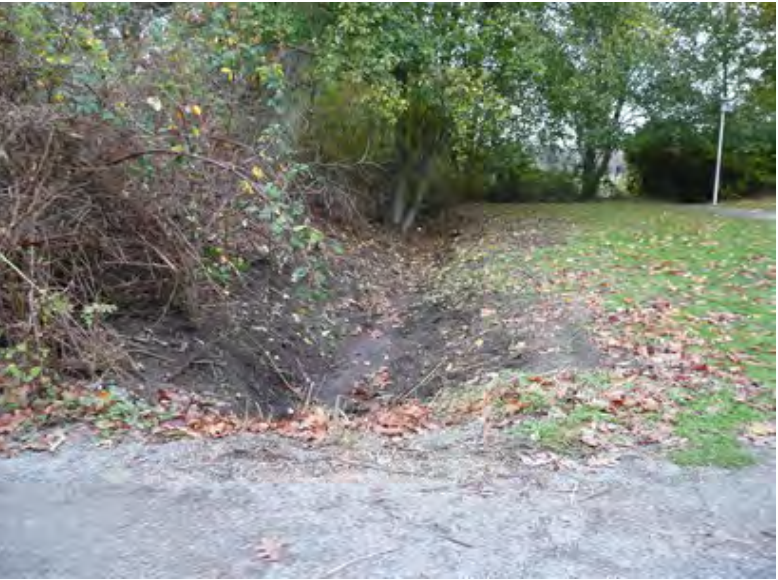
Plate 65: Runoff comes from the Fraser parking lot and is delivered to the channel both overland and through this ditch.
