# 2008 Water Quality Investigations

## Esquimalt Lagoon

Prepared For  
Esquimalt Lagoon Stewardship Initiative

## ESQUIMALT LAGOON 2008 WATER QUALITY INVESTIGATIONS

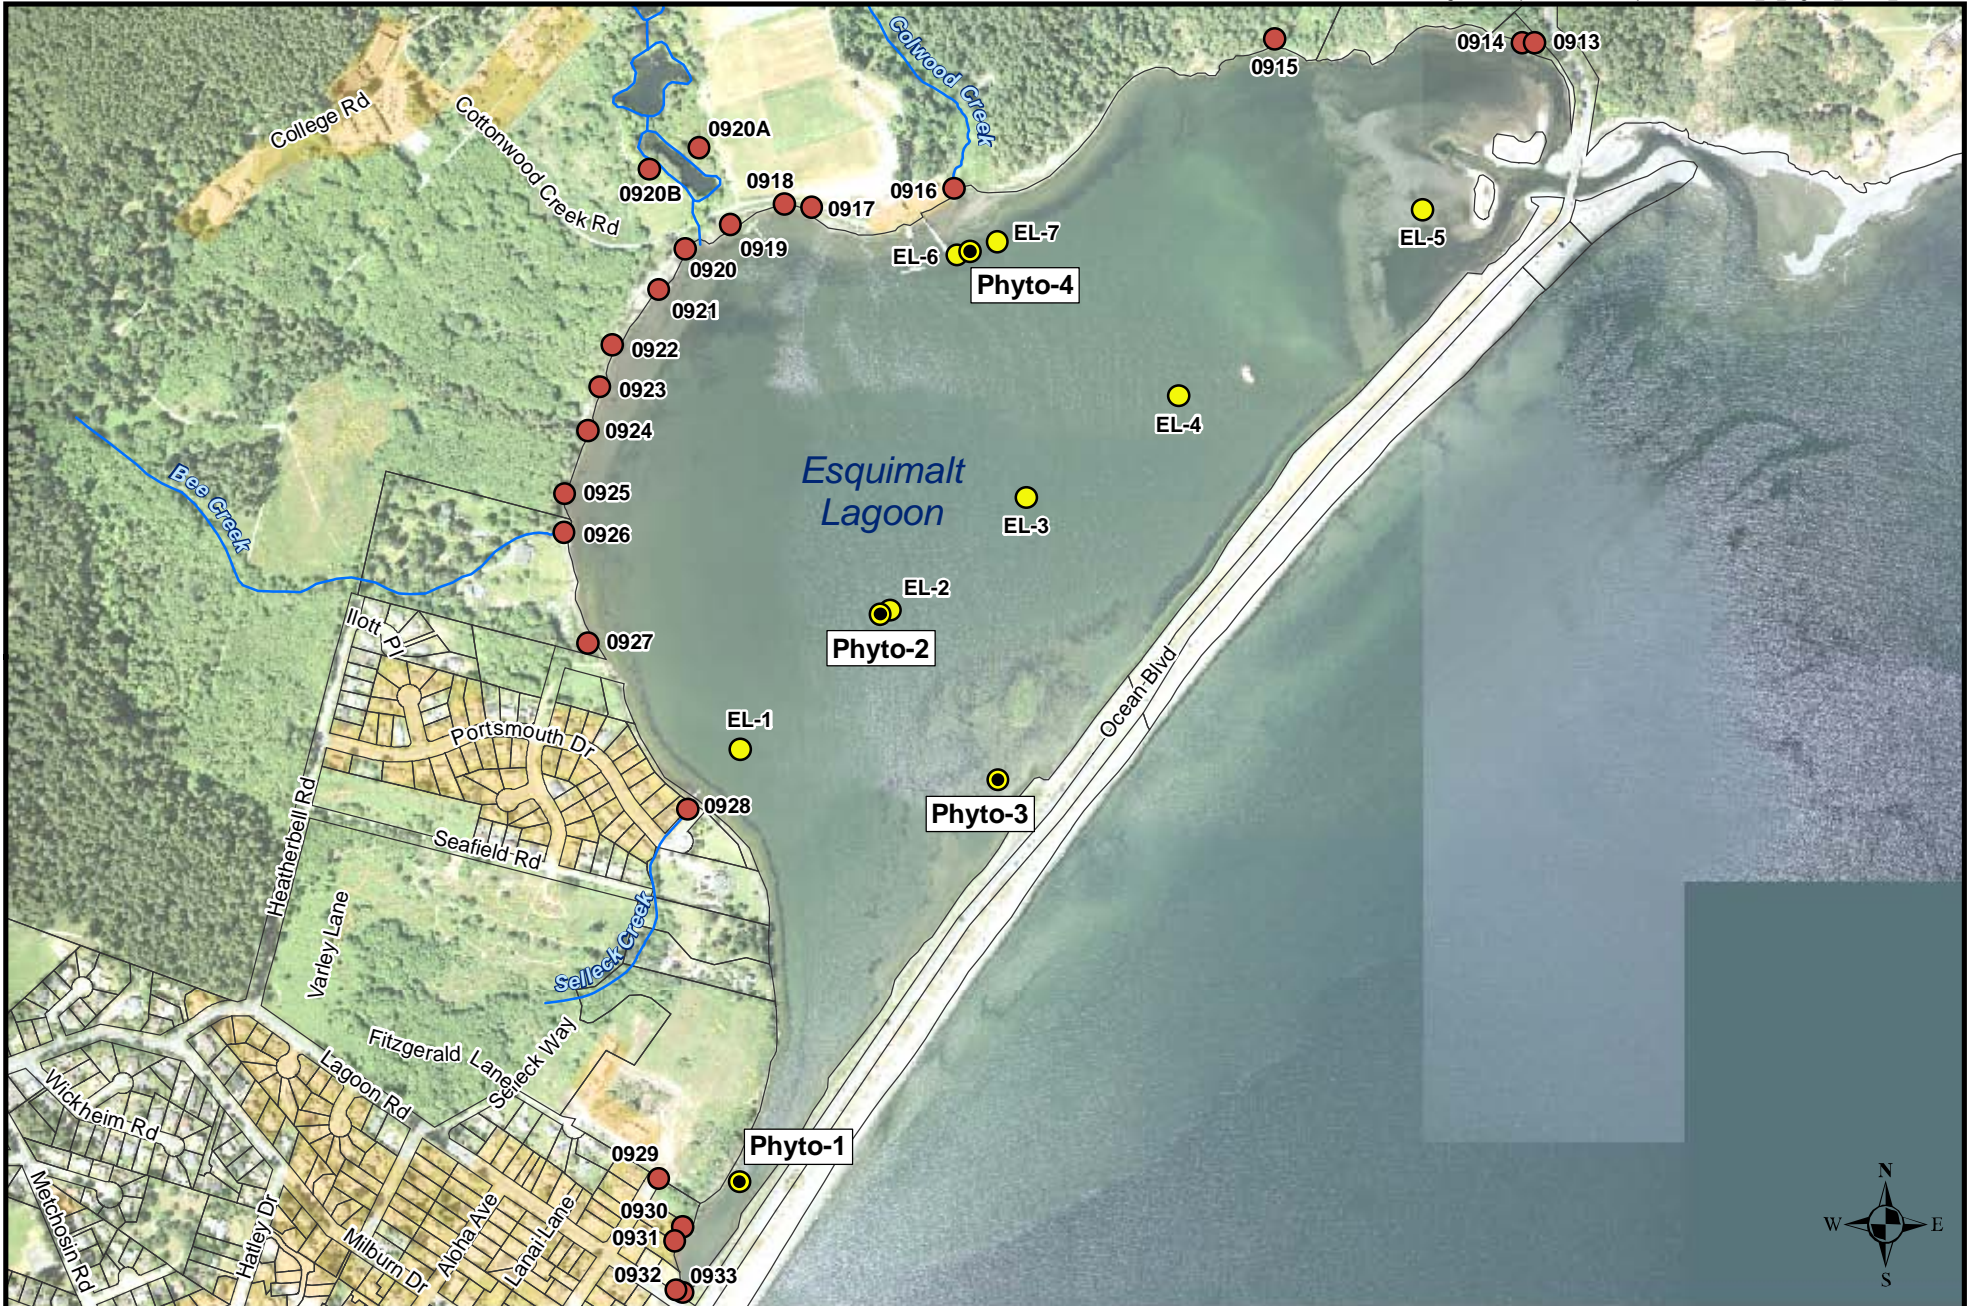
**Figure 1**  
 Esquimalt Lagoon  
 Summer Sampling 2008

**Esquimalt Lagoon**—Marine surface water is sampled during ebb and flood tides at seven stations throughout the lagoon and analyzed for fecal coliform (stations EL-1 to EL-7) twice per year.

- Summer 2008 Marine Surface Water Sampling Points
- Marine Surface Water Sampling Points
- Stormwater Discharge Locations
- Streams
- Lot Lines
- Sewered Areas

**Stormwater discharges**—All stormwater discharges and creeks entering the lagoon have been sampled and analyzed for fecal coliform bacteria at least twice in the last five years. Discharges previously rated high or moderate for public health concern are sampled every year. Sediment samples collected from stormwater discharges that have the potential to contain chemical contaminants are analyzed for metals and polycyclic aromatic hydrocarbons (PAH). Each discharge sampled is rated high, moderate or low for environmental concern. Discharges of a low concern for public and environmental health are re-sampled approximately every five years, depending on time, budgets and environmental conditions. CRD discharges flowing into Esquimalt Lagoon are 913–933 (see Figure 1).

In 2008, due to ongoing occurrences of seasonal algal blooms and previous reports of stress or death of aquatic life in the lagoon, further investigations of water quality and stormwater influences were undertaken. These investigations involved increased parameter sampling and additional locations, including the following (see Figure 1 for sampling locations):

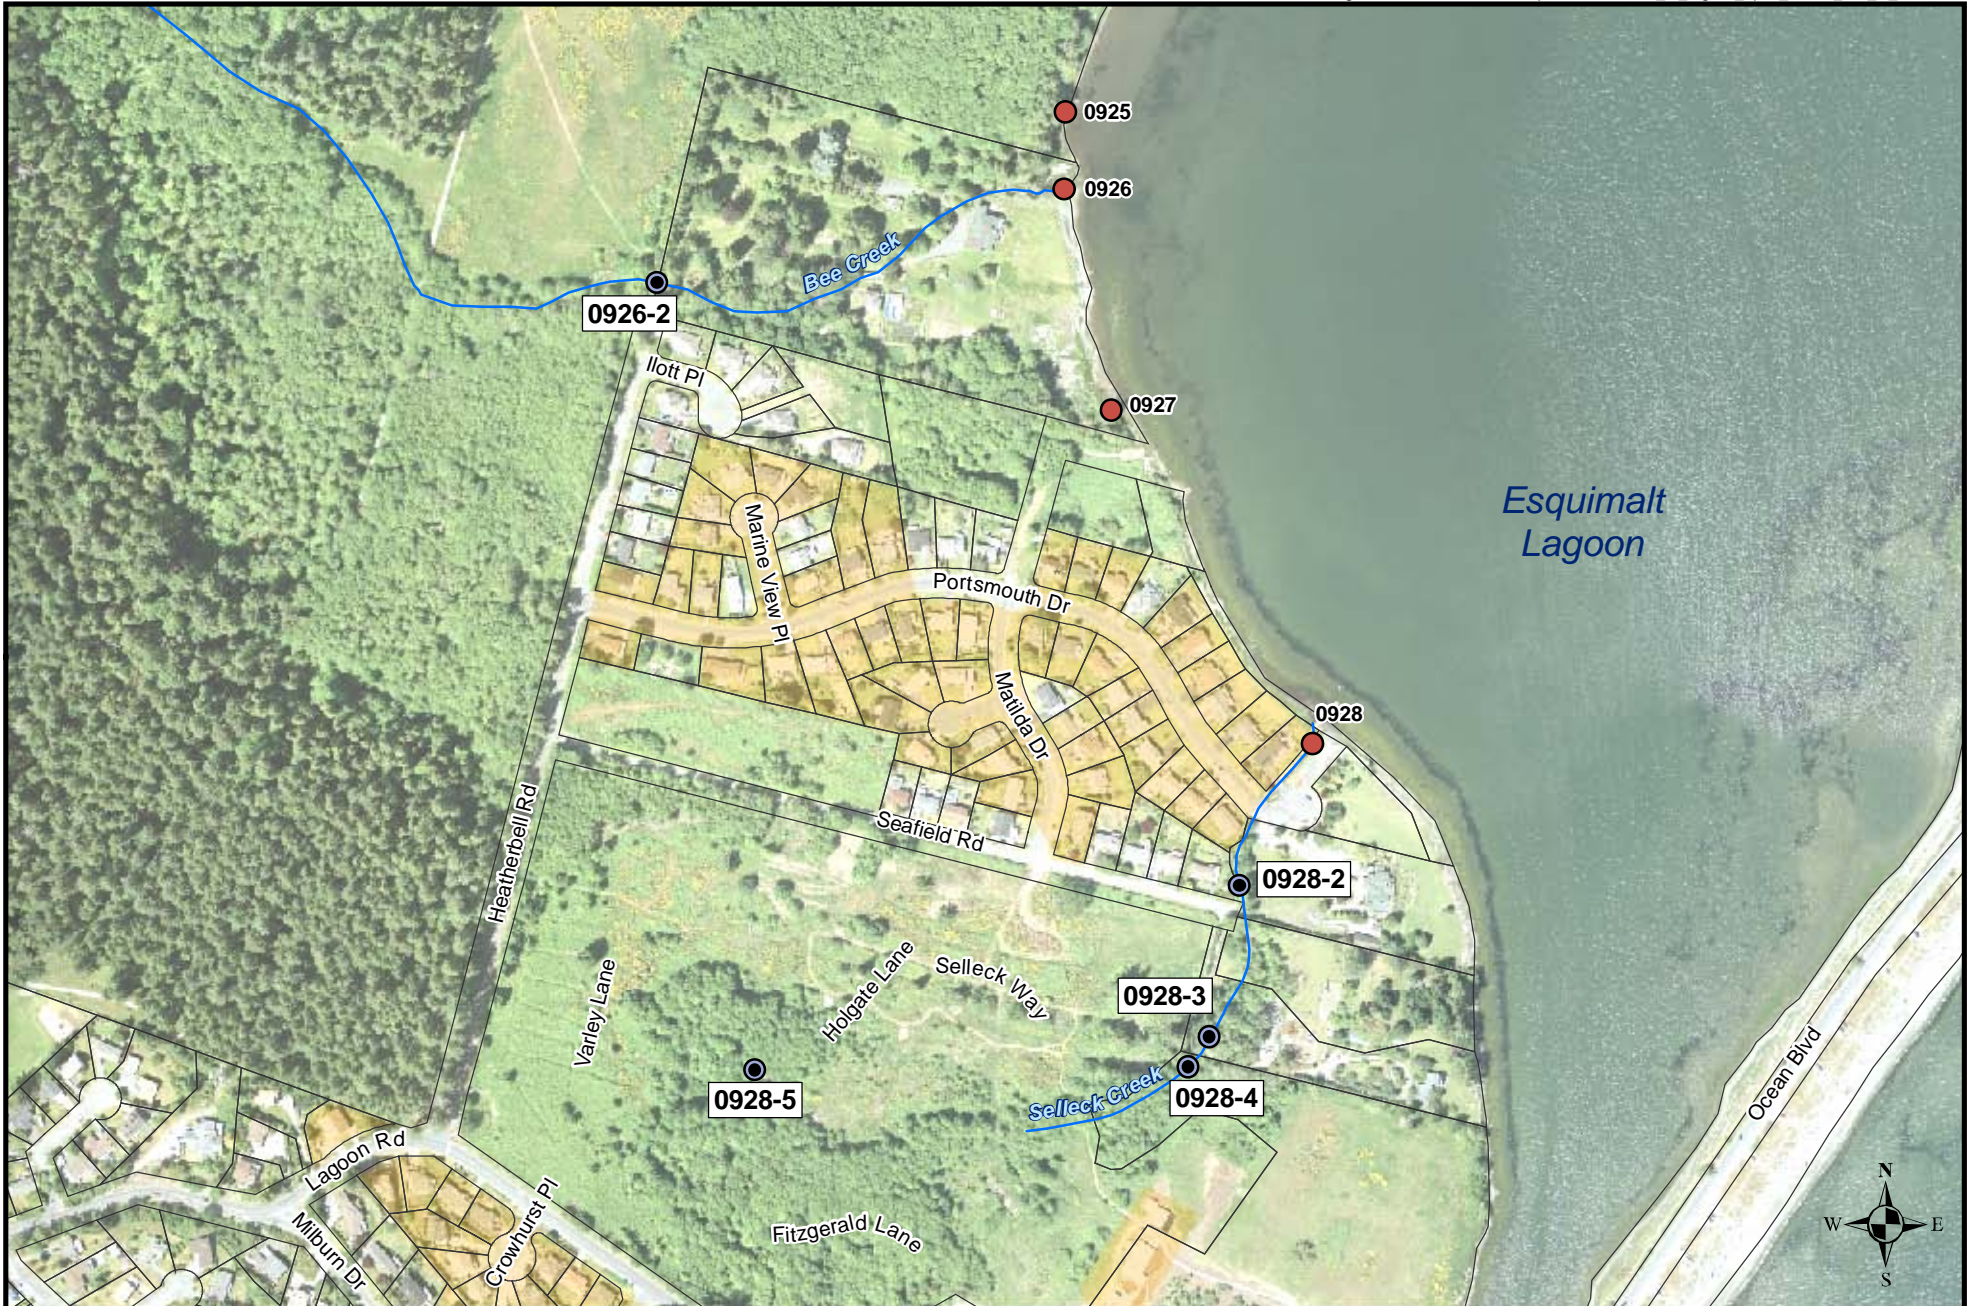
- Summer 2008 Upstream Stormwater Sampling Points
- Stormwater Discharge Locations
- ~ Streams
- Lot Lines
- Sewered Areas

In the summer of 2008, high levels of nitrate, phosphorus and fecal coliform concentrations were found in Selleck Creek. Upstream investigations were done on October 22 and 30, 2008, to narrow down the sources. Of the six nitrate results taken at the mouth of the creek, only one (5.39 mg/L N) exceeded the CCME guideline of 2.95 mg/L N for aquatic life. This result was found on August 5, 2008. One of the six nitrate results was elevated at 2.7 mg/L N on October 8.

The October 22 upstream investigation included sampling the mouth of the creek and sites 928-2 and 928-3. The fecal coliform counts were low at the mouth (point of discharge) (110 FC/100 mL) and at upstream sites 928-2 (100 FC/100 mL) and 928-3 (40 FC/100 mL). An elevated nitrate level of 2.5 mg/L N was found at the mouth of the creek. Only one of the upstream nitrate levels was high at site 928-3 with a result of 3.5 mg/L N. All three sites had turbidity levels (8.29–9.37 NTU) above the BC AWQ guideline of 8 NTU. Phosphorus was above the lower end of the CCME guidelines of 0.035 to 0.1 mg/L in all samples, ranging from 0.036–0.055 mg/L. Field notes indicate the water at 928-3 was “sudsy”, there were geese in the area, and that the riparian zone on the Aquattro property was newly hydro-seeded.
