**SUBTIDAL SURVEY OF PHYSICAL AND BIOLOGICAL FEATURES
OF ESQUIMALT HARBOUR**

**REPORT
& MAP FOLIO**

**DRAFT VERSION - November 2000
REVISED AND UPDATED - February 2004**

Prepared by: Archipelago Marine Research Ltd.
525 Head Street
Victoria, BC
V9A 5S1

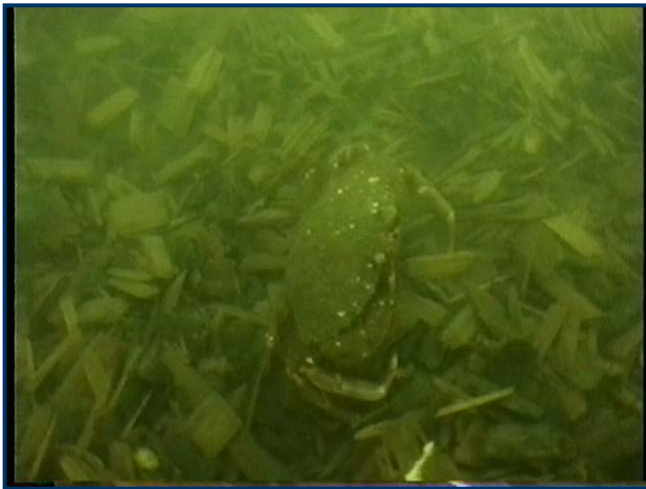
Crab (*Cancer* sp.) with dense bark debris.

As noted in Section 3.3, about 16% of the harbour seabed is impacted by a bark and wood debris (>30% cover). Of this area, approximately 37 hectares are impacted by heavy (>80%) wood and bark debris cover. The largest areas of organic debris are former and current log booming areas located in Plumper Bay/Thetis Cove and the upper part of the harbour north of Smart Island (Figure 8). Decomposing organic material generates anoxic sediments with impacts to benthic community structure, and possibly mobilize sediment contaminants. It is likely that the eelgrass bed in Thetis Cove has been adversely impacted, both in terms of bed size and plant density, by bark and wood debris. Figure 23 shows the distribution of anaerobic bacterial mats (*Beggiotoa* sp.) on the seabed sediments within the harbour. These mats are concentrated in areas of highest organic debris areas (Plumper Bay) as well as in dredge pockets in Lang Cove and south of the Graving Dock (see below). Despite the degraded nature of these areas, some invertebrate species (crab, plumose anemones) are relatively abundant in former log storage areas.

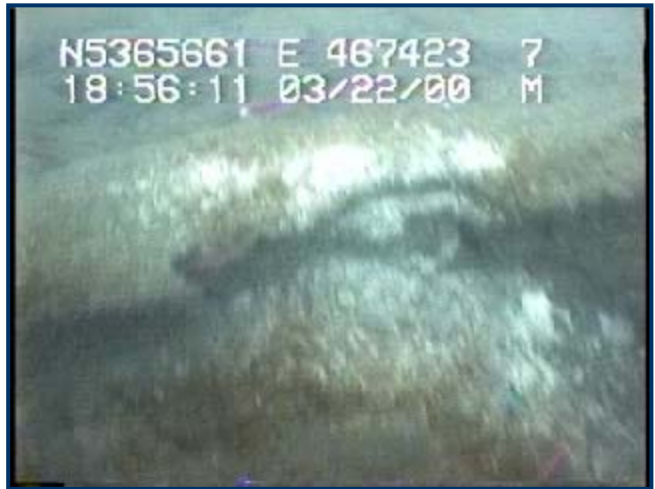
White bacteria (*Beggiatoa* spp.) on log.
