FULFORD WATER SERVICE COMMISSION SPECIAL MEETING

Fulford Water System Asset Management Plan

McElhanney Consulting Services Ltd.

FULFORD WATER SYSTEM ASSET CONDITION ASSESSMENT TABLE

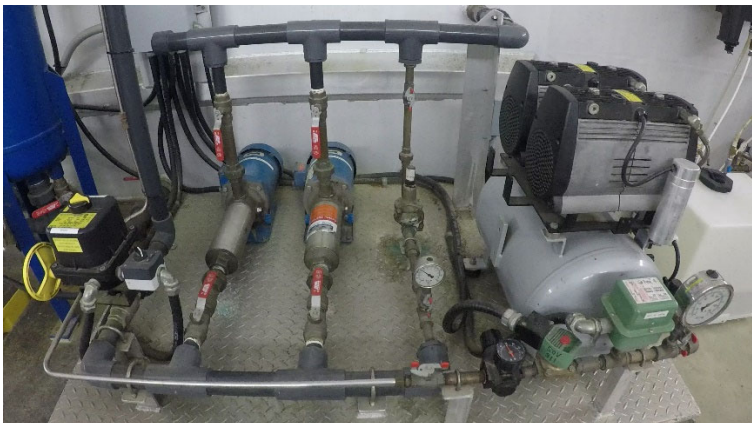
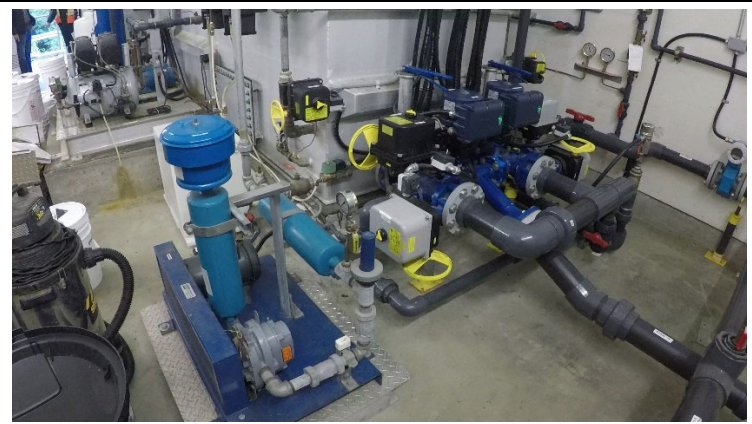
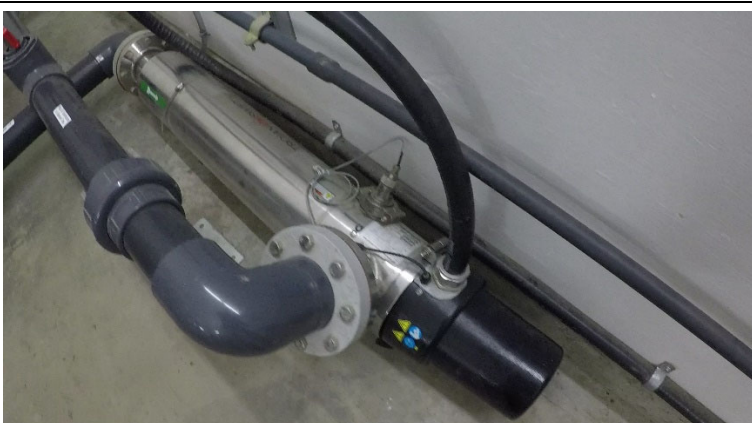
Description:
	Fulford Water Treatment Plant
	Observation:
	DAF duplex pressurization pumps and duplex compressor sitting on top of the air tank. Vertical pressurization vessel (blue) is seen on the left-hand side. The assembly is an integral part of the package WTP.
	Observation:
	DAF outlet manifold on the right-hand side in the background and air scour blower used for filter backwash in the foreground. DAF pressurization system on the left-hand side in the background is an integral part of the package WTP.
	Observation:
	Pressurized single UV disinfection module.

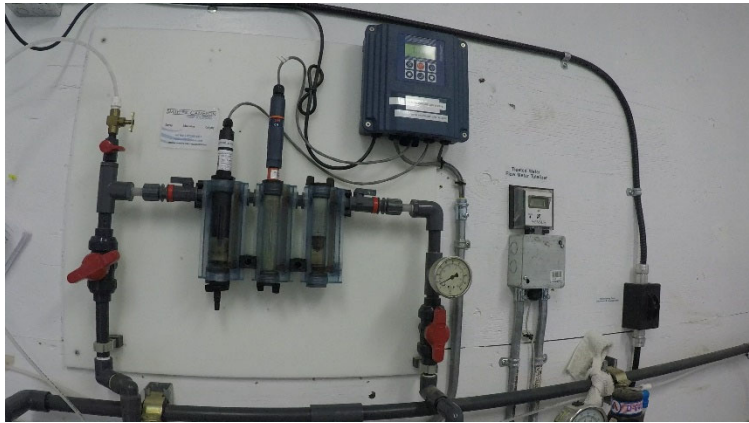
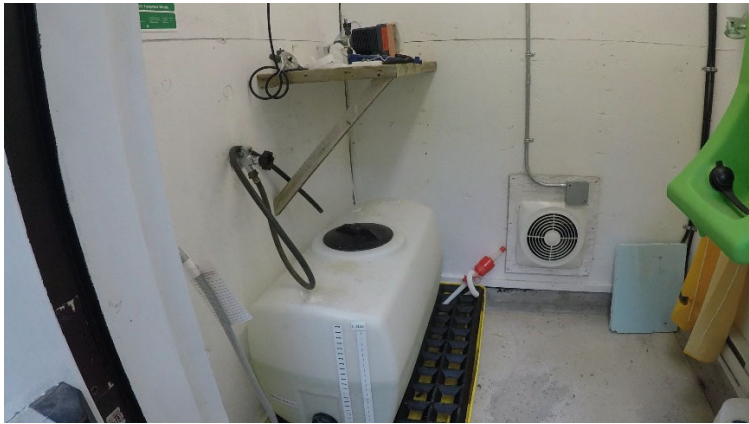
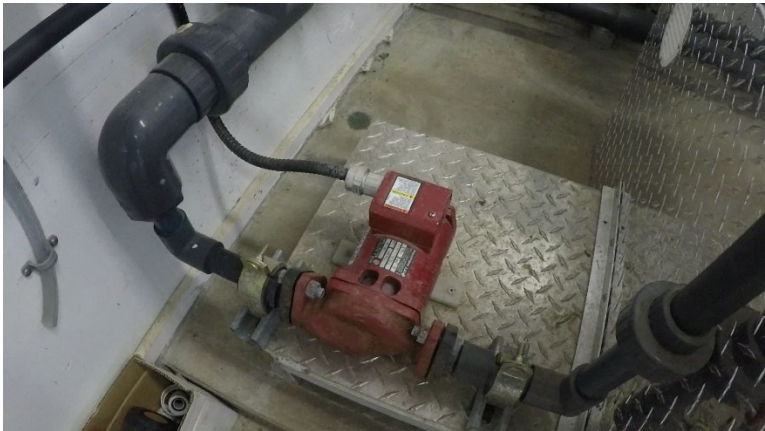
Description:
	Fulford Water Treatment Plant
	Observation:
	Loop system for the clear well and chlorine monitoring equipment.
	Observation:
	Chlorine room with a single chlorine pump and eye wash station (green) on the right-hand side.
	Observation:
	Single chlorine recirculation pump.

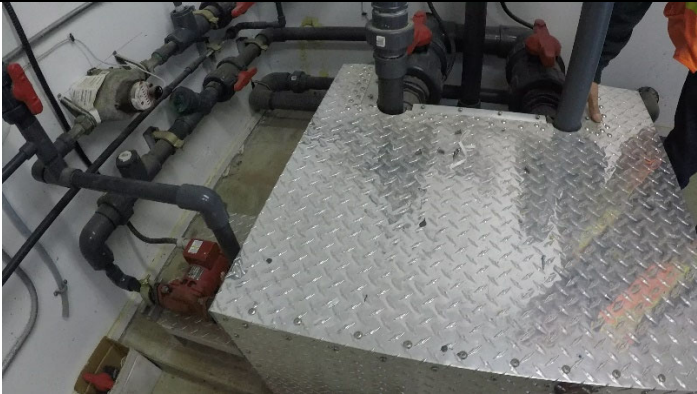
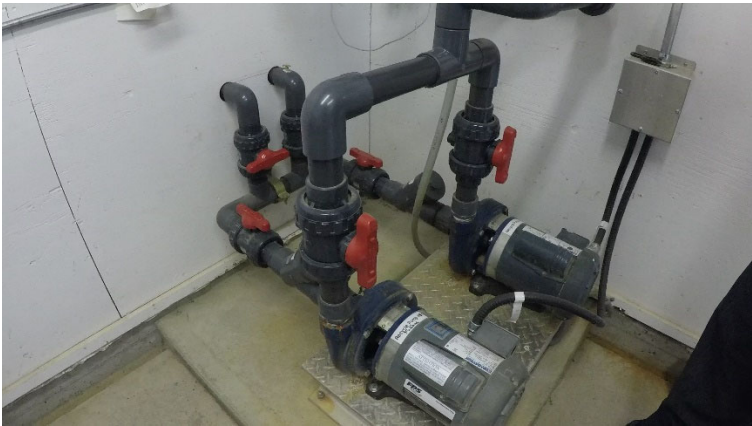
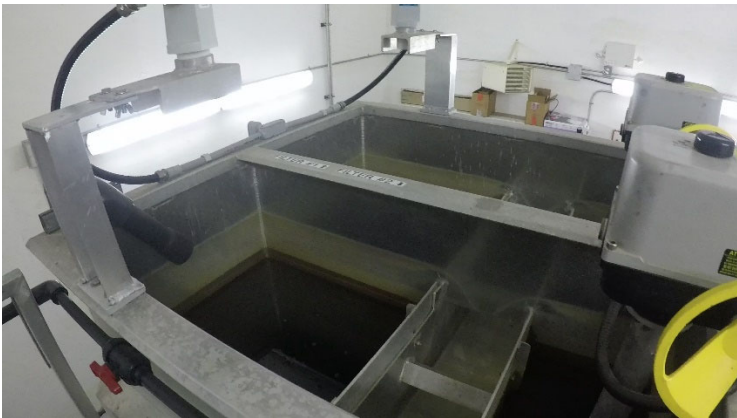
Description:
	Fulford Water Treatment Plant
	Observation:
	Duplex effluent pumps enclosed in a sound insulation box.
	Observation:
	Duplex backwash and rinse water recycle pumps.
	Observation:
	Duplex effluent filters with automatic valves. The WTP processing capacity is 4.5 L/sec (16.2 m ³ /hr).
