SOUTHERN GULF ISLANDS HARBOURS COMMISSION
Notice of Meeting on **Thursday, November 23, 2023 at 9:30 a.m.**
Saanich Peninsula Wastewater Treatment Plant Meeting Room,
9055 Mainwaring Road, North Saanich, BC

Southern Gulf Islands Harbours DOCK INSPECTION REPORT

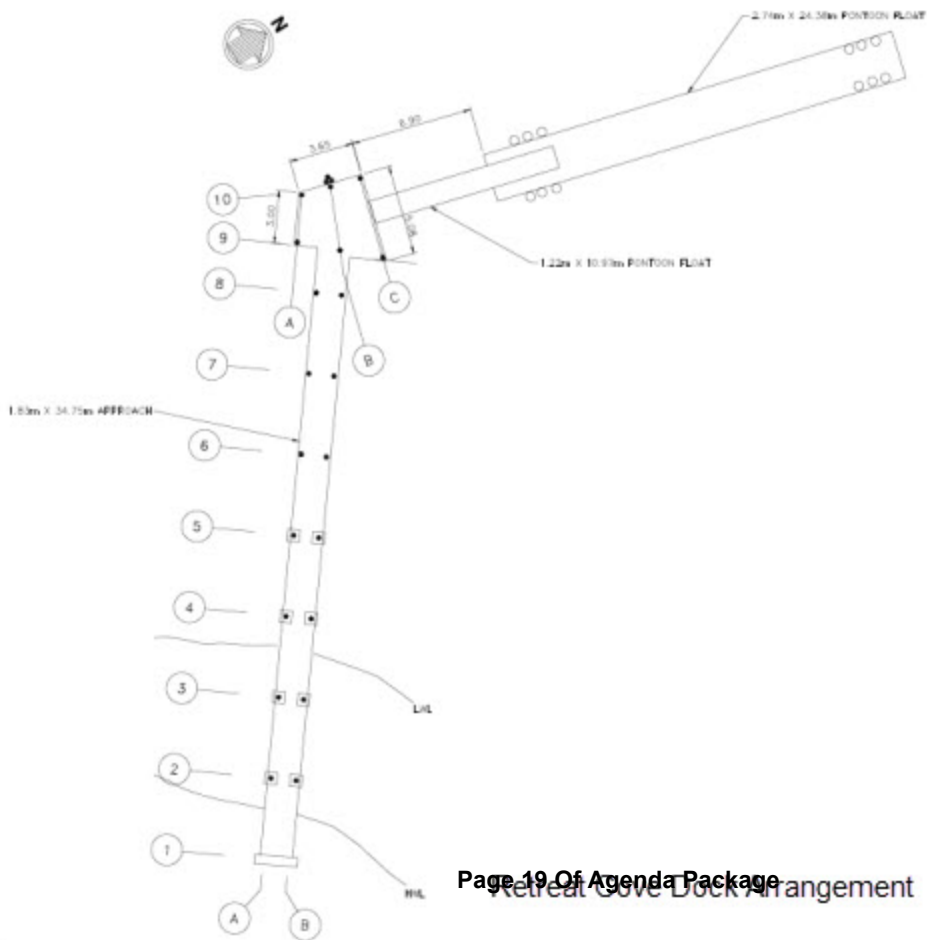
OTHER INSPECTIONS	<input type="checkbox"/> Lighting N/A <input checked="" type="checkbox"/> Life Rings / Heaving Lines good
	<input checked="" type="checkbox"/> Extinguishers (expiry dates) May 2024 <input type="checkbox"/> Unpaid Moorage

COMMENTS/INSTRUCTIONS	> Pressure washing later in the winter is required.

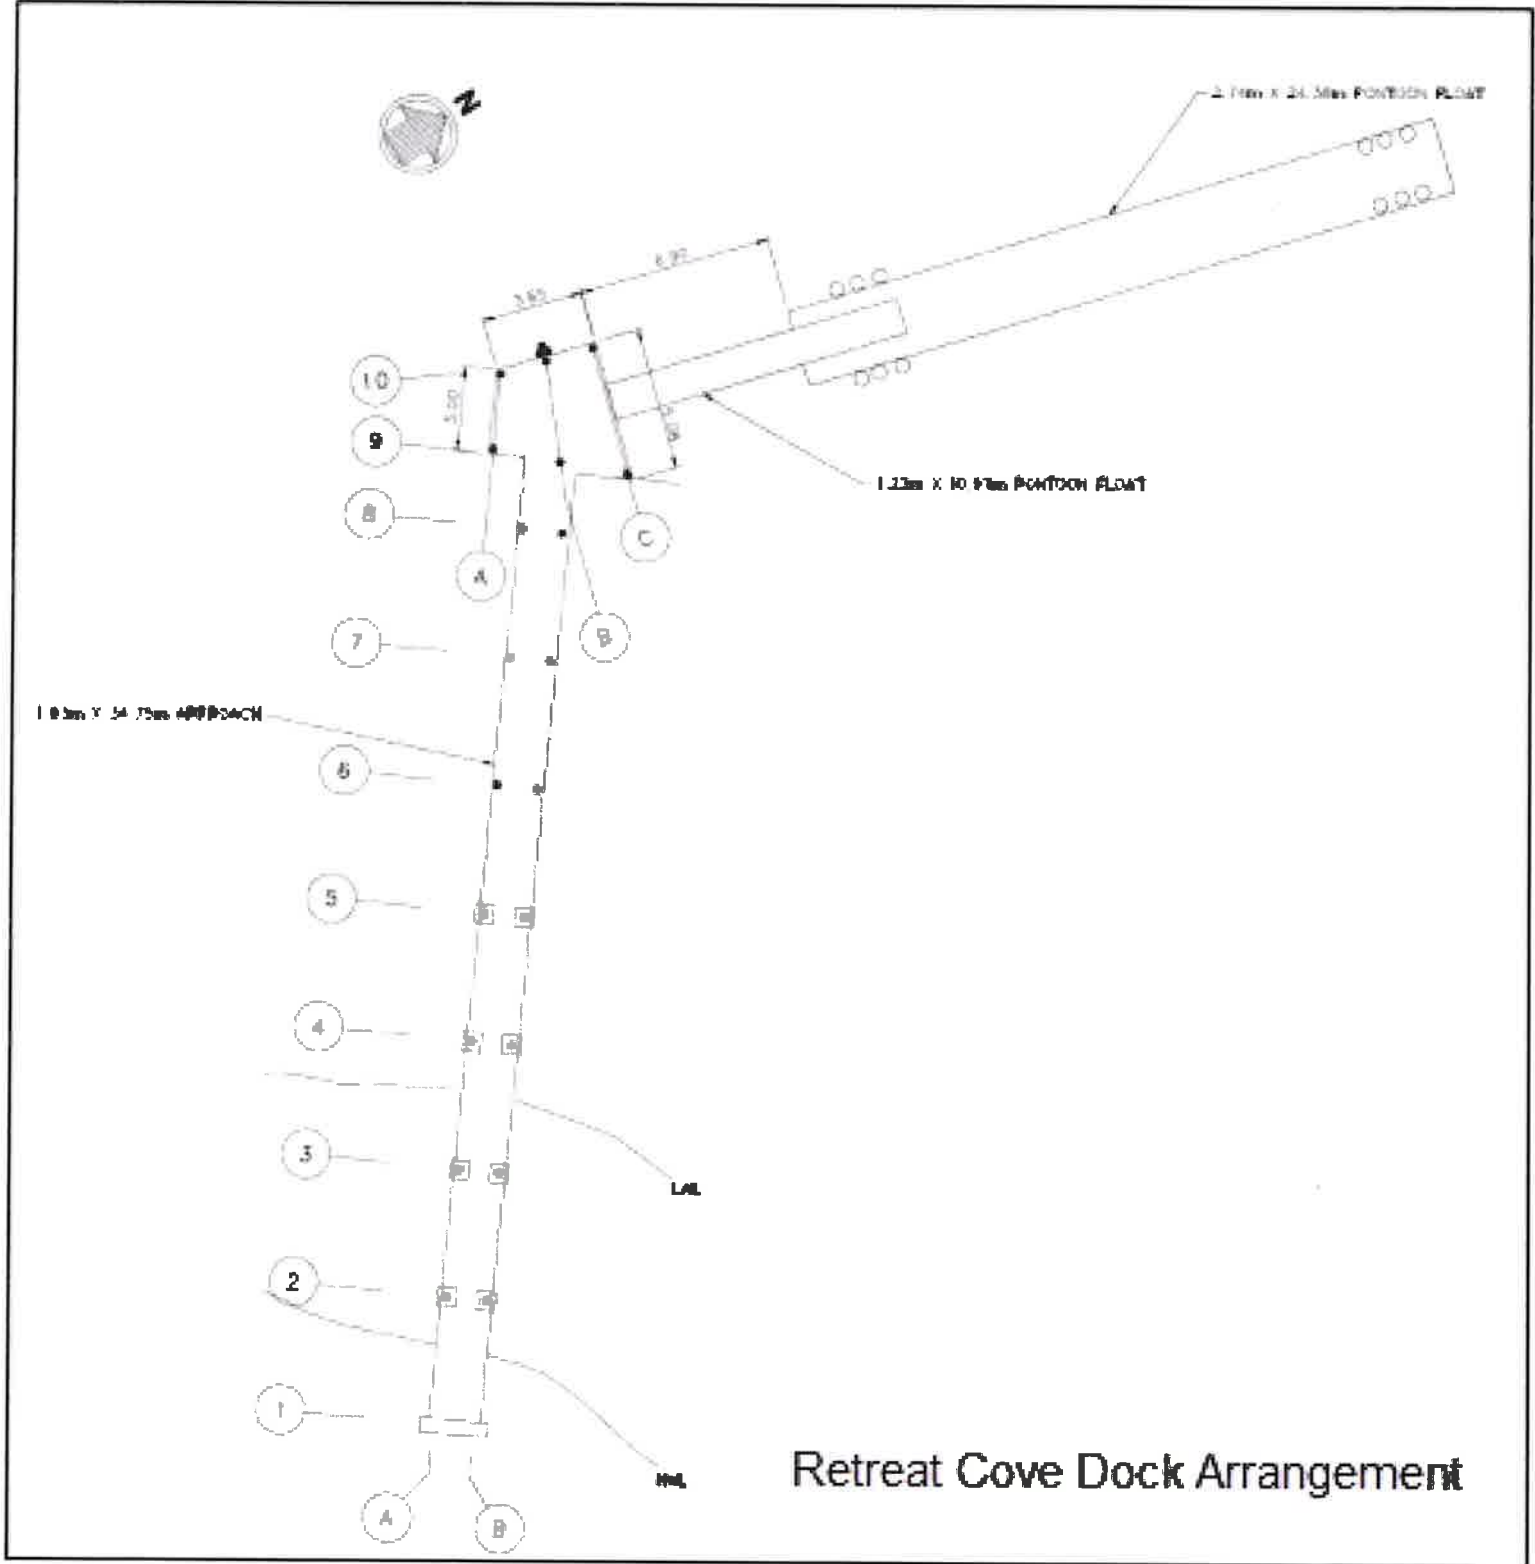
GANGWAY FLOATS	The gangway is painted, the decking is in good condition and the roller, the bearings and guide rail are rusty but in fair condition. The UHMW skid strip has been replaced for the bottom transition plate.			
	The float is in good condition, the decking and flotation are good and there is minor looseness with the bull rail bolts likely due to the hot weather. The group of 3 piles on either side of the gangway (no pile well) are showing minimal wear with one pile having moderate wear. The group of 3 piles in 2 wells are all in good condition with minimal wear showing.

COMMENTS/INSTRUCTIONS	There are no issues.

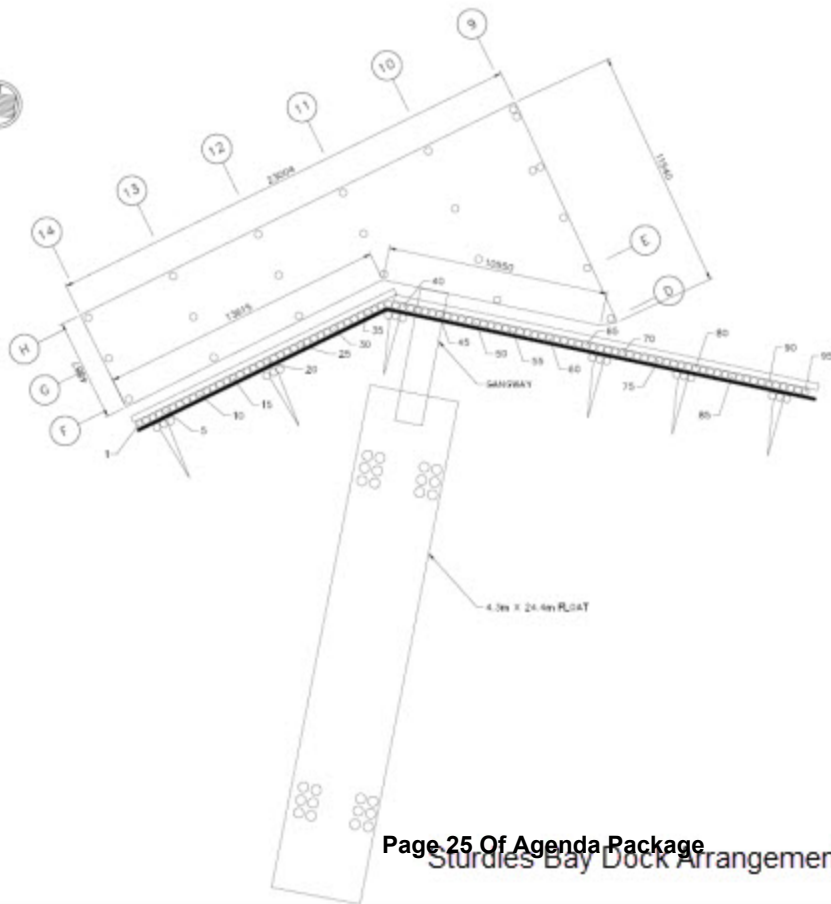
GANGWAY FLOATS	<p>The heavy steel gangway requires painting. The decking is old but in fair condition with minor rot at the bottom end. The roller and bearings are difficult to access and the guide rails are rusty but in fair condition. The float is in fair condition for its age and requires pressure washing, no help from the Otters with this! The decking is good, the bull rails are showing a fair amount of wear and tear and the bull rail bolts are tight with some slight looseness in the middle, shore side. Normal for this float. The 4 pile wells with 6 piles/well are in good condition with minimal to minor wear in each well.</p>

COMMENTS/INSTRUCTIONS	<p>> Pressure washing and painting as described.</p> <p>> Repair the electrical panel door.</p>

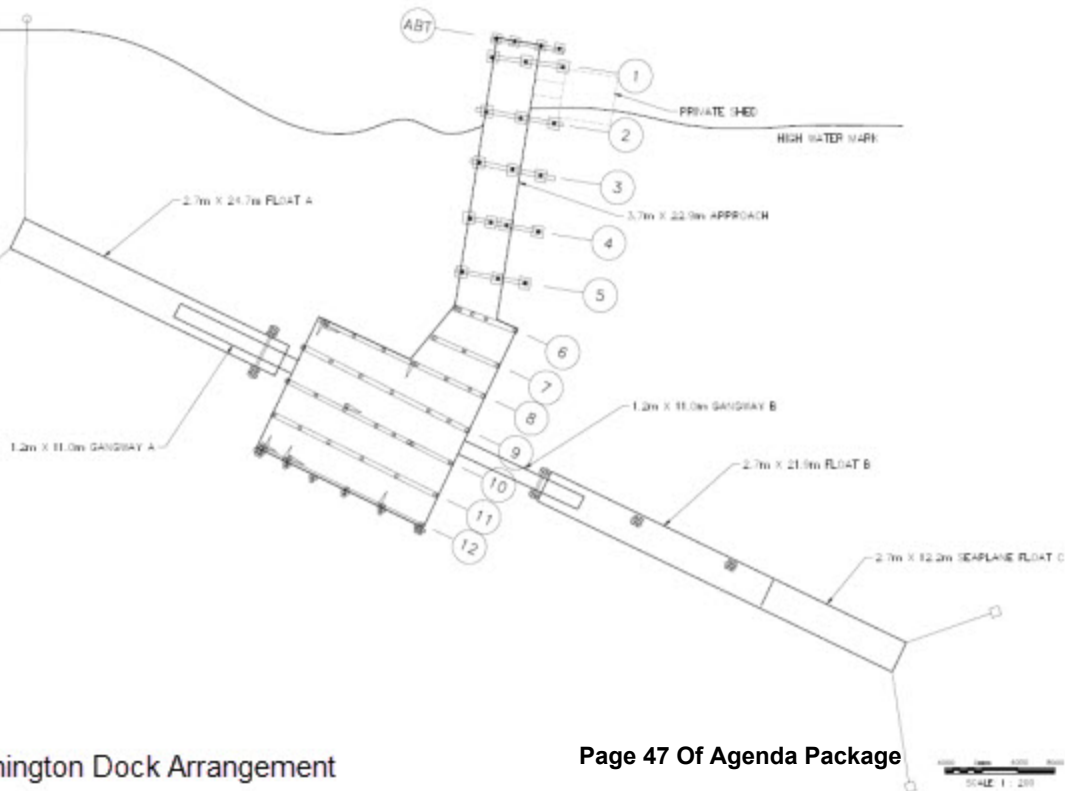
COMMENTS/INSTRUCTIONS	> Replace rotten notice board. > Replace 3 missing tires in the seaplane zone. > Pressure washing floats B&C is required. > For minor work, see recommended items.
------------------------------	---
