**SURFSIDE PARK ESTATES WATER SERVICE COMMITTEE**  
Notice of Meeting on **Tuesday, February 13, 2024 at 2 p.m.**  
Goldstream Conference Room, 479 Island Highway, Victoria, BC

**SUBJECT**     **Surfside Park Estates Water System Tank Replacement Options Analysis**

**TO:** Natalie Tokgoz, P.Eng.  
**FROM:** Katarina Konicek, P.Eng.  
**DATE:** August 21, 2023  
**SUBJECT:** **Mayne Island – SURFSIDE PARK ESTATE WATER SYSTEM: System Review and Options Analysis for Tank Replacement & Relocation**

### Surfside Park Estate Water System Tank Replacement Options Analysis

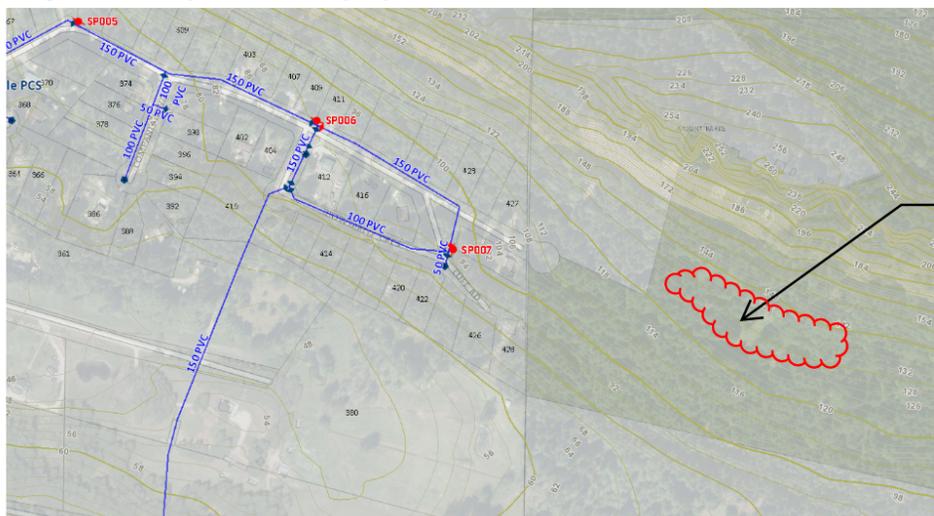
Figure 2 - Proposed Gravity System Tank Location

- New tanks (2x45m<sup>3</sup>) – possibly proprietary glass fused to steel flat panel tank with reinforced concrete pads and aluminum geodesic dome roof, polyethylene or other suitable recommended tanks.
- New tank location proposed on Figure 2 (300m east of Wood Dale Drive, within Mount Parke, a CRD Regional Park) at an approximate elevation of 130m.
- CRD Regional Parks have reviewed the location and confirmed that the tanks can be located in this area, but further review will be required as more detailed information becomes available.
- Environmental Impact Assessment to be completed and reviewed by CRD Regional Parks.
- Slope stability assessment for new tank location.
- Approximately 300m of new watermain to new tank location (one tank fill/discharge line).
- Decommissioning of existing pipe and tanks.

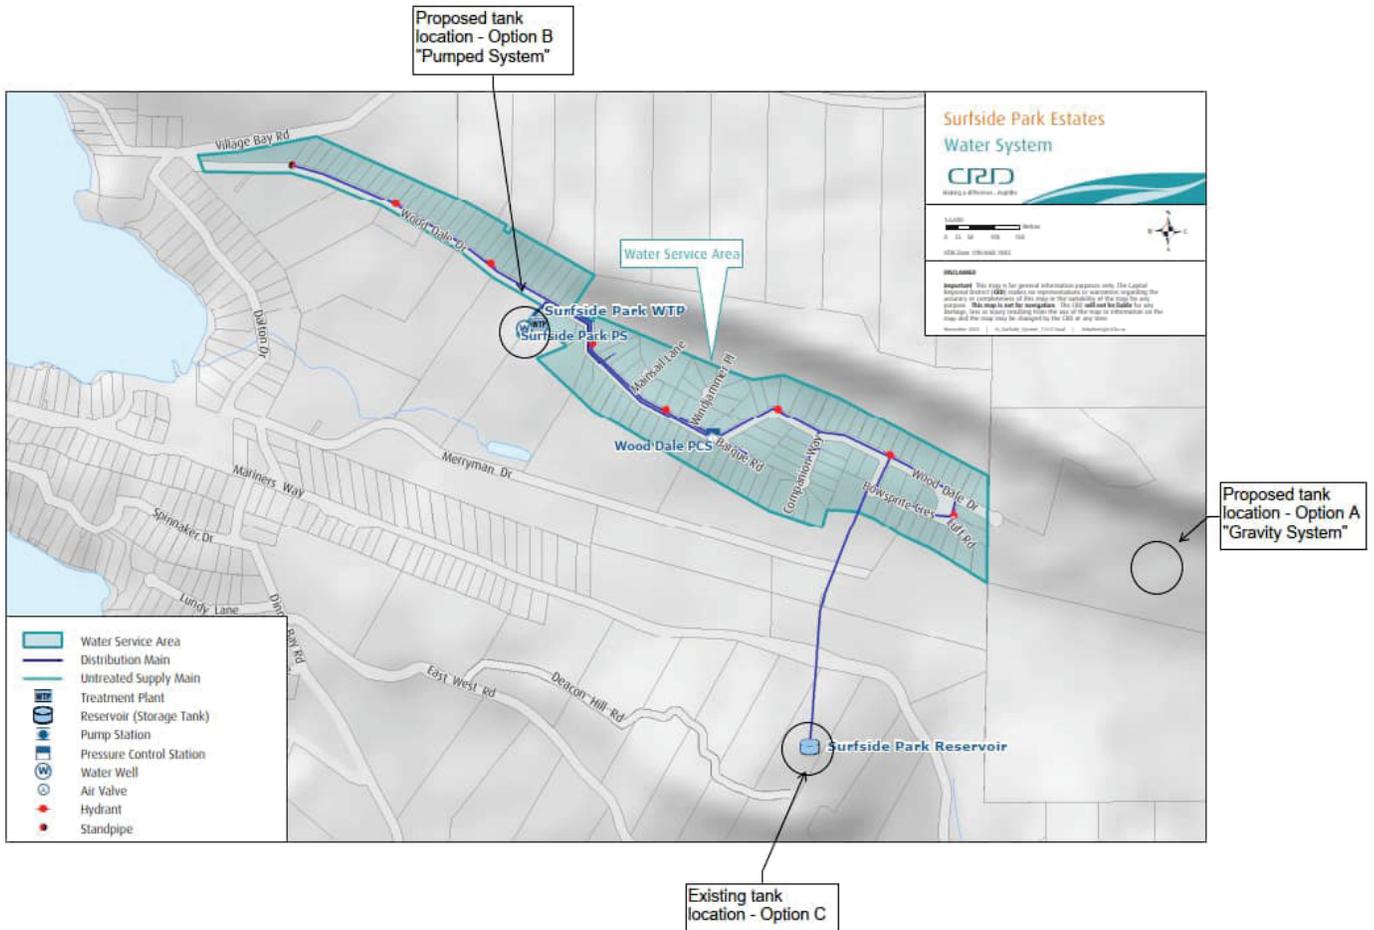
Figure 2-3: Potential Tank Locations Identified

Figure 2-3 Illustrates the three potential tank locations identified in relation to the existing system, while Table 2-1 compares some important considerations for the options.

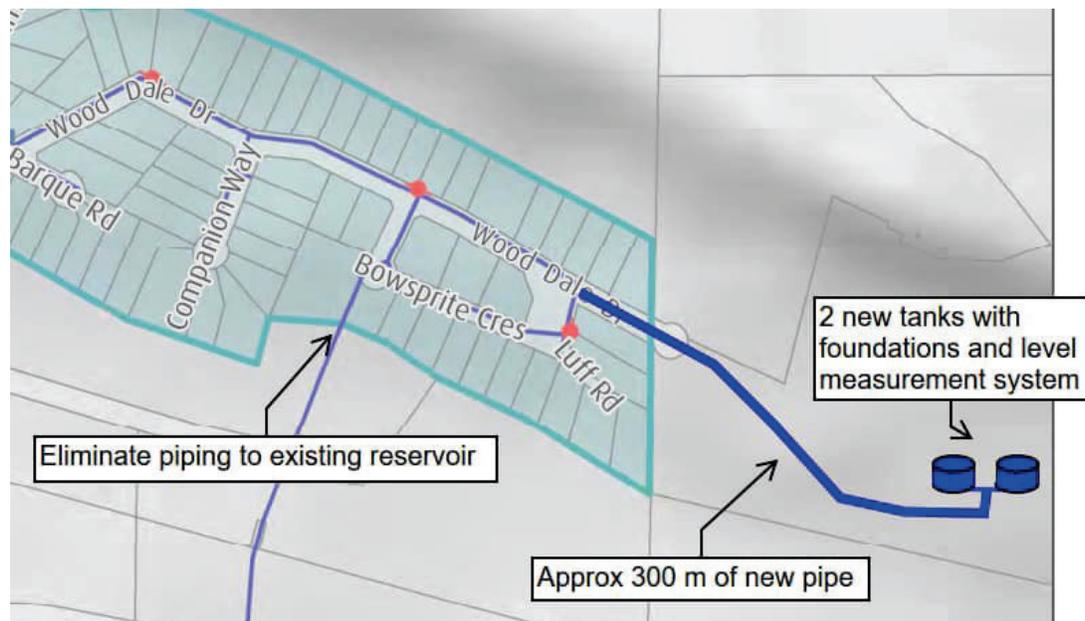
Figure 5-1 – Option A Gravity System Upgrade Concept

Construction of new tanks within Mount Parke would result in a water system that operates in the same way as the existing system but provides greatly improved access to the storage tanks for operations and maintenance and eliminates the section of piping which is believed to be causing much of the non-revenue water loss. This would require the construction of new tanks complete with foundations, piping from the existing end of line off Wood Dale Drive, and instrumentation complete with power supply and communication system. Since tanks at this location would be hydraulically similar to the existing tanks, no modifications to the treatment plant or PRV would likely be required. Figure 5-1 illustrates the required upgrades.

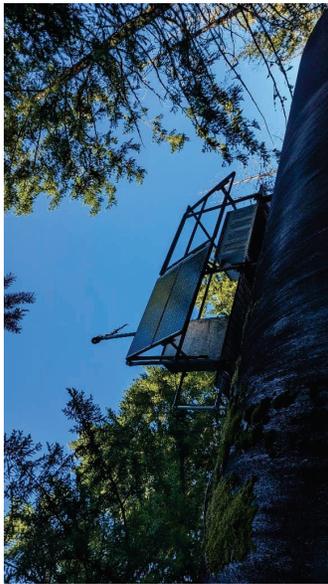
Figure A-12 Existing Reservoir Antenna/Transmitter

The tanks include a level measurement device mounted on the top of one of the tanks, which utilizes a radio link to convey this information back to the treatment plant and control the production of water. This system is powered by a solar panel. This equipment is visible atop the tank in Figure 2-1.

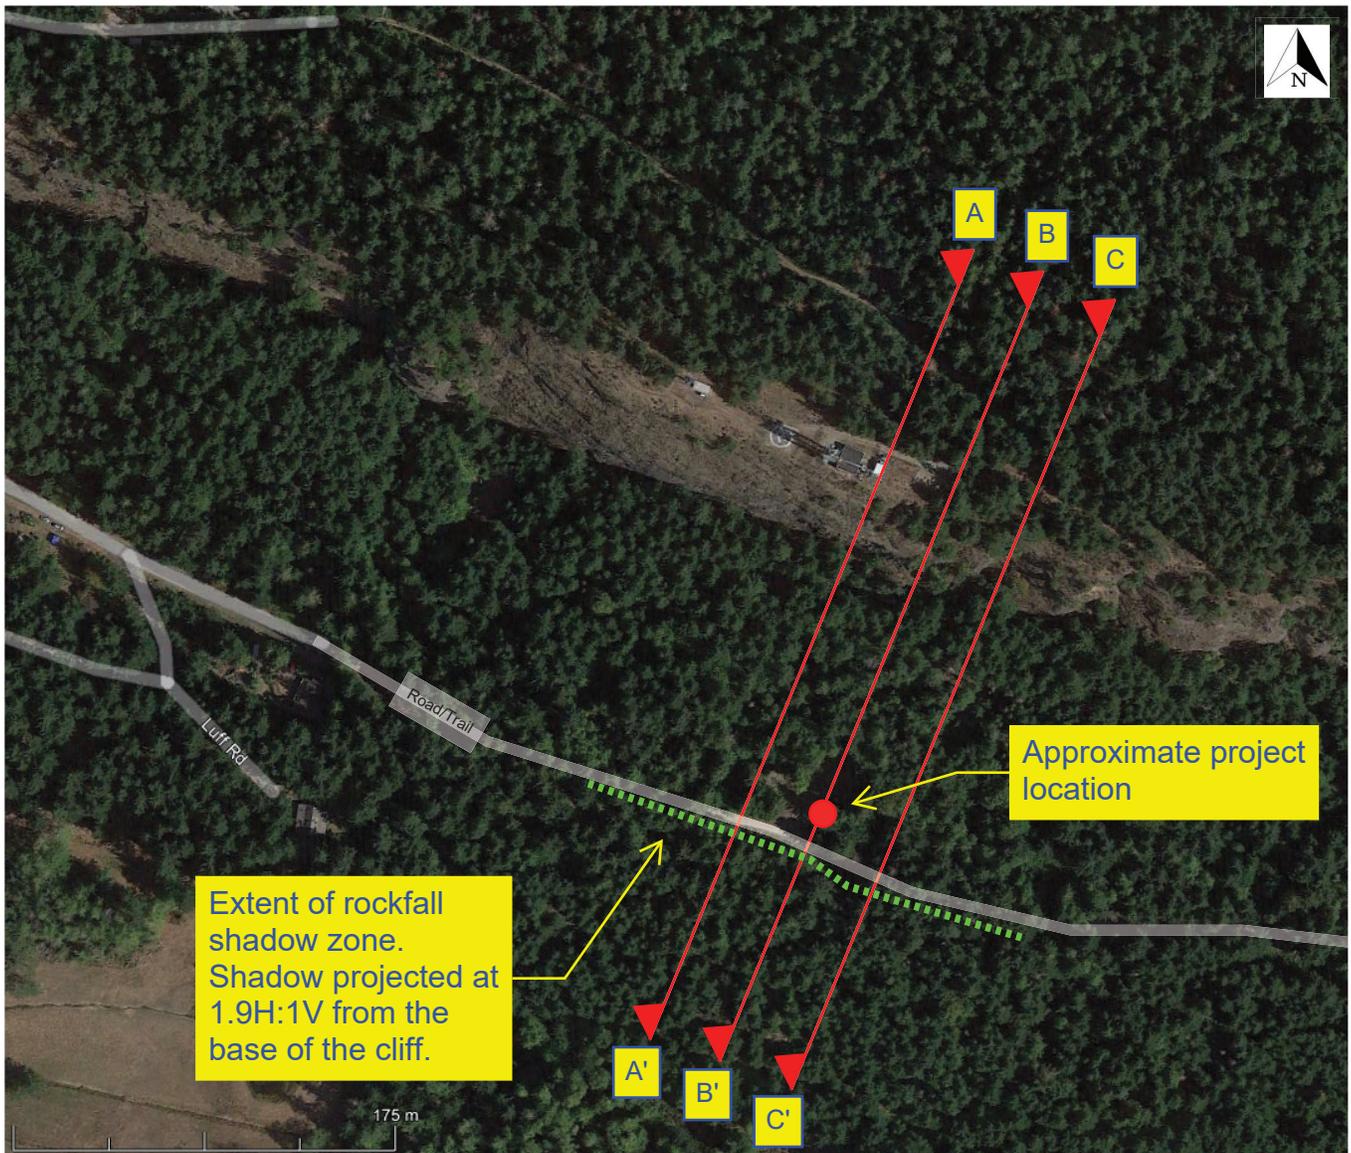
Figure 1 - Site Plan View - Orthoimagery

Based on the results of our desktop study, the proposed water tank location is within the rockfall shadow of the cliff band. Figures 1, 2 and 3 show the location of the project site with respect to the cliff, talus zone and rockfall shadow. It should be noted that these preliminary lines are based on a desktop study only and could possibly be refined after a site reconnaissance and rockfall trajectory analyses.

Generally, geotechnical approaches to geohazard problems such as rockfall include avoiding the hazard, protection measures, and/or mitigation measures. Protection measures are implemented to protect structures from a rockfall that will occur. Examples of protection measures include soil or rock berms, walls and rockfall fences. Mitigation measures are implemented to reduce the probability of a rockfall event occurring. Examples of mitigation measures include rock scaling and rock bolting. In general at this location, avoidance would be the more practical measure. Avoiding the rockfall hazard would mean establishing sufficient setbacks from the hazard zone such that the risk to the water tanks and individuals would be sufficiently low and considered acceptable. The tanks should be located at least on the south side of the road, which delineates the rockfall shadow zone as shown in Figures 1 and 2.
