**SOUTHERN GULF ISLANDS HARBOURS COMMISSION**  
Notice of Meeting on **Friday, October 9, 2026 at 9:30 am**  
Saanich Peninsula Wastewater Treatment Plant Meeting Room,  
9055 Mainwaring Road, North Saanich, BC

The Southern Gulf Islands Harbours service area is comprised of thirteen dock facilities among six islands. Through the service's five-year capital plan, the Capital Regional District (CRD) executes capital projects to maintain the level of service, improve service and conduct major repairs. The following is a summary of the projects that are active and recently completed.

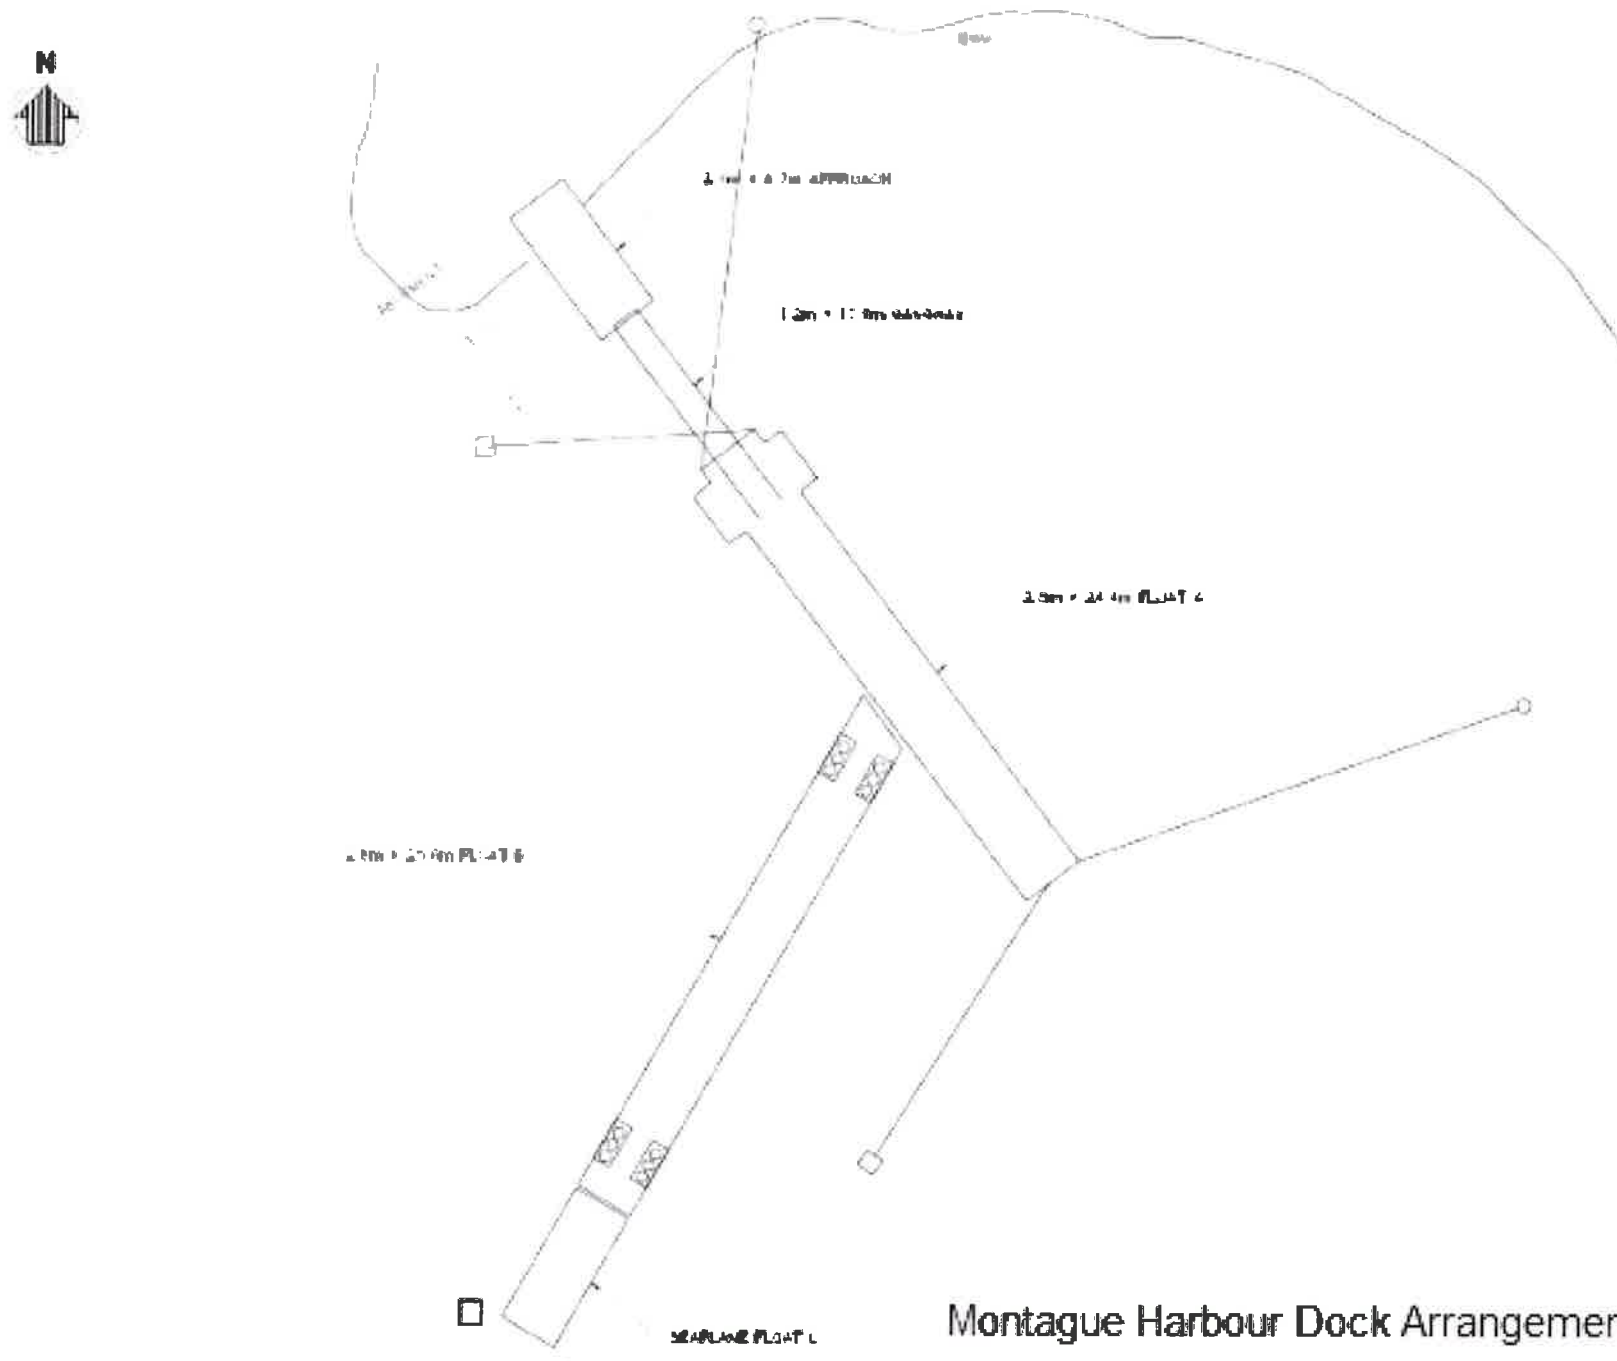
| <b>COMMENTS/INSTRUCTIONS</b> | <p>&gt; Loose deck boards require re-nailing.</p> <p>&gt; Float A life ring requires a new grab line.</p> <p>&gt; Monitor the flotation at the end of float A.</p> <p>&gt; Monitor the wear on the connecting hardware for floats A &amp; B.</p> |

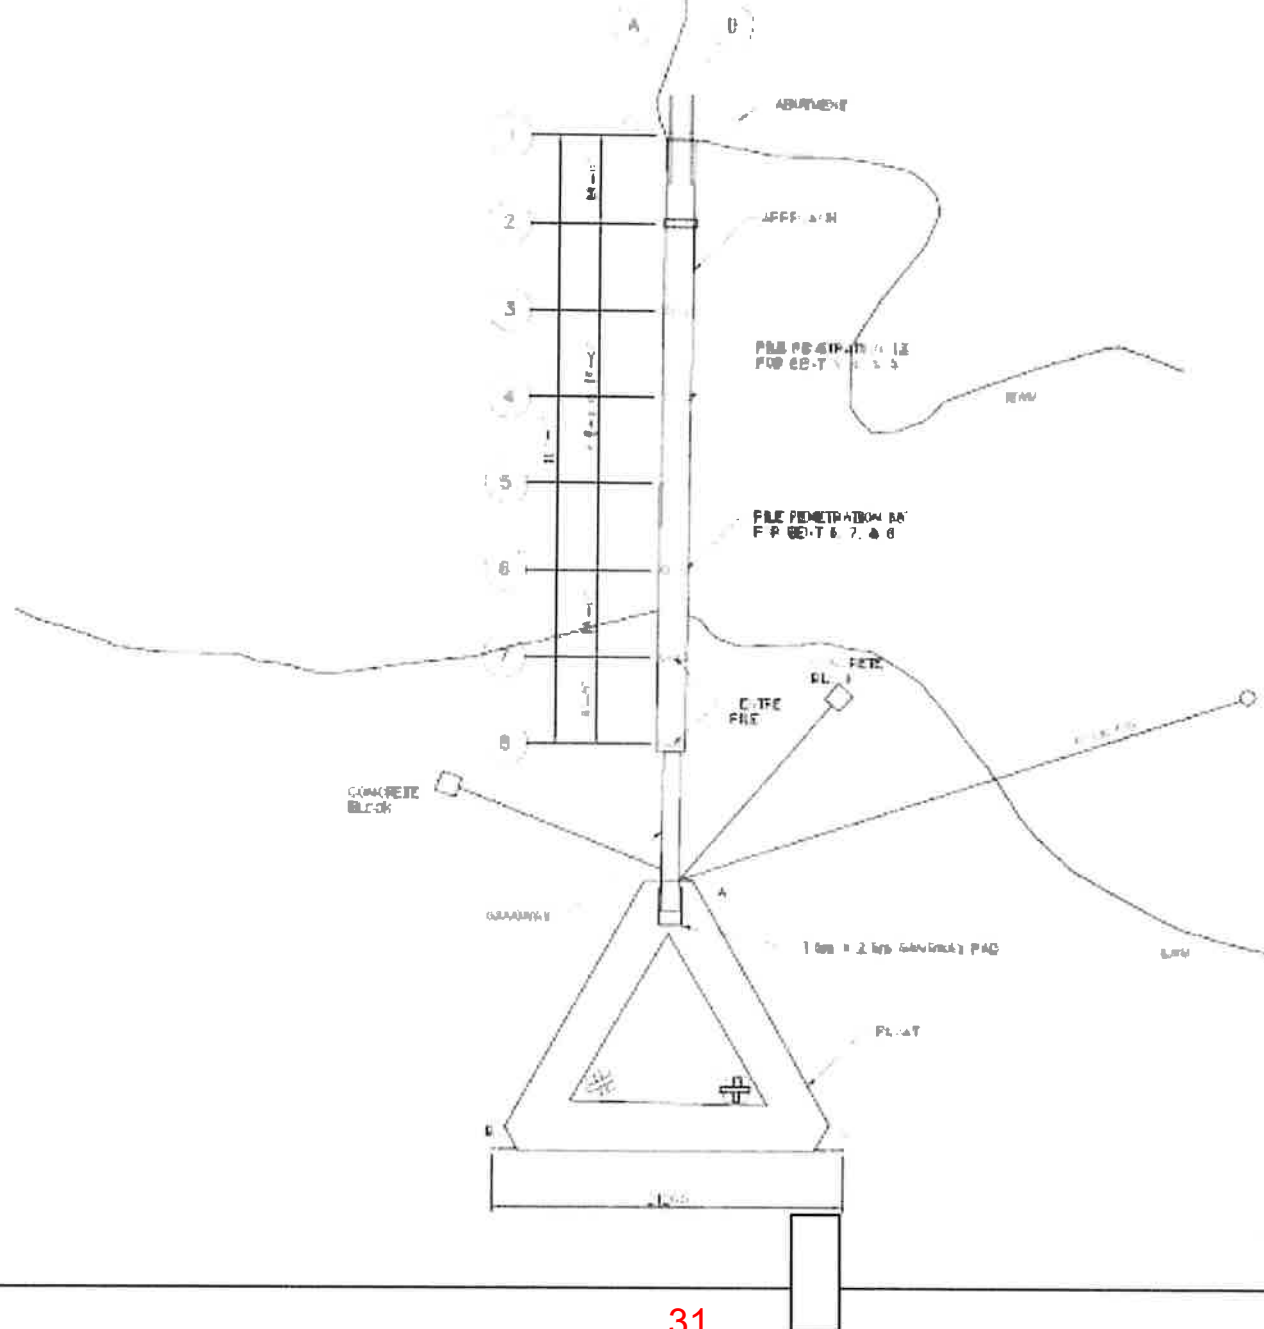
| <b>COMMENTS/INSTRUCTIONS</b> | <p>&gt; Monitor for replacement, areas of developing rot on the main float or replace all decking with Mini Mesh decking.</p> <p>&gt; Removal of the expanded metal grating on the main float is recommended.</p> |

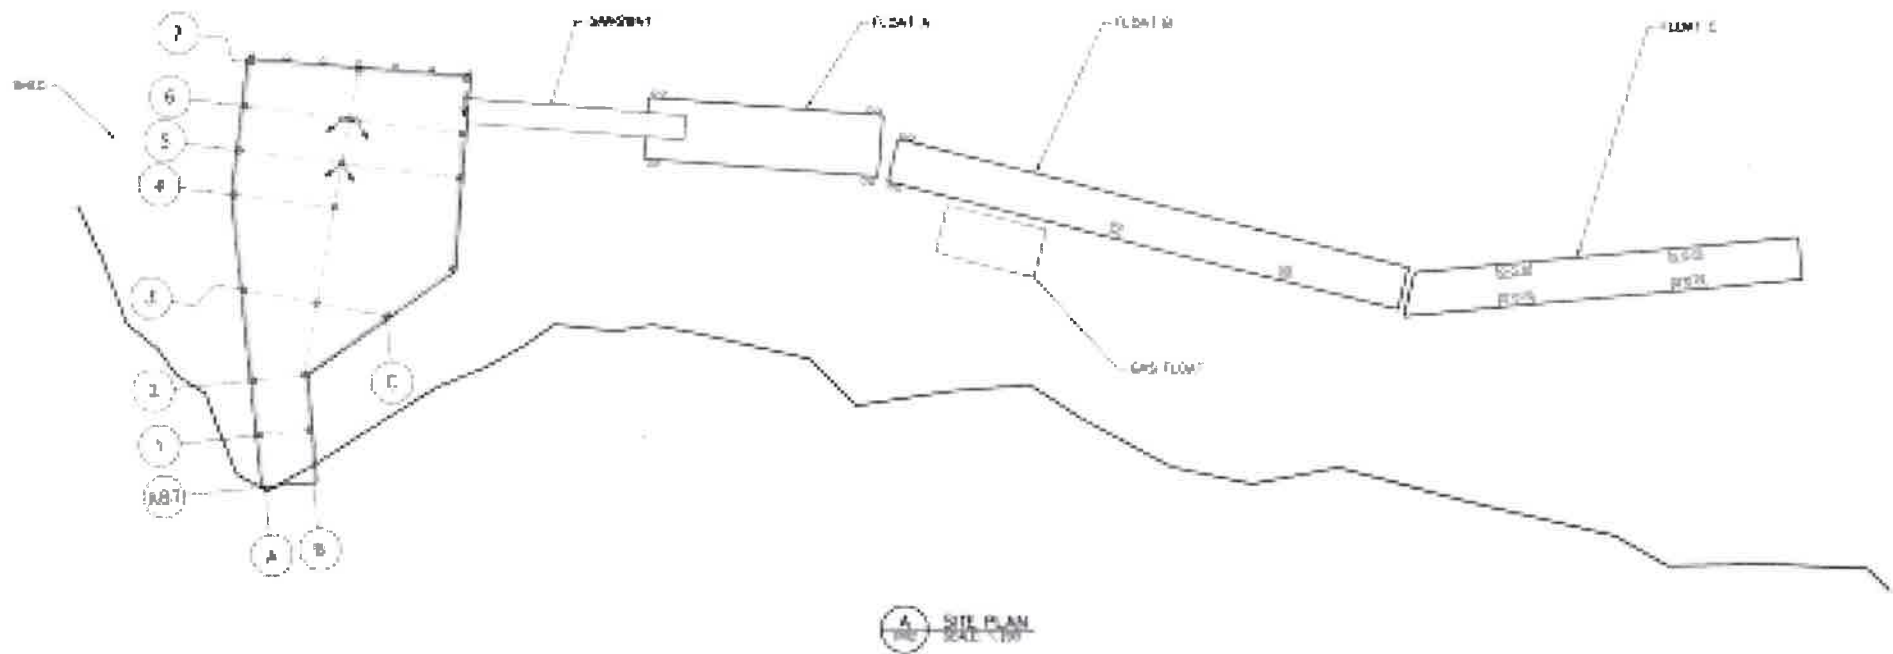
| <b>COMMENTS/INSTRUCTIONS</b> | <p>&gt; Replace the broken envelope box on the notice board.</p> <p>&gt; Tighten the loose bull rail bolts at the end of float A under the gangway.</p> <p>&gt; Repair the bull rail on float</p> <p>&gt; Monitor the flotation with float A.</p> |

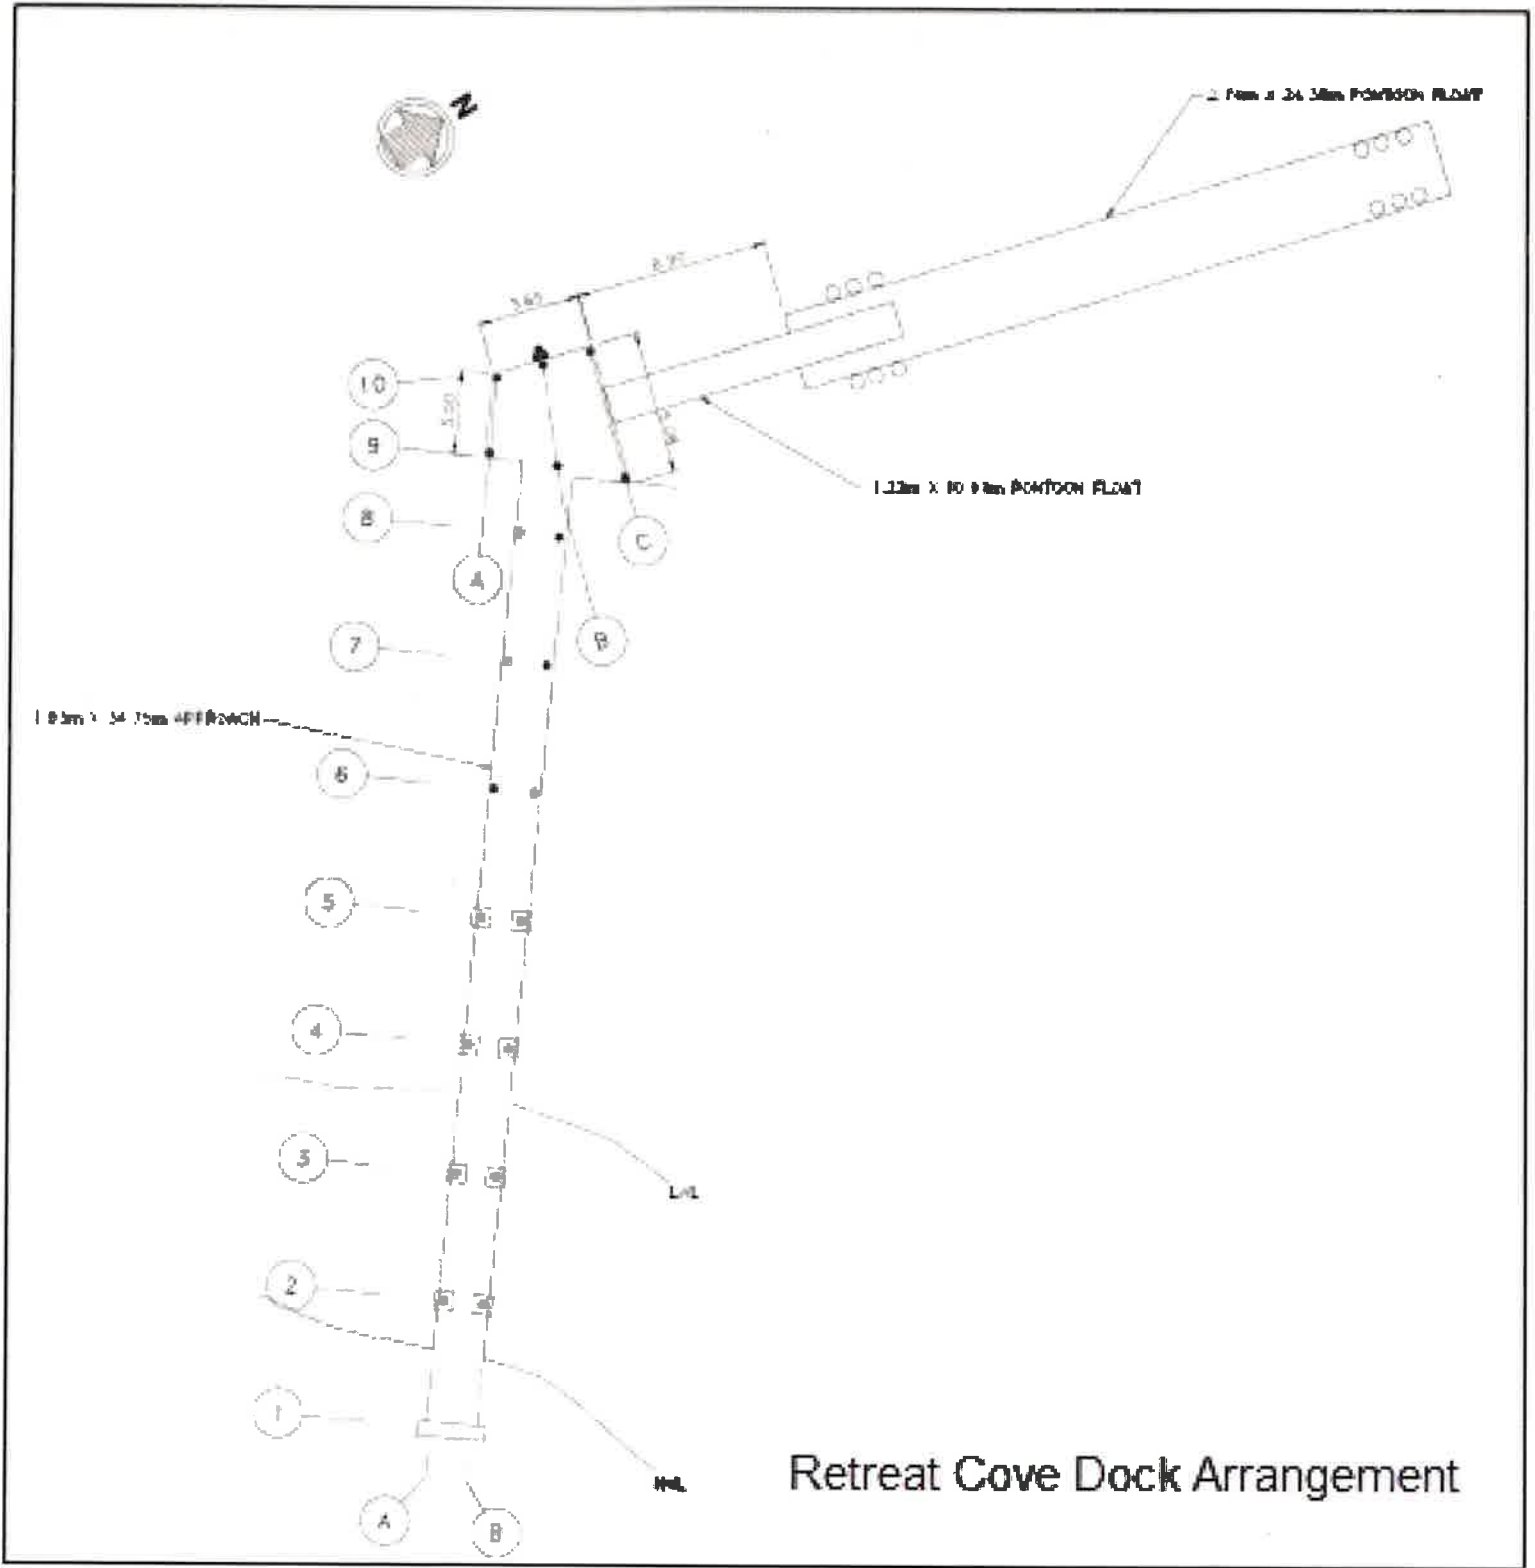
| | <p>&gt; The steel gangway requires painting and inspection of the very deteriorated frame rails at the bottom end.</p> <p>&gt; Monitor for replacement the wear of the 2 worn piles in the open well next to the gangway.</p> |

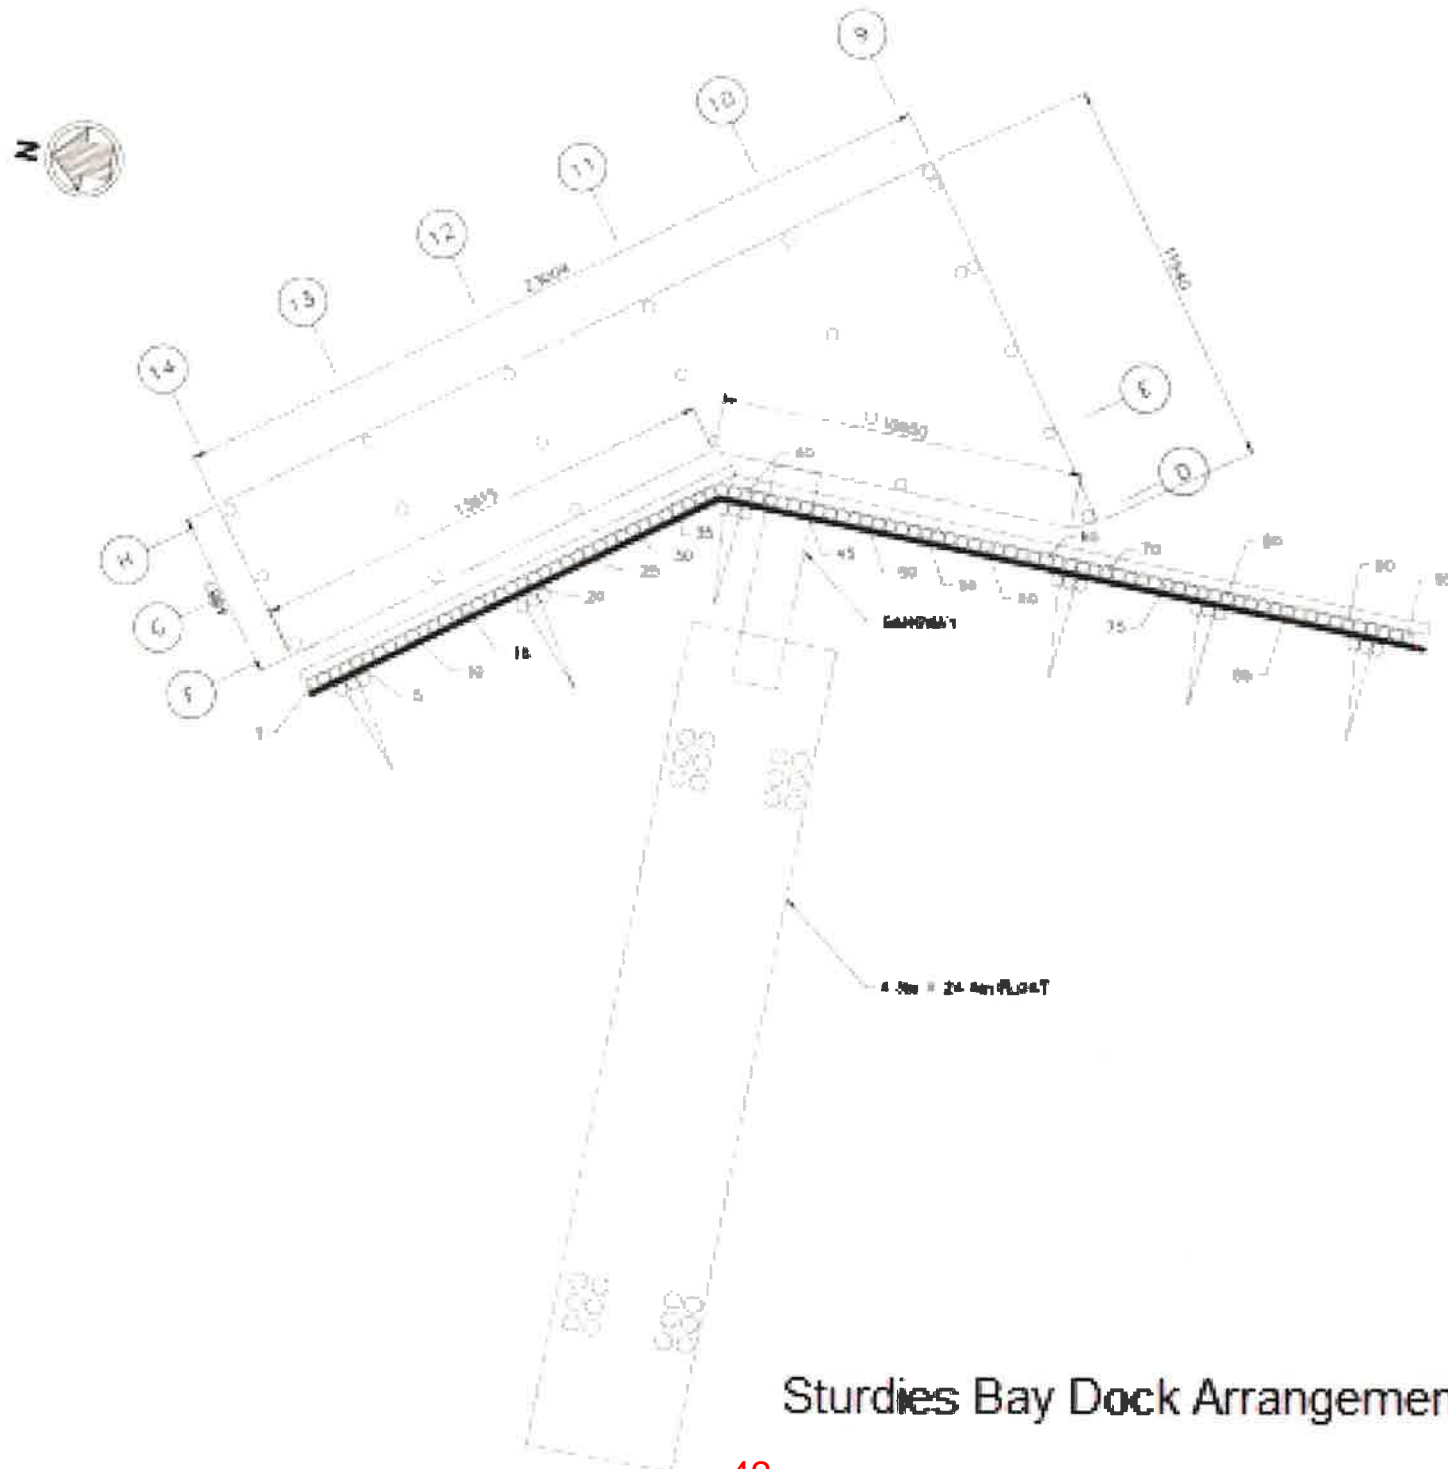
Sturdies Bay Dock Arrangement

| | <p>&gt; Tighten the loose bull rail bolts on the shore side of the float near the gangway.</p> |

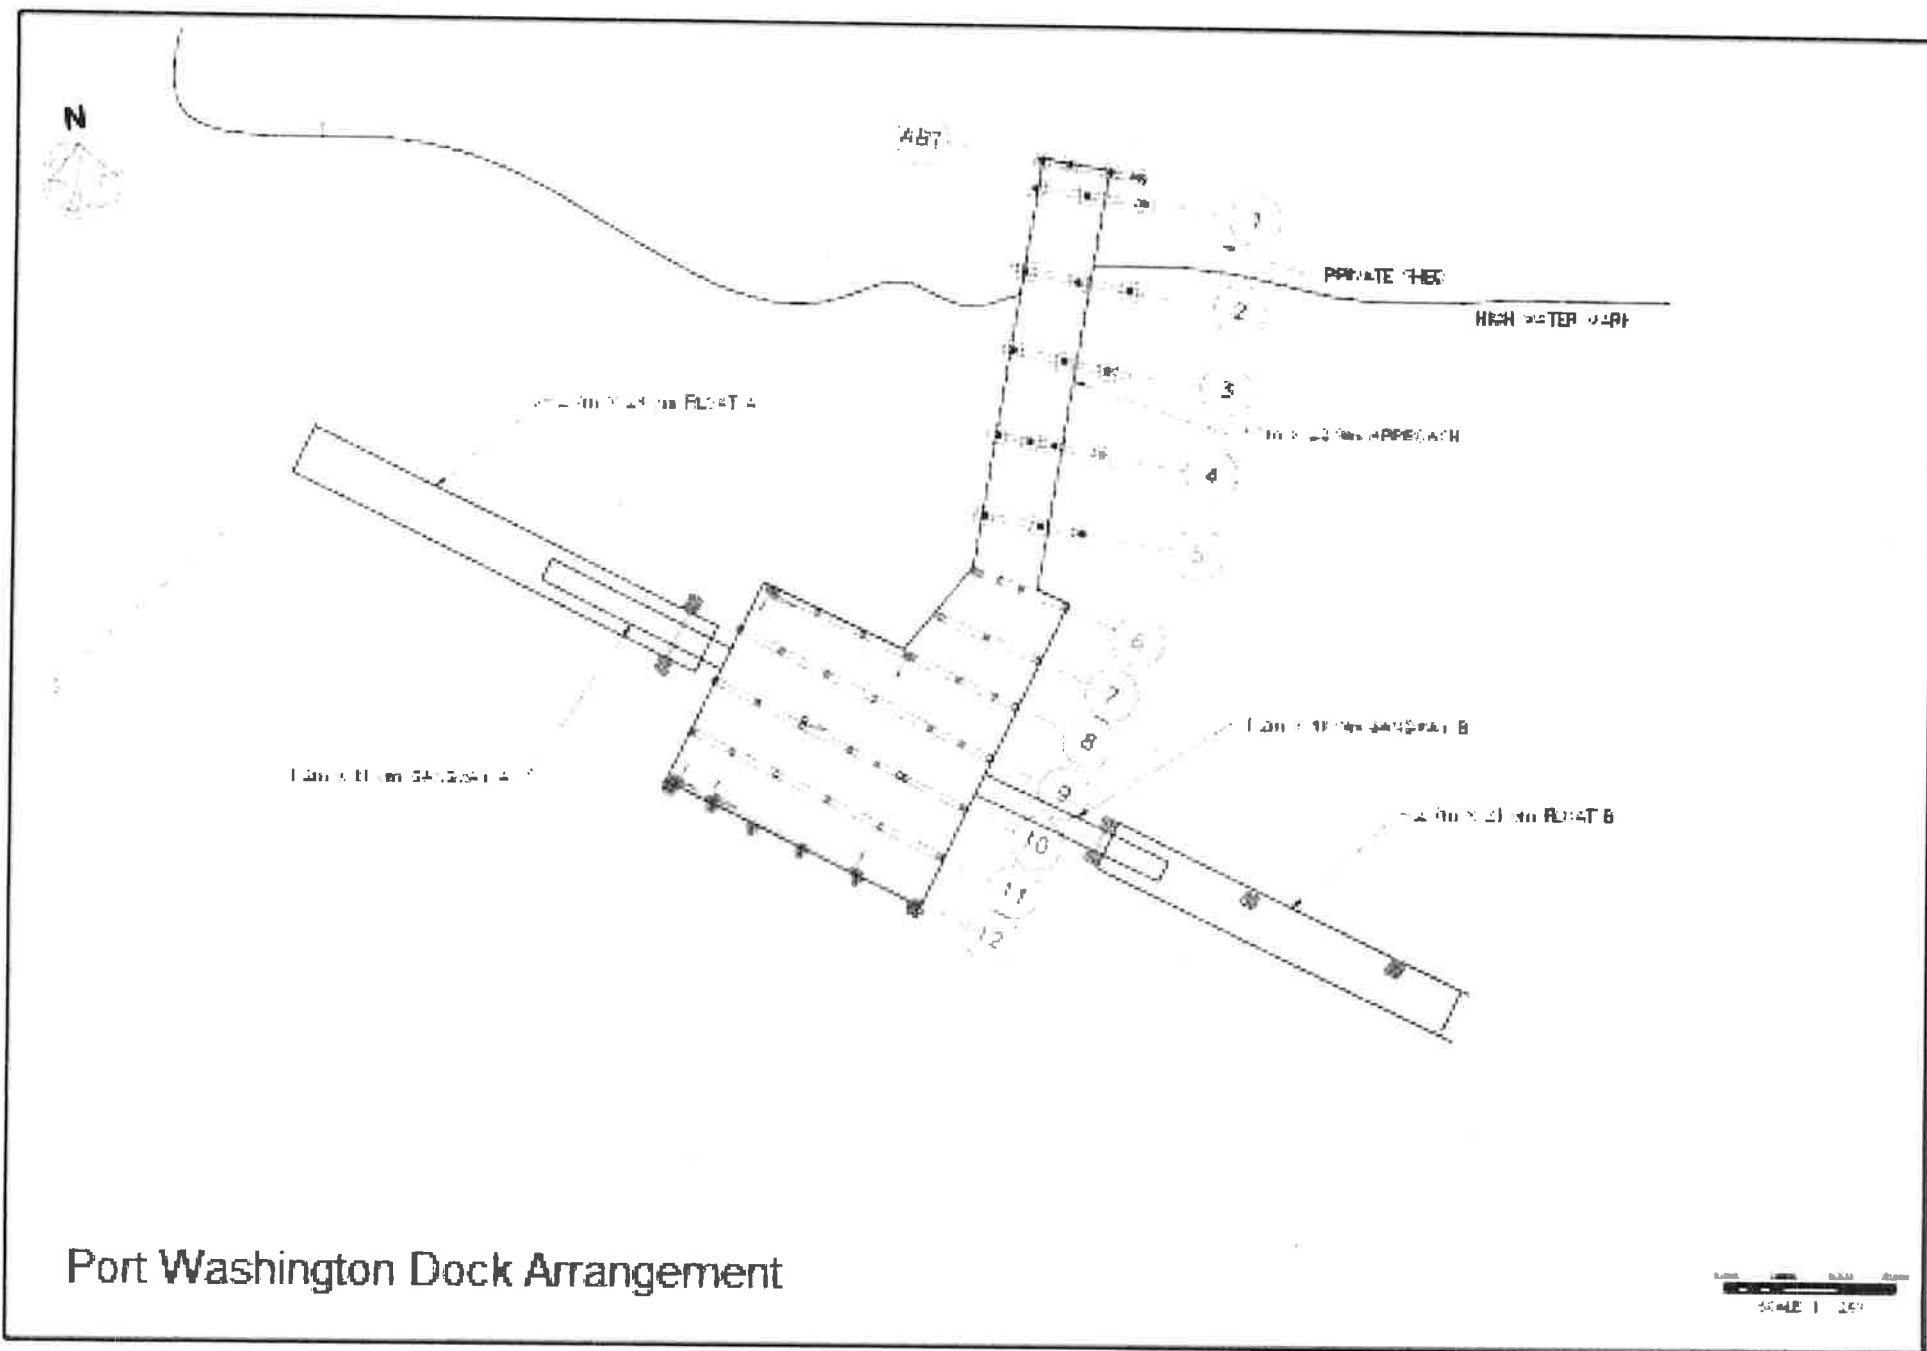
| <b>COMMENTS/INSTRUCTIONS</b> | <ul style="list-style-type: none"> <li>&gt; Float A bull rail bolts require tightening and broken rail replaced.</li> <li>&gt; The gangway roller on float B requires replacement.</li> <li>&gt; A pillow block is required for the roller on gangway B.</li> <li>&gt; Replacing the decking on the 2 gangways with mini mesh decking is recommended.</li> <li>&gt; UHMW runners or a shoe are recommended for gangway A's bottom apron.</li> <li>&gt; Deadhead requires removal.</li> </ul> |

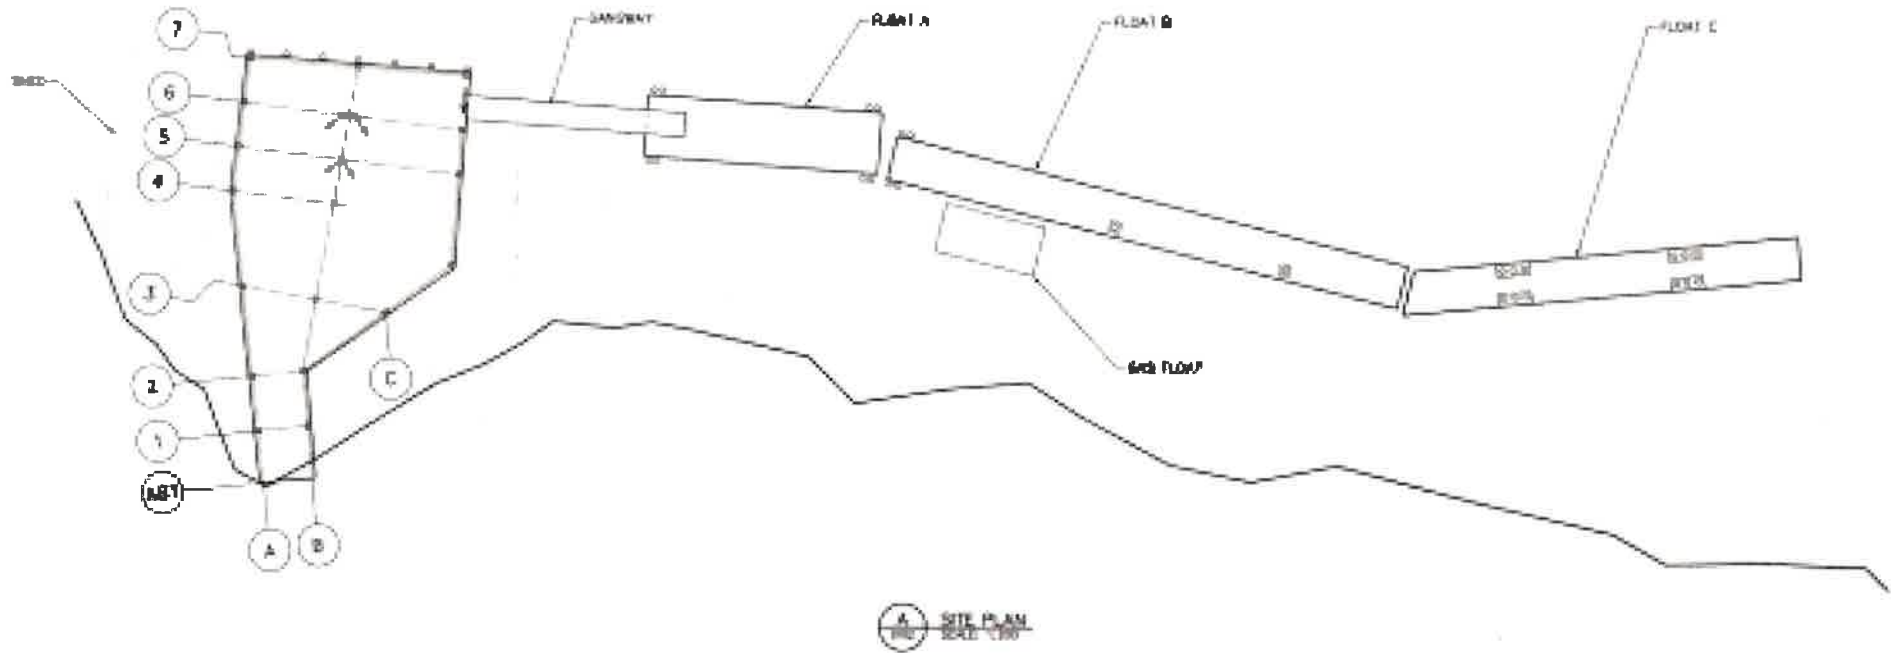
| <b>COMMENTS/INSTRUCTIONS</b> | <p>&gt; Replace the broken envelope box on the notice board.</p> <p>&gt; Repair the damaged notice board or replace with a new aluminum one.</p> <p>&gt; Tighten the loose bull rail bolts at the end of float A under the gangway.</p> <p>&gt; Repair the bull rail on float C.</p> <p>&gt; Monitor the flotation with float A.</p> |
