SOUTHERN GULF ISLANDS HARBOURS COMMISSION
Notice of Meeting on **Thursday, May 29, 2025 at 9:30 a.m.**
Saanich Peninsula Wastewater Treatment Plant Meeting Room,
9055 Mainwaring Road, North Saanich, BC

Southern Gulf Islands Harbours DOCK INSPECTION REPORT

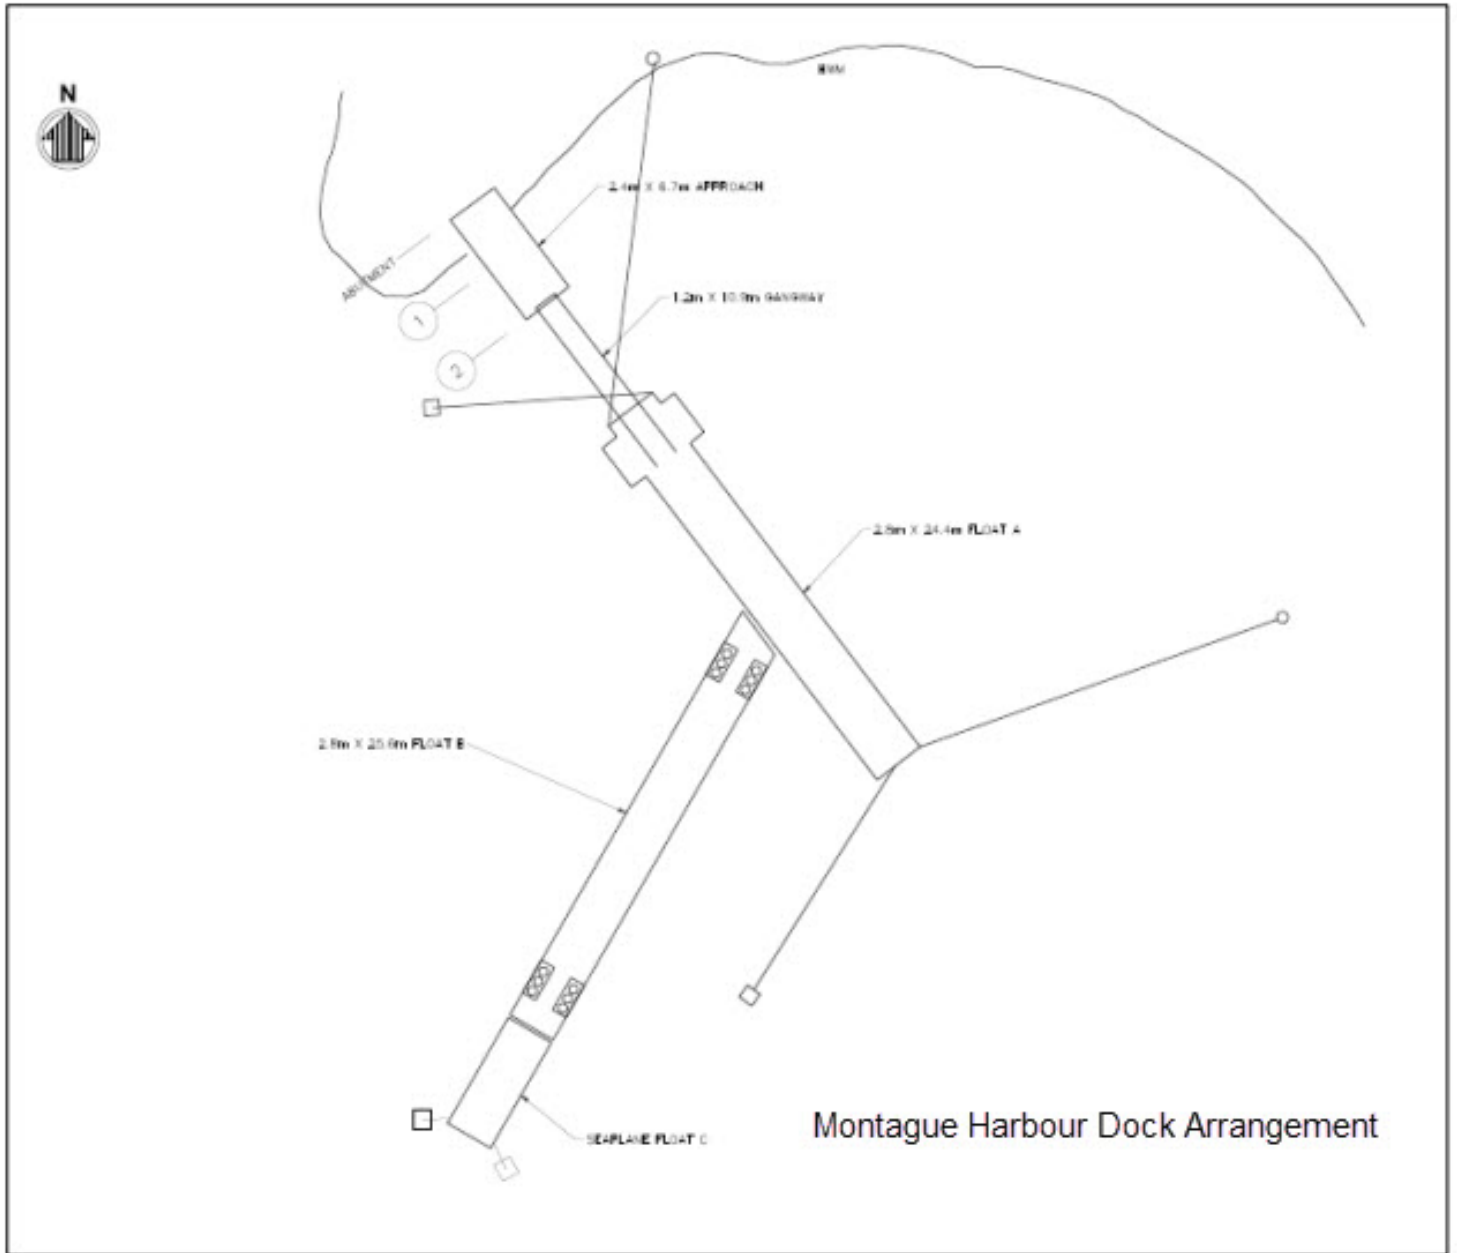
COMMENTS/INSTRUCTIONS	<ul style="list-style-type: none"> > Non-skid paint is required for the large transition plate between float A & B. > Yellow paint is required for the Emergency/Landing & Seaplane Landing zones > New signage is required for the seaplane landing zone. > One tire is required for the seaplane landing zone.
------------------------------	--

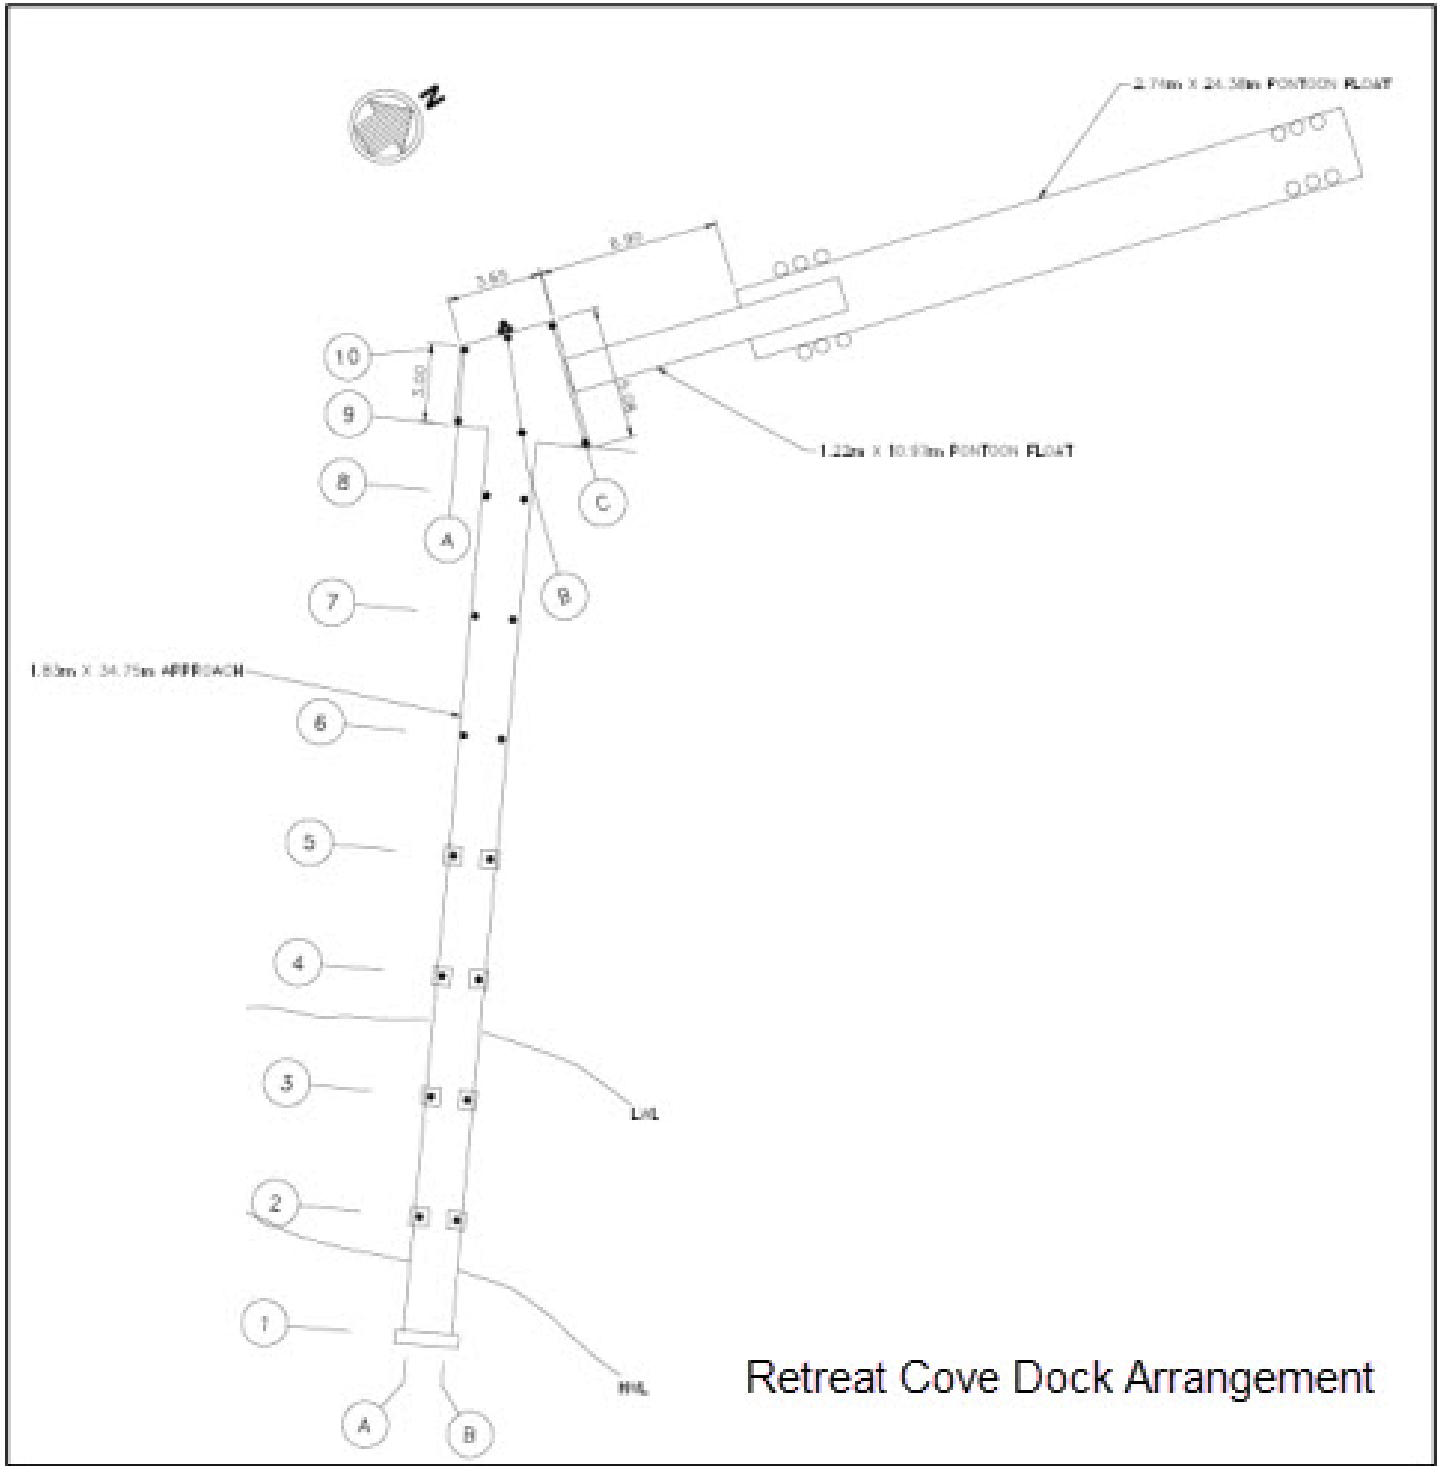
APPROACH	<input checked="" type="checkbox"/> Signage <input checked="" type="checkbox"/> Envelope Supply <input checked="" type="checkbox"/> Notices Posted <input checked="" type="checkbox"/> Rates Posted
	<p>The painted wood railings, the unpainted bull rails and wood decking are in good condition. There is a steel mud grate that is clear. The painted wood notice board is in good condition and a spill kit barrel is located here.</p>

GANGWAY FLOATS	<p>The older painted steel gangway is in fair condition with the usual amount of rust showing on the frame. The wood decking with half expanded metal grating for non-slip is in fair condition. The top transition plate and the bottom apron are steel with a painted non-skid surface with UHMW runners that are in good condition. The steel roller and guide rails are in fair condition and the pillow blocks do not require servicing.</p>
	<p>The older wood float has wood decking, rub boards and bull rails with tight bolts which are in good condition. The flotation is good.</p> <p>At the gangway end, there are 3 piles in open wells on each side of the float that are in fair condition with 2 piles on the north west side showing 20 - 30% wear and the remaining piles are showing minimal wear. The UHMW rub boards in both wells are in good condition. The 2 pile wells at the end of the float have 3 piles in closed wells. These piles, wells and UHMW rub boards are in good condition with minimal wear showing.</p>

COMMENTS/INSTRUCTIONS	<p>> Monitor the 2 worn piles for future replacement.</p>

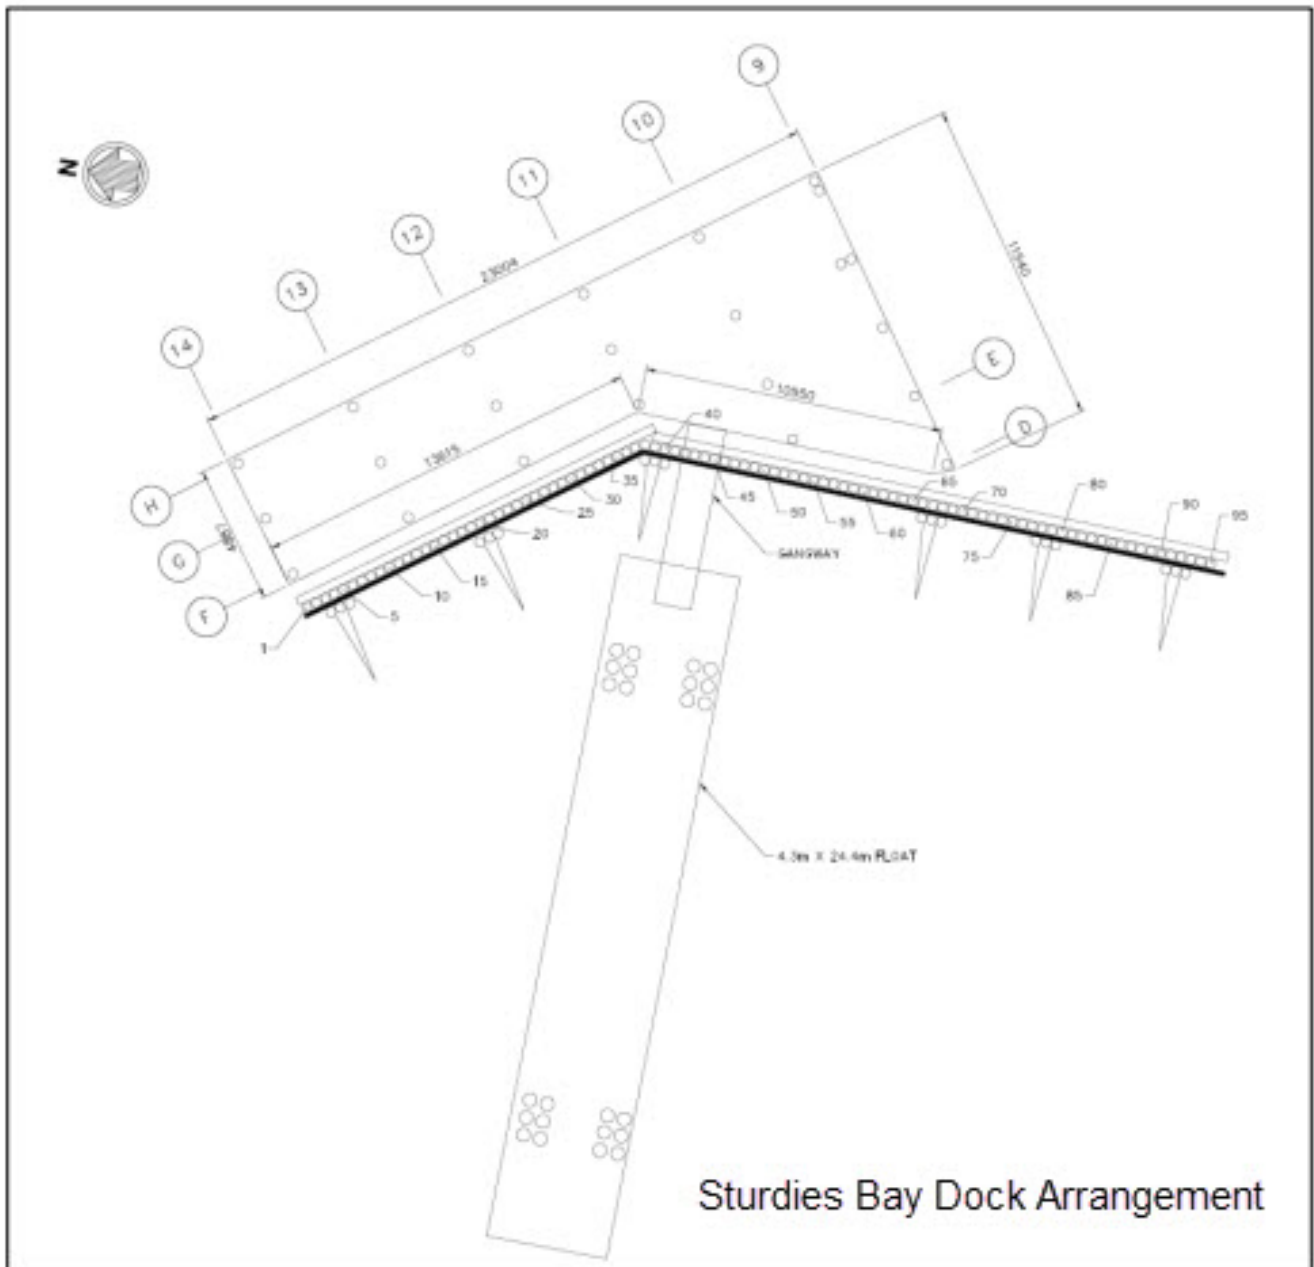
WHARF HEAD	<input checked="" type="checkbox"/> Signage <input checked="" type="checkbox"/> Envelope Supply <input checked="" type="checkbox"/> Notices Posted <input checked="" type="checkbox"/> Rates Posted
	<p>The unpainted wood railings, bull rails and decking are all in good condition. There are a few deck boards with minor rot developing and monitoring for future replacement is recommended. The wood notice board is in fair condition, cleaning and painting is recommended.</p>

GANGWAY FLOATS	<p>The old, heavy, painted steel gangway is in fair condition and has wood decking that is in poor condition and replacement is required. There is a steel top transition plate with painted yellow non-skid and the bottom apron is made of aluminum expanded metal and these are in good condition. The roller, guide rails and pillow blocks are very difficult to access do to the design of this beast. The roller bed boards are very old and in poor condition, replacement is recommended. If the decking is upgraded, the roller bed boards should be replaced. The roller, guide rails and pillow blocks require inspection and servicing. Painting is also required.</p>
	<p>The old wooden float has wood decking, rub boards, bull rails with tight bolts, good flotation and is in fair condition. The safety ladders have been cleaned and are in good condition. Yellow paint is required for the Loading Zone.</p> <p>There are 4 closed pile wells with 6 piles/well. Most of the pile wear showing ranges from minimal to a few piles with as much as 20% wear. All pile wells and UHMW rub boards are in good condition.</p>

COMMENTS/INSTRUCTIONS	<p>> The decking on the gangway requires replacement along with the wood roller bed boards. Inspecting the roller, pillow blocks, guide rails and any required service is recommended. Painting the steel gangway is also recommended.</p>
	<p>> The Loading Zone requires yellow paint.</p> <p>> The notice board requires cleaning and painting.</p>

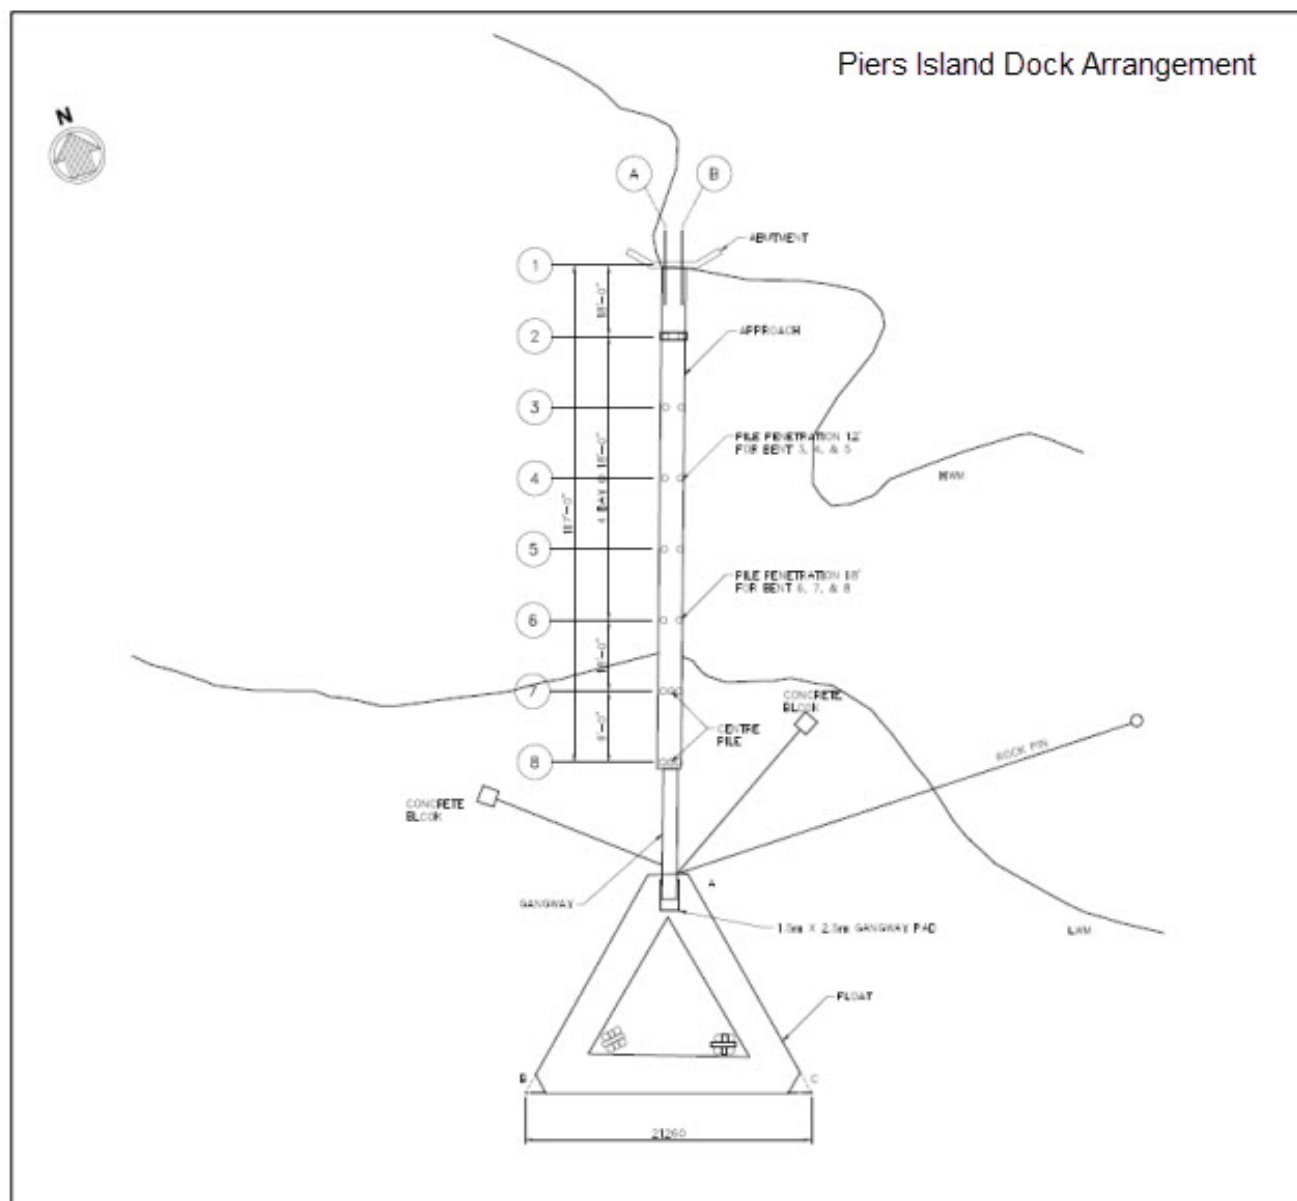
OTHER INSPECTIONS	<input type="checkbox"/> Lighting N/A	<input checked="" type="checkbox"/> Life Rings / Heaving Lines On notice board, good condition
	<input checked="" type="checkbox"/> Extinguishers (expiry dates) April 2026	<input type="checkbox"/> Unpaid Moorage

COMMENTS/INSTRUCTIONS	<p>> Removal of the expanded aluminum non-slip grating on the main float is recommended.</p> <p>> Extend the Emergency/Loading zone and yellow paint is also required.</p> <p>> Inspect the wood decking at the bottom of the gangway and replace if required.</p> <p>> Monitor the gangway bottom apron for further breakage.</p> <p>> Monitor the rot developing on the approach bull rails, decking and deck boards on the main float.</p>
	Empty space for Comments/Instructions
