CEDARS OF TUAM WATER SERVICE COMMISSION

Notice of Meeting on **Thursday**, **November 5**, **2020 at 1:00 PM**Lions Hall, 103 Bonnet Ave, Salt Spring Island, BC

REPORT TO CEDARS OF TUAM WATER SERVICE COMMISSION MEETING OF THURSDAY, NOVEMBER 5, 2020

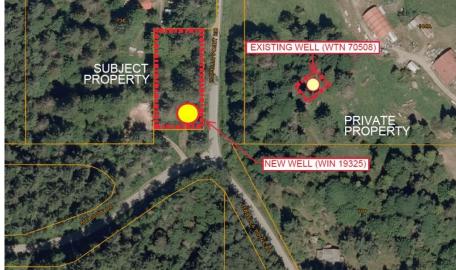
The existing well, treatment facility, and reservoir are situated on a statutory right-of-way (SRW) on private property at 184 Roland Rd. Access restrictions have led to operation and maintenance issues since commissioning of the local water service. The CRD is considering relocating the treatment facility and associated infrastructure to a 10 m wide SRW on the former Isabella Point school property at 736 Isabella Point Rd, the subject property. The 2 sites and locations of the new and existing wells are shown in Figure 1. They are both adjacent to the Isabella Point Rd and Meadow Dr intersection.

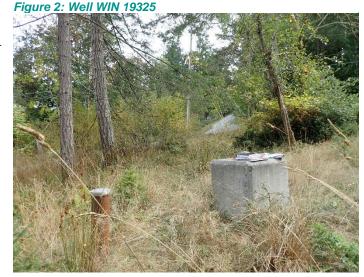
Well WIN 19325 is located at the southeast corner of 736 Isabella Point Rd and is within an allotted 35.2 m L x 10.0 m W SRW (see *Figure 2*). The topography of the site has steep-to-moderate slopes and is on a gently sloping bench located on bedrock-controlled terrain. The well is approximately 500 m west from Fulford Harbour, approximately 87 m above sea level and within an artesian aquifer. The site was originally the Isabella Point School property, in which the school building and all facility appurtenances have been removed from the site since 1951.

A single test / production well, Well WIN 19325, was drilled and test pumped early in 2010. Characteristics of the well are as follows:

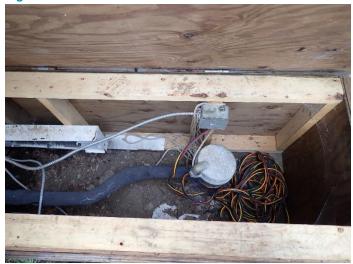
Figure 3: Well WTN 70508

Well WTN 70508 is currently in operation supplying groundwater to the Local Water Service via small treatment facility and reservoir (see *Figure 3*). The well is situated on private property at 184 Roland Rd.

A second well was drilled approximately 1.4 m (5') away from Well WTN 70508 to a depth of 27 m but was not used due to an inadequate well yield. Water was encountered 16.1 m below grade – since there is limited data for Well WTN 70508, we are assuming that the water will be the same depth as the second well for the conceptual design.

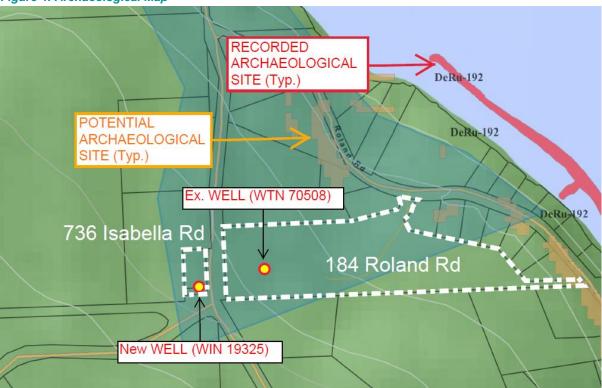
Figure 4: Archaeological Map

See *Figure 4* below for map illustrating recorded archaeological sites in **red** and high potential archaeological areas in **orange**.

For development projects in this area, a Preliminary Field Reconnaissance (PFR) is recommended for further investigation to move forward with detailed design and construction. Specifically, this is an onsite visit by an archaeologist (usually accompanied by staff from local First Nations) to judge the archaeological potential in the precise project areas. This visit does not require a Heritage Conservation Act (HCA) permit.

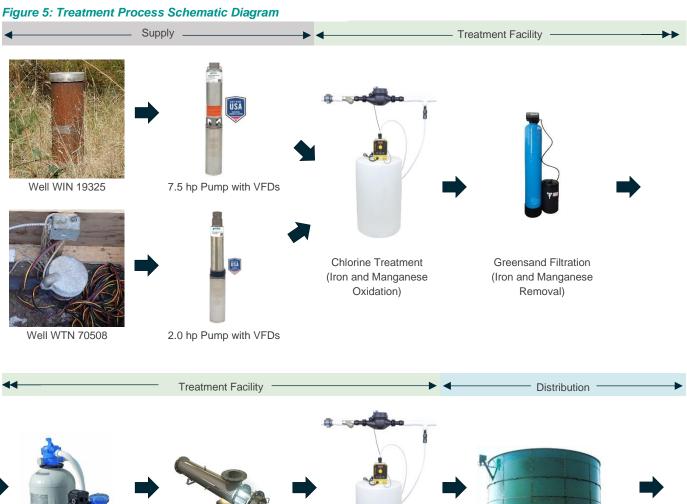
Treatment Process

The treatment process will include filtration and disinfection. This will comprise of the following items shown in the schematic diagram below (see Figure 5).

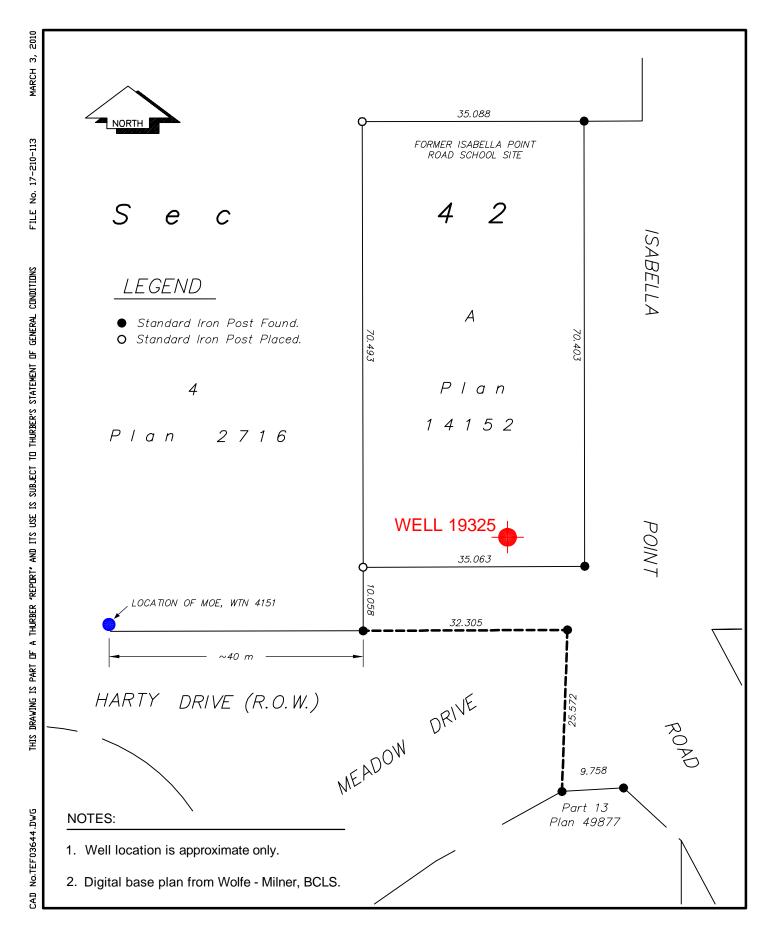
CAPITAL REGIONAL DISTRICT - CEDARS OF TUAM WATER UTILITY WELL PROGRAM WELL 19325 - LOCATION PLAN

SCALE: 1:600

The target location of Well 19325 was selected from Geological Survey of Canada mapping (Victoria Geology Map 1553A, Muller, 1980), air photo geological (lineament) mapping by Thurber and an examination of information on existing wells within the study area from wells shown in the MOE WELLS Data Base. Well 19325 was located in the south-east corner of the school site at the intersection of Isabella Point Road and Meadow Drive, as shown on Figure 2 in Appendix A.

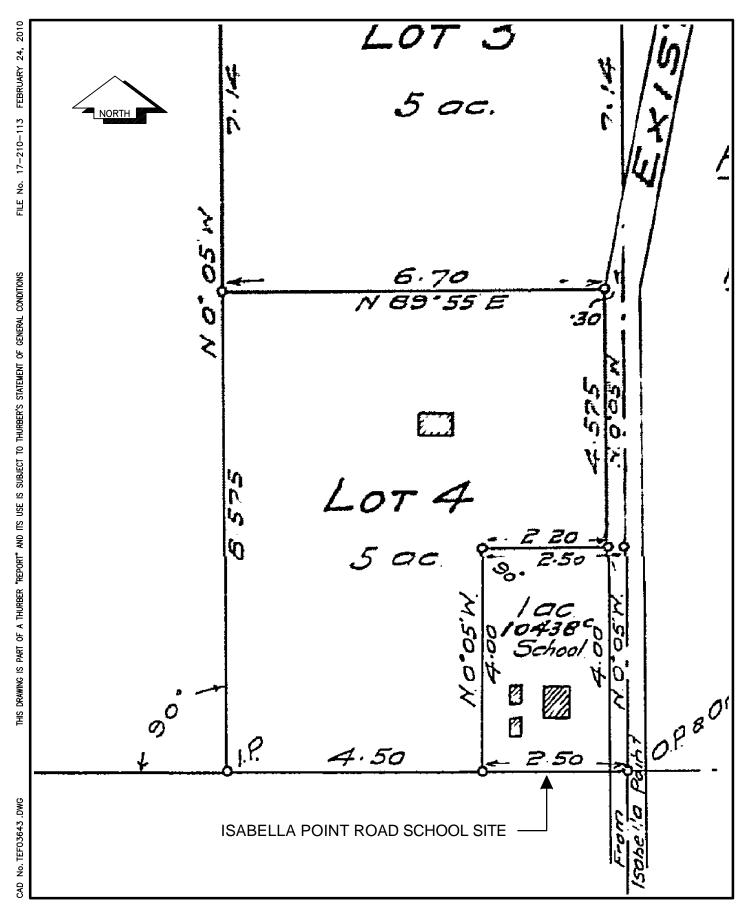
CAPITAL REGIONAL DISTRICT - CEDARS OF TUAM WATER UTILITY WELL PROGRAM PORTION OF 1921 LEGAL PLAN

Not to Scale

We understand that the school was closed and buildings removed in 1951. An enlarged portion of a 1921 legal plan (see Figure 4) in Appendix A shows what is assumed to be the old one-room school house location and two small outbuildings, which we assume to be (Boys/Girls) pit privies. The sites of the school house, and pit privies are not identifiable today.

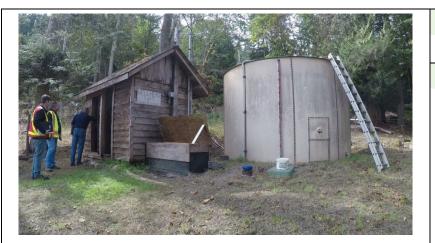
View of the water treatment plant (left-hand side) with 10,000 lmp. gallon (45 m³) water reservoir in the foreground.

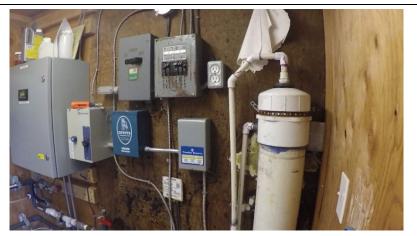
Interior of the water treatment plant. The building is damp and showing signs of aging. Vortex (sand) separator needs repair.

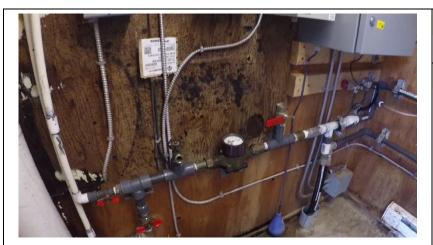
Interior of the water treatment plant. The building is damp and showing signs of aging.

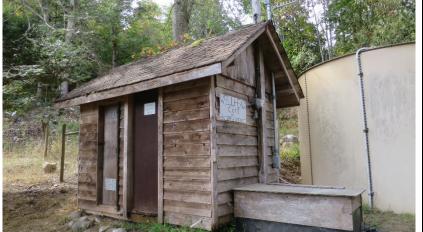
Front view of building with WTP room (left) with PST room (center) and well enclosure (right).
Reservoir is in the background.

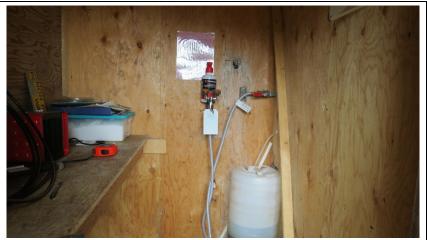
Inside of WTP with eyewash and chlorine treatment.

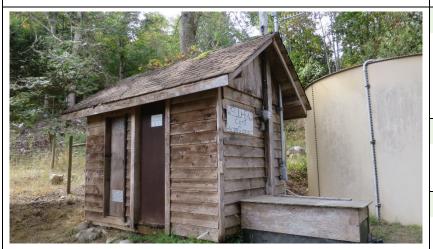
Front view of building with WTP room (left) with PST room (center) and well enclosure (right).
Reservoir is in the background.

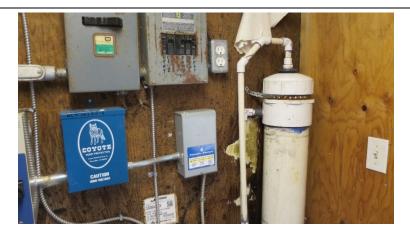
Inside of Pump Station Building

Mould is present on the wall behind water system components.
Electrical components are rusted due to continued exposure to moisture.

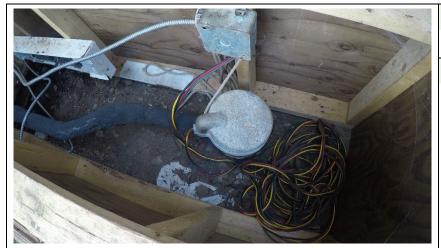
Cedars of Tuam WTP

Production GW well and well head located inside a wooden enclosure.

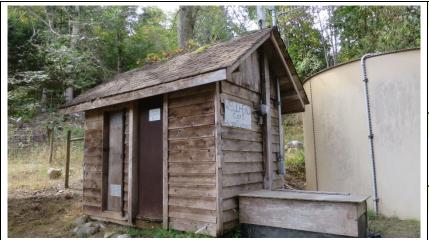
Front view of building with WTP room (left) with PST room (center) and well enclosure (right).
Reservoir is in the background.

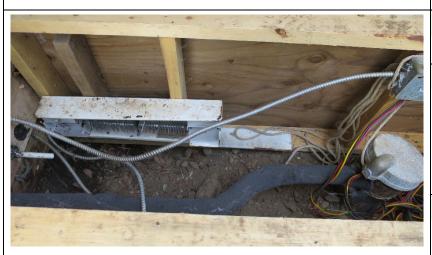
Inside of Well enclosure.

There are no foundations or interior finishes to protect structure from moisture. There is no floor. Electric baseboard heater is damaged and requires replacement.

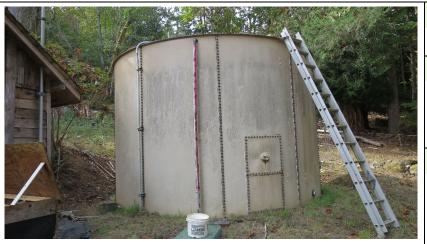
Reservoir tank

The temporary ladder and lack of fall protection make access to the tank lid unsafe.

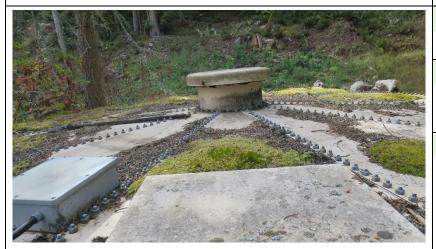
Top of Reservoir.

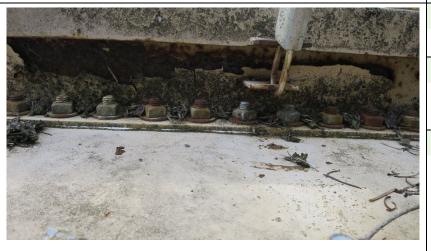
Reservoir lid.

Paint is chipping and steel is rusting.

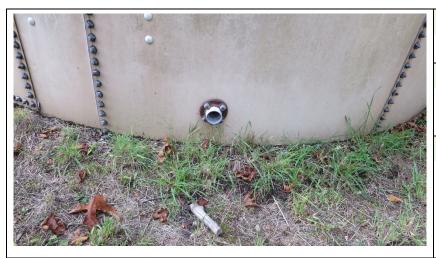
Reservoir drain.
