Hartland Landfill Groundwater, Surface Water and Leachate Monitoring Program Annual Report

(April 2022 to March 2023)

Capital Regional District

Project number: 60631284

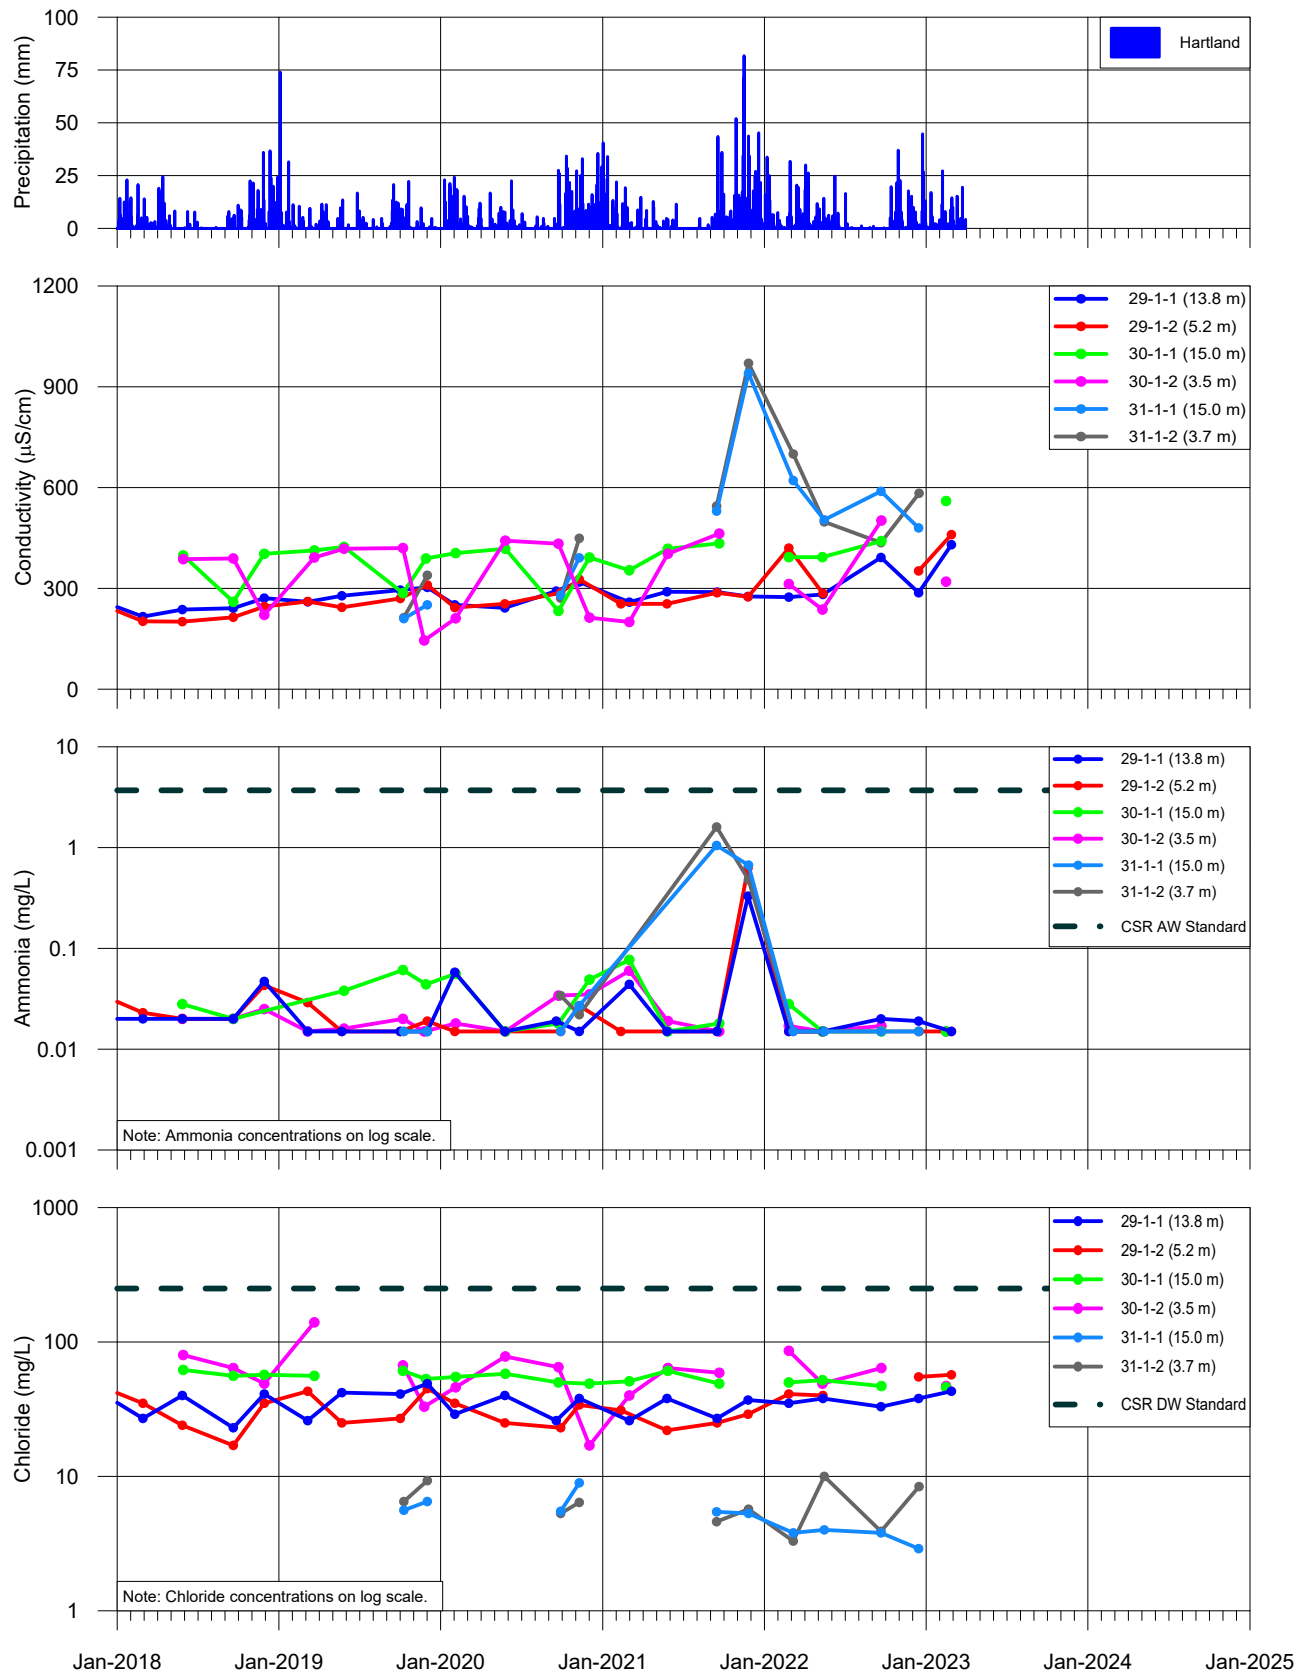
Figure 5-5. Groundwater Quality North of Willis Point Road

At groundwater monitoring station 39, conductivity values were below 400 $\mu\text{S}/\text{cm}$, and nitrate concentrations decreased on most sampling dates. However, nitrate concentration was elevated at 7.49 mg/L in GW-39-1-1 and 1.94 mg/L in GW-39-2-1 in March 2023. Groundwater quality in both wells has exhibited statistically significant increasing trends in sulphate and nitrate concentrations, and a decreasing trend in ammonia concentration has been observed at GW-39-1-1. On all sampling dates, sulphate concentrations in both wells were below 25 mg/L . Overall, the slight increase in nitrate levels observed in groundwater at sites 28 and 39 may suggest minor impacts related to aggregate production, stockpiling and road construction activities along the northern property boundary. Groundwater quality at these locations should be monitored closely to evaluate aggregate runoff impacts.

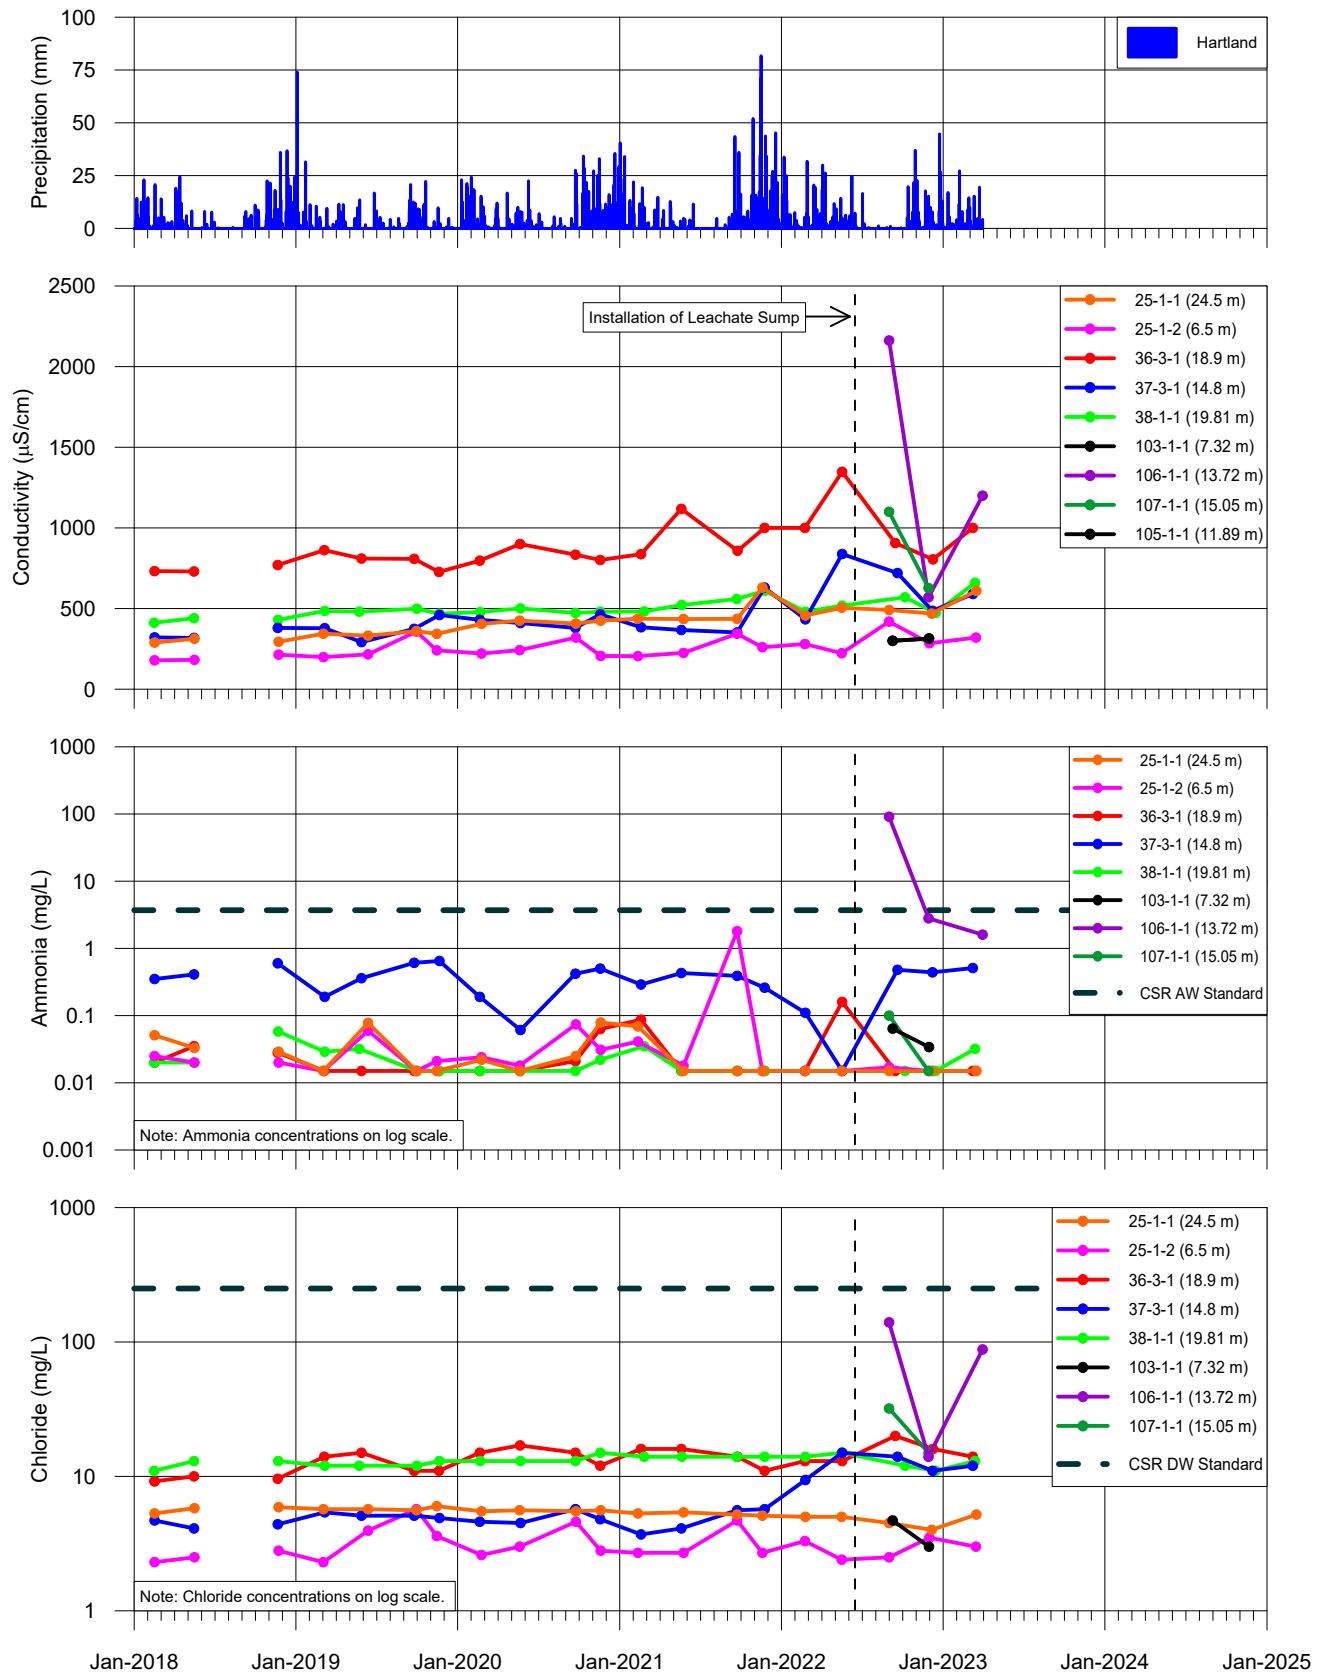
Figure 5-6. Groundwater Quality North of Phase 2 - Landfill Leachate Impacts

In 2022/23, conductivity and sulphate concentrations observed at GW-37-3-1 ranged from 590 to 838 $\mu\text{S}/\text{cm}$, and 110 to 240 mg/L, respectively, showing substantial increases from the previous monitoring year. The average conductivity observed at GW-37-3-1 increased by about 48% from the previous monitoring year, whereas sulphate concentrations increased by about 28%. Chloride concentrations remained low (i.e., <15 mg/L), but the average chloride concentration doubled from the previous monitoring year. Ammonia and nitrate concentrations increased slightly, peaking at levels of 0.51 mg/L and 0.689 mg/L, respectively. Due to the low chloride and ammonia concentrations, water quality degradation is interpreted to be the result of onsite aggregate stockpiling and not leachate.

Throughout the 2021/22 and 2022/23 monitoring periods, groundwater quality at monitoring station 37 degraded slightly, showing evidence of impacts associated with aggregate stockpiling. Groundwater quality at this location should be monitored closely to confirm the cause(s) of groundwater quality changes in this area. Consideration should be given to reinitiating sampling of GW-37-2-1.

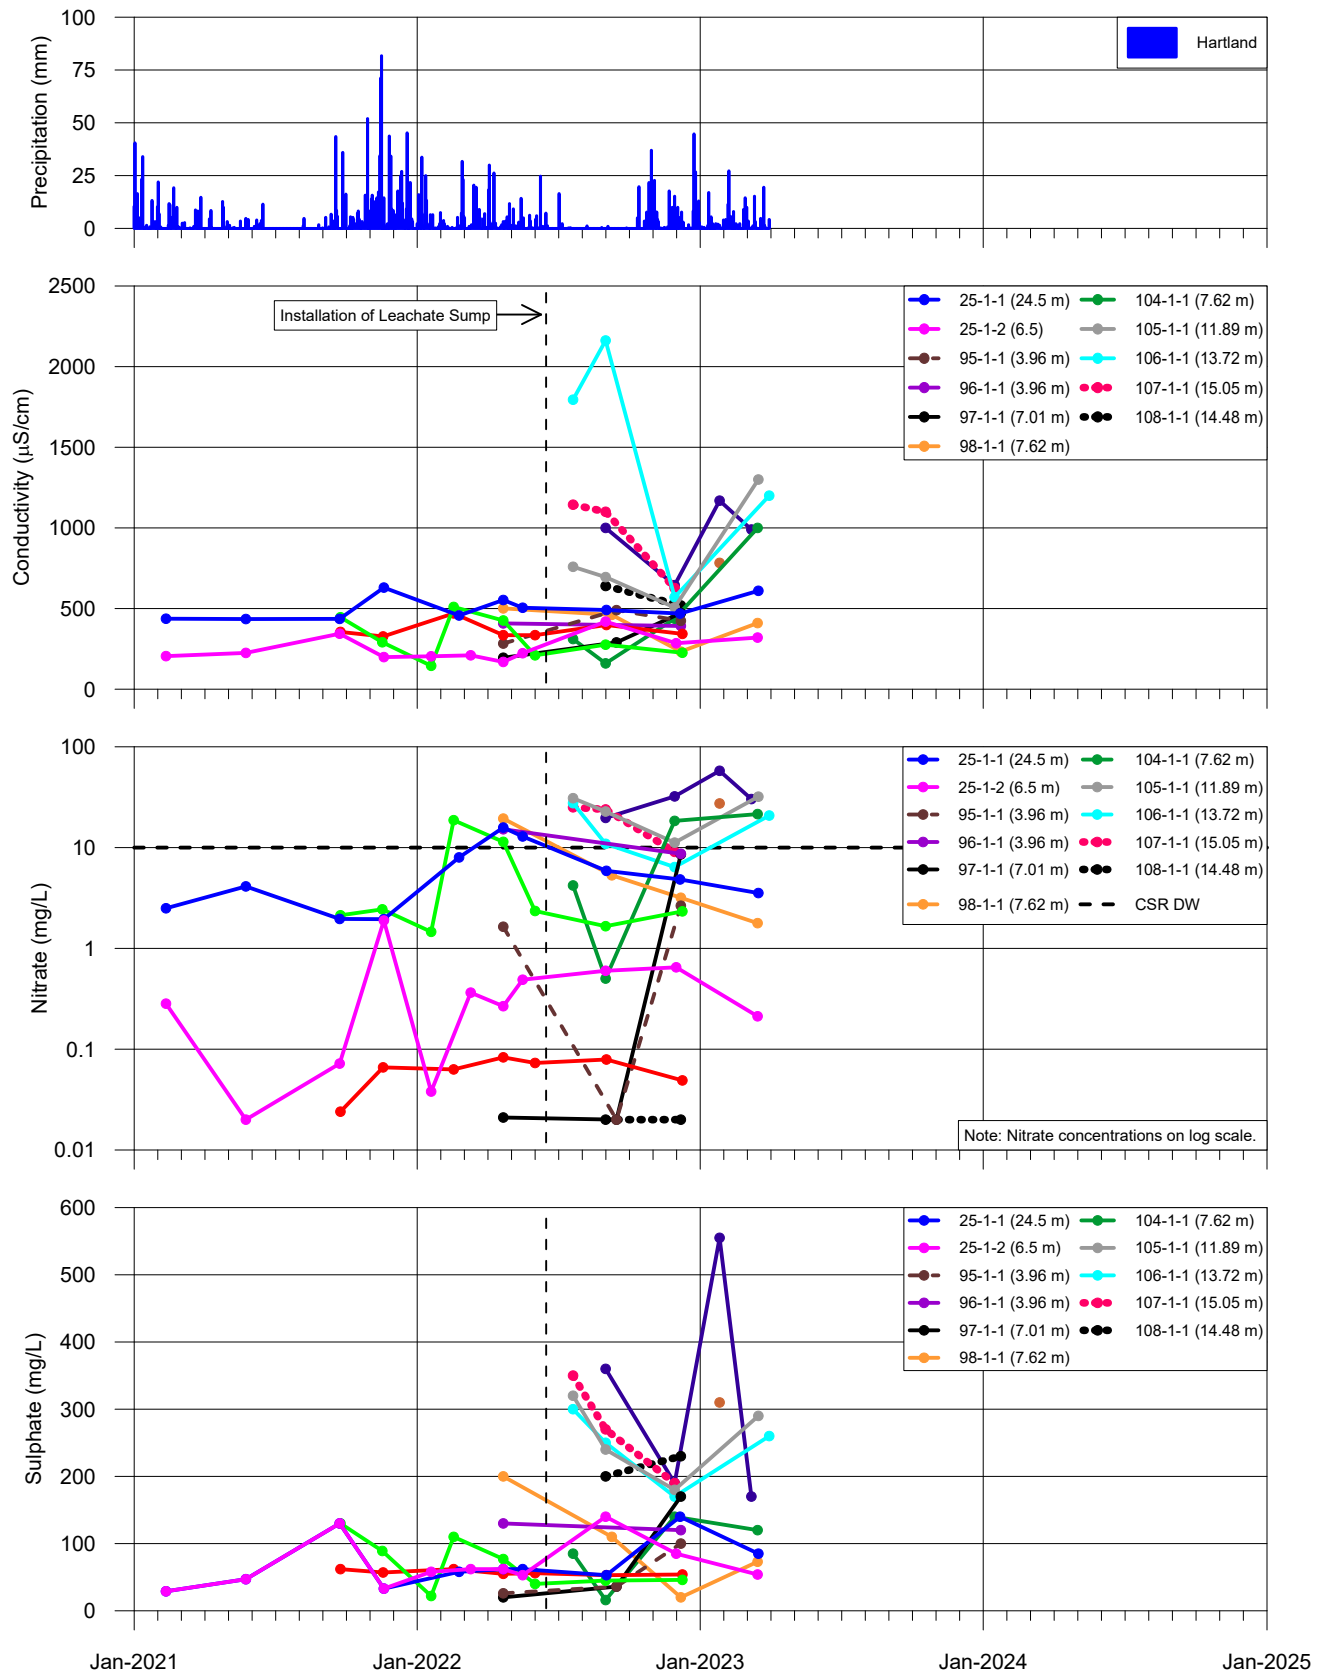
Figure 5-7. Groundwater Quality North of Phase 2 - Aggregate Impacts (2021 to Present)

At groundwater monitoring station 92, conductivity was elevated and ranged from 406 to 580 $\mu\text{S}/\text{cm}$. Chloride and ammonia concentrations were low or below the detection limit. Nitrate concentrations were low, ranging from 0.067 mg/L in December 2022 to 0.204 mg/L in September 2022, and sulphate concentrations were elevated, ranging from 110 to 120 mg/L. Over the past five years, statistically significant increasing trends in conductivity and sulphate concentrations have been observed in well GW-92-1-1.

At groundwater monitoring stations 91 and 92, elevated conductivity and sulphate concentrations did not correlate with elevated nitrate concentrations, so it is unlikely that aggregate runoff impacted groundwater quality in this area of the landfill. Similarly, there are no signs of leachate impacts.

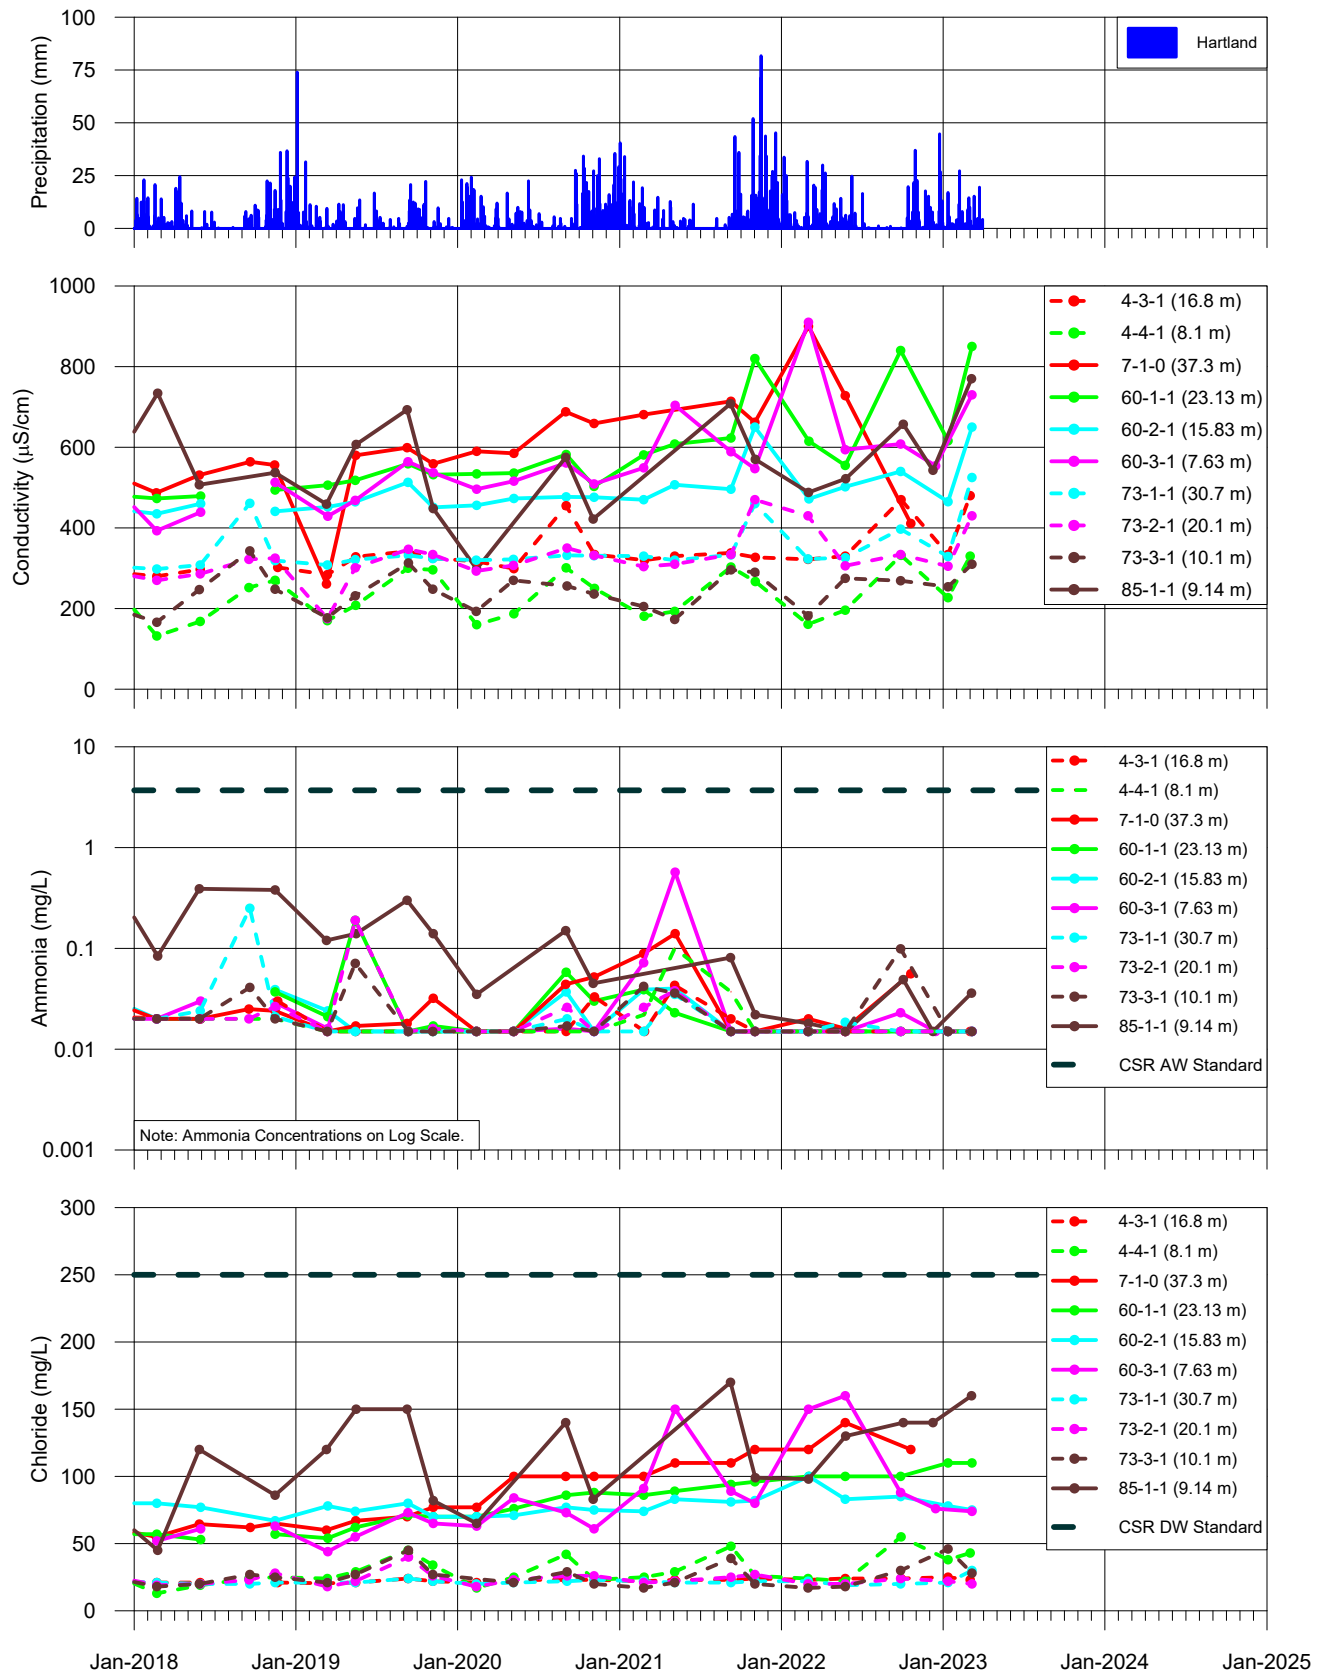
Figure 5-9. Groundwater Quality South of Landfill

In 2022/23, all solute concentrations observed at location 72 were below applicable CSR standards. The groundwater exhibited slightly elevated conductivity values, ranging from 426 to 610 $\mu\text{S}/\text{cm}$, and ammonia and nitrate concentrations were low. Chloride and sulphate concentrations were moderate, ranging from 39.0 to 74.0 mg/L and 44 to 68 mg/L, respectively. Over the past five years, a statistically significant increasing trend in conductivity has been observed in GW-72-1-1, and ammonia has shown a decreasing trend. Additionally, in well GW-72-3-1, conductivity and chloride concentrations have exhibited decreasing trends. Overall, groundwater quality at location 72 is good, with no evidence of landfill leachate or aggregate runoff impacts.

In 2022/23, all solute concentrations observed at location 73 were below applicable CSR standards. Conductivity was low to moderate, ranging from 269 to 525 $\mu\text{S}/\text{cm}$, and ammonia concentrations were generally at or below detection, except for in one groundwater sample collected from GW-73-3-1 in September 2022 (0.099 mg/L). Average nitrate concentrations were 0.083 mg/L in GW-73-1-1 and 0.708 mg/L in GW-73-3-1, with the highest concentrations nearest ground surface. In March 2023, a maximum nitrate concentration of 1.18 mg/L was observed at GW-73-3-1, but sulphate concentrations remained low (30 mg/L). Over the past five years, statistically significant increasing trends in conductivity and nitrate concentration have been observed in wells GW-73-1-1 and GW-73-2-1, and well GW-73-1-1 has exhibited an increasing trend in sulphate concentrations. Additionally, well GW-73-3-1 has exhibited an increasing trend in nitrate, and well GW-73-2-1 has exhibited a decreasing trend in ammonia. Groundwater quality at this location shows no evidence of landfill leachate impacts. Although nitrate concentrations were occasionally elevated, the low and stable sulphate concentrations indicate that groundwater quality was not impacted by aggregate runoff.

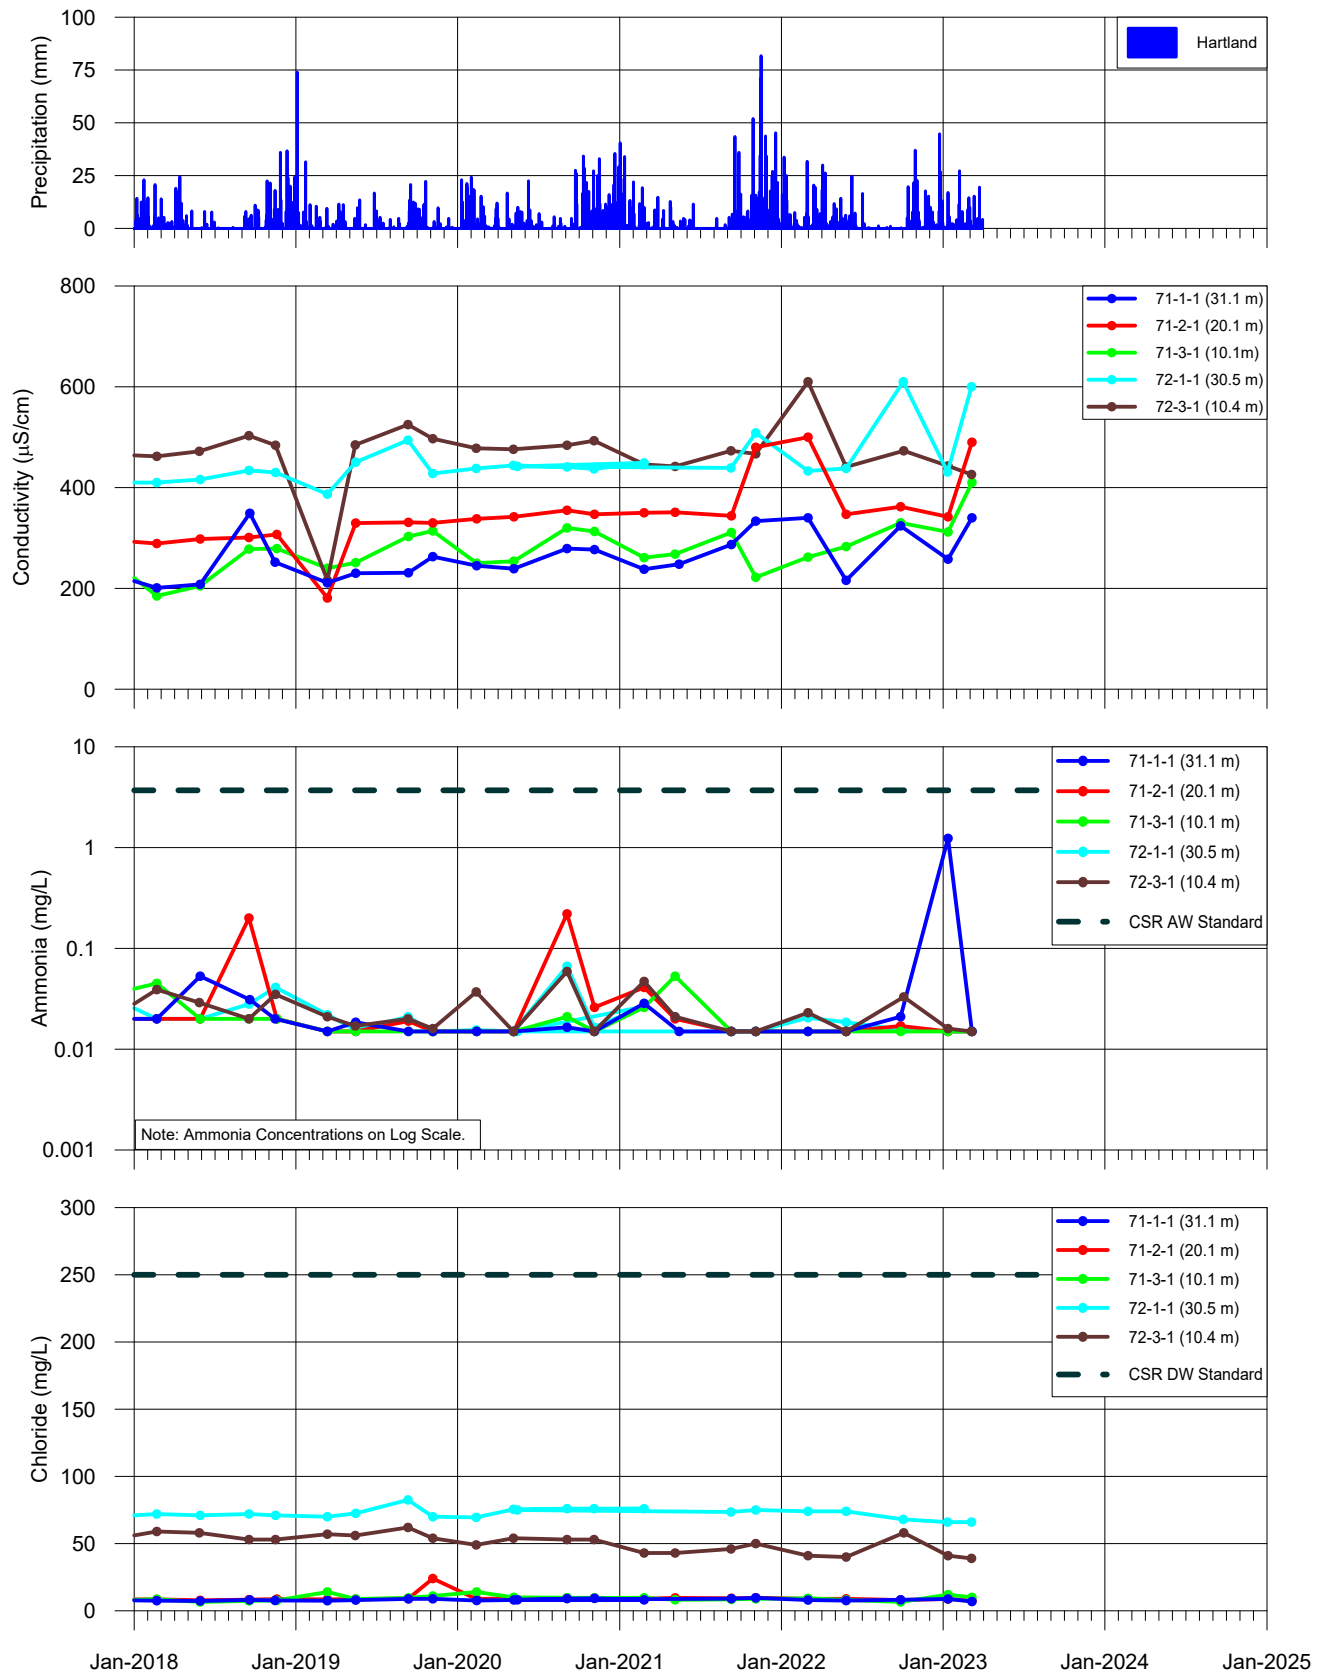
Figure 5-10. Groundwater Quality Southeast of Landfill

- Water quality along the southern boundary of the Phase 1 landfill showed no evidence of landfill leachate impacts. Since 2020, chloride concentrations have been occasionally elevated at some monitoring stations (e.g., stations 85 and 60) in the area, but the elevated chloride concentrations have not correlated with elevated ammonia concentrations. High Cl/Na molar ratios (>1) suggest there is additional source of chloride other than road salt, but the source of chloride is currently unknown. In addition, elevated nitrate concentrations were observed in some shallow wells, accompanied by moderate concentrations of sulphate. The elevated nitrate may be sourced from the Phase 1 Stockpile or dust originating from other stockpiles.

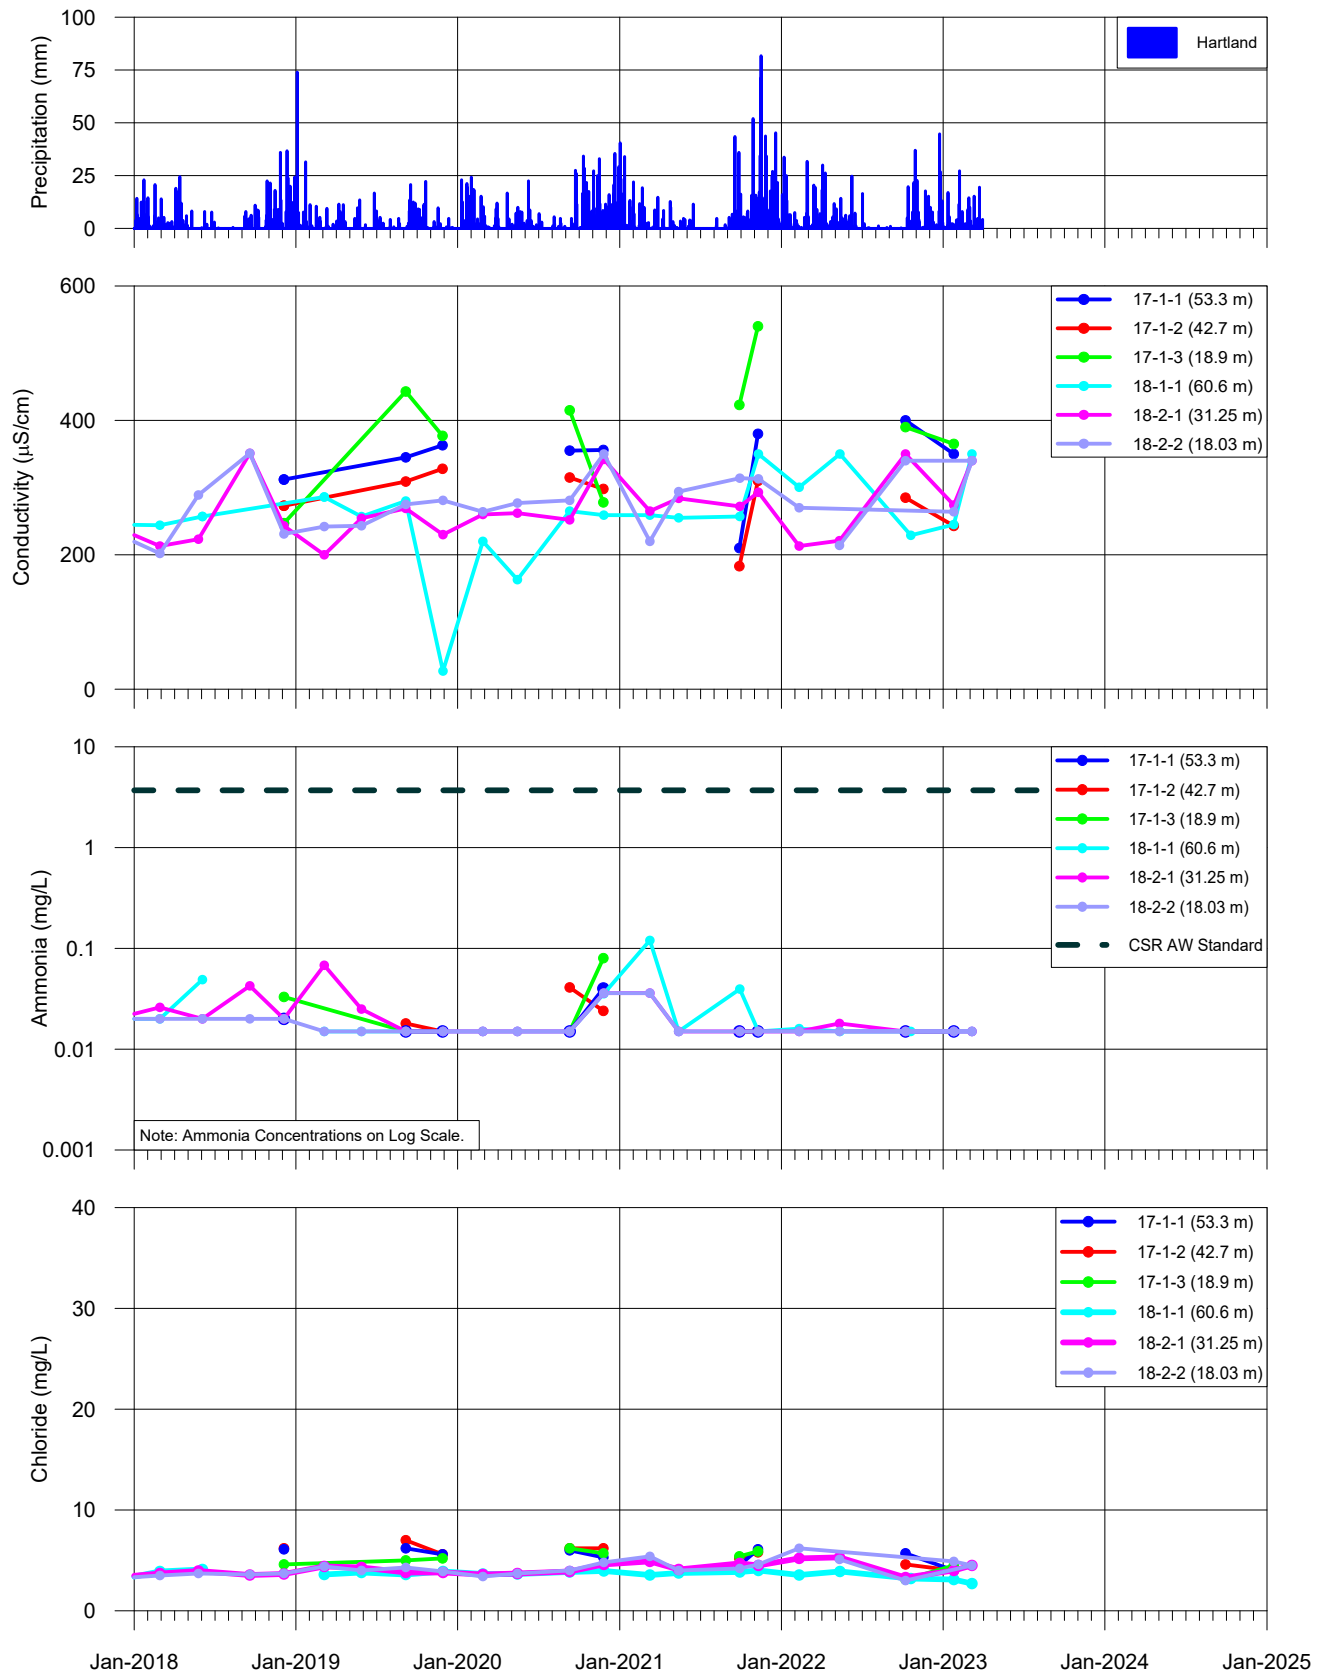
Figure 5-11. Groundwater Quality East of Landfill

- Water quality along the east boundary of the Phase 1 landfill was similar to previous years and was not impacted by leachate. Ammonia concentrations at monitoring stations 16, 17 and 18 were below the detection limit on all sampling events, and groundwater quality at met all applicable CSR standards. However, groundwater quality at station 16 likely showed signs of aggregate impacts during the March 2023 sampling event.

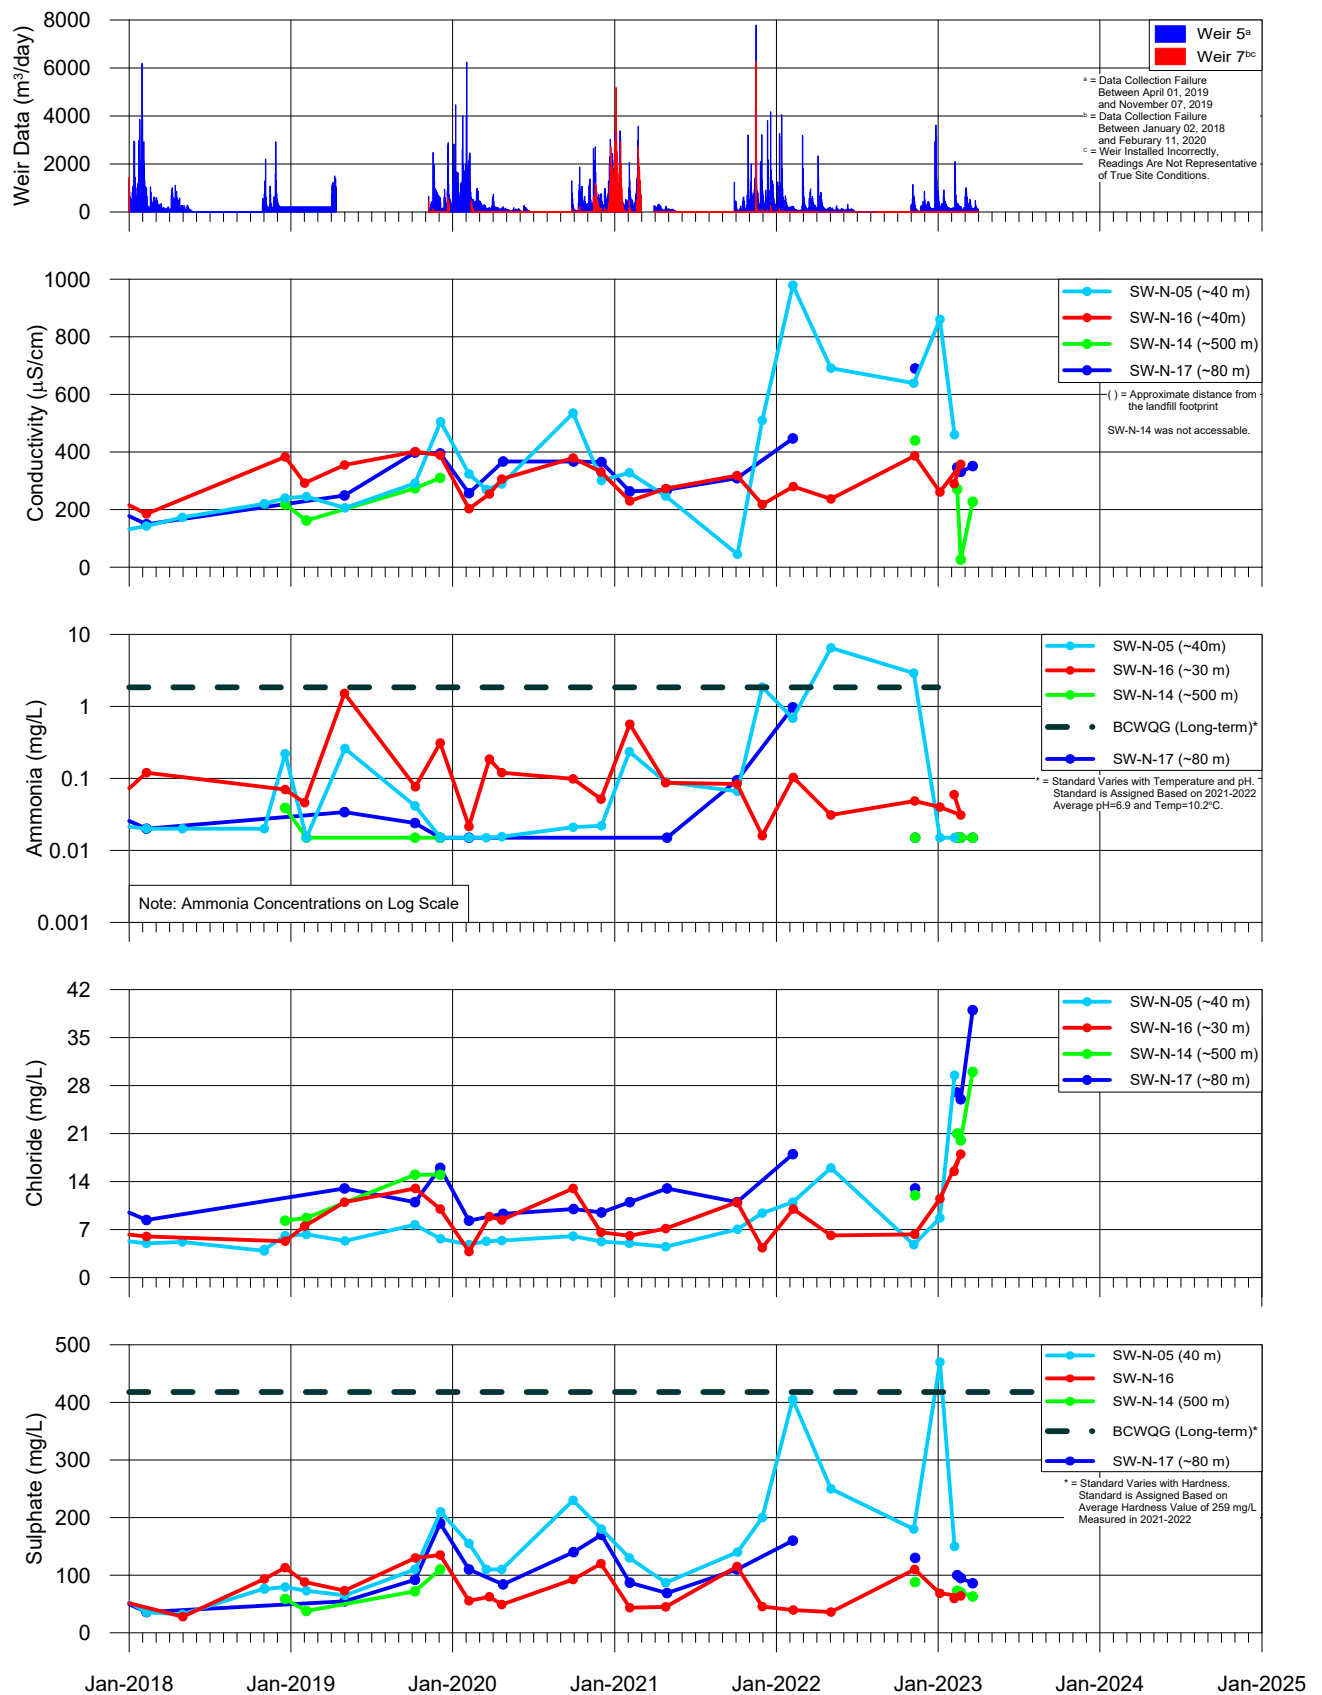
Figure 7-2. Surface Water Quality North of Phase 1

Figures 7-2 and 7-3 present solute concentration and conductivity trends observed at surface water monitoring stations in the north area of the landfill and beyond the northern property boundary. In Figure 7-2, the distance of each station from the landfill boundary is shown in brackets in the legend. Sw-N-05 and Sw-N-16 are compliance monitoring stations. Elevated and non-compliant nitrate concentrations were observed at Sw-N-05. In addition, nitrate concentrations exceeded the BCWQG-LTC at Sw-N-05 and Sw-N-16 during all sampling events. Nitrite and ammonia concentrations exceeded BCWQG-LTC at Sw-N-05 on two out of four sampling dates. The water quality impacts observed at Sw-N-05 and Sw-N-16 are linked to runoff from the Northwest Stockpile. Similar water quality impacts were observed at Sw-N-17 and Sw-N-14. Like previous years, these sampling locations were dry periodically in 2022/23 due to arid summer conditions.

Sw-N-17 is located north of Willis Point Road and is downstream of Sw-N-45 and Sw-N-05. Water quality at Sw-N-17 met BCWQG-STA guidelines on all sampling dates, but concentrations exceeded the BCWQG-LTC for nitrate on all sampling dates, and for dissolved copper in March 2023. Sulphate concentrations were elevated and decreased throughout the monitoring year, ranging from 86.0 to 130 mg/L. Chloride concentrations were also elevated slightly and decreased throughout the monitoring year from 13.0 to 39.0 mg/L. Ammonia concentrations were below the detection limit on all sampling dates. Conductivity was relatively high at the beginning of the monitoring year (690 µS/cm) and later decreased to values ranging from 331 to 351 µS/cm. Over the past five years, a statistically significant increasing trend in chloride concentrations has been observed at Sw-N-17, which may reflect road salting.

In 2022/23, surface water quality at monitoring locations 17 and 45 was impacted by aggregate production and stockpiling, as indicated by elevated conductivity, nitrate and sulphate concentrations. Surface water quality at these locations should continue to be monitored closely to assess the evolution of these water quality impacts downstream of the landfill.
