#### JUAN DE FUCA WATER DISTRIBUTION COMMISSION

Notice of Meeting on **Tuesday, December 7, 2021 at 12 pm** Goldstream Room, 479 Island Highway, Victoria, BC

#### **SUBJECT** Greater Victoria pH & Corrosion Study Update

Capital Regional District, District of Saanich, City of Victoria, District of Oak Bay
Greater Victoria pH and Corrosion Study
Final Report
August 31, 2021

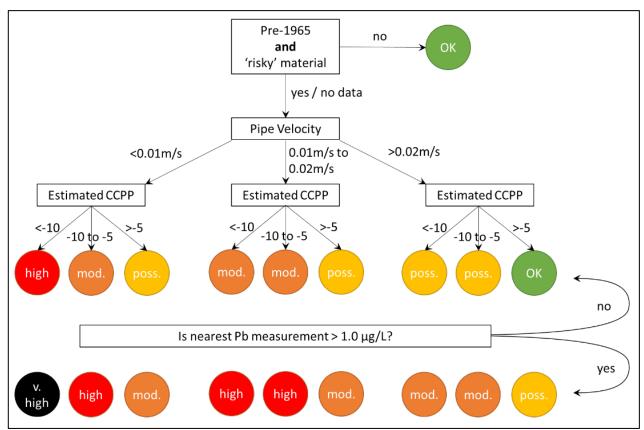
Figure 2-1: Pipe Corrosion Index Logic

For each pipe in the network, a series of queries was asked as highlighted in Figure 2-1. The results of each query were used to assign a score to each pipe segment which were then added up so that they could be mapped as illustrated in Figure 2-1. Refer to Figure 7-2 through 7-5 for the pipe corrosion index assignments across the study areas.

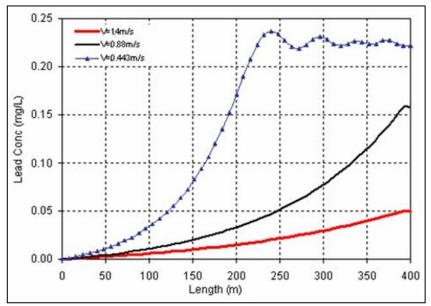
Figure 2-2: Effect of Flow Velocity on Lead Pipe Corrosion<sup>6</sup>

A limited literature review was conducted to identify appropriate water velocity bounds for assessing lead leaching risk across a distribution system. The review suggests that there is contradiction in the body of research. Some studies suggest that corrosion rate is higher at high velocities because there is a higher driving force for mass transfer (i.e., more oxidants can reach the surface of the pipe and therefore cause accelerated corrosion)<sup>4</sup>. Others found that corrosion rate is inversely related with flow velocity <sup>5</sup>. A hydraulic transient and advection-dispersion-reaction (ADV) modelling exercise was conducted in 2010 that as flow velocity decreases then corrosion activity increases<sup>6</sup> (refer to Figure 2-2 below).

Corrosion rate is also only part of the picture; it represents the amount of lead that is being released into the water. As the flow rate increases, the dilution of this released lead becomes more significant. As noted in the 2002 US EPA Permeation and Leaching Distribution System Issue Paper, "The movement of water through mains acts to dilute contaminants that have permeated the pipe wall."

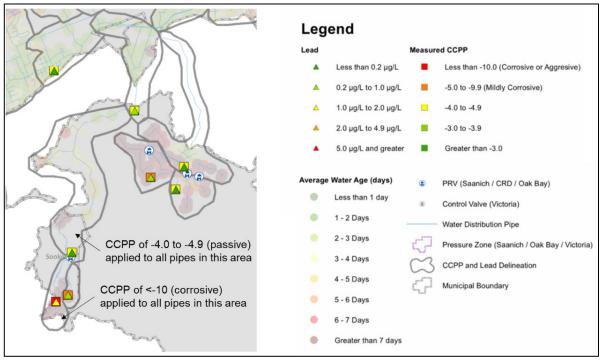
Figure 2-3: CCPP Assignment Illustration

3. What is the CCPP in the area? CCPP was calculated for each of the samples collected across the distribution system. These CCPP values were then assigned to each pipe in the system based on how the system operates by delineating the area within which that CCPP is applied.

The CCPP values tended to decrease (i.e., predict increasing corrosivity) as the water moved to the far ends of the system. To be conservative, it was assumed that the CCPP measured further away from treatment applied until a new CCPP value was measured (i.e., at the next sampling point. This is illustrated in Figure 2-3 below. Refer to Figure 2-4 for the delineation across the system.

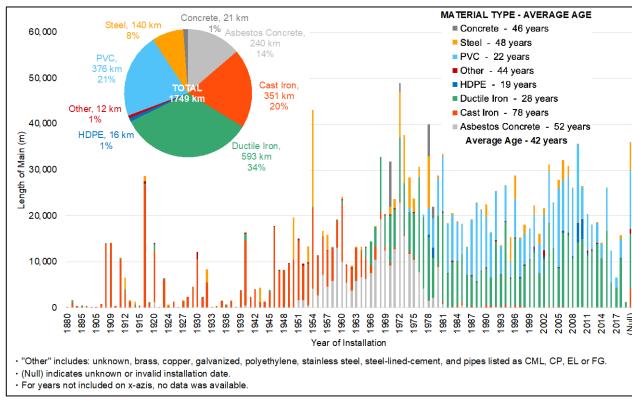
Figure 4-1: Water Main Ages, Lengths and Material Types for All Jurisdictions in Greater Victoria

Figure 4-1 illustrates water main ages, lengths, and material types for all regions in Greater Victoria (District of Saanich, District of Oak Bay, City of Victoria, and Capital Regional District). Some pipes date back to the late 1800s, with a length-weighted average age of 42 years. Concrete, HDPE, and other (possible Pb risk – listed in Figure notes) pipe types each account for approximately 1% of the installed length. For the principal pipe types, key observations are as follows:

- cast iron (possible Pb risk) was common from 1880 to the 1960s;
- asbestos concrete was common from the early 1950's to the early 1980s;
- ductile iron was common from the mid-1960s to present;
- PVC was common from the mid-1960s to present; and
- steel (possible Pb risk) appeared sporadically over the past century.

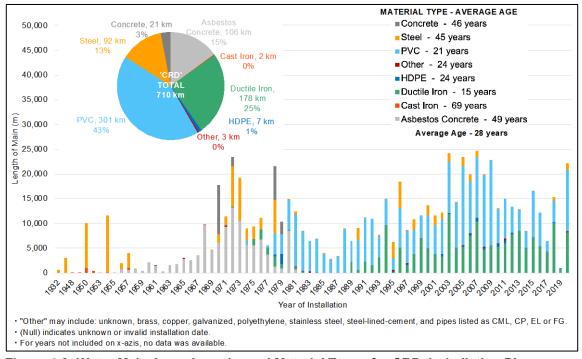
Figure 4-2: Water Main Ages, Lengths and Material Types for CRD Jurisdiction Pipes

- asbestos concrete was common from the mid-1950s to the early 1980s;
- ductile iron was common from the late 1980s to present;
- PVC was common from the late 1970s to present; and
- steel (possible Pb risk) appeared sporadically since the 1930s and was associated with the larger transmission mains.

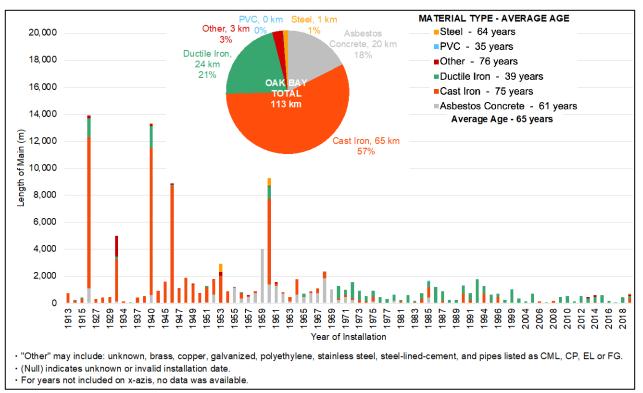
Figure 4-3: Water Main Ages, Lengths and Material Types for District of Oak Bay Jurisdiction Pipes

- cast iron (possible Pb risk) was common from the 1910s to 1960s;
- asbestos concrete was common from the mid-1950s to the early 1970s; and
- ductile iron was common from the early 1970s to present.

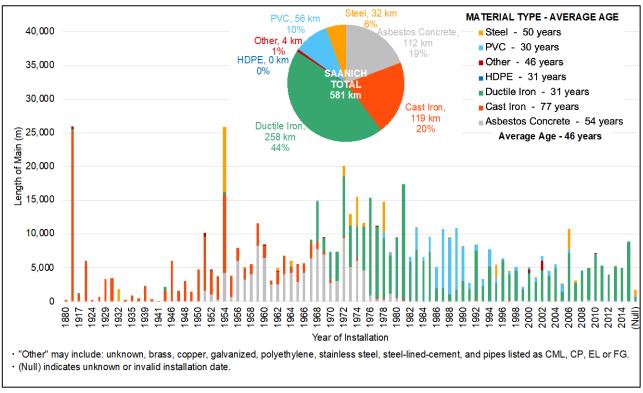
Figure 4-4: Water Main Ages, Lengths and Material Types for District of Saanich Jurisdiction Pipes

- cast iron (possible Pb risk) was common from 1880 to the 1960s;
- asbestos concrete was common from the early 1950s to the 1970s;
- ductile iron was common from the late 1960s to present;
- PVC was common from the late 1980s to early 1990s; and
- steel (possible Pb risk) appeared sporadically over the past century.

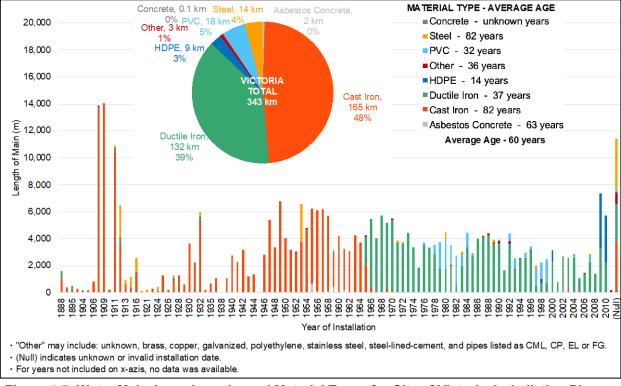
Figure 4-5: Water Main Ages, Lengths and Material Types for City of Victoria Jurisdiction Pipes

- cast iron (possible Pb risk) was common from 1880 to the mid-1960s;
- ductile iron was common from the late 1960s to present;
- PVC appeared sporadically from the late 1970s to the 2000s;
- steel (possible Pb risk) appeared sporadically over the past century; and
- HDPE appeared in the 2000s.

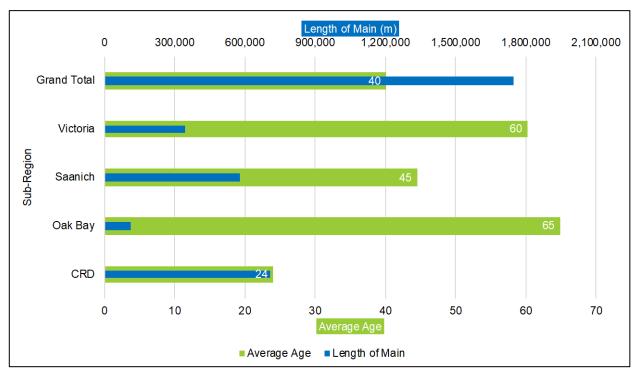
Figure 4-6: Water Main Ages and Installed Lengths for the Greater Victoria Region

Figure 4-6 illustrates water main ages and installed lengths for the Greater Victoria region and sub-jurisdictions. The jurisdictions with the oldest water mains (Victoria and Oak Bay) also have the least total installed water main length within the available inventory. The jurisdictions with newer water mains (Saanich and CRD) have the greatest water main inventory.

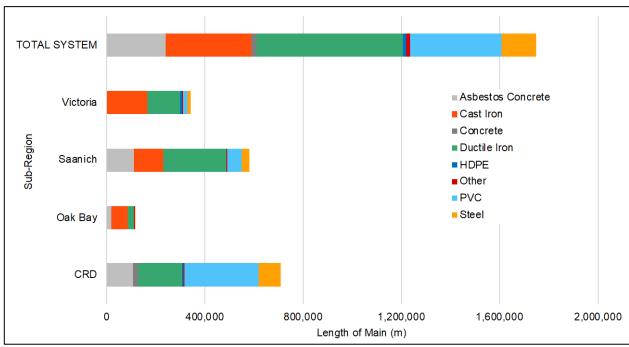
Figure 4-7: Pipe Materials and Installed Lengths for the Greater Victoria Region

Figure 4-7 illustrates water main material types and installed lengths for the Greater Victoria region and sub-jurisdictions. Ductile iron has been used across all jurisdictions. PVC and asbestos concrete were most common for in the CRD and Saanich jurisdictions. Cast iron was common in all jurisdictions except for the CRD.

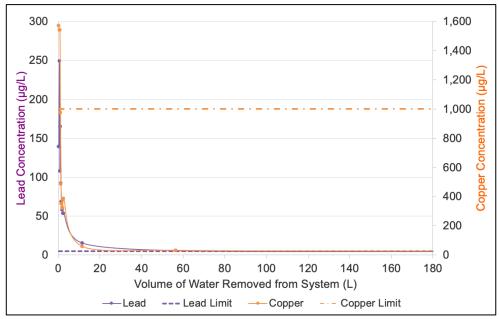
Figure 6-9: Lead and Copper Decline as a Function of Volume Removed

A third round of sampling was completed at the Cook and Mallek location to confirm that the lead was being contributed from the copper piping supplying the water sampling station. The lead and copper concentration decrease versus volume removed from the system. Results are shown in Figure 6-9 and Figure 6-10. The results suggest that the source of the lead was the copper sampling station supply line.

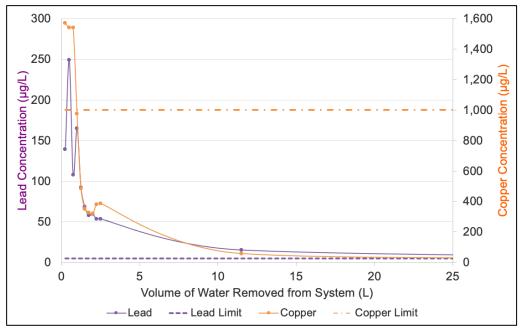
Figure 6-10: Lead and Copper Decline as a Function of Volume Removed (first 25L)

The copper supply line was later removed by the CRD and replaced with stainless steel. Two samples were then collected: a first draw and after a 3-minute flush. The test results from the new stainless-steel pipe showed a first draw lead level of 0.64  $\mu$ g/L and a post flush lead level of less than 0.02  $\mu$ g/L which means that the lead level was below the detection limit. This significant reduction in first draw lead (250  $\mu$ g/L to 0.64  $\mu$ g/L) strongly supports that the copper piping was the source of lead at this location. The removed copper piping was kept and stored for future tests.

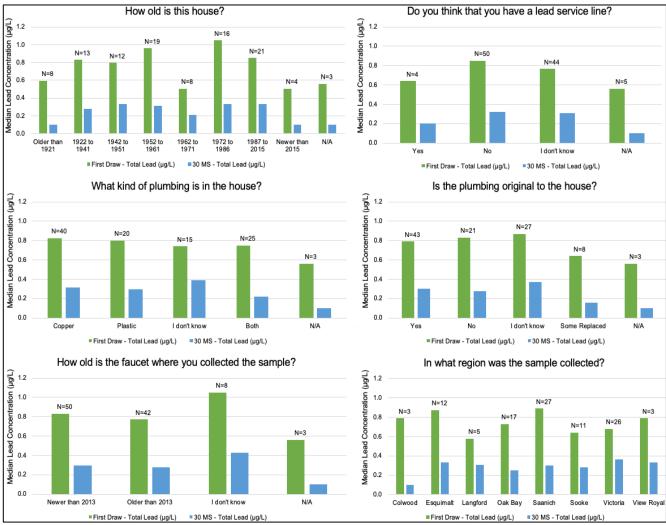
Figure 6-11: Private Side Median Lead Concentrations, Broken Down by Survey Question9.

The median water analysis results were grouped based on responses to six survey questions. These data are presented in Figure 6-11 (lead results), and Figure 6-12 (copper results).

<sup>&</sup>lt;sup>9</sup> The "N" value over each set of bars indicates how many respondents gave this answer. For 30MS samples, an average was found for the two samples from each home and the overall median of these averages is reported.

Generally, lead was found to be low across both the First Draw samples (i.e., below the action limit of  $15 \,\mu g/L$ ) the 30MS samples (i.e., below the MAC of  $5 \,\mu g/L$ ). Median lead concentrations were  $0.8 \,\mu g/L$  for First Draw and  $0.3 \,\mu g/L$  for 30MS. The  $90^{th}$  percentile lead concentrations were  $1.9 \,\mu g/L$  for First Draw and  $0.9 \,\mu g/L$  for 30MS. One site of 104 had a lead concentration over the First Draw action limit, and the same site had a 30MS lead concentration over the Health Canada MAC. The homeowner with high lead concentrations was notified and given advice on corrective actions. No sites sampled had copper concentrations over the aesthetic objective (1 mg/L) or the MAC (2 mg/L).

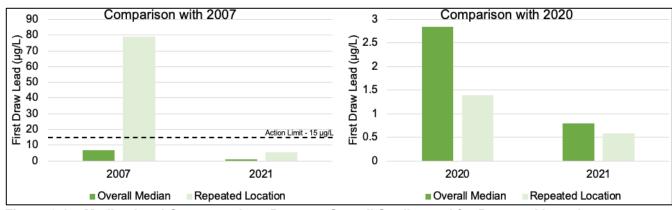
Figure 6-14: Median Lead Concentrations Between Overall Studies and for Repeated Locations

In addition to study-wide comparison with the 2020 data, there was one individual location which was sampled in both 2007 (see study details in Section 1.4.2) and 2021, and there was another individual location that was sampled in both 2020 and 2021. The results at these two locations were compared, as well as the overall medians from the three different studies, as presented in Figure 6-14. Based on our understanding, there have been no changes to residence-specific plumbing at either of the repeated locations. This data further supports the hypothesis that the changed water chemistry in the GVDWS, because of the changes to the disinfection process at the GWTP, is driving the decrease in lead concentrations observed at users' taps.

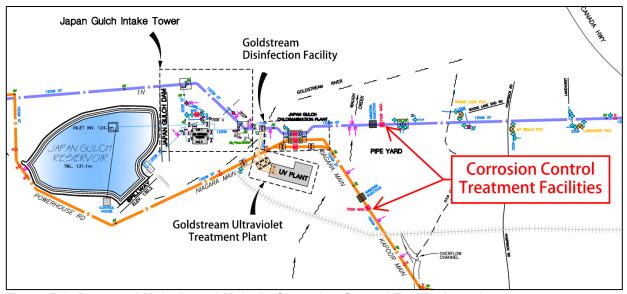
Figure F-1: Proposed Main #4 and Main #5 Corrosion Control Facility Locations

In order to avoid interfering with the current disinfection systems (especially as the ammonia will impact pH, causing a change to the water's corrosivity), it was assumed that corrosion control would be implemented downstream of the ammonia injection points on Main #4, Main #5 and Main #15 as illustrated in Figures F-1 and F-2.
