## Notice of Meeting and Meeting Agenda Regional Water Supply Commission

Wednesday, May 19, 2021

# Greater Victoria Drinking Water Quality 2020 Annual Report

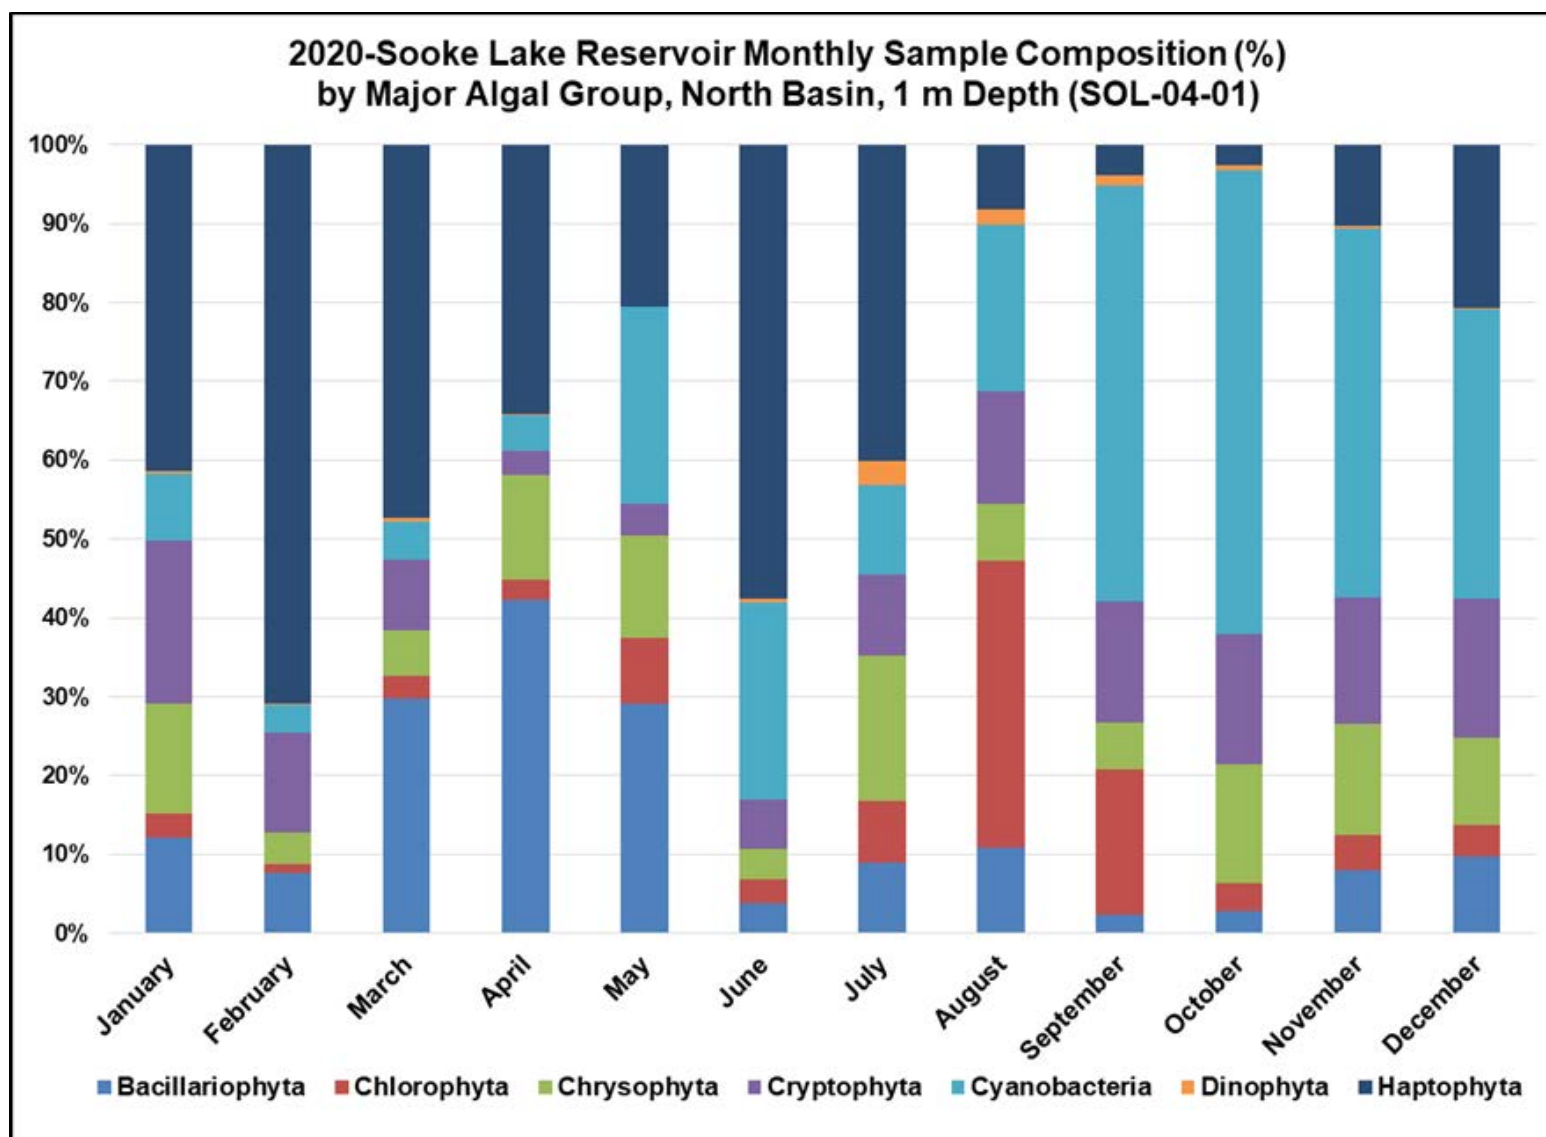
**Figure 10 Monthly Abundance Percent of Different Algal Groups, North Basin, 1 m depth, SOL-04-01, 2020**

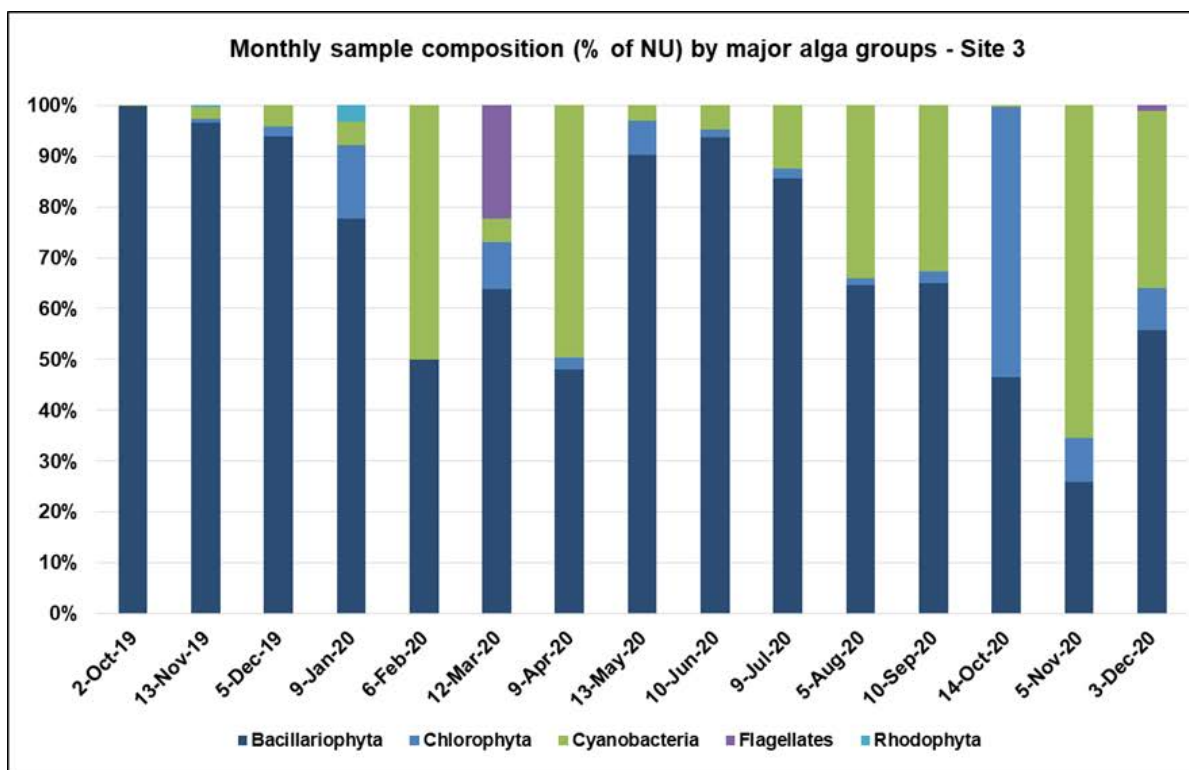
**Figure 16 Monthly Sample Composition (% of Natural Unit counts - NU) by Major Alga Groups for Site 3 (top) and 4 (bottom)**

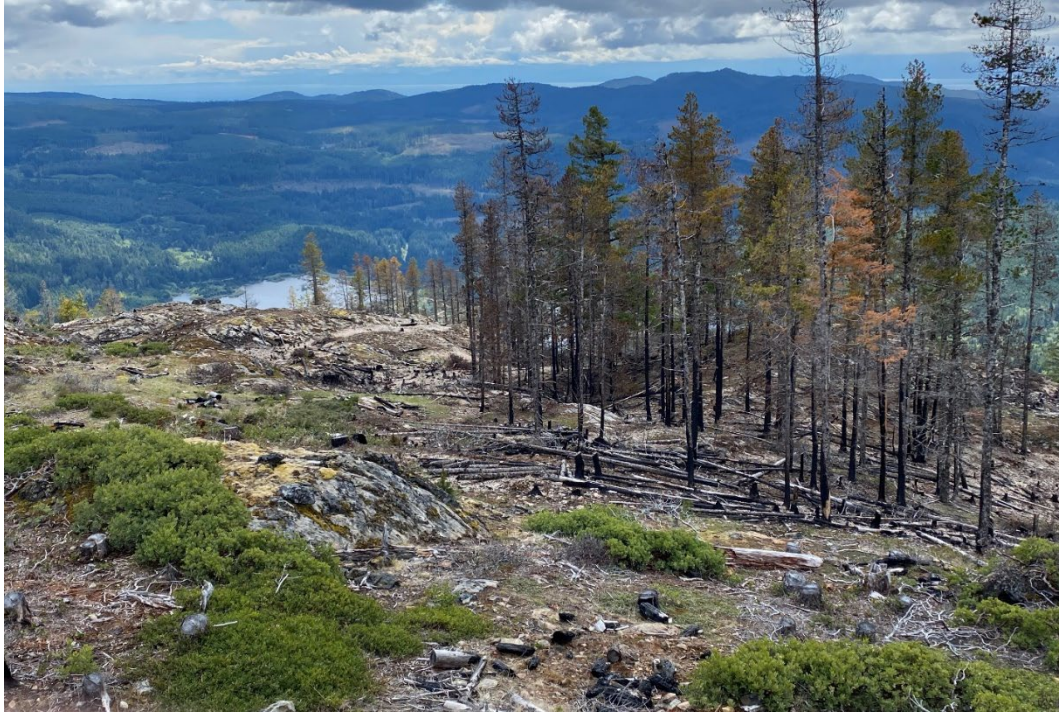
Green unburned area in front with evidence of previous fuel management; example of fire killed trees, fire scorched trees and green trees within the burn area. Light areas where wood straw was deployed. Sooke Lake Reservoir in the background.

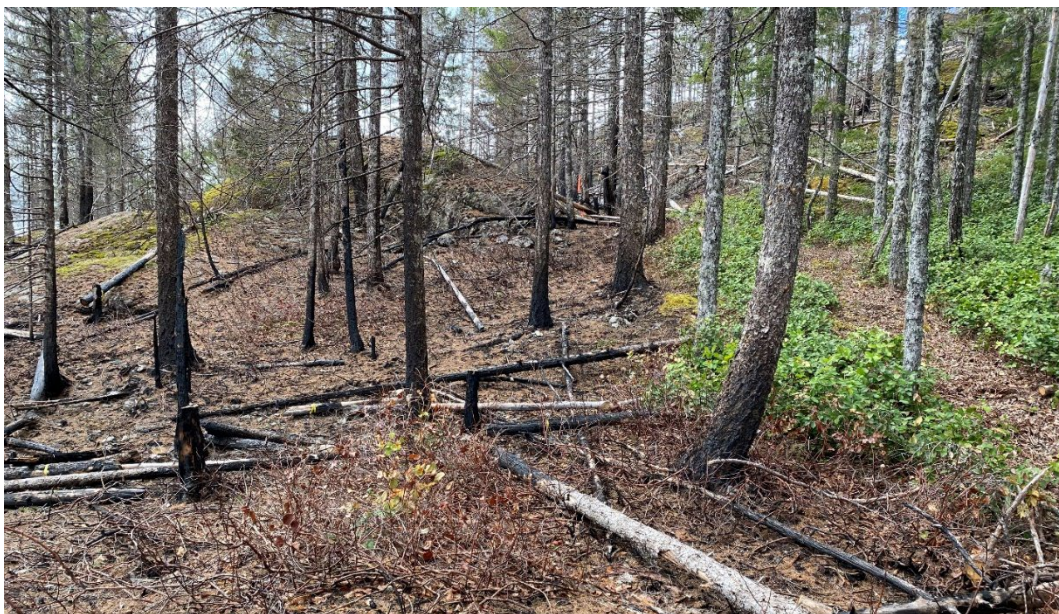
Comparison of burned and unburned area. The dominant salal understory was mostly completely burned. Looking carefully new vegetation can be seen coming up in the foreground.

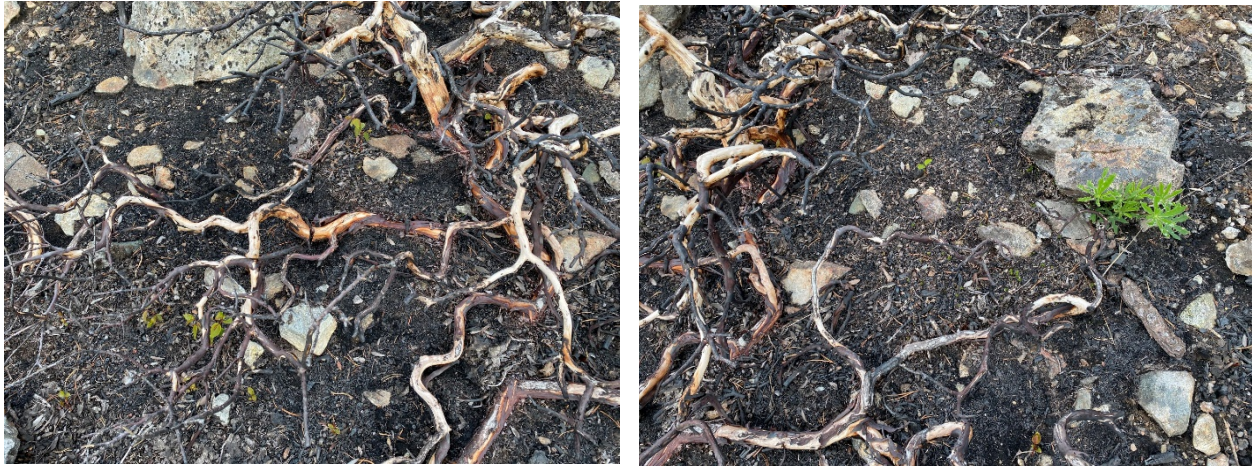
Burned hairy manzanita (*Arctostaphylos columbiana*) with lupine (*Lupinus nootkatensis*) and other new growth underneath.

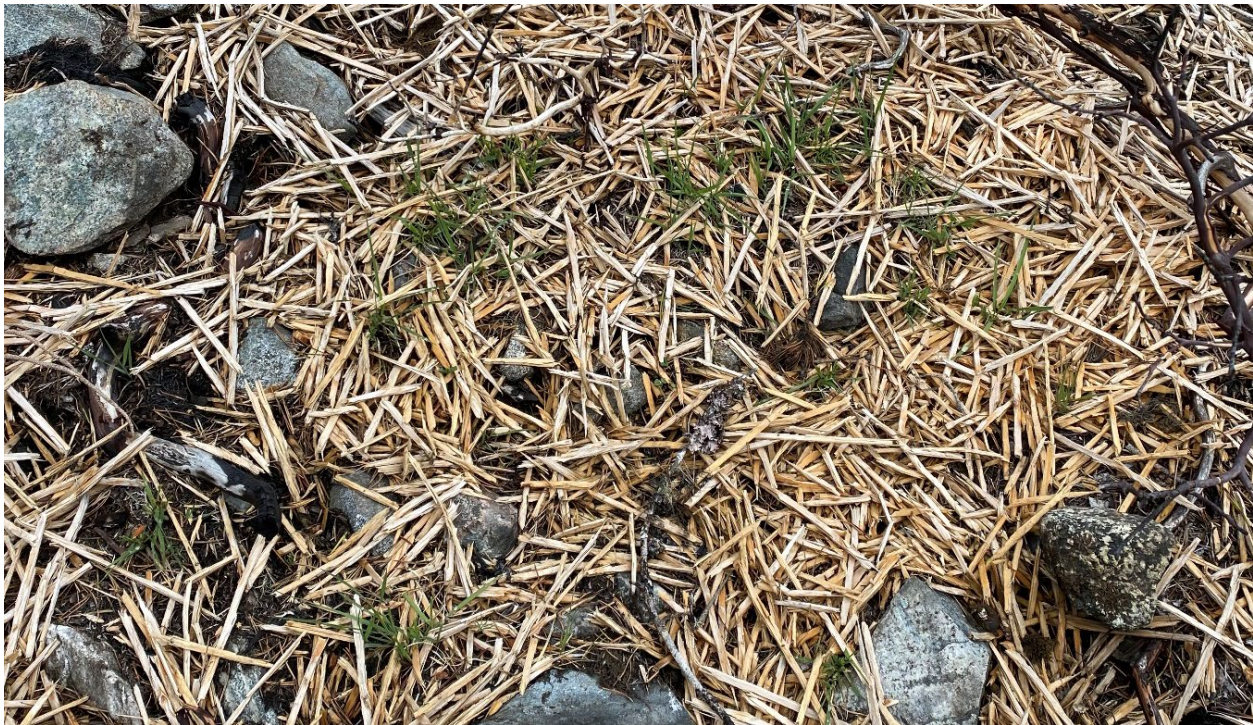
Even where woodstraw was heavily applied, new vegetation is growing through.

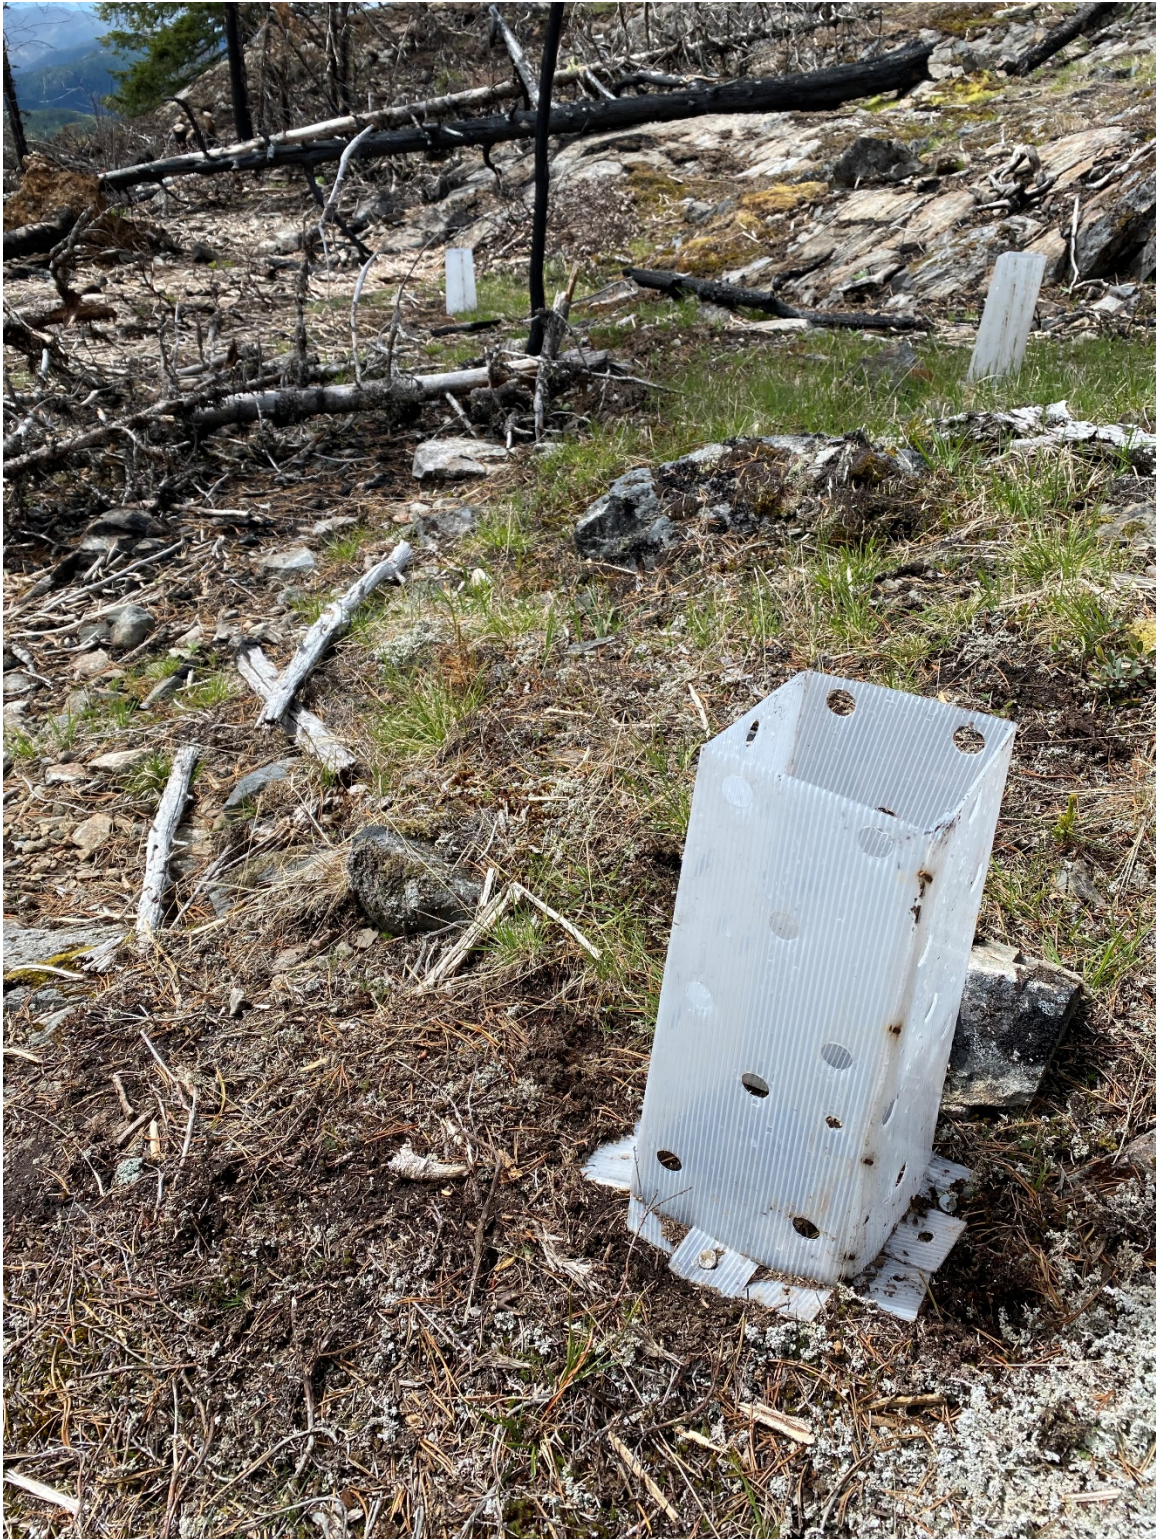
Arbutus seeding trial - cone protectors nailed into the soil to prevent seeds from being consumed by rodents. Cones and nails will be removed when seedlings established.
