Notice of Meeting and Meeting Agenda Regional Parks Committee

6.2. [23-141](#) Island View Beach Regional Park - Ditch Maintenance

**DITCH MAINTENANCE 2022
ISLAND VIEW BEACH REGIONAL PARK**

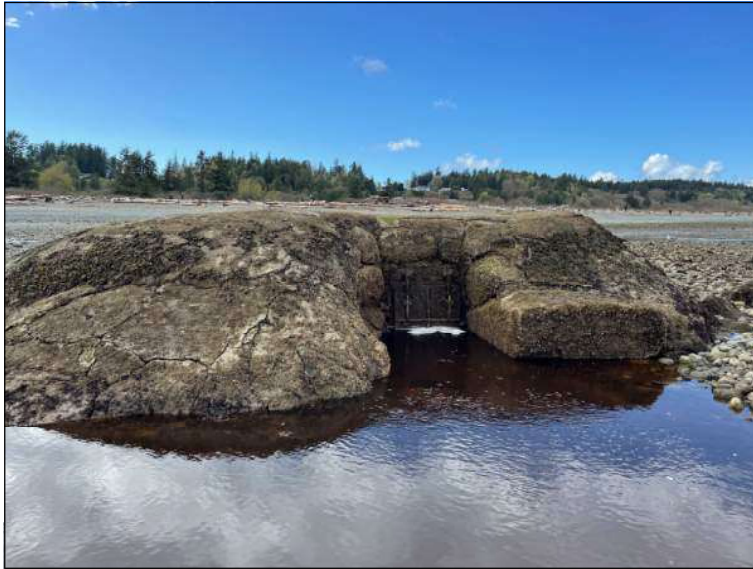
Photo 1:

Description: Terminus of ditch network outfall. Outfall culvert terminates in an antiquated flap gate. Approximately 115 m upstream of this point, a separate tidal gate is understood to lie within a chamber in a coastal berm.

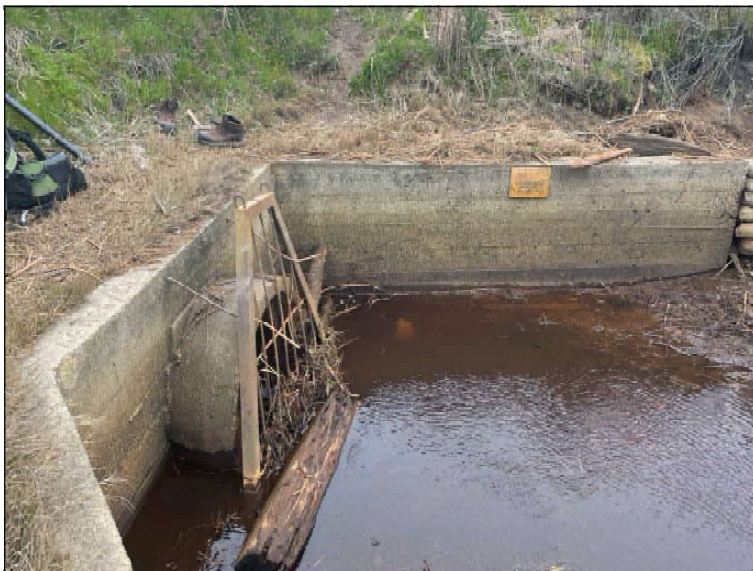
Photo 2:

Description: Inlet to storm culvert at coastal berm. Valve chamber is approximately 10 m downstream of this location.

A substantial quantity of debris is present on the inlet cage of this culvert (to approximately pipe springline) resulting in reduced hydraulic capacity.

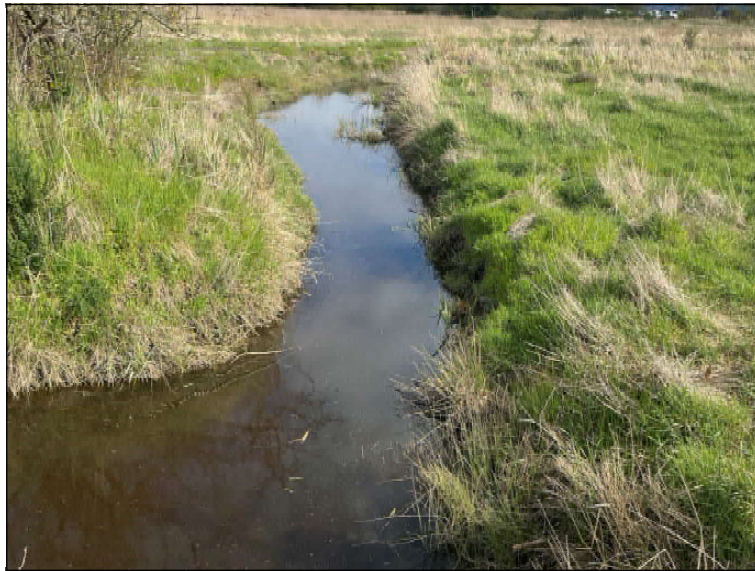
Photo 3:

Description: Section of ditch line within Ditch Section 9.

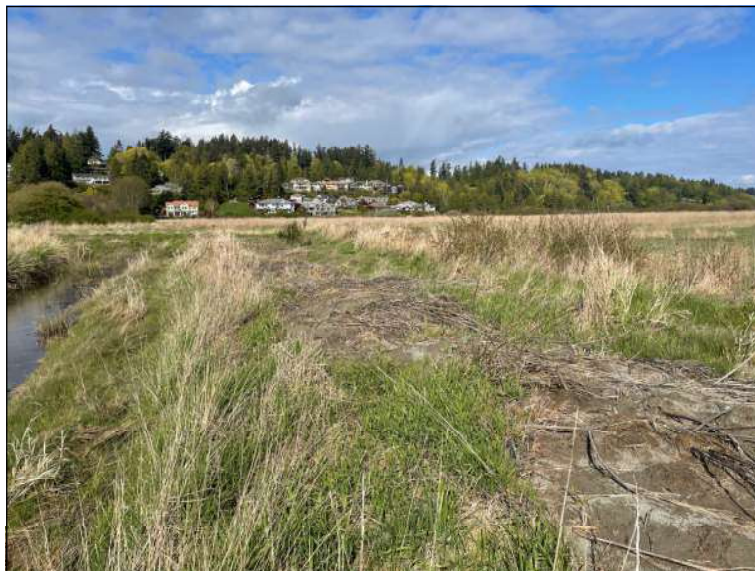
Photo 4:

Description: Top of ditch bank along portion of Ditch Section 9. Top of bank is elevated above adjacent lands.

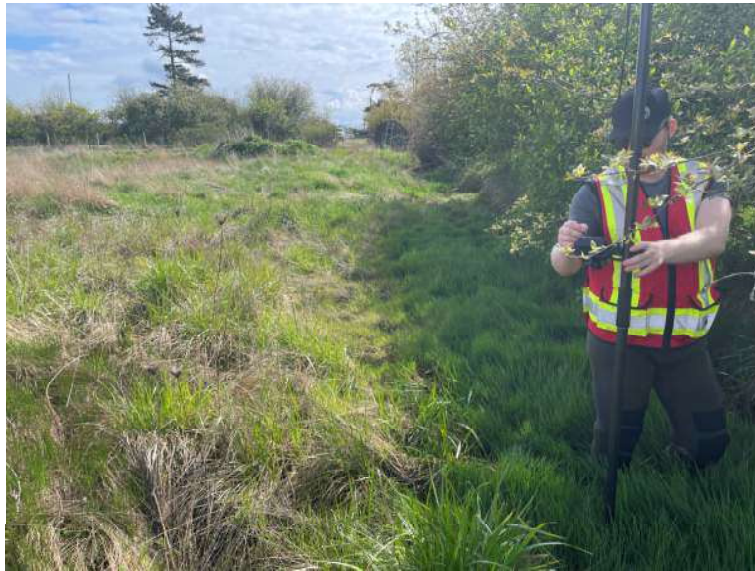
Photo 5:

Description: View of Section 8 ditch, demonstrating generally shallow/ poorly defined swale with vegetated grasses within depression.

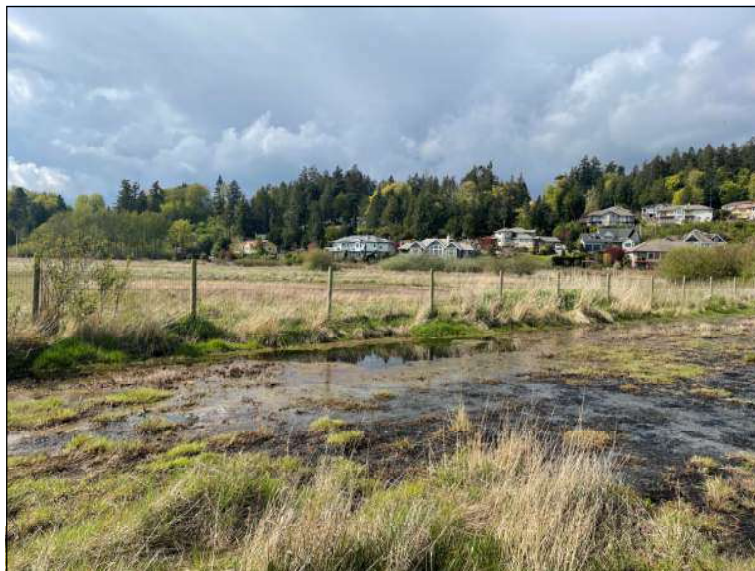
Photo 6:

Description: Ponded water in an up-stream segment of Section 8 ditching.

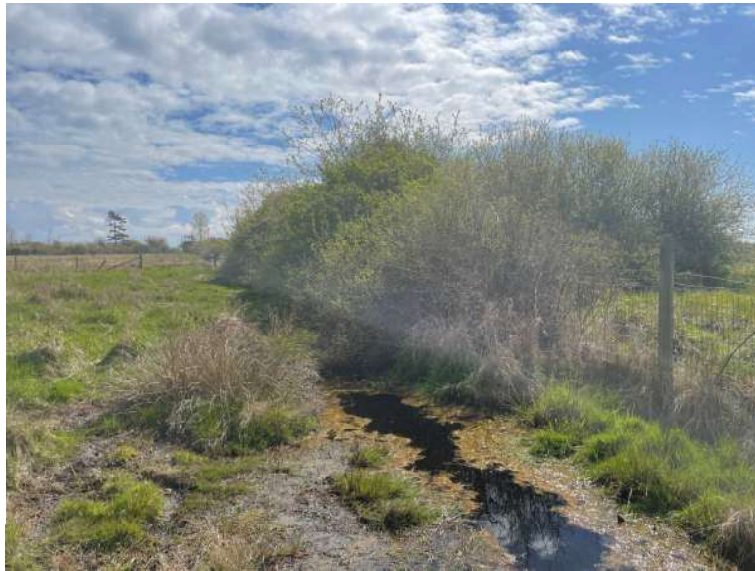
Photo 7:

Description: Overgrowth of vegetation in along Section 5 ditch. Pondered water visible in foreground.

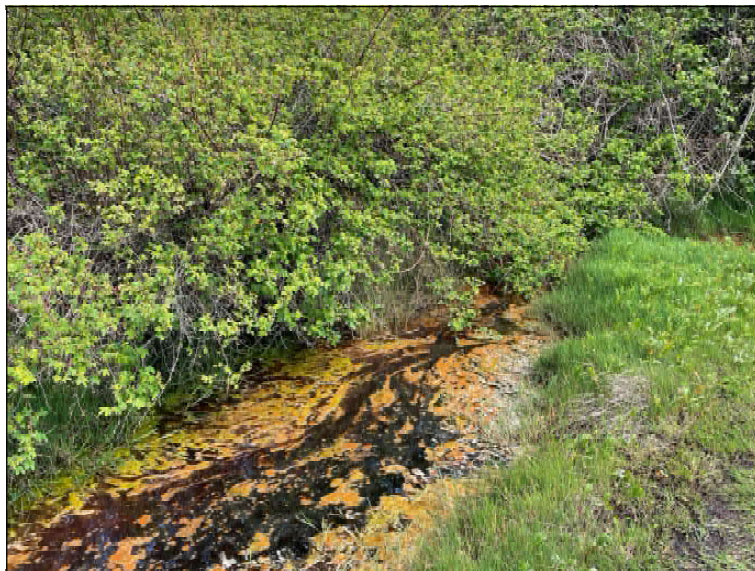
Photo 8:

Description: Upstream extent of Ditch 7 extending into overgrown vegetation.

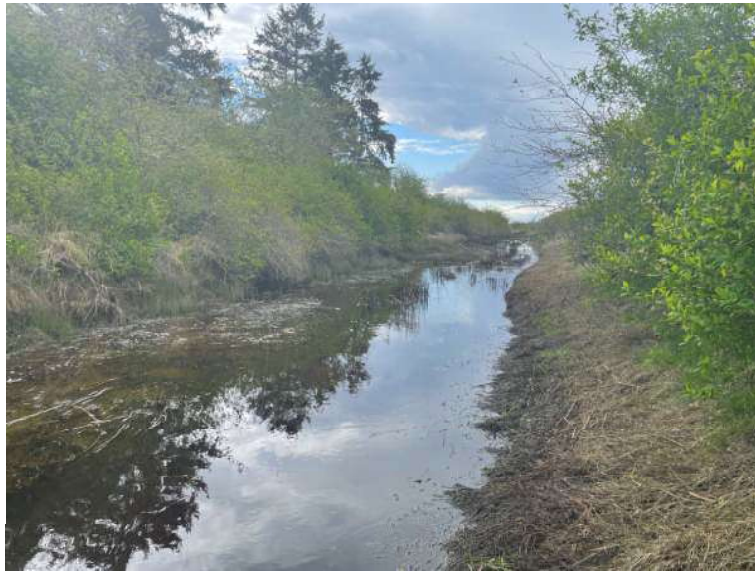
Photo 9:

Description: View of Section 6 ditching.

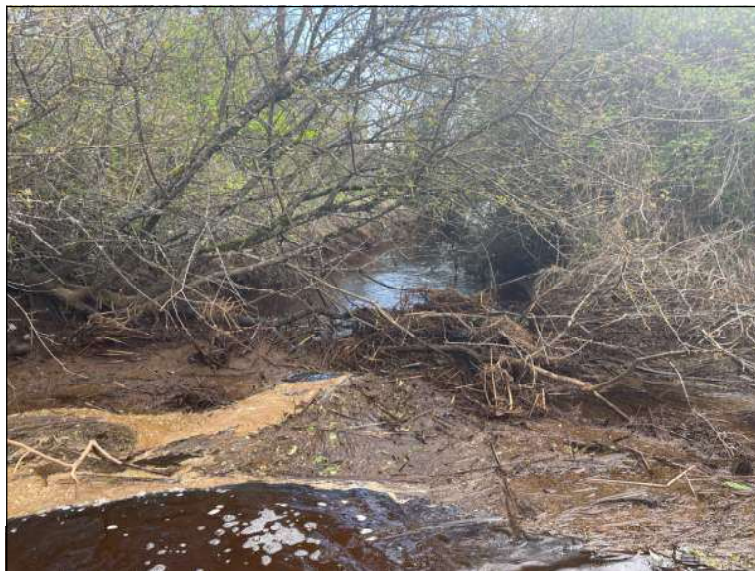
Photo 10:

Description: Debris obstruction within ditching at intersection of Sections 5 and 6.

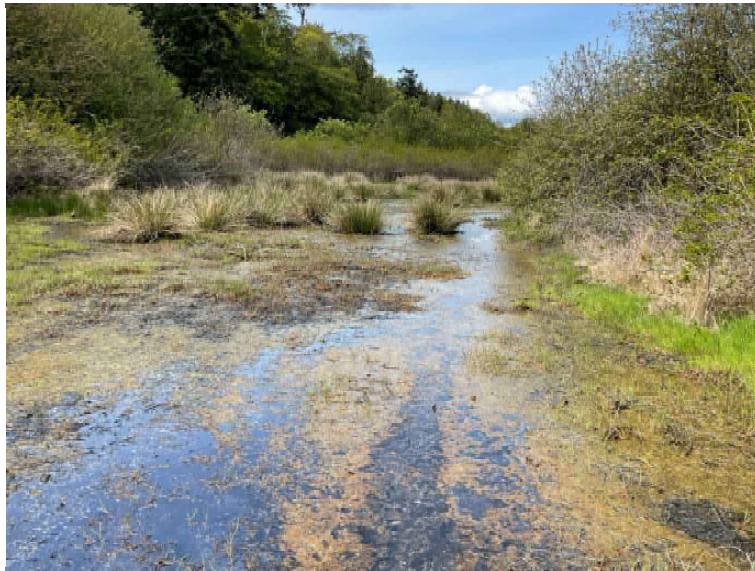
Photo 11:

Description: Substantial ponded water without direct surface discharge linkage to ditching, located in the west of the Park between Section 5 and 7 ditches.

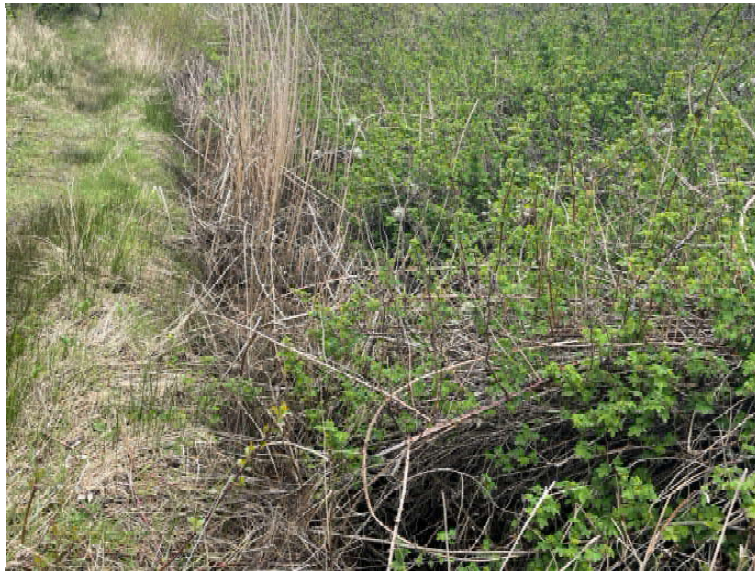
Photo 13:

Description: Overgrown vegetation within upstream areas of Section 5 ditch.

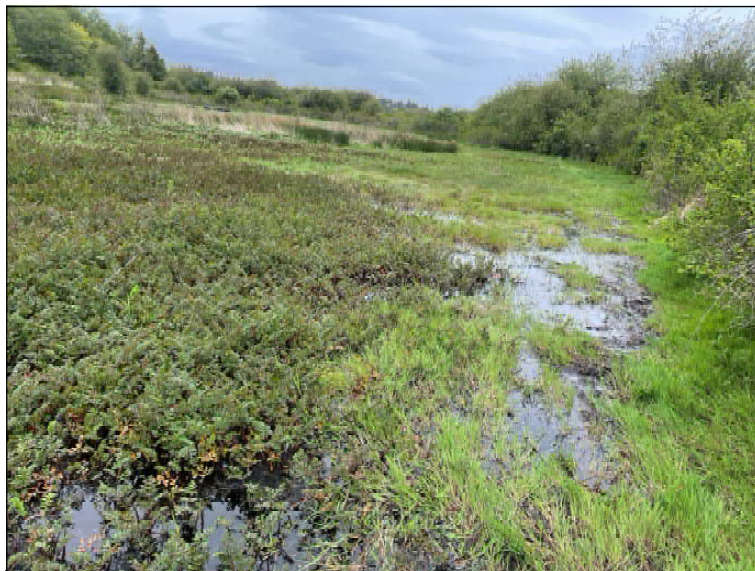
Photo 14:

Description: Large area of standing water located in the western segment of the Park between Section 3 and 5 ditches.

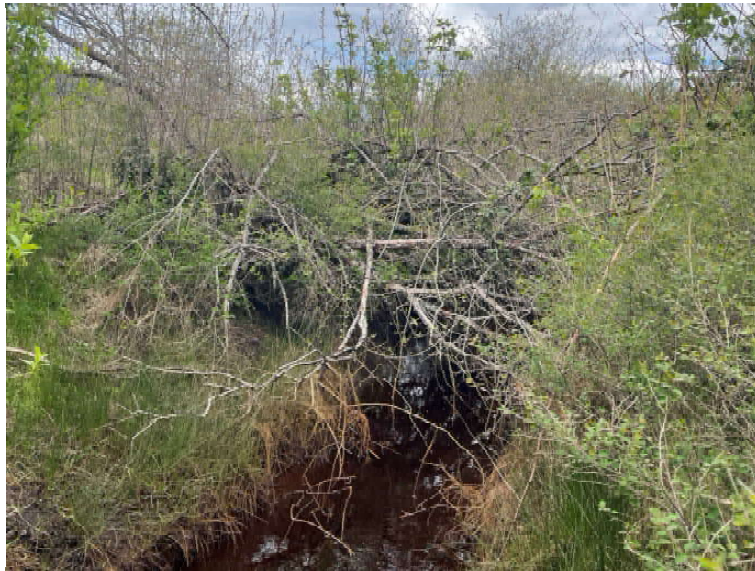
Photo 15:

Description: Vegetative debris in the area of Section 4 ditch .

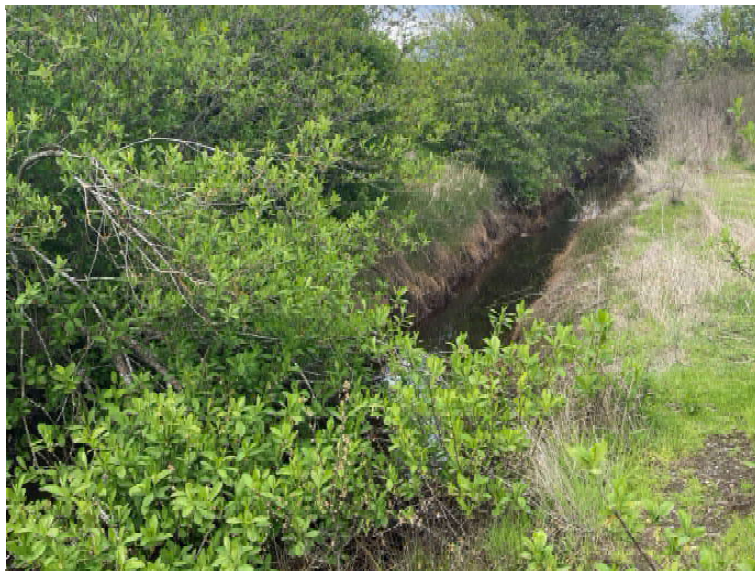
Photo 16:

Description: View of Section 4 ditching.

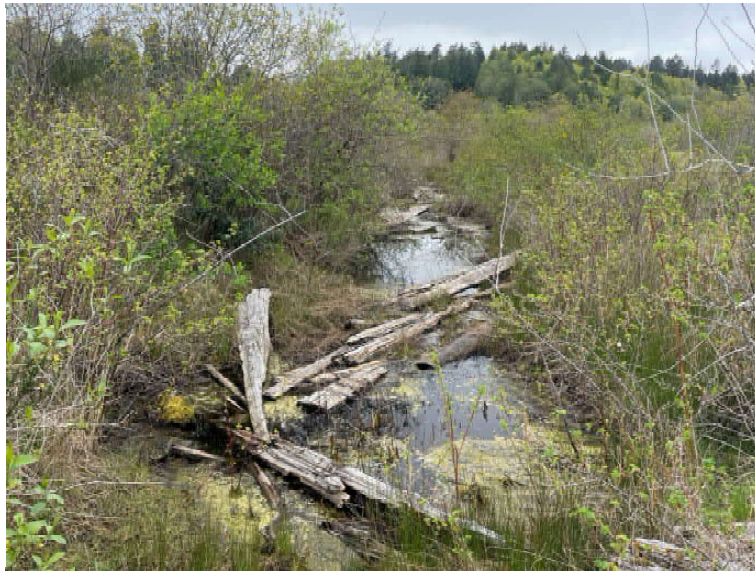
Photo 17:

Description: Debris within eastern reach of Ditch Section 3.

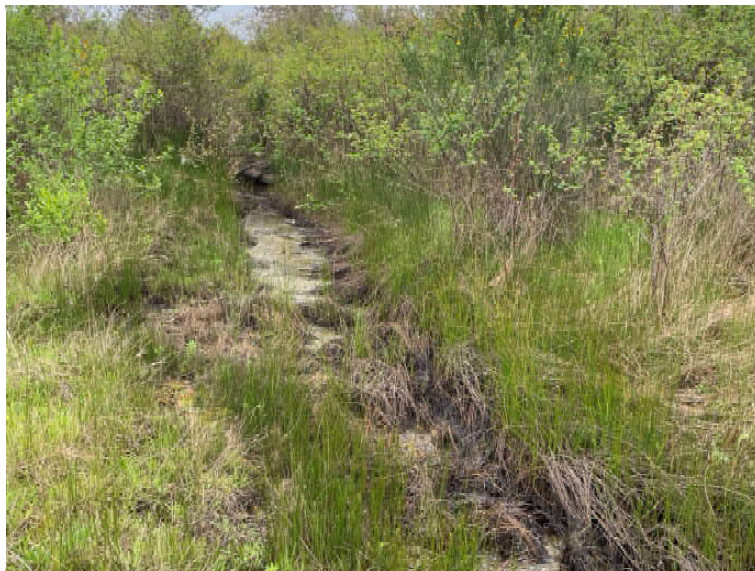
Photo 18:

Description: Shallow ditching with long grass growth within the further east reaches of Ditch Section 3.

Ditch appears to be intended to drain a low lying area but does not appear to effectively do so.

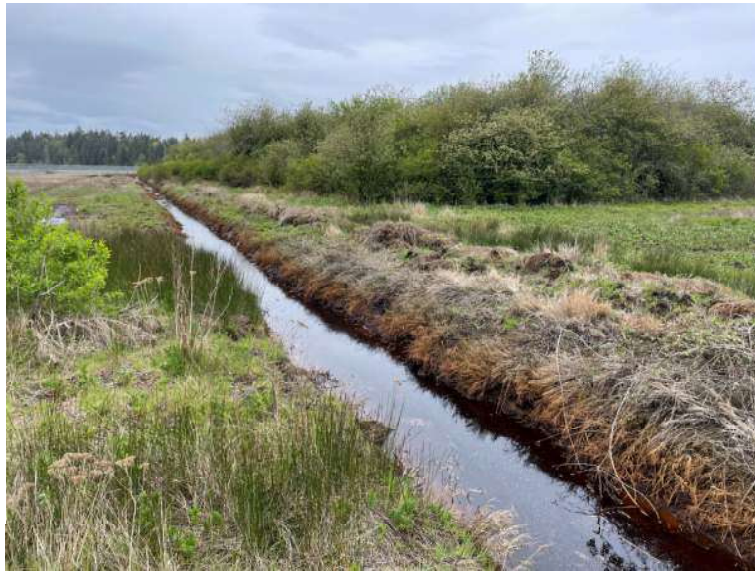
Photo 19:

Description: Ditching along Ditch Section 2. Sidecasted materials shown along the ditch.

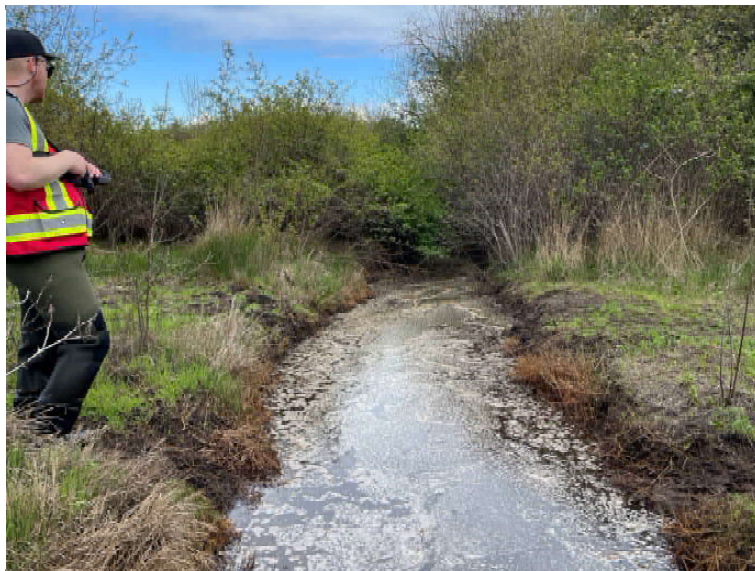
Photo 20:

Description: Looking east towards Ditch 10 extension near the intersection with Ditch 2. Overgrowth precluded inspection.

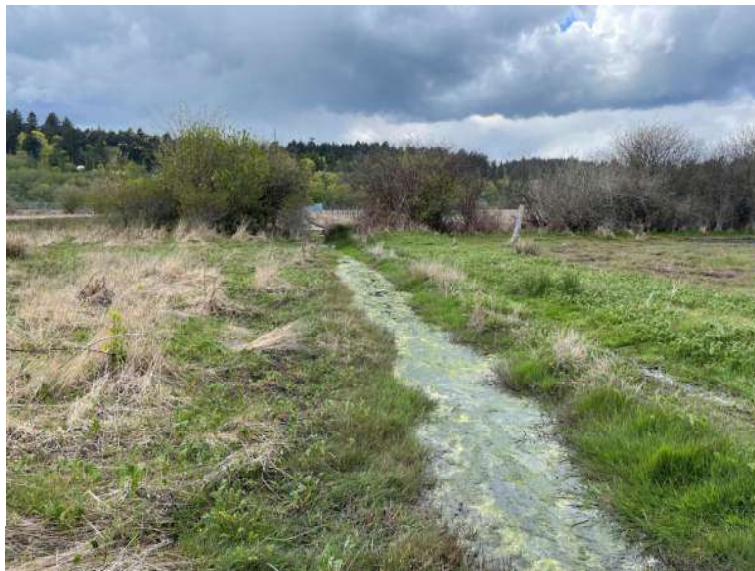
Photo 24:

Description: Upstream reaches of Ditch 1, showing generally poor conveyance to downstream.

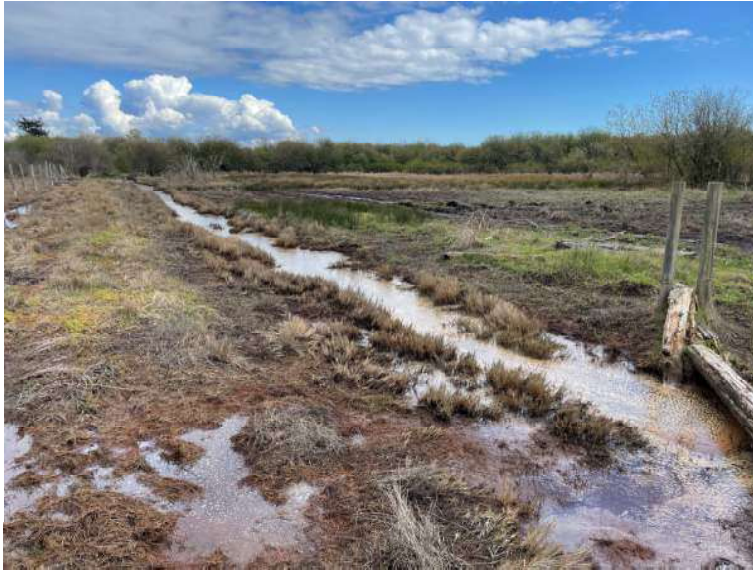
Photo 25:

Description: Ditching system of Ditch Section 1.

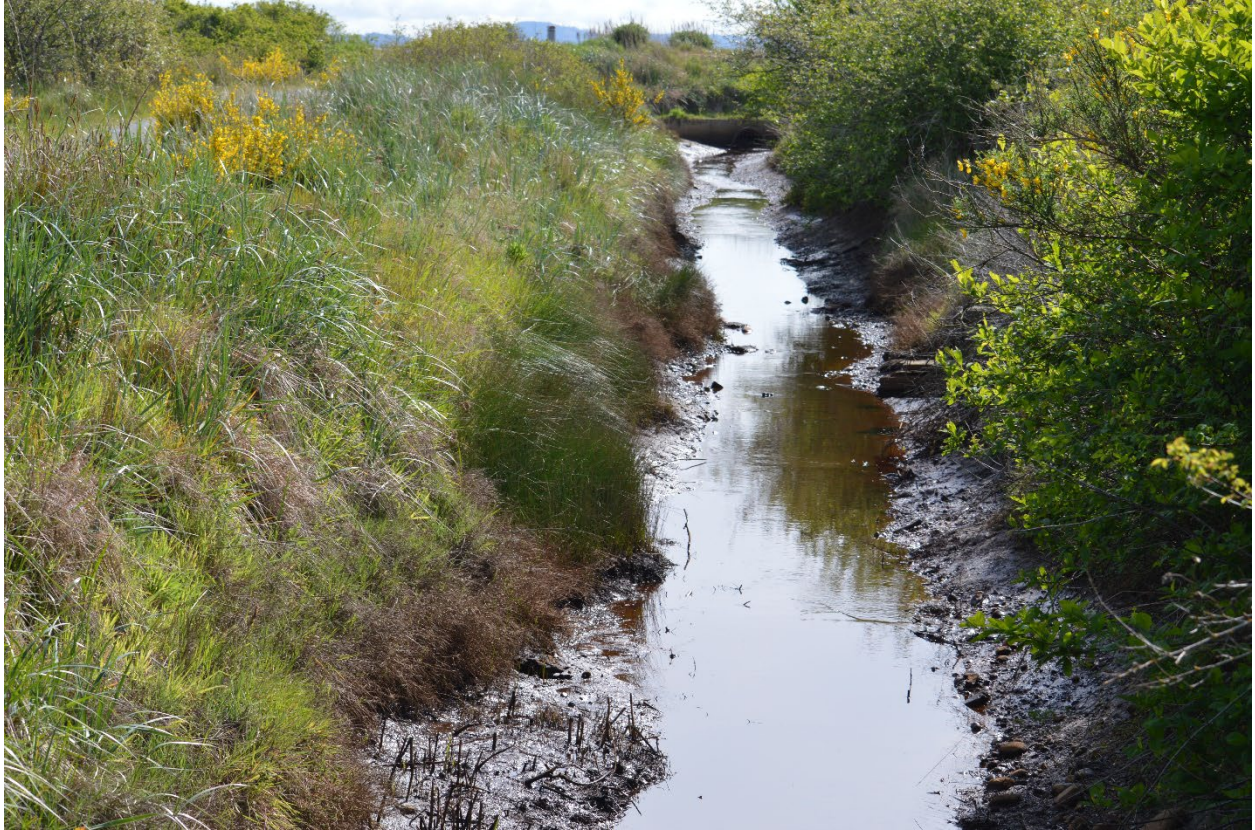
Typical view of unimpeded IVBRP drainage ditch

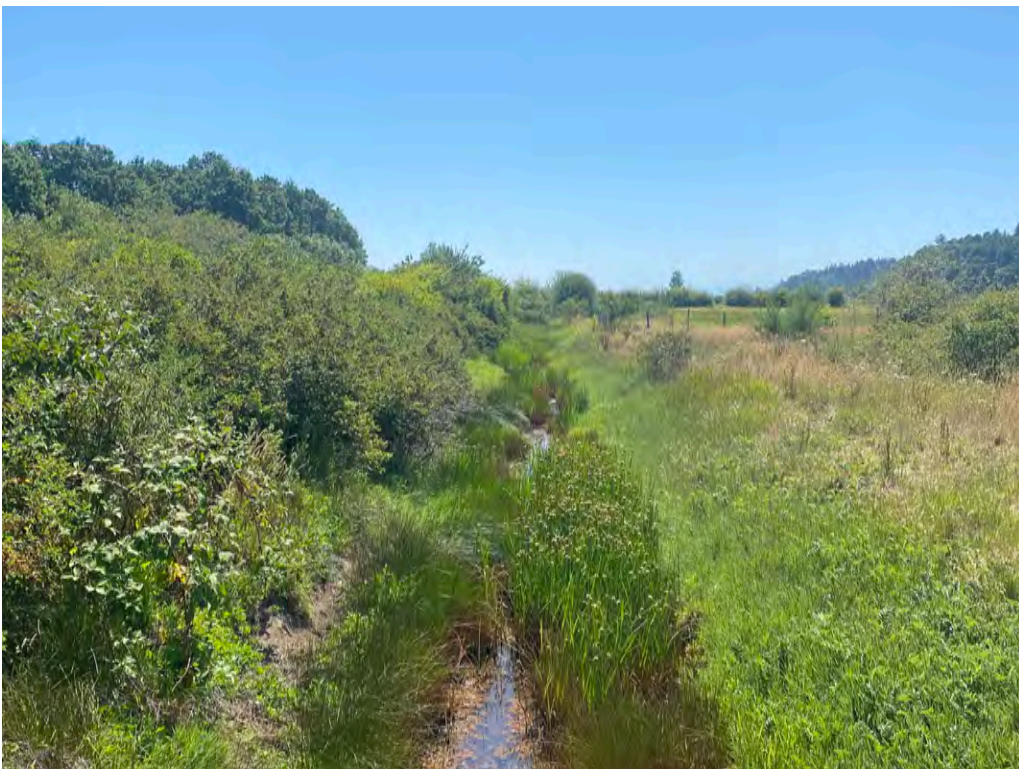
Campground ditch July 5, 2021 prior to 2021 maintenance.

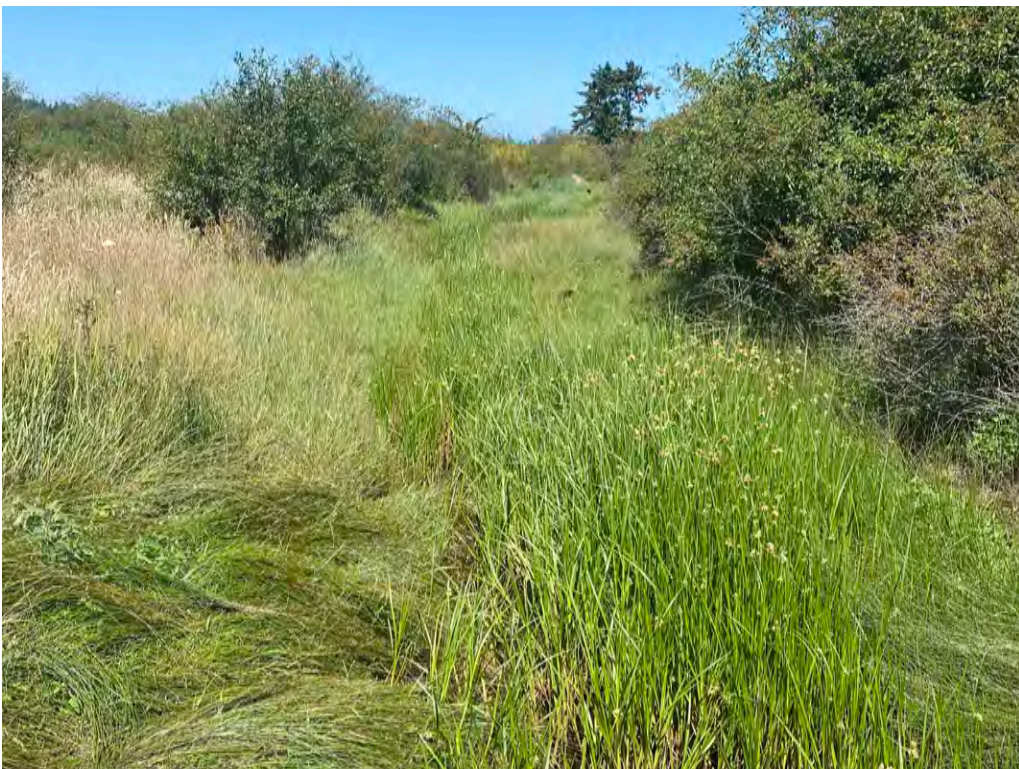
Campground ditch looking north July 5, 2021 prior to 2021
maintenance.

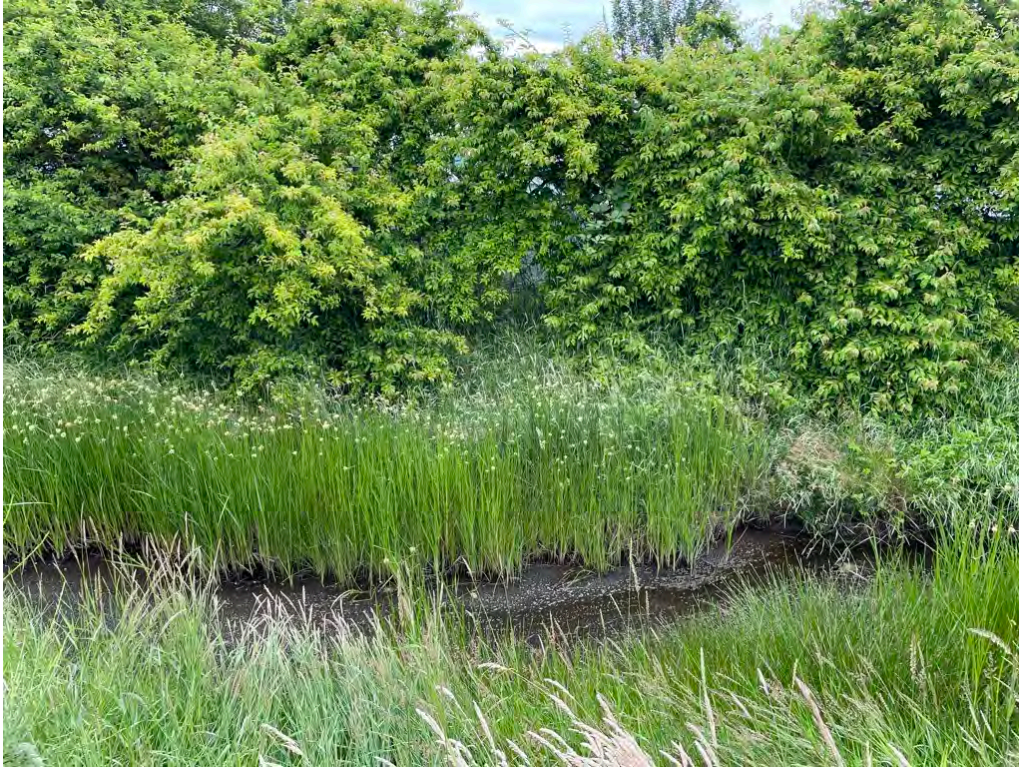
Ditch behind the tenting area of the campground July 16, 2022.

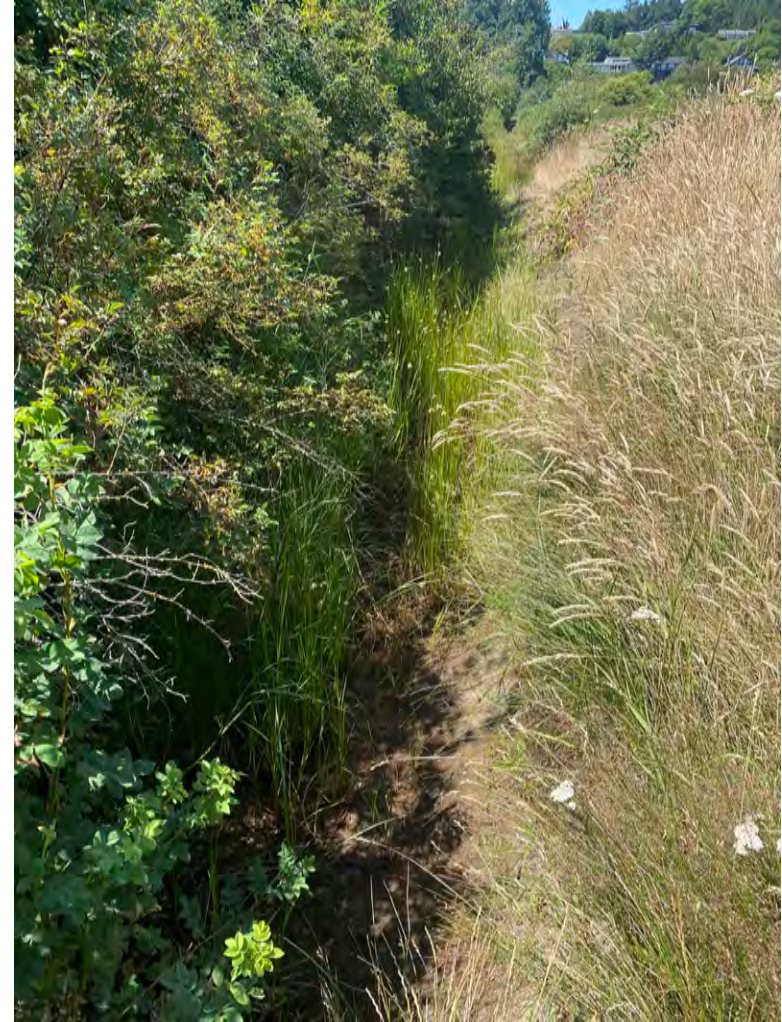
Lamont ROW ditch looking west, downstream end July 5, 2021.

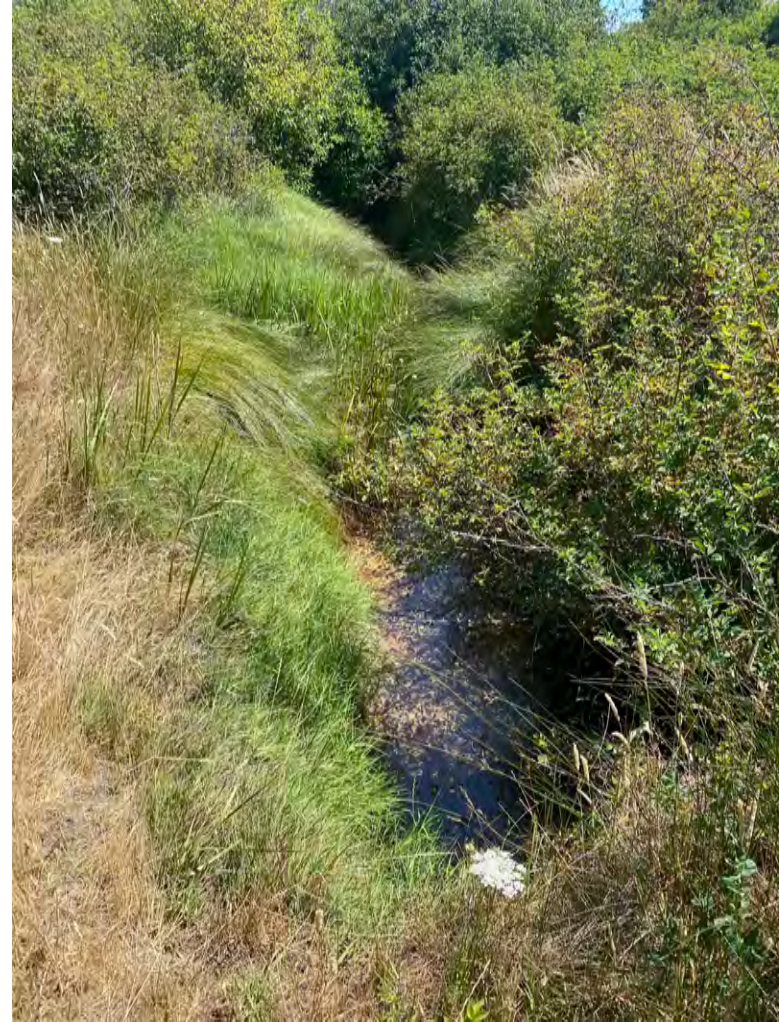
Confluence of Lamont Road ROW and Ditch 4 July 5, 2021.

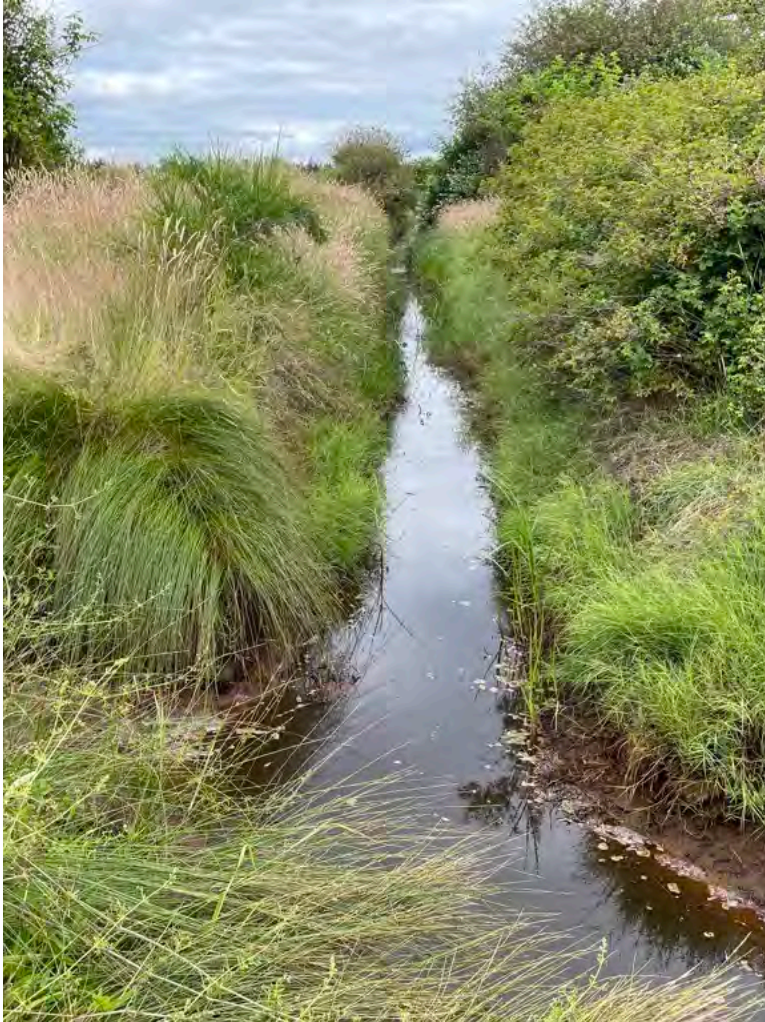
Ditch 4 at confluence with Lamont Rd ROW July 16, 2022.

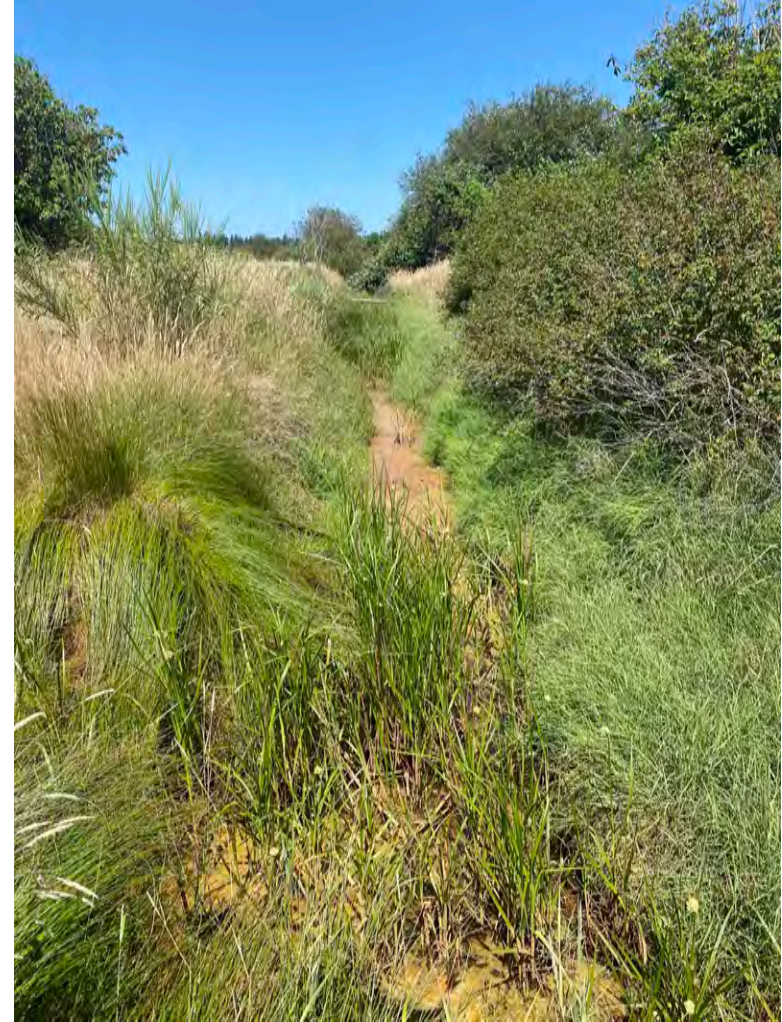
Ditch 4 at confluence with Lamont Rd ROW July 5, 2021.

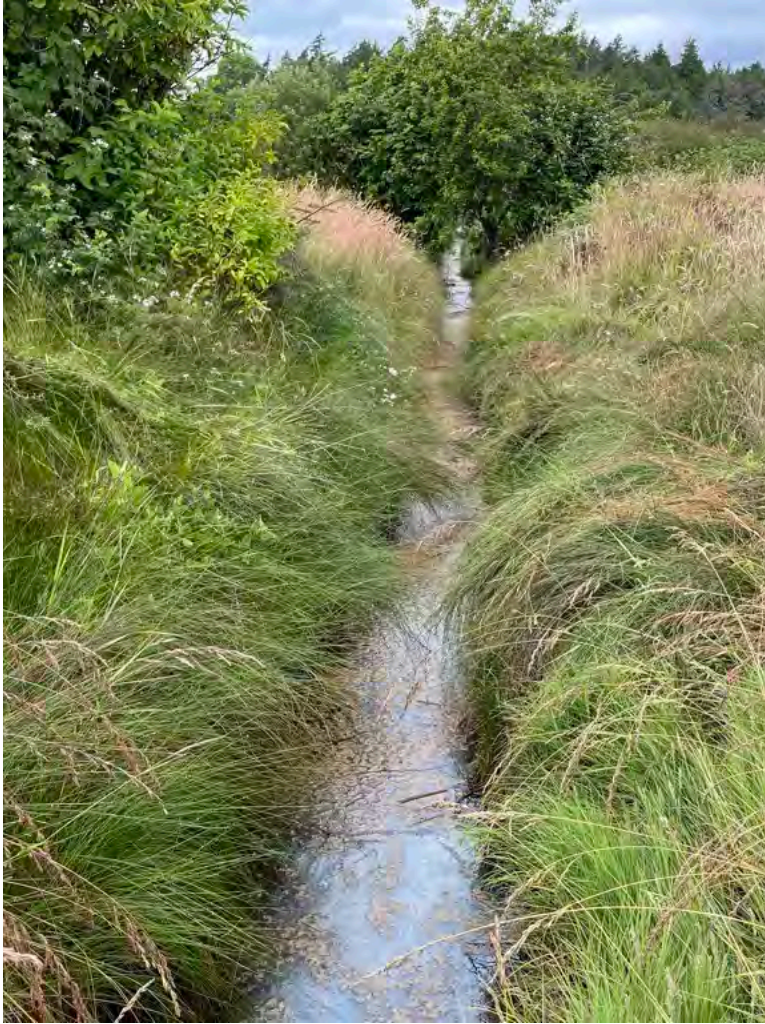
Downstream end of Ditch 1 July 16, 2022.

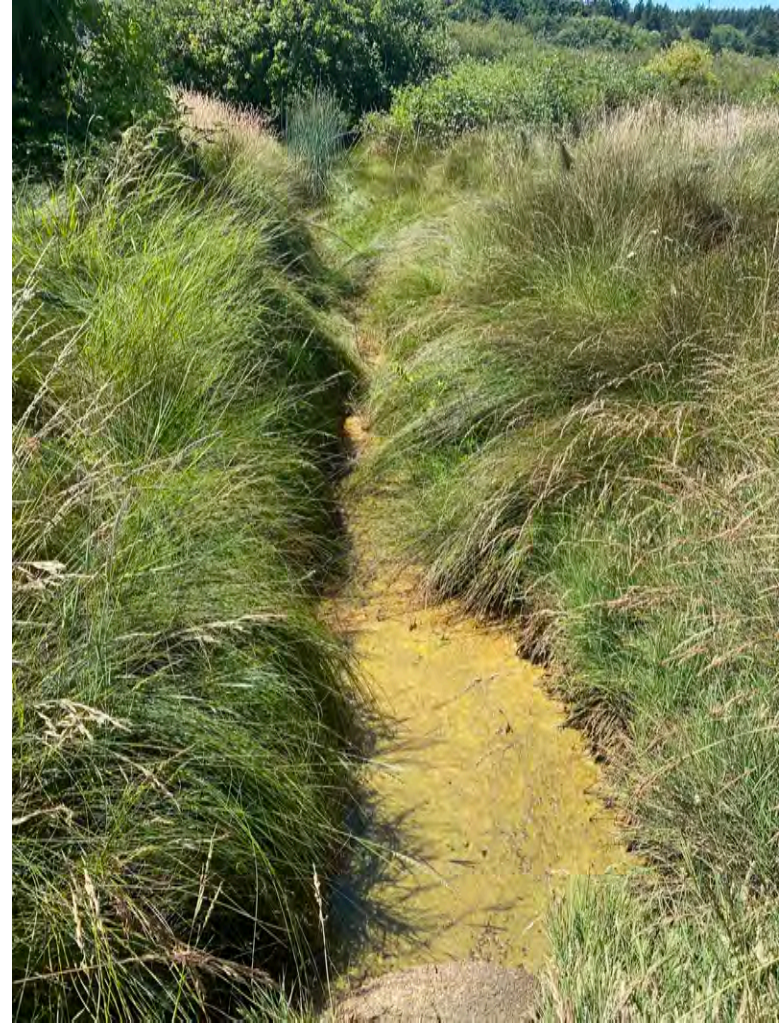
Downstream end of Ditch 1 July 5, 2021.

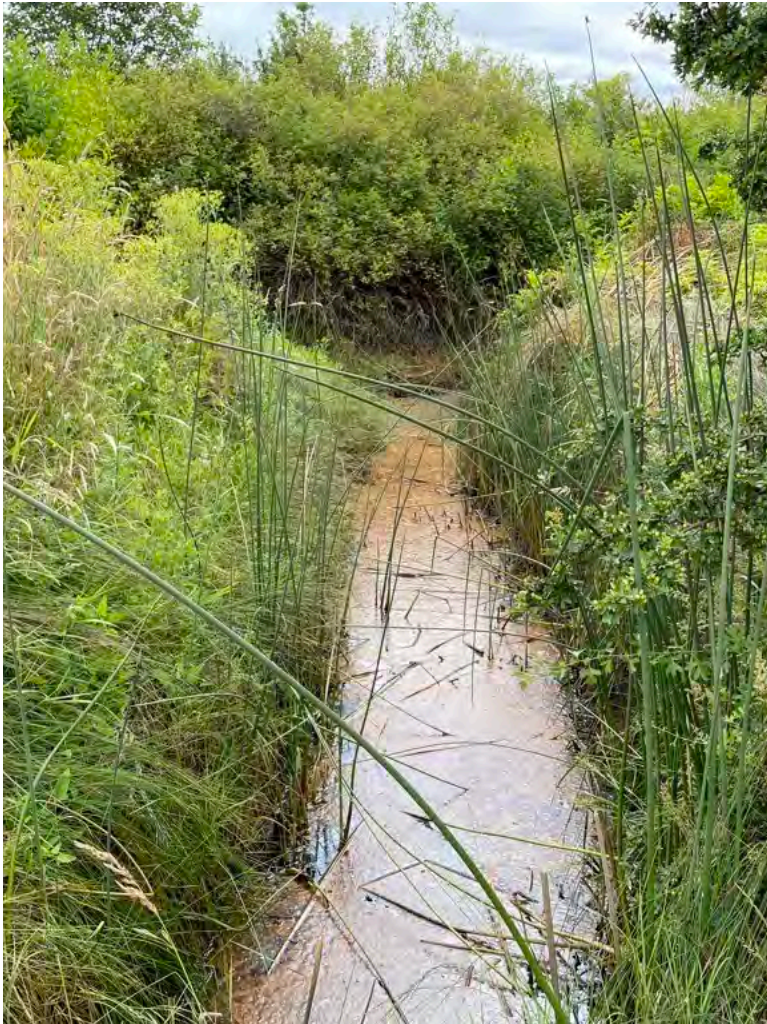
Confluence of Ditch 1 and Ditch 3 July 16, 2022.

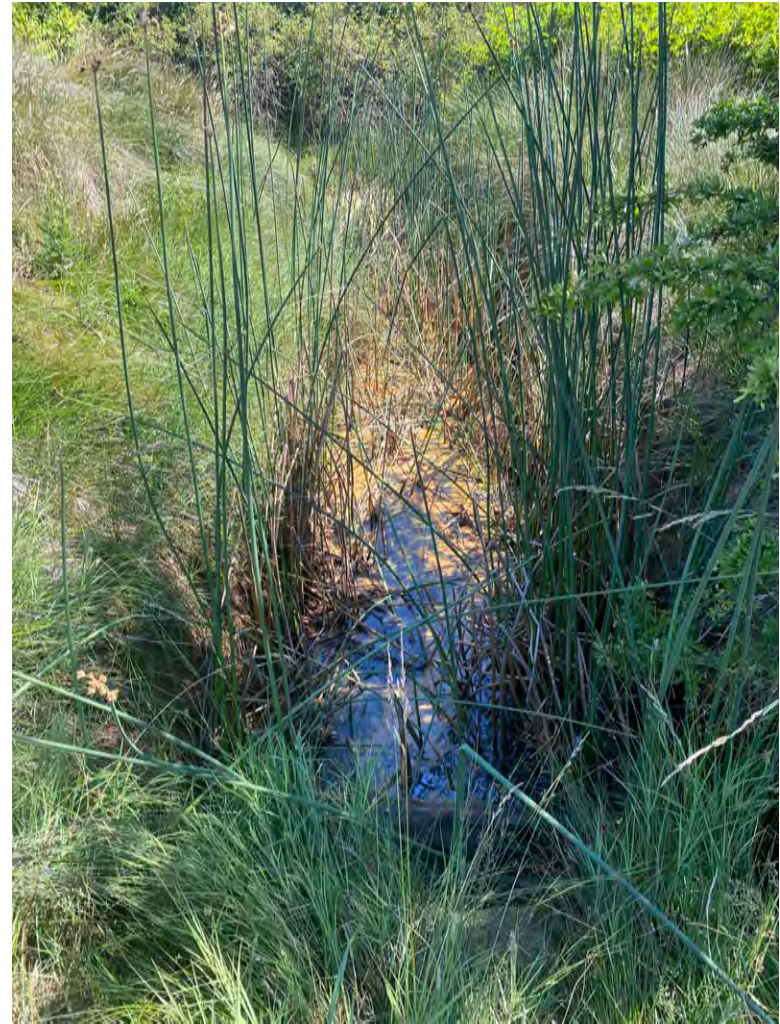
Confluence of Ditch 1 and Ditch 3 July 5, 2021.

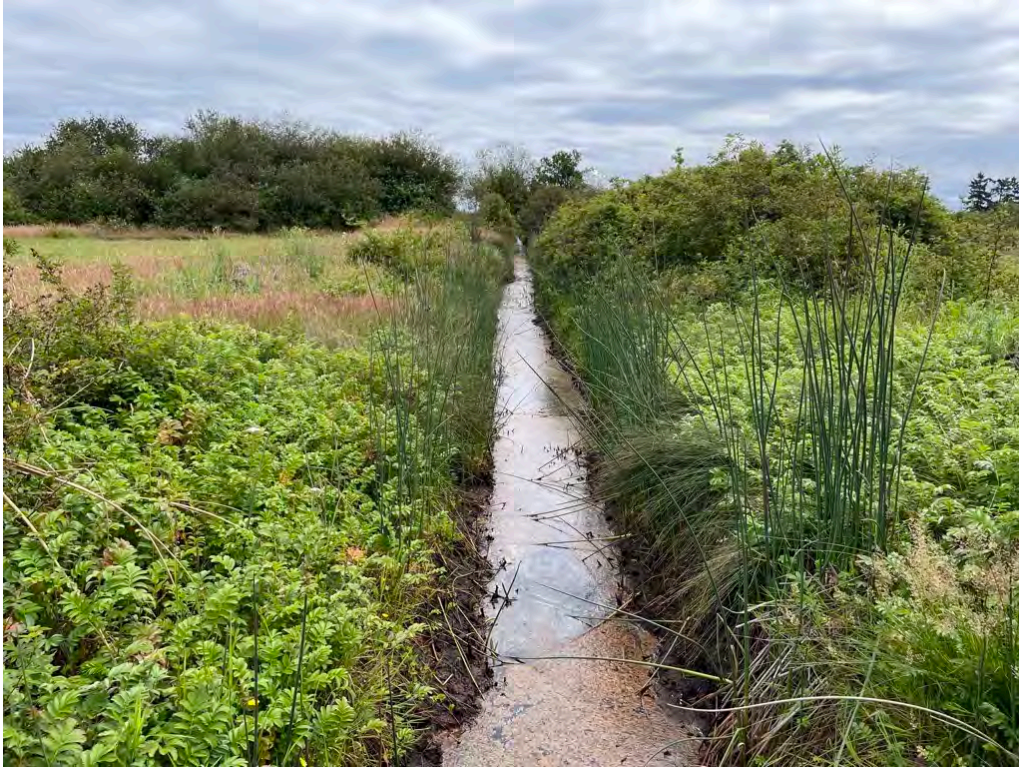
Looking east down Ditch 1 from the confluence of Ditch 1 and Ditch 2
July 16, 2022.

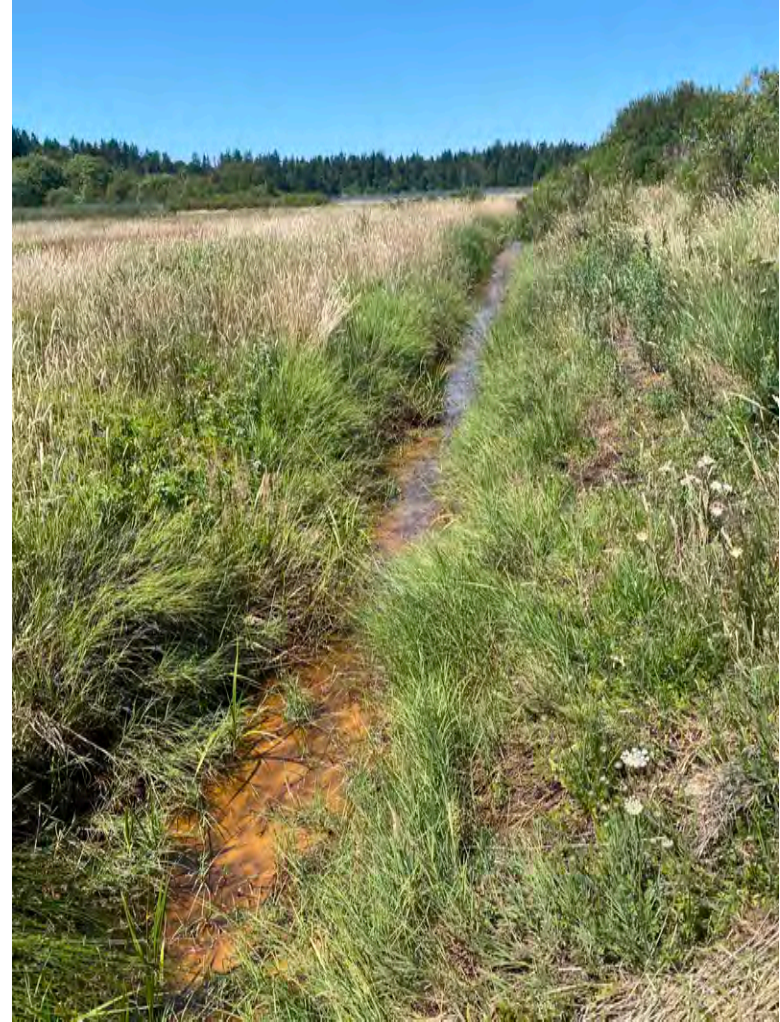
Downstream end of Ditch 2 looking northwest July 5, 2021.

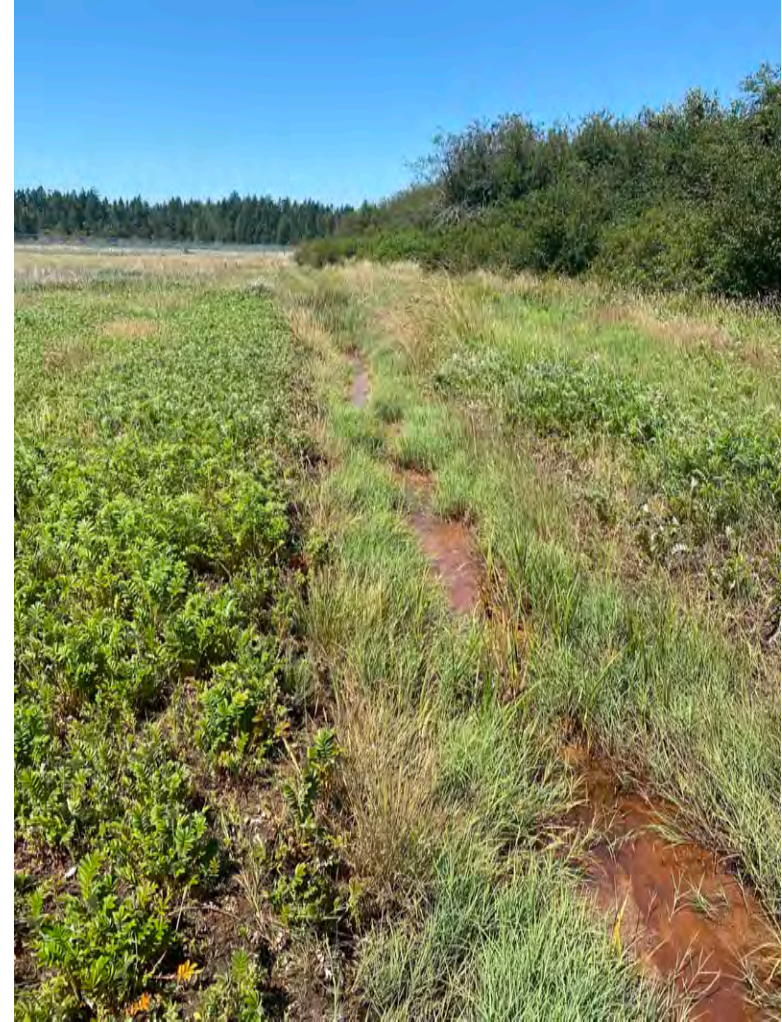
Ditch 2 from middle of the channel looking northwest July 5, 2021.

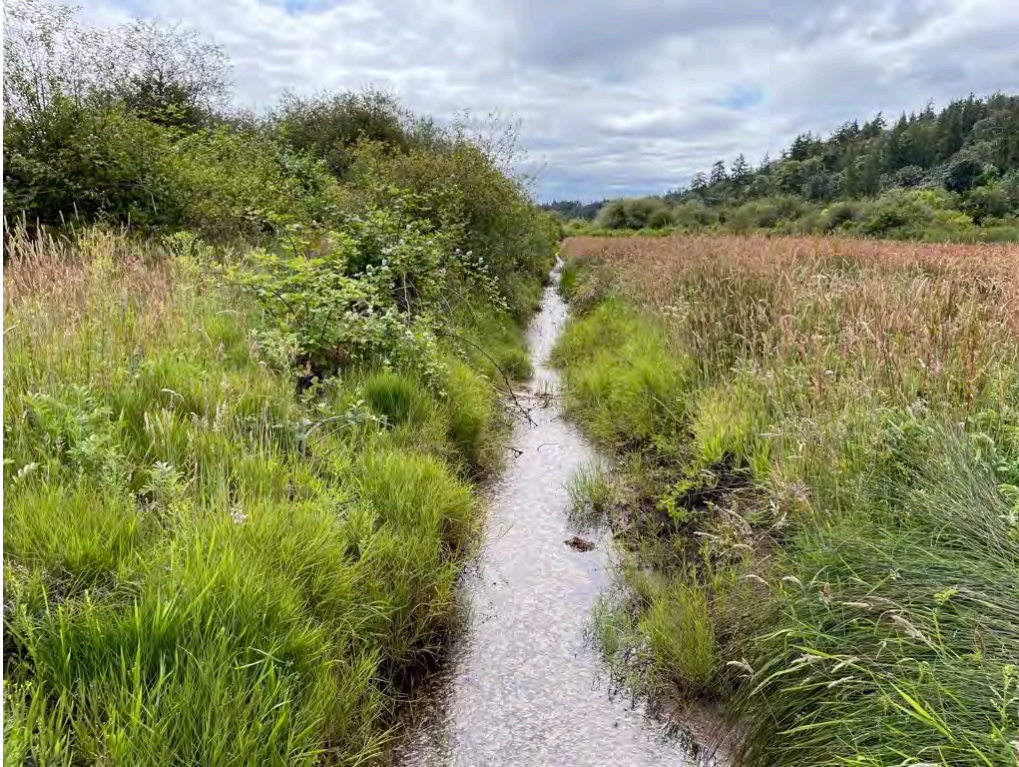
Above: Ditch 2
looking
southwest
July 16, 2022.
