Notice of Meeting and Meeting Agenda Regional Parks Committee

6.2. [23-141](#) Island View Beach Regional Park - Ditch Maintenance

**DITCH MAINTENANCE 2022
ISLAND VIEW BEACH REGIONAL PARK**

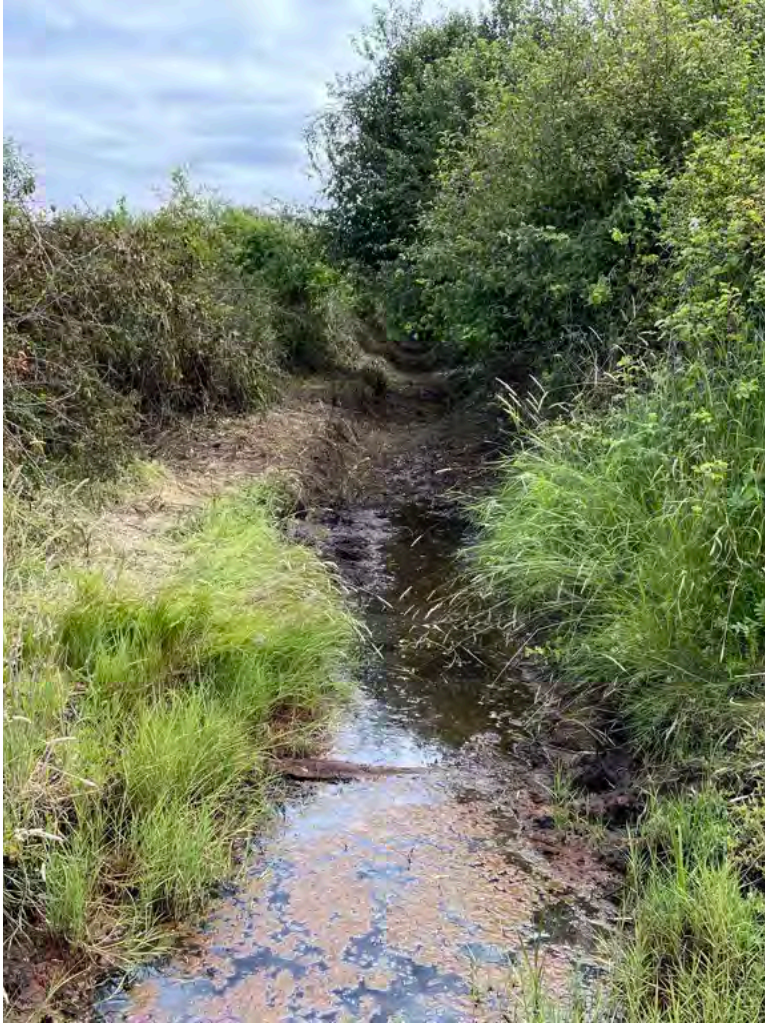
Right: Ditch 2
looking
southwest
July 5, 2021.

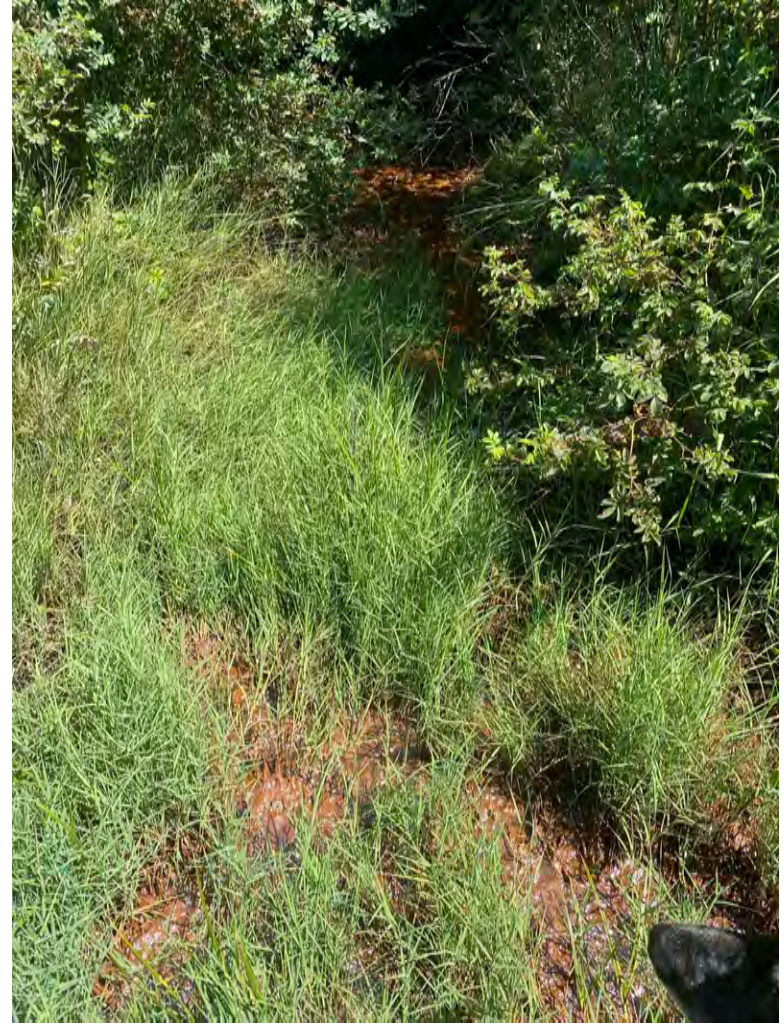
Confluence of Ditch 2 and Ditch 3 July 16, 2022.

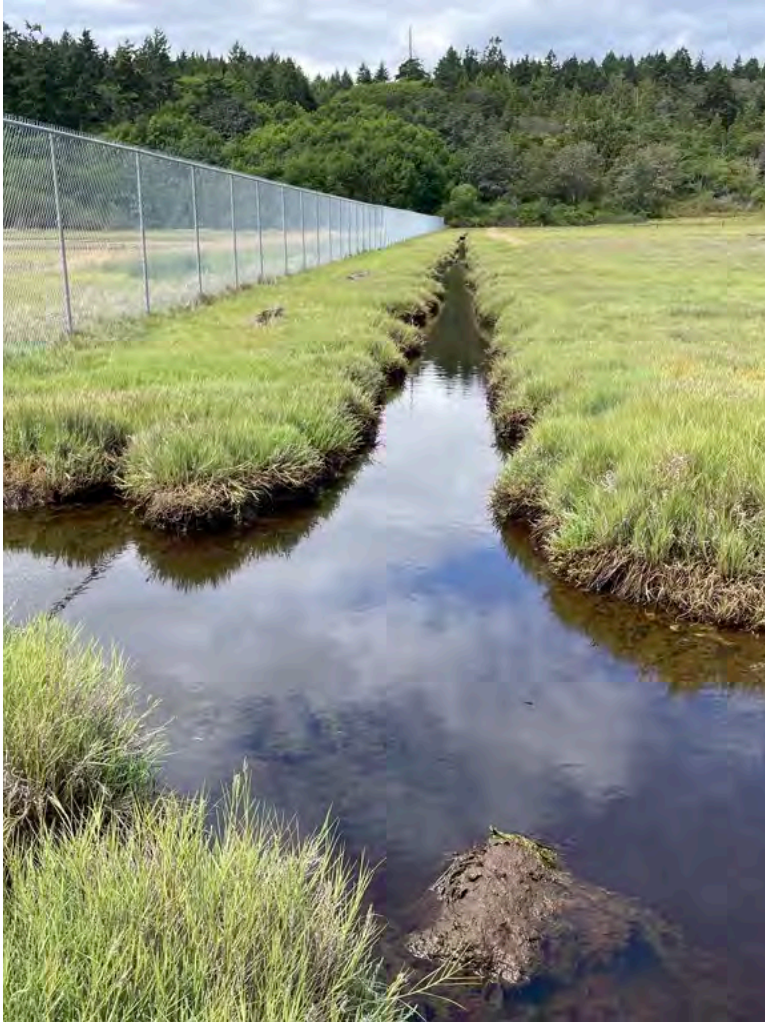
Confluence of Ditch 2 and Ditch 3 July 5, 2021.

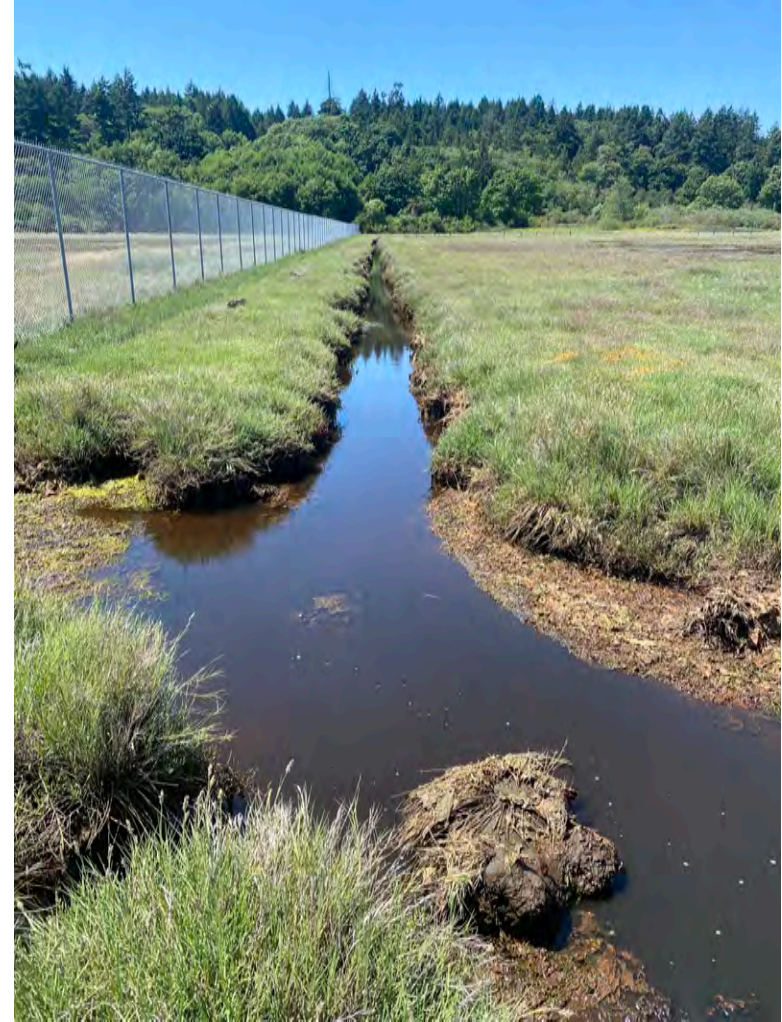
Ditch on Tsawout land running east-west along chainlink fence (looking west) July 16, 2022.

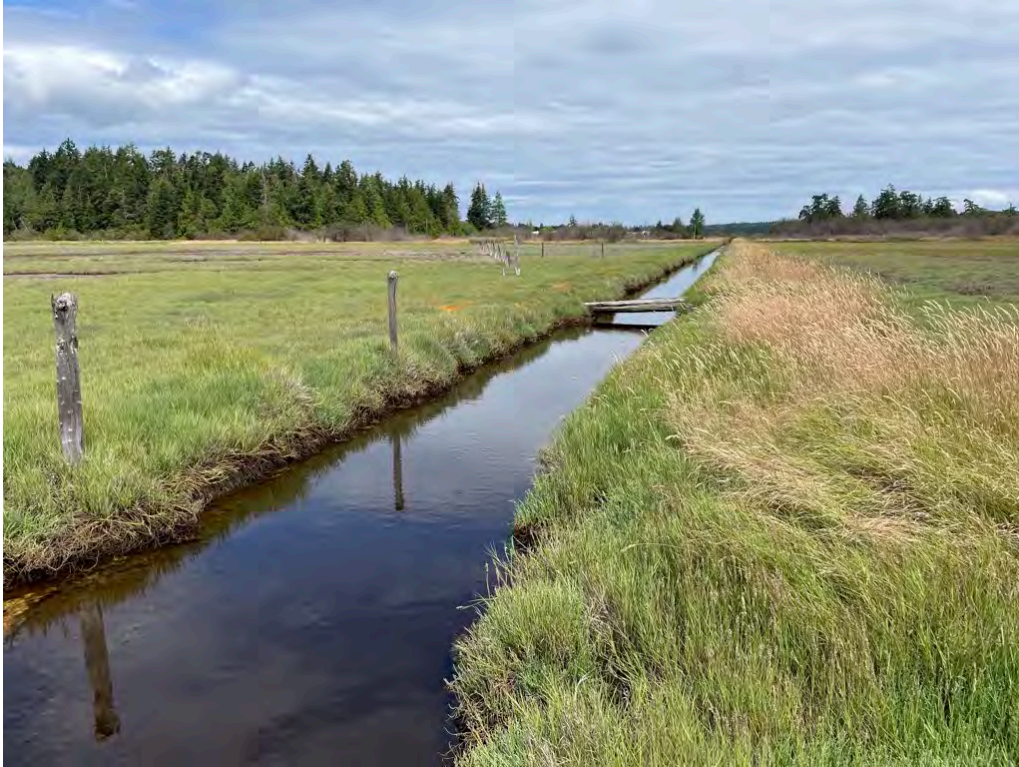
Ditch on Tsawout land running east-west along chainlink fence (looking west) July 5, 2021.

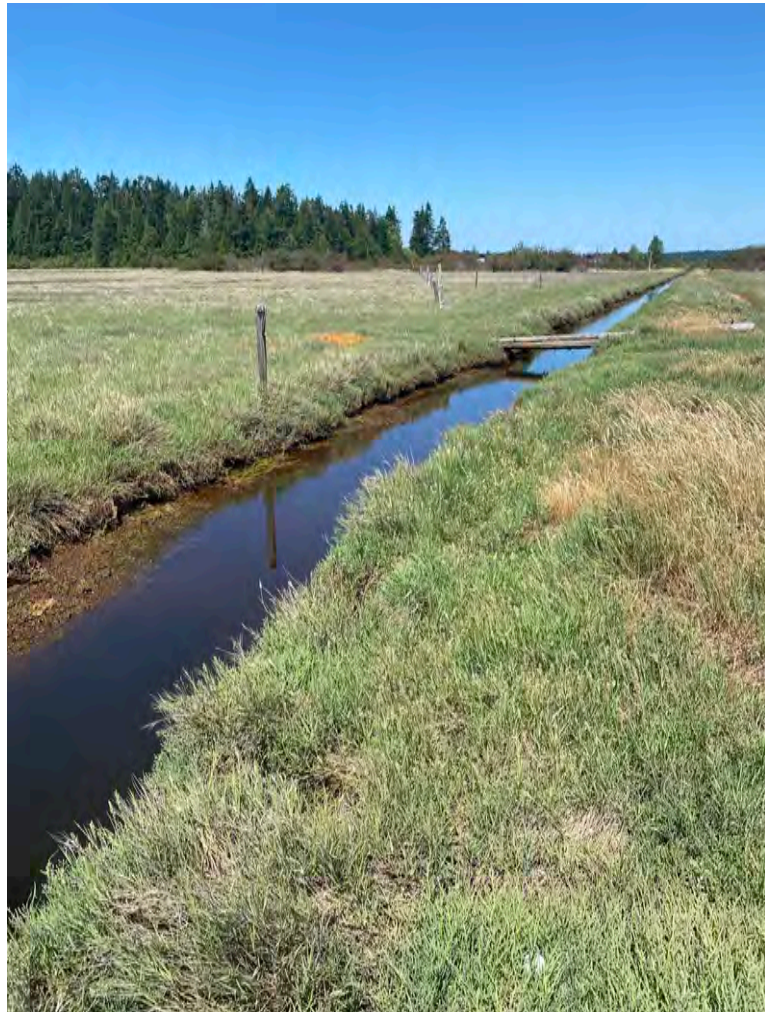
Above: Ditch running northeast on Tsawout land July 16, 2022.

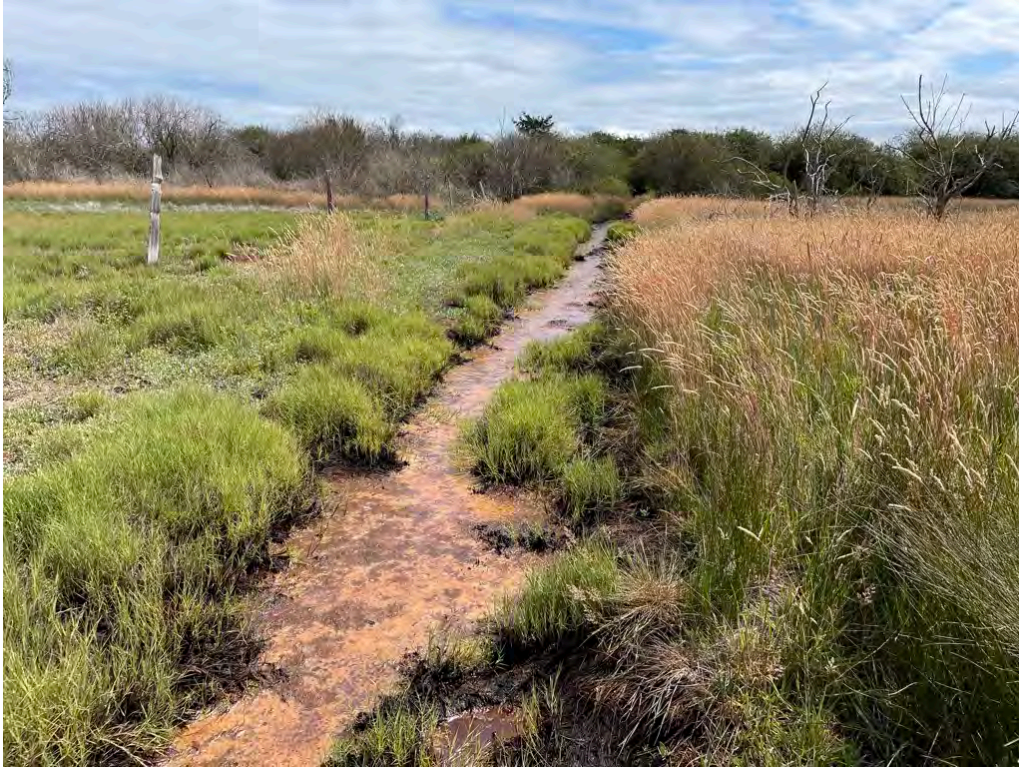
Above: Ditch running northeast on Tsawout land July 5, 2021.

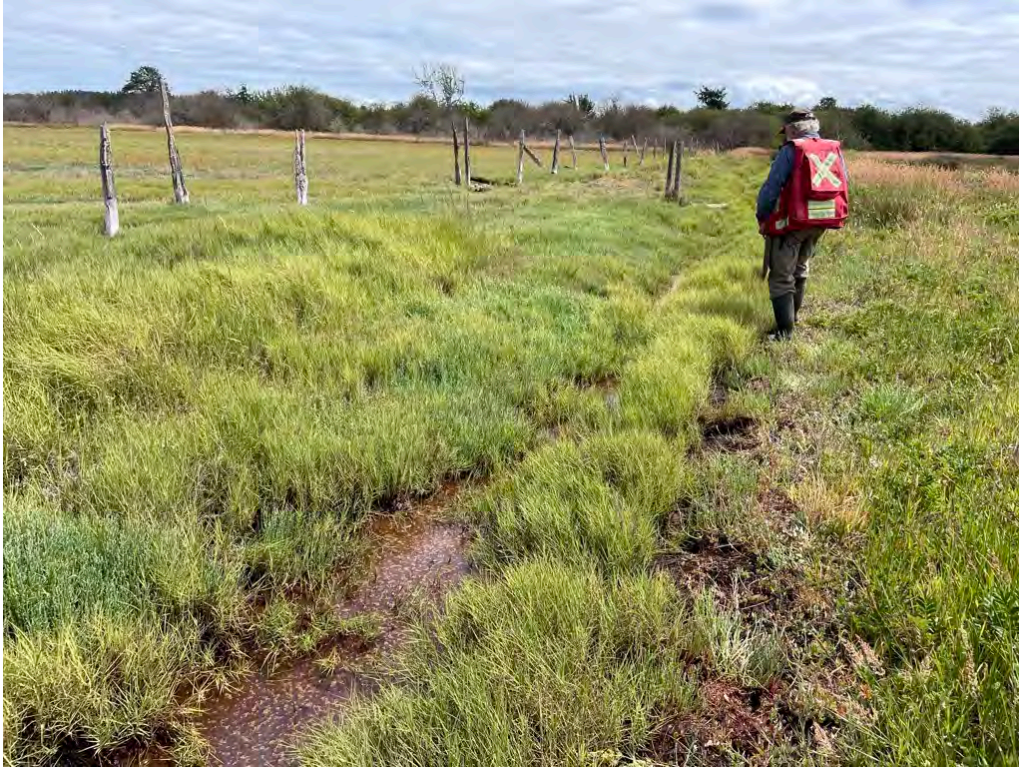
Ditch 5 July 16, 2022. Taken from mid-point of channel looking east.

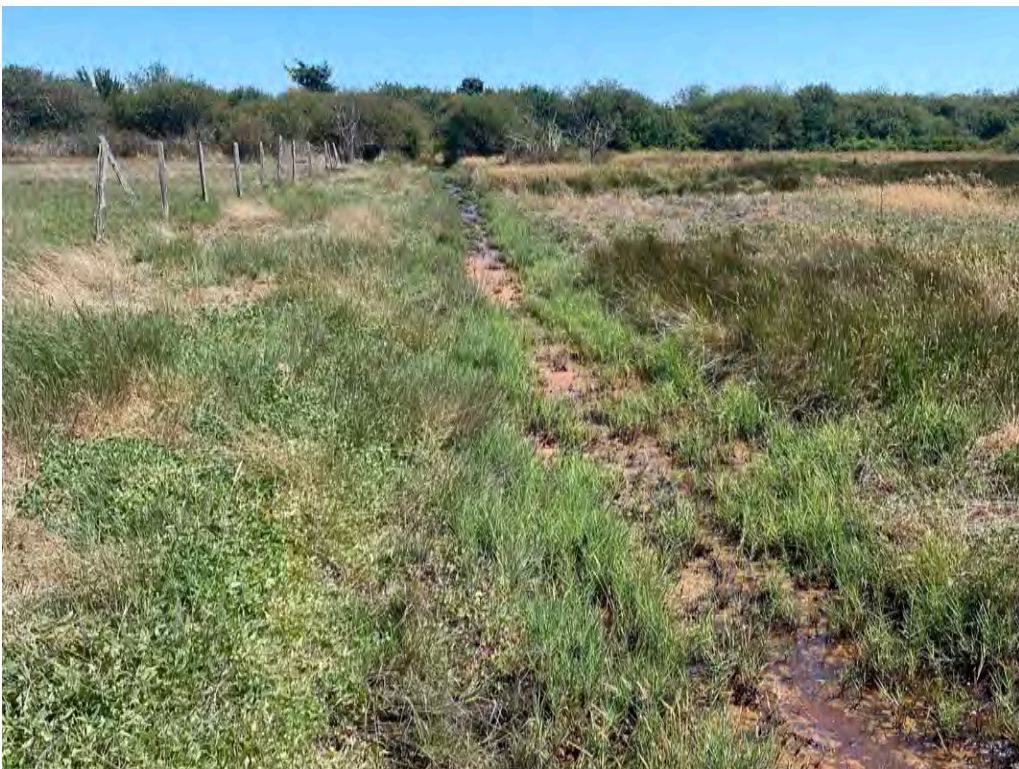
Ditch 5 from the western end of the ditch looking east July 16, 2022.

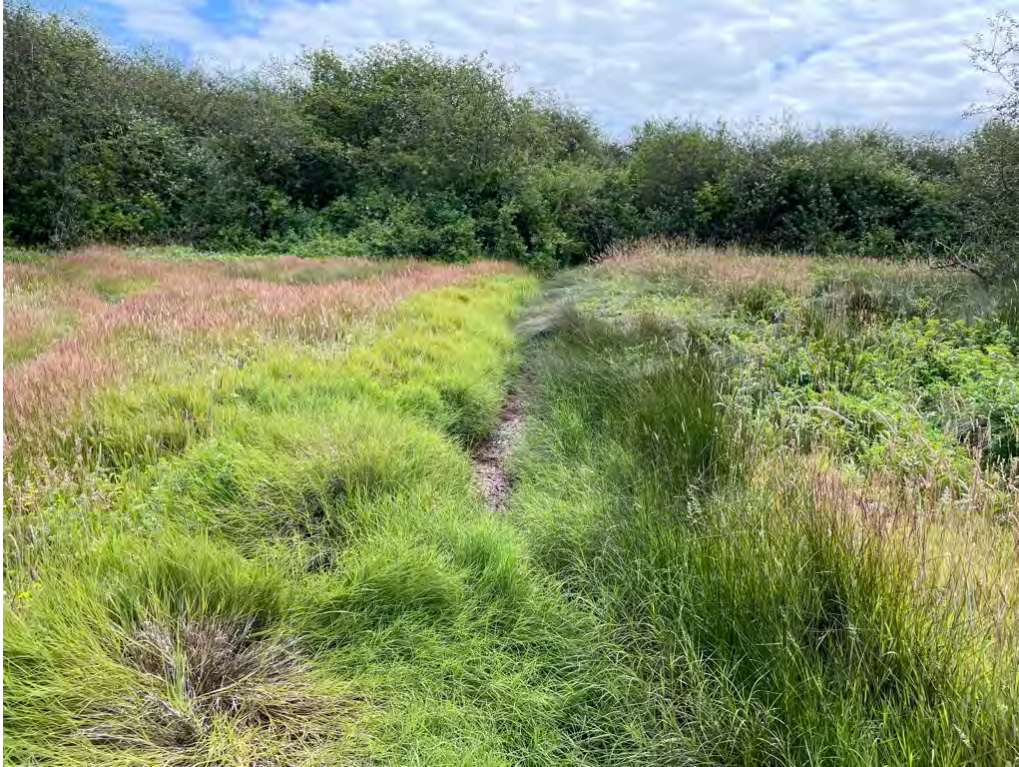
Ditch 5 from the western end of the ditch looking east July 5, 2021.

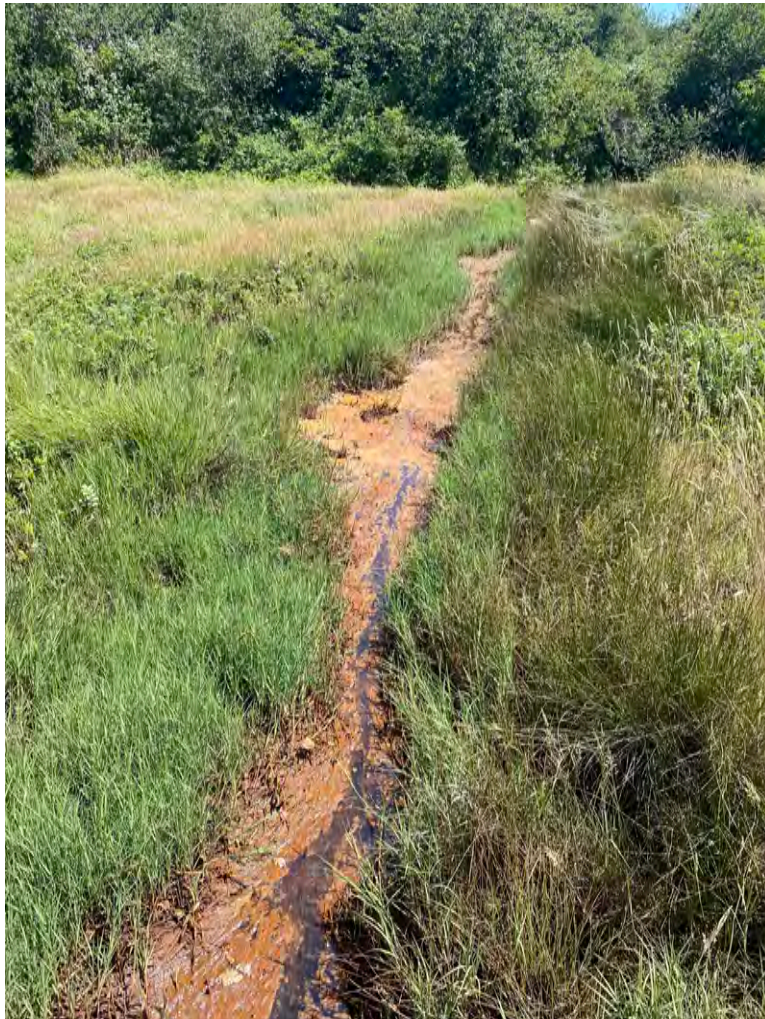
Above: Ditch 3
near north end
of the wet
depression
looking
southeast July
16, 2022.

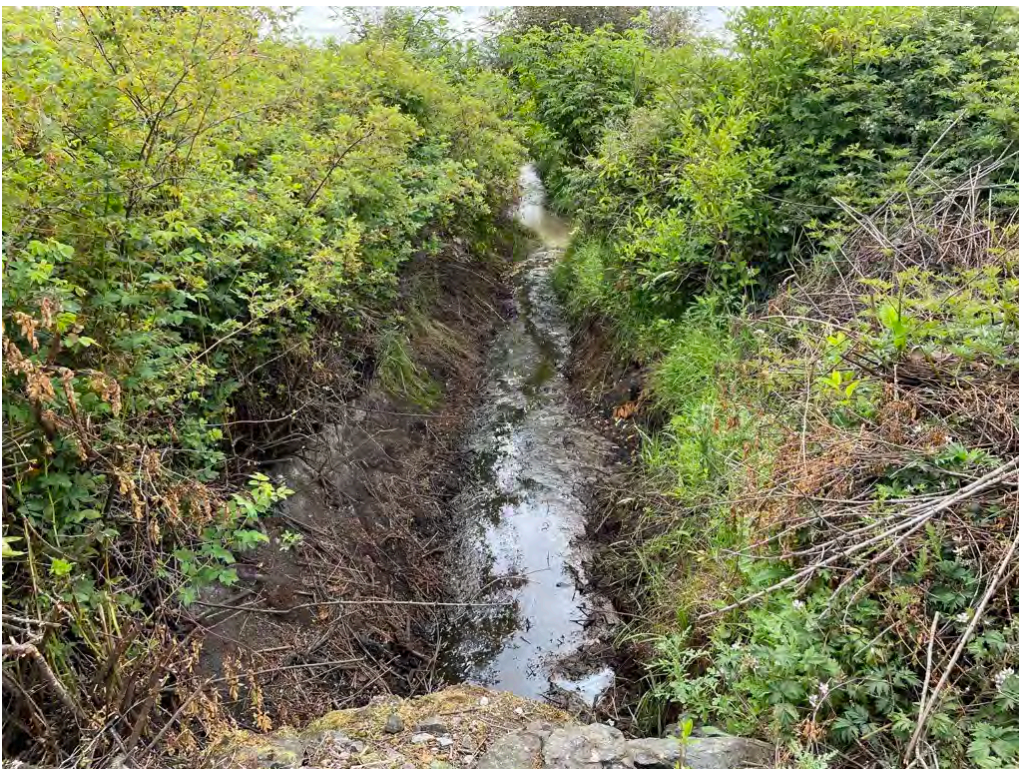
Looking south from trail crossing over intersection of Ditches 3 & 4 looking south down Ditch 4, July 16, 2022.

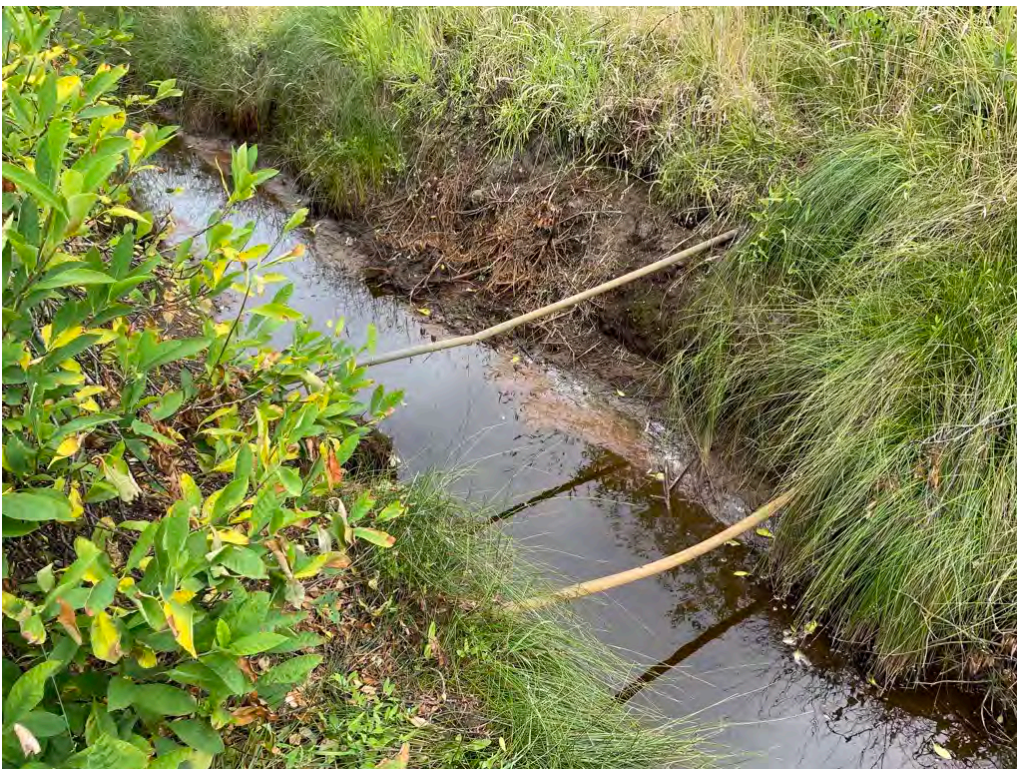
Ditch 4 about 6 m north of the Lamont ROW where old waterlines cross the creek July 16, 2022.

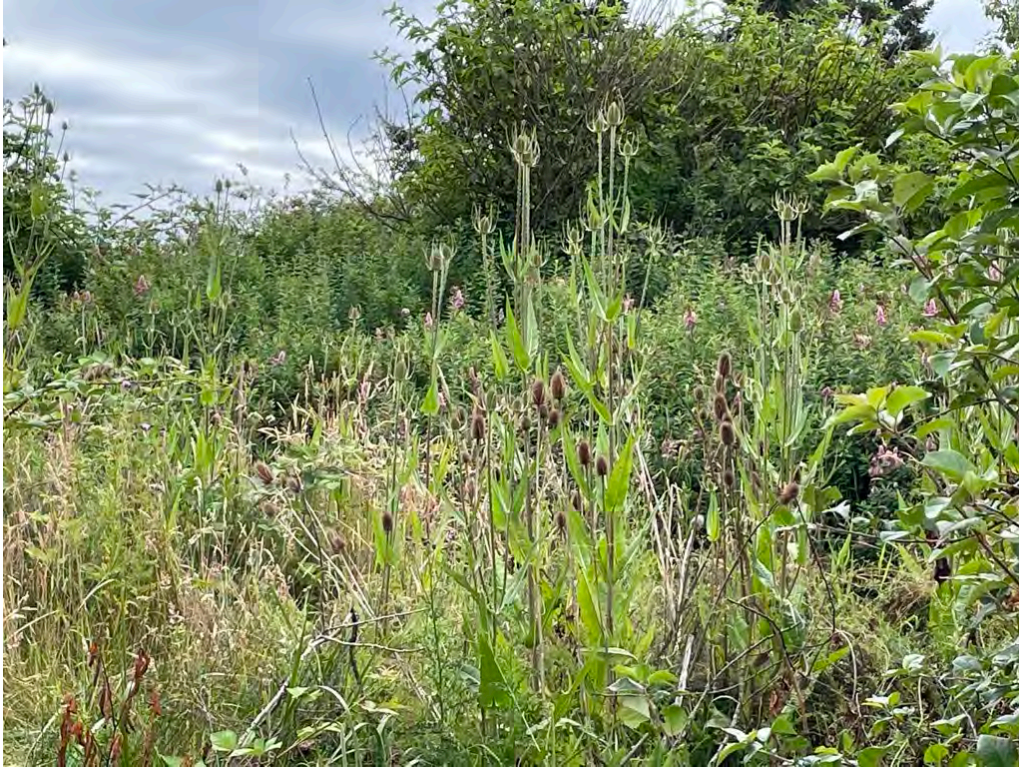
Invasive teasels (*Dipsacus fullonum*) were observed this year along Ditch 4. This is the first time we have noted this plant, but it is becoming common in much of the CRD. It produces thousands of seeds, so controlling this plant before it takes over a larger area is essential.

Invasive teasels (*Dipsacus fullonum*) along Ditch 4 about 60 m north of the Lamont ROW July 15, 2022.

In summary, the ditches were clear of impeding vegetation and sediment and no maintenance was recommended this year, other than control of invasive plants, especially teasels.

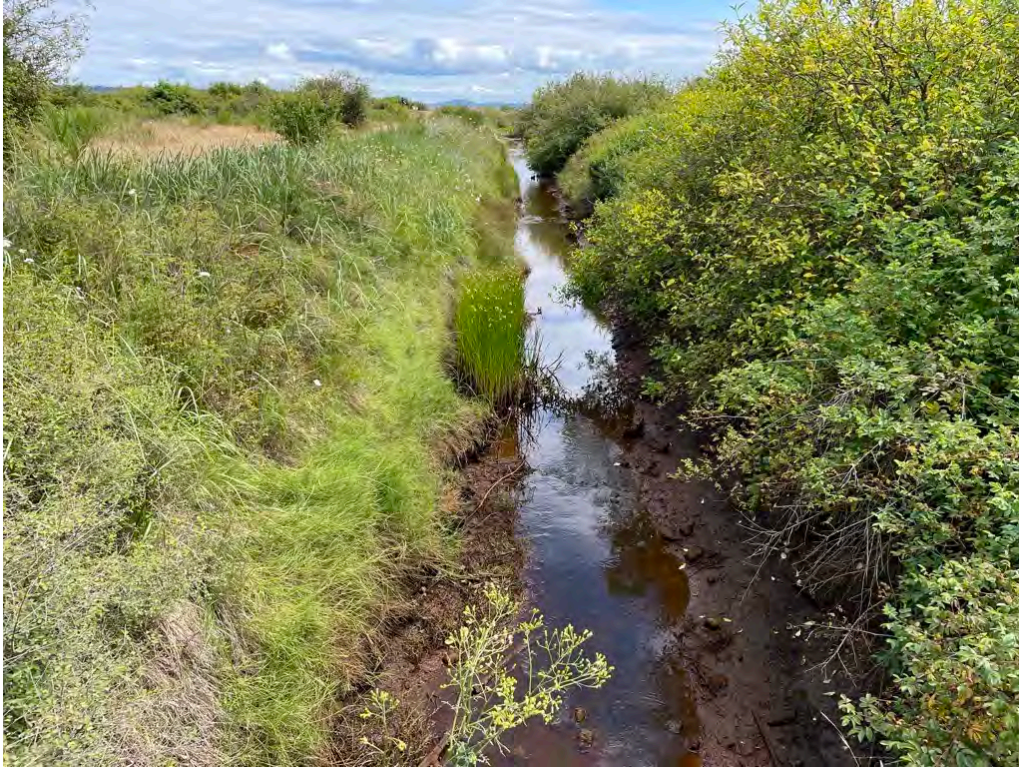
Lamont ROW looking east toward the tide gate July 16, 2022. Water was actively flowing toward the trash rack (seaward).

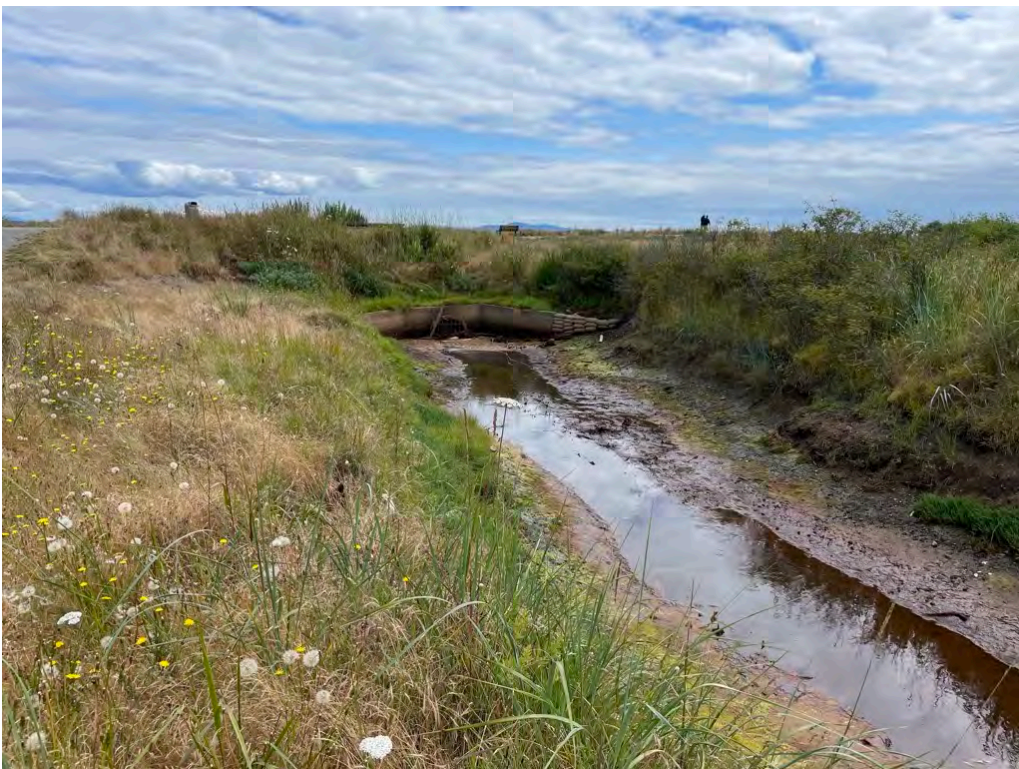
The tide was low enough to observe the trash rack on the Lamont ROW and the tide gate very clearly. Both appeared in good condition though a small amount of debris was noted on the trash rack.

Lamont ROW at the trash rack upstream of the tide gate July 16, 2022.

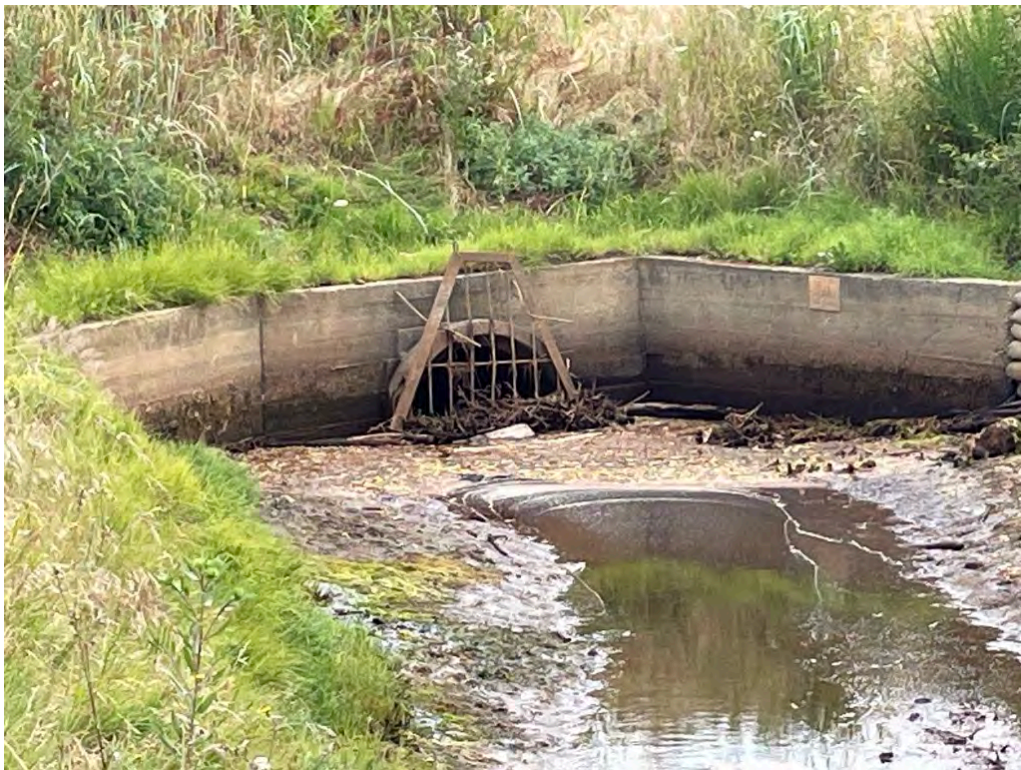
Trash rack upstream of the tide gate July 16, 2022.

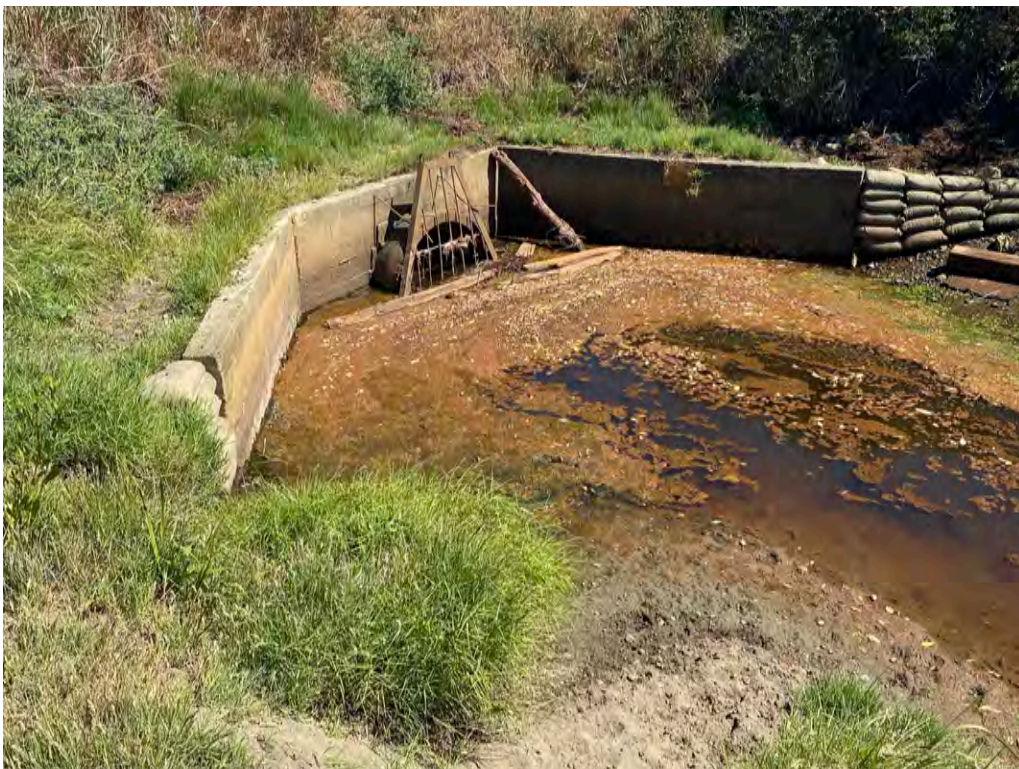
Trash rack upstream of the tide gate July 5, 2021.

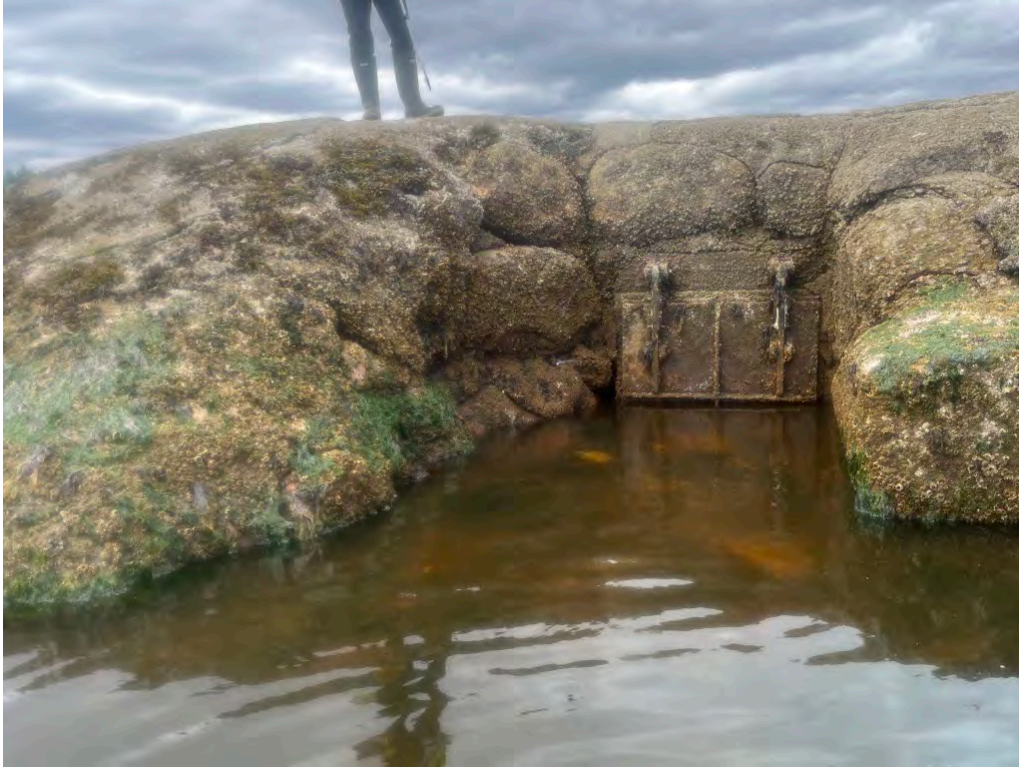
Tide gate at close to low tide 1:00 p.m. July 16, 2022.
