## FULFORD WATER SERVICES COMMISSION

Notice of Meeting on **Tuesday, November 3, 2020 at 10:00 AM**  
Fulford Community Hall, 2591 Fulford-Ganges Road, Salt Spring Island, BC

# Fulford Water System Asset Management Plan

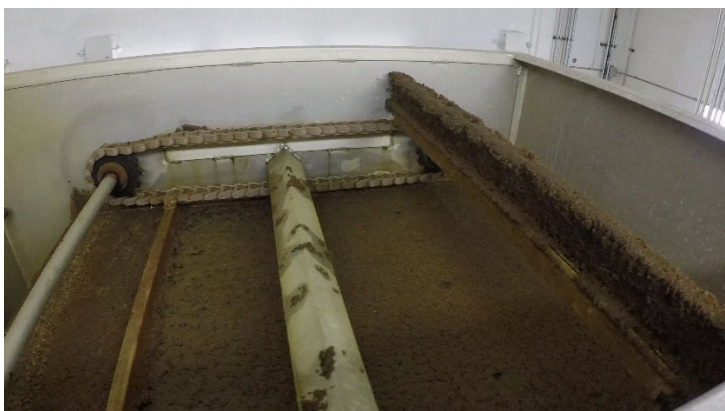
Top of the rapid mix and flocculation tanks. Both mixer motors are leaking. Temporary fix implemented by wrapping the motors with fabric cloths. Drip trays are required to prevent oil from dripping into the rapid mix/flocculation tanks.

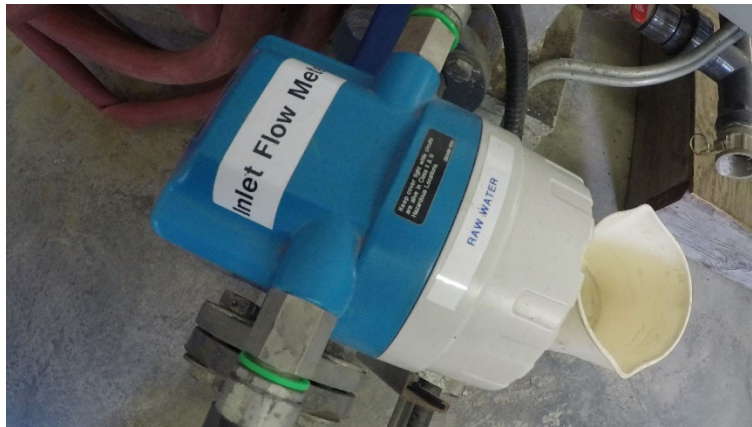
Observation:  
Raw water influent flow meter.

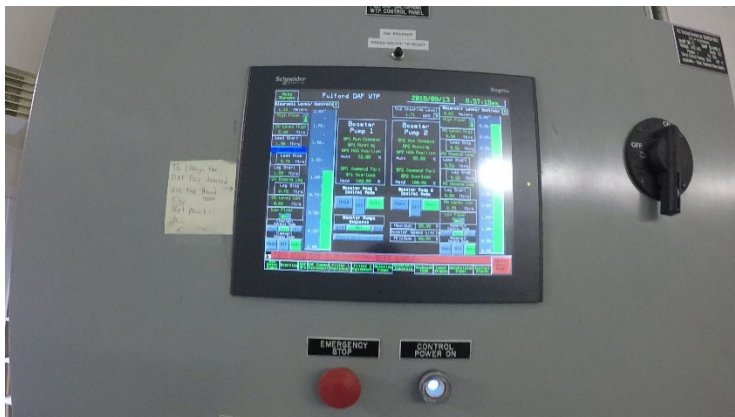
Observation:  
Process control panel with HMI. The WTP has PLC control system for fully automatic operation.

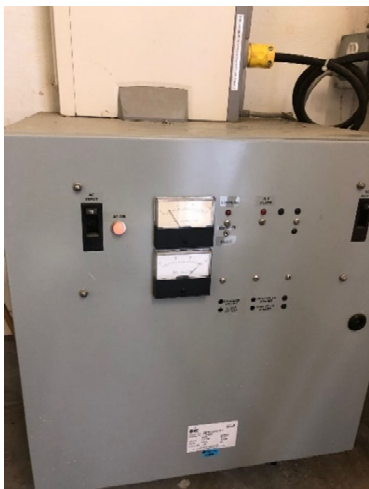
Description:
	DC UPS
	Observation: No issues noted
	CRD Personnel Observation:
	No issues noted

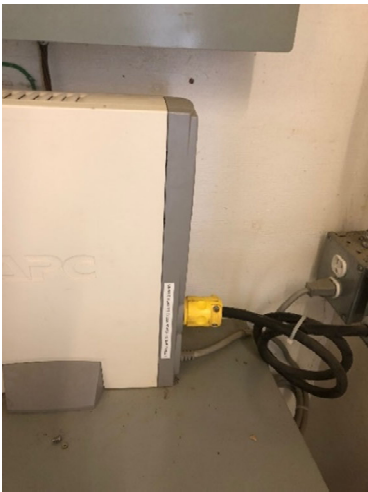
Description:	AC UPS
	Observation:	No issues noted
	CRD Personnel Observation:	No issues noted

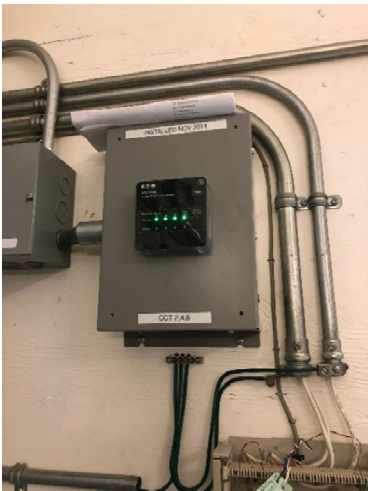
Description:	Surge Suppression TVSS
	Observation:	No issues noted
	CRD Personnel Observation:	No issues noted

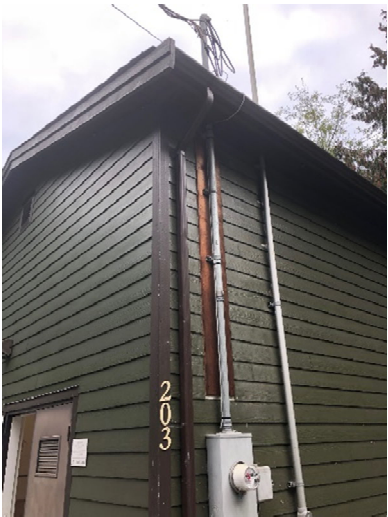
Description:
	Main Service and Radio Mast
	Observation:
	No issues noted

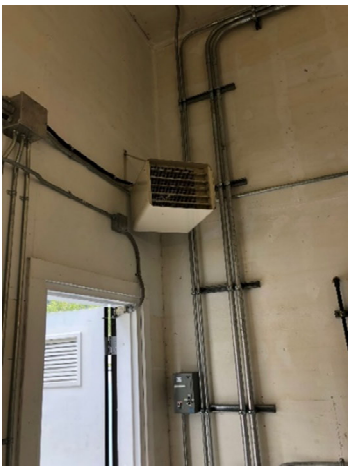
Description:
	Fan Forced Unit Heater
	Observation:
	No issues noted

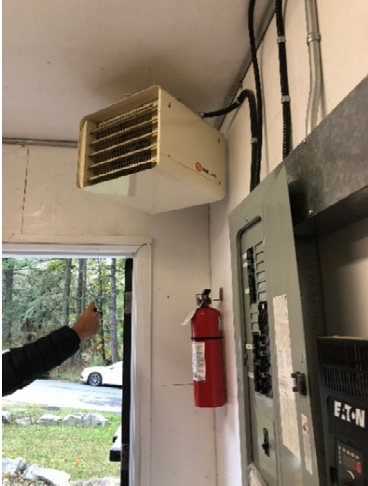
Description:	Fan Forced Unit Heater
	Observation:	No issues noted
	CRD Personnel Observation:	No issues noted

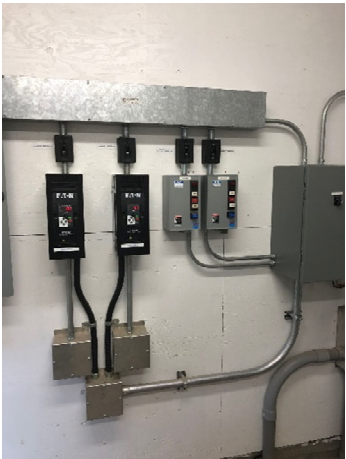
Description:	Recycle Pump Starters
	Observation:	No issues noted
	CRD Personnel Observation:	No issues noted

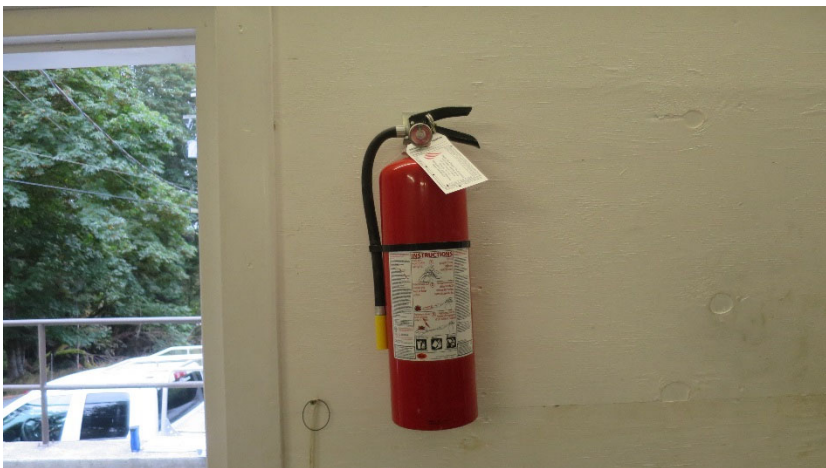
Description:
	Inside Water Treatment Building
	<p>Observation:</p> <p>Fire extinguishers, emergency eyewash, and emergency lighting equipment are serviced on a regular basis.</p>

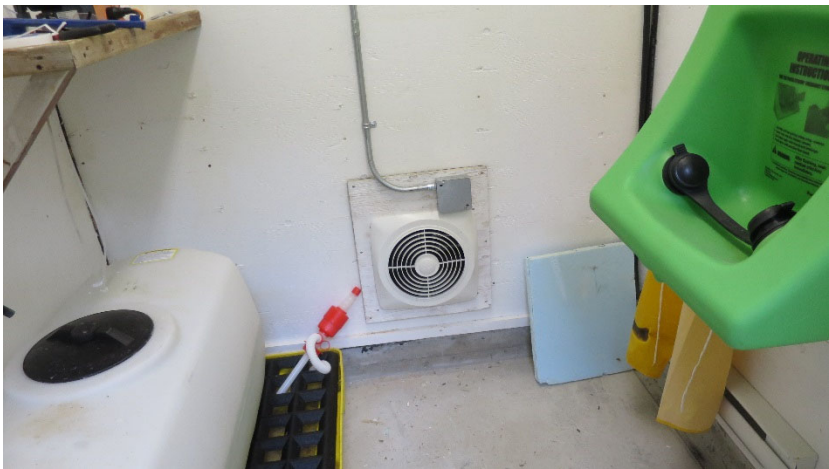
CRD Personnel Observation:
	No issues noted
	Description:
	Chlorine Room in Pump Station Building
	Observation: Inside of chlorine room. Exhaust fan is functional. There is a chlorine containment spill tank installed.
	CRD Personnel Observation:
	No issues noted

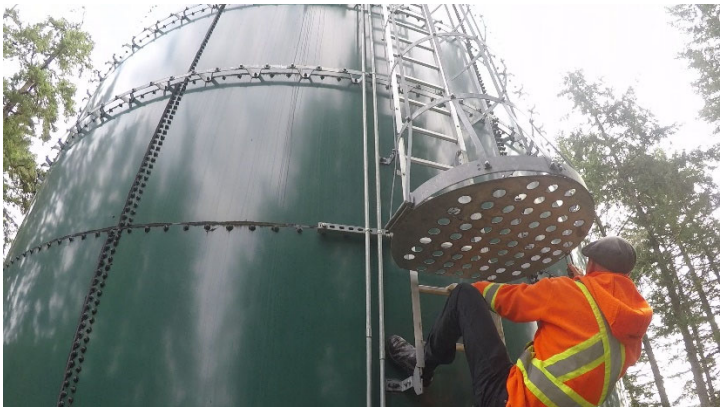
<p>Description:</p> <p>Fulford Water Reservoir</p>
	<p>Observation:</p> <p>Access to the top of the 80,000 Imp. gallon (360 m<sup>3</sup>) bolted steel water tank.</p>

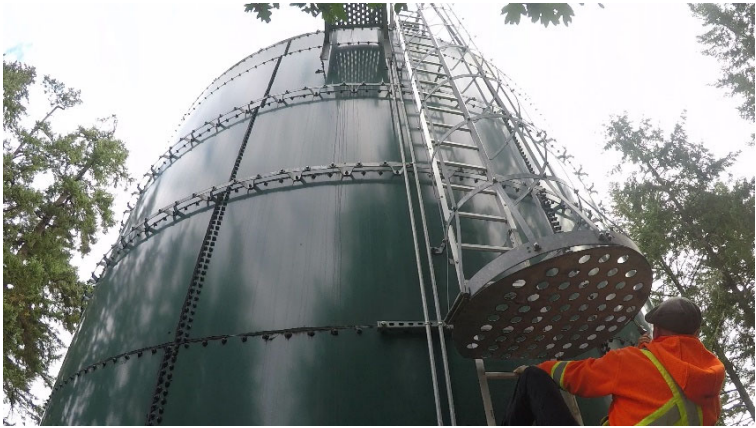
Description:
	Fulford Water Reservoir
	Observation:  Access to the top of the 80,000 Imp. gallon (360 m <sup>3</sup> ) bolted steel water tank.
